TESTS ON THE BIRD IMPACT RESISTANCE OF POLYURETHANE FOAM†

by H.S. Fowler *, AFCASI

National Research Council of Canada

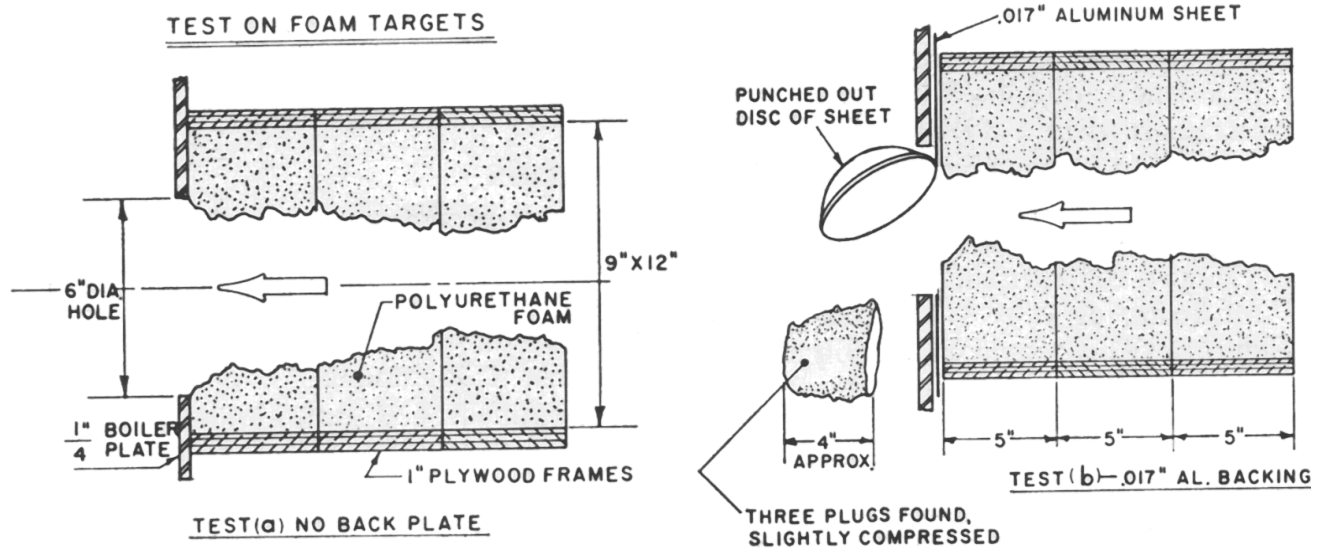
Figure 4 Damage to foam targets

After firing, the target was completely undisturbed, except for a ragged hole through its centre. This hole was about 4" d. at entry, and increased gradually to 6" d. at exit, as shown in Figure 4. The sides of the hole were ragged and torn, showing no sign of compacting due to any lateral pressure. The material removed from the hole was visible only as fine powder and small fragments, No grease from the "bird" was found in the hole, so it must have passed through without rupturing.

After firing, the foam target was found to have a hole through it, exactly similar in nature to that of the previous shot. The backing had made no difference. The backing sheet had been forced against the boiler plate, and punched cleanly round the 6" d. hole in the plate, although the hole through the foam was only about 4"/5" d. The "bird" was found in the tank behind the plate, in a relatively undamaged condition, and three plugs of foam were found with it. These had been driven through the target in a practically uncompressed condition, showing that the foam shears out at extremely low compressive stress.

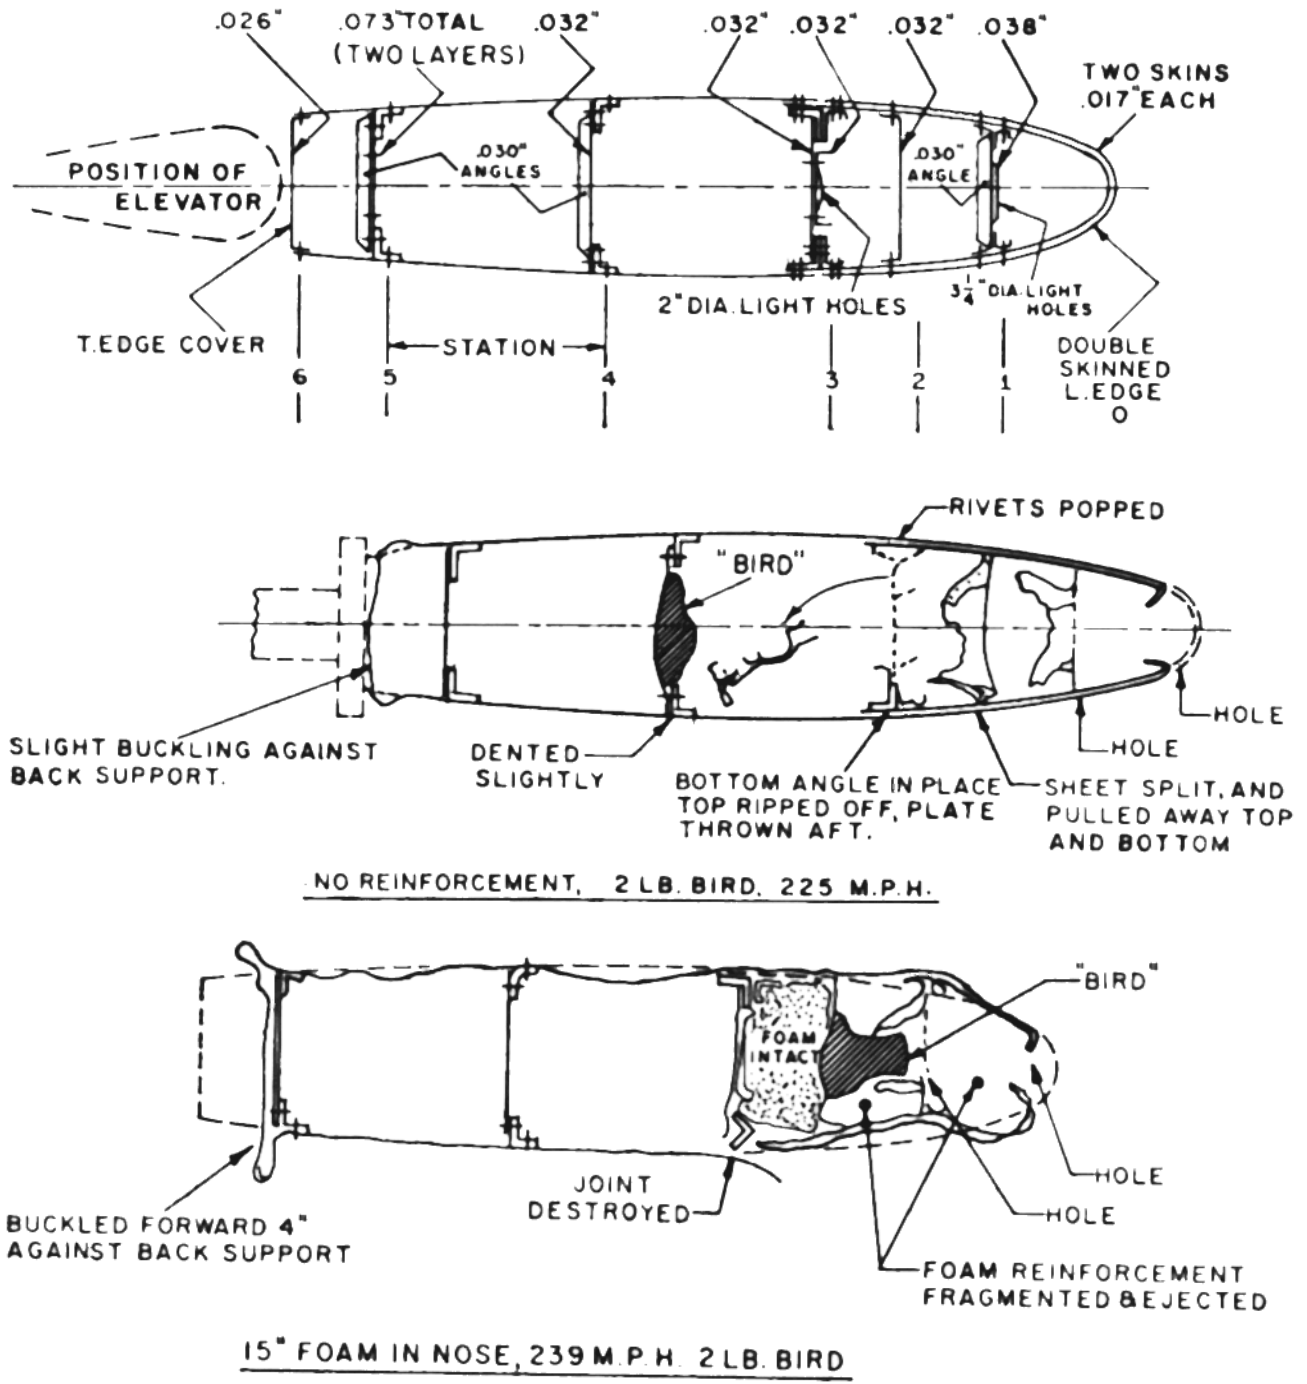
Figure 5 Horizontal stabilizer tested

The results of the shot are seen in Figure 5. The "bird" made a 5" d. hole in the leading edge, a 5" d. hole in the plate at station 1, split and pulled away the plate at station 2, pulled out and broke off the top angle, smashed the main spar, and tossed the remains from station 3 into the space aft, and came to rest against the dented spar at station 4. The wrecked area extended over a good 12" length of structure in the spanwise direction.

It is the writer's opinion that the stabilizer would have failed under normal flight loads, after this strike. The load imposed on the stabilizer mountings can be surmised from the 1/2" or so of buckling at the trailing edge, where the main impact load was transmitted to the ground in this target set-up.

A 2 lb. "bird" was fired at the leading edge, at 350 ft./sec. (239 mph). Referring again to Figure 5, the entry hole in the leading-edge was exactly similar to the case without foam packing, and the "bird" again penetrated the plate at station 1 in the same way. The foam packing between stations 0, 1, and 2 was completely fragmented and flew in all directions, in pieces varying from 2" d. to fine powder.

The unit formed by the plate at station 2, the main spar at station 3, and the block of foam between, stopped the "bird". However, in doing so the attachment of the main spar to the skin was completely destroyed and the skin joint split open, with all rivets popped, over an 18" length (spanwise) of tailplane. Furthermore, the trailing edge of the tailplane was crumpled about 4" against its supports by the impact, and the whole plane was badly distorted.

Owing to the local detachment of the main spar, the writer again feels that the tailplane would have failed under flight loads. The crumpling of the support surface shows that the impact load imposed on the stabilizer mountings would have been much greater in this case than in the previous case.
