Client Report (National Research Council of Canada. Construction); no. A1-008997-01, 2016-07-19

Les Terrasses de la Chaudière — Preliminary Risk Assessment of Existing Brick-faced Wall Panels

A1-008997-01
19 July, 2016

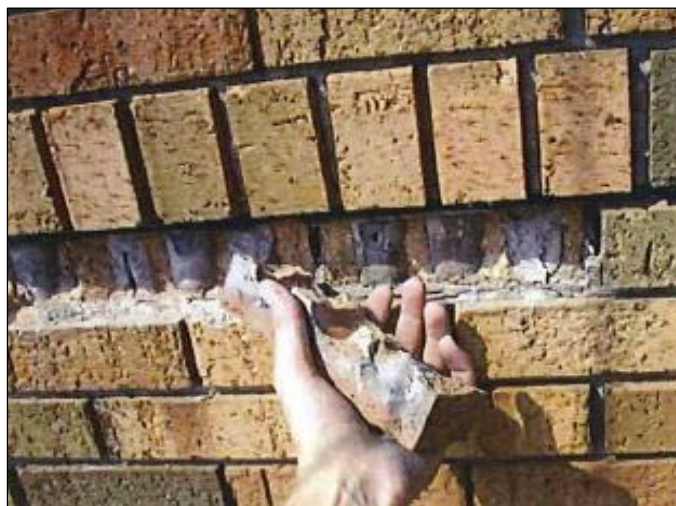
Figure 13 – Brick splitting as observed by JCAL 2010

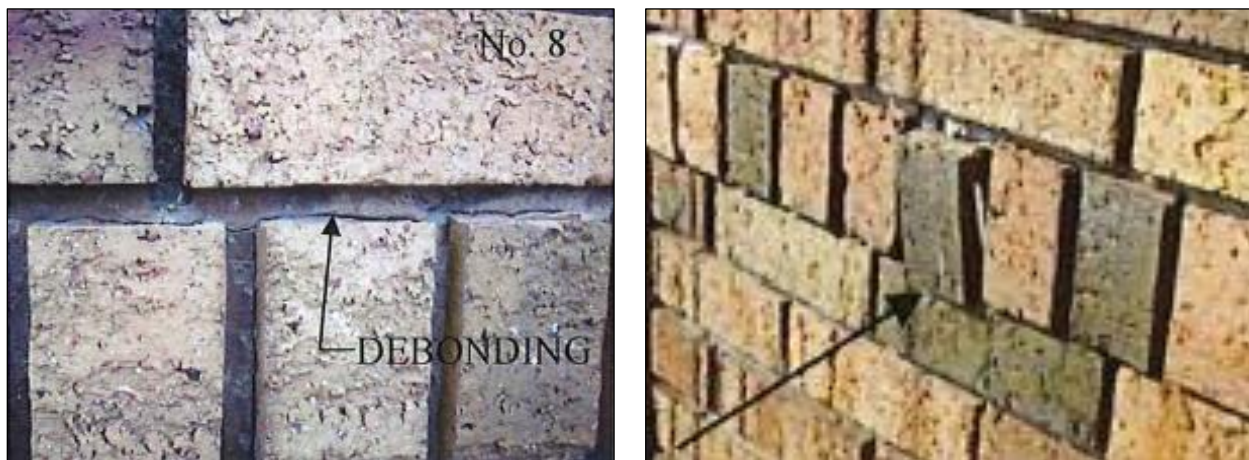
Figure 17 – Brick de-bonding and loosening as observed by JCAL (2000)

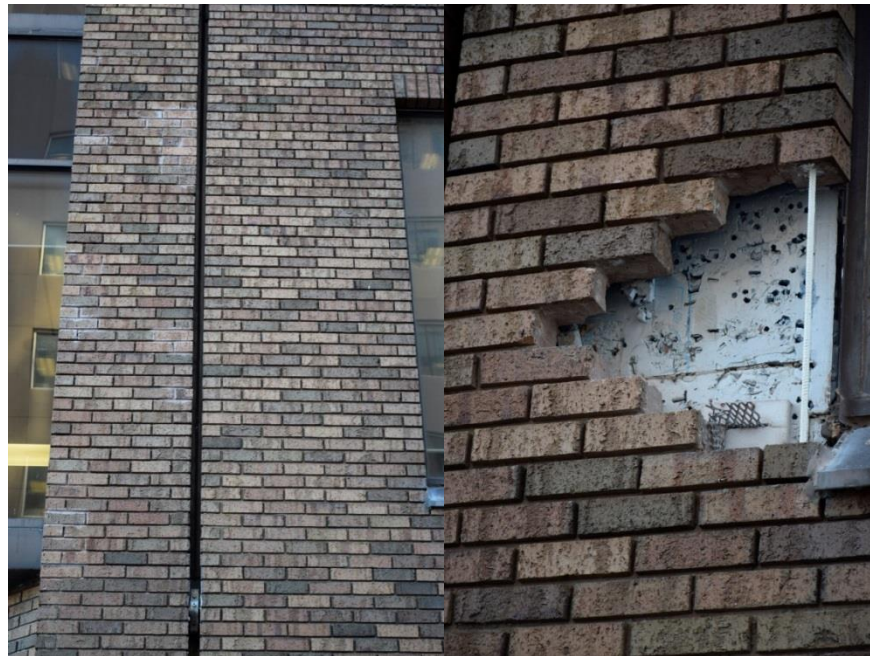
Figure 25 – Examples of repairs to brick units and brick veneer assembly conducted on East (Left) or to be completed on North (Right) façade of TDLC Block 100.

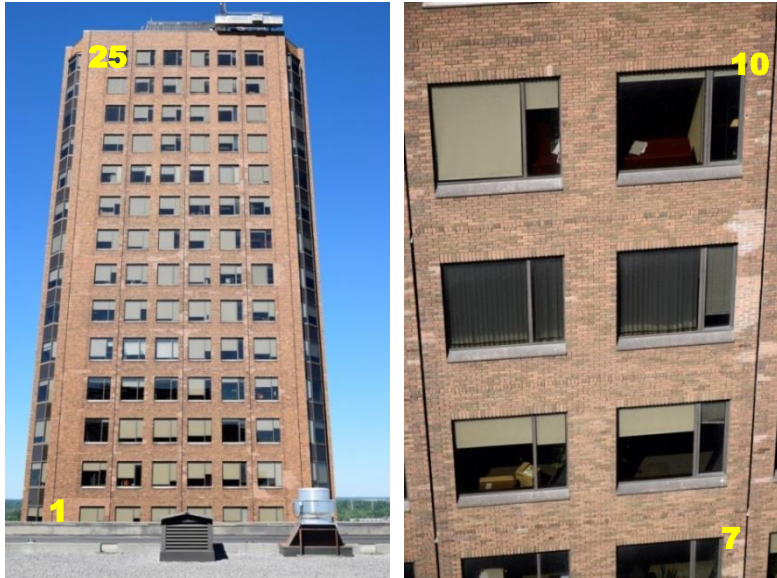
Photos of elevations of Block 200 showing the East façade (levels 11 to 25) and in which recent repairs to the brick façade are evident are given in Figure 26 and Figure 27. In Figure 26, the East facing facade from levels 11 to 25 are apparent and in which can be seen a number of instances where repairs have been completed; this is more clearly evident for repairs undertaken on levels 7 to 10 where the differences in tint of the bricks

Figure 26 –Elevations of Block 200 showing East façade of levels 12 to 25 (left) and details (right) of recent repairs along levels 7 to 10

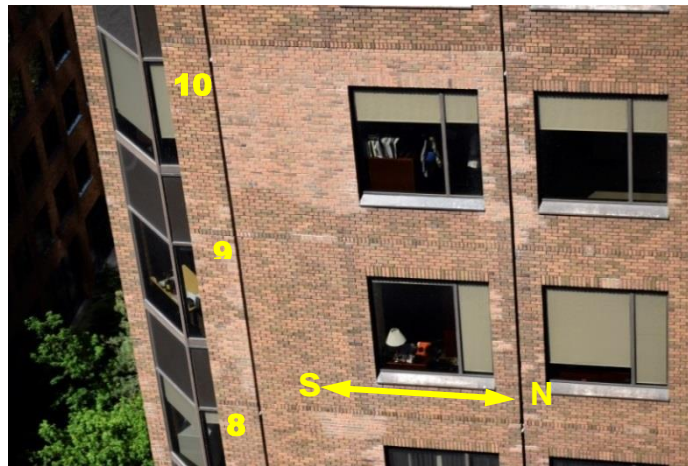
Figure 27 – East façade elevation, Block 200 showing extensive repairs to brick façade at level 8, but particularly at level 9

provides evidence of recent repairs on wall panels where the lighter hue indicates newly repaired brick. In Figure 27 can be seen the extensive repairs to the brick work undertaken on a panel located on the East façade of Block 200 at level 9; this panel is located towards the South side of the East façade.

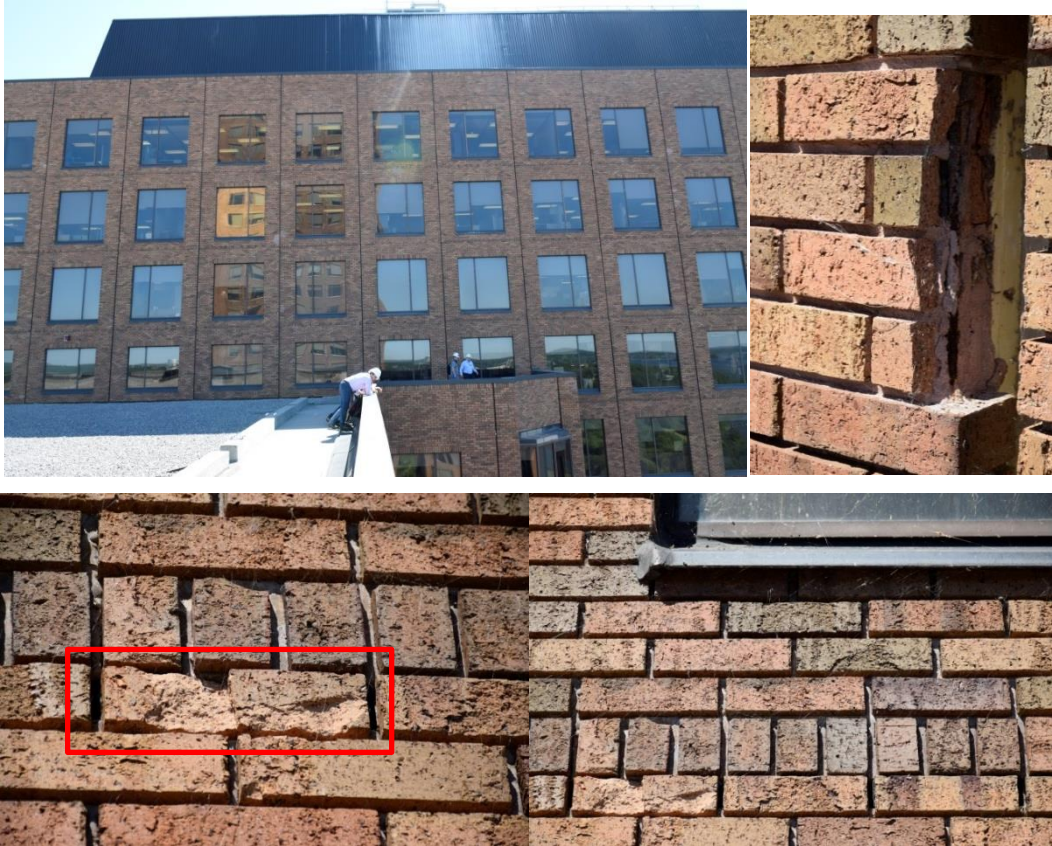
Figure 28 - Photos (Top-left) of elevation of West facing façade of Block 100 showing Roof (level 11) to Level 14; (Top-right) Evidence of brick fracture at panel joints; (Bottom photos) Details of brick spalling on East face of Block 100; Evidence of spalling of brick facia, likely due to freeze-thaw action; water run-off from window sill above wet portions of brick beneath sill making these locations more susceptible to freeze-thaw action

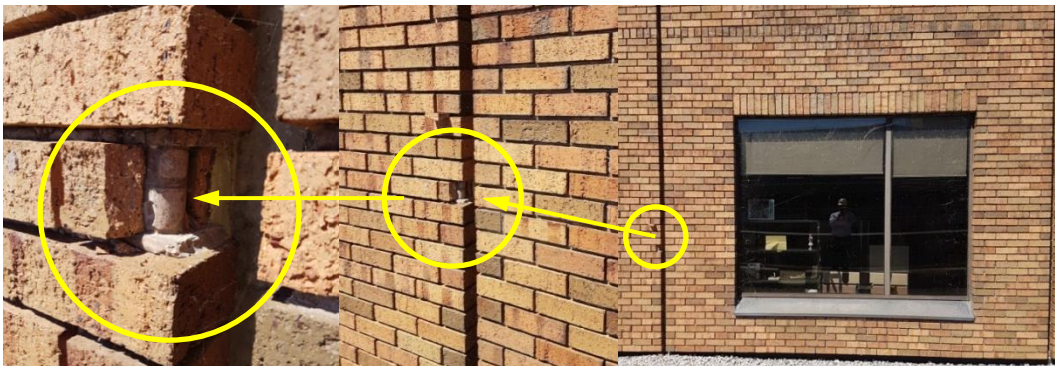
Figure 29 – Evidence of brick failure at a panel joint; failure of half brick unit likely due to dissimilar values of coefficient of thermal expansion between brick and mortar; mortar is seen to be completely intact; no degradation of mortar evident

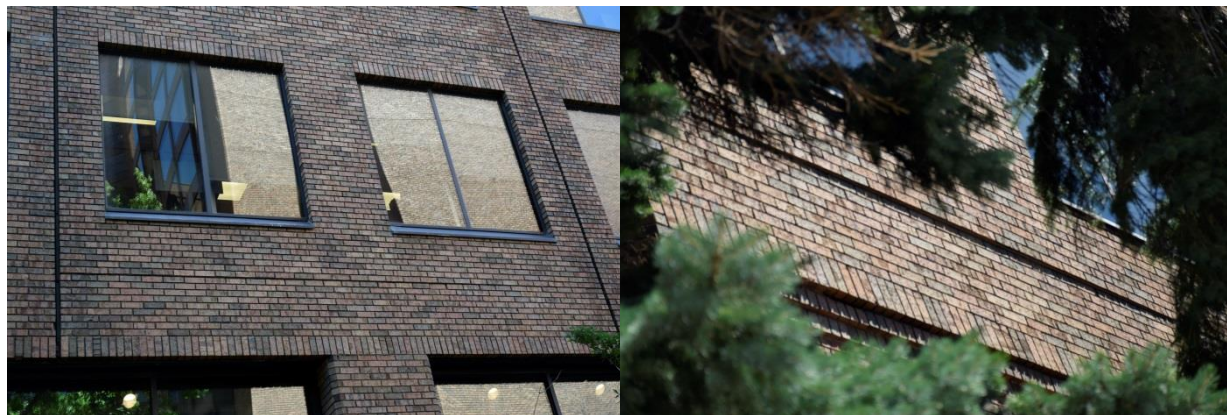
Figure 30 – Evidence of bowing of concrete panels; clearly evident only on panels having 2 windows

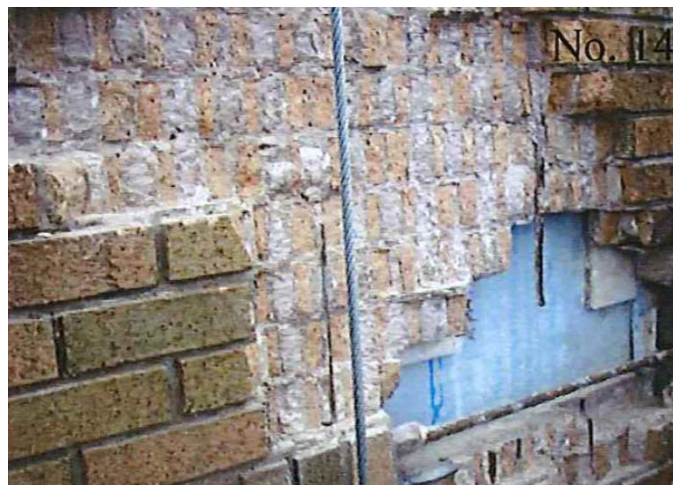
- Rare climate events such as severe decrease or increase in temperature or prolonged periods of elevated temperature, freezing rain events, which could lead, for example, to excessive deformations in either the brick or mortar.
- Seismic events that may have induced some damage to the cladding system. Rapid fluctuations in temperature in combination with other effects could as well lead to non-synchronous expansions between components (brick, mortar) that in turn could result in fracture of the brick, as is shown in Figure 42.

Figure 42 – Example of brick failure on wall panel

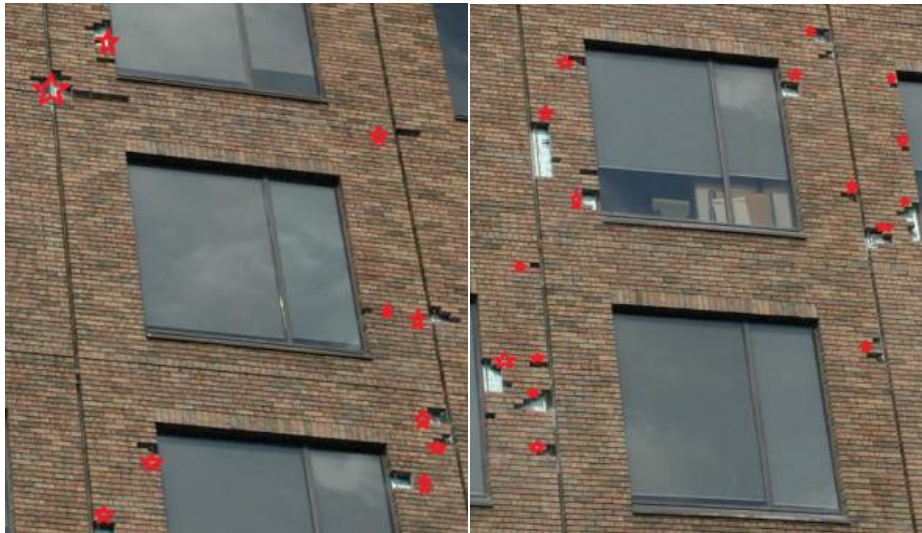
Figure 43 – Examples of brick damage at panel edges and window
