Tests on an air-cushion assisted trailer ACAT-1: test stage 6: completion of road, gravel road & soft track tests 15 ton total load (including lift system)

Laboratory Technical Report (National Research Council Canada. Division of Mechanical Engineering. Engine Laboratory); no. LTR-ENG-43, 1975-07

REPORT RAPPOR LTR-ENG-43

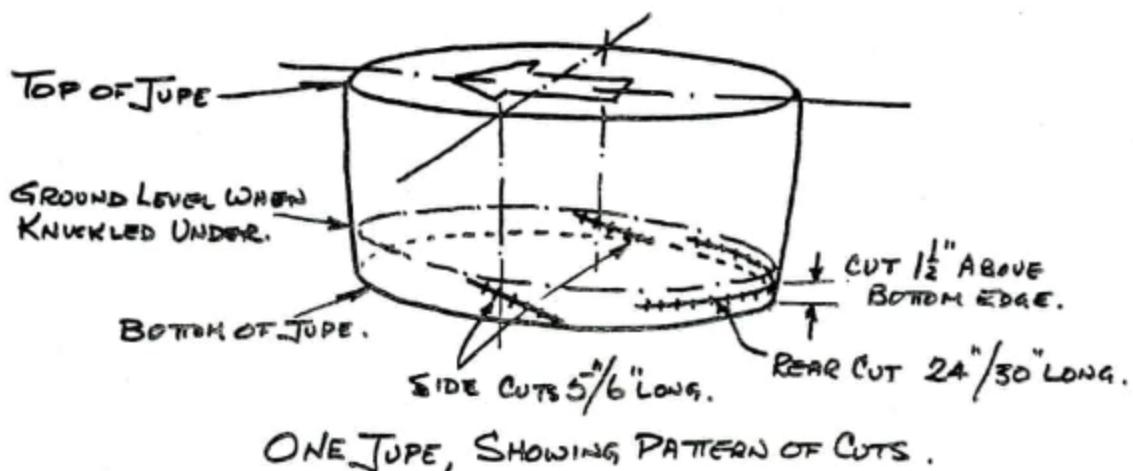
To date it appears that skirt wear is due mainly to about $7\frac{1}{2}$ miles of operation over poor concrete road at 50% load relief (of a 15 ton load). It is noted that the blow-off valves in the lift pack bags have not been operating and that the airboxes are leaking, probably with a greater total flow than the blow-off valves would provide. There is also an intermittent very large leak (usually leaking) between the aft lift pack rear centre curtain (partial jupe) and the aft right jupe. Under these conditions, every jupe is knuckled-under to an extent of about $2\frac{1}{2}$ " (witnessed by scrape marks on jupes, see photo 1A3, Fig. 8 for example), and the knuckled-part folds in a pattern closely repeated from one jupe to another, over all the jupes. The material then scrapes on the ground with great force along the crests of the folds, causing abrasion, and finally cutting clear through the material in a precise and repeatable pattern.

In practice, the blow-off valves are of such absurdly poor mechanical design that they are not operating, and at the operating condition noted the jupe is knuckled-under about $2\frac{1}{2}$ " , while the lift pack airbag is stable at almost full extension. In effect, the failure of these valves to operate is completely crippling the performance of the lift packs." [End of quotation]

From this point on, the wear pattern did not rise further up the jupes, but simply became more severe in the existing pattern and place. The rear 120" cut parallel to the jupe lower edge became more definite, and the partly detached ribbon of material ripped off. The "tails" from the two side cuts became more damaged, and in most cases ripped off. The remaining lower edges of the jupes had the rubber eroded off on the downward facing side (usually the outside) leaving bare scraped nylon.

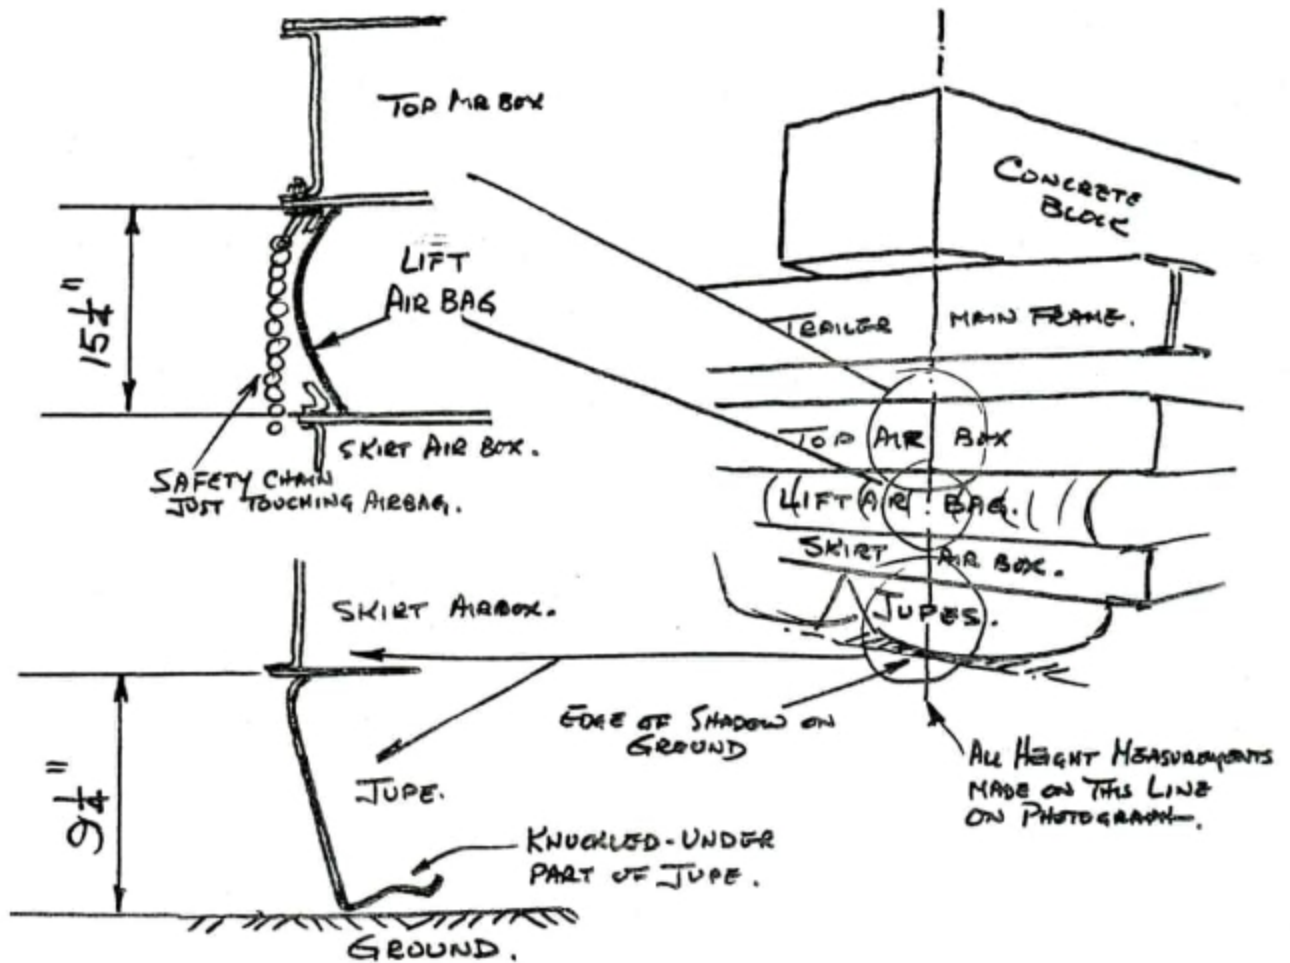
A photograph of the vehicle hovering over a flat gravel road at the end of the soft-road test was analysed to determine the extension of the lift-pack airbag and the jupes, at 80% load relief. Observations showed that these extensions were almost constant over a range of load relief.

Measurements made at the middle of the Left hand side of the rear lift-pack. Front lift-pack was at exactly the same height, as the photo clearly showed.
