Marine icing events: an analysis of images collected from the Marine Icing Monitoring System (MIMS) Gibling, L.

Student Report (National Research Council of Canada. Institute for Ocean Technology); no. SR-2007-07, 2007

**MARINE ICING EVENTS AN ANALYSIS OF IMAGES
COLLECTED FROM THE MARINE ICING MONITORING
SYSTEM (MIMS)**

SR-2007-07

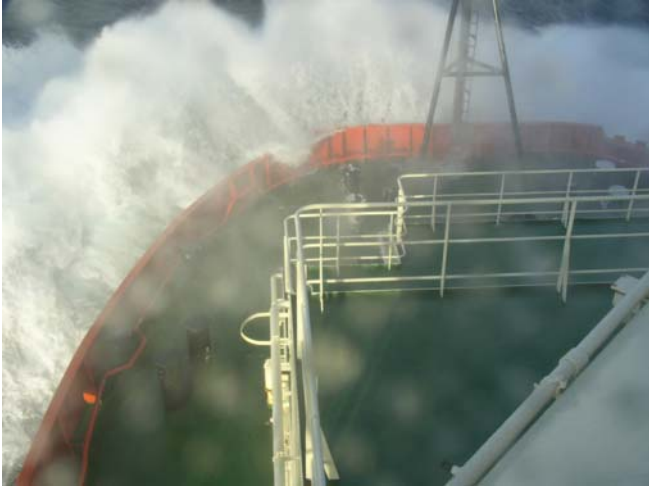
Figure 1a. Wave induced deck spray

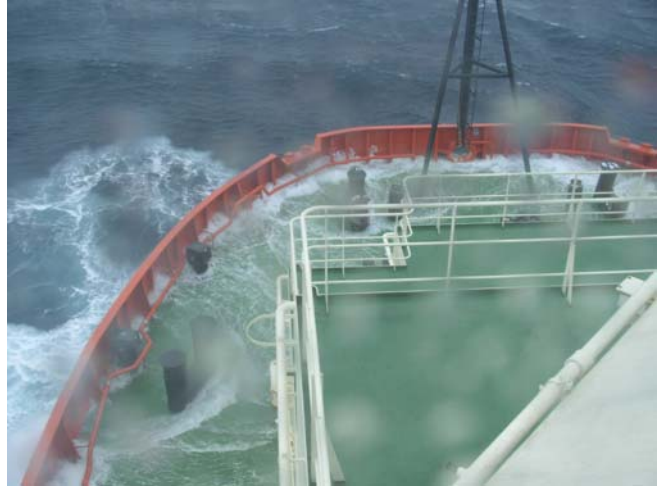
Figure 1b. Water on the deck

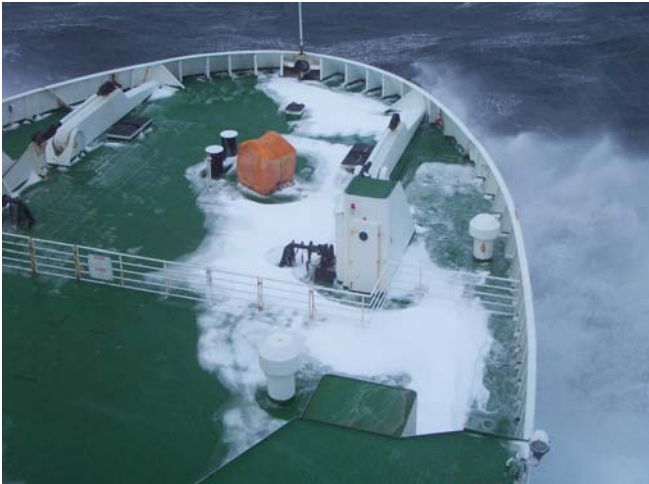
Figure 1c. Wet snow on deck

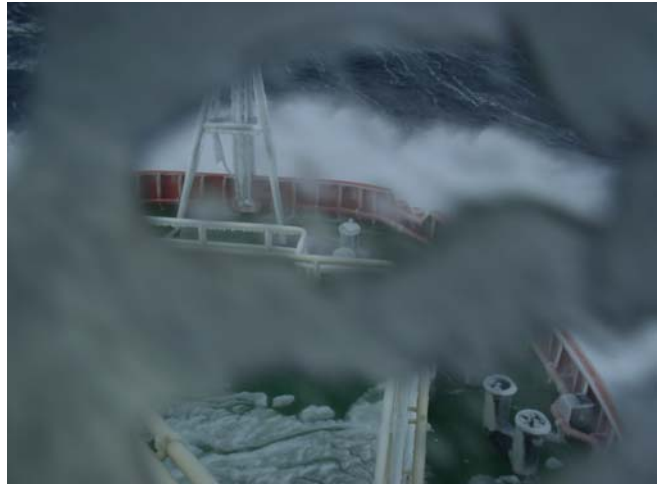
Figure 1d. Partial camera coverage

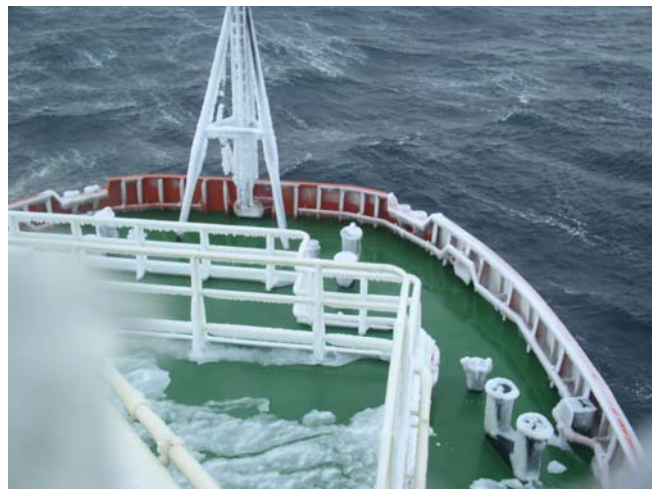
Figure 1e. Ice on the vessel

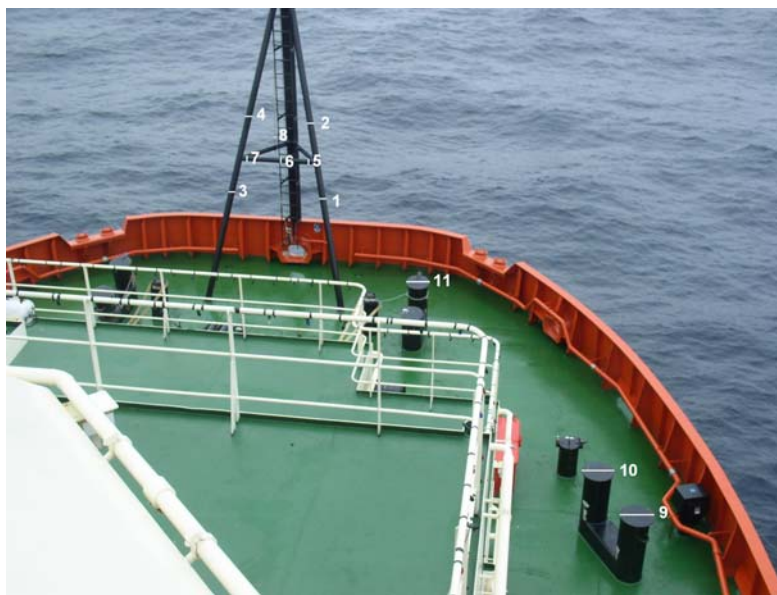
Figure 2. Points selected for measurement of ice thickness

Certain areas on the vessel experienced greater ice accumulation than others. The area labelled point 8, which was located on a rope in Figure 3 experienced a significantly larger fractional growth than all other points of measurements. The rope was the only object selected for measurements that was not made of metal. This could indicate why it had a larger fractional growth. The two points that experienced the second and third highest fractional growth were points 5 and 7. These points were located on the black structure at the front of the bow, at each end of the horizontal pole. Significant ice build

up here could have been caused by water running off the vertical poles, pooling, and freezing on the ends of the horizontal bar. The points 9, 10, and 11 (the posts along the deck of the vessel) experienced the least fractional growth.

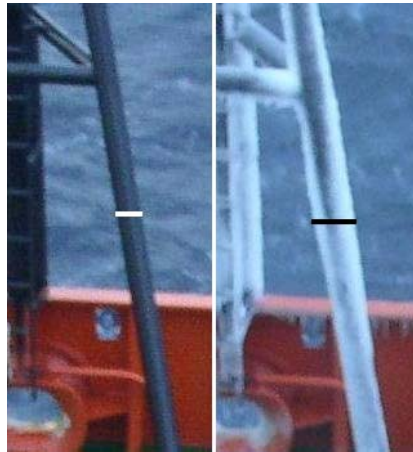
Figure 4. Measurements of Point 1 before and during an icing event
