# **Water Stream Displacement of Aircraft Windows and Overwing Exits – A Preliminary Study**

**Report No.:** LTR-SMM-2017-0032

**Date:** February 2017

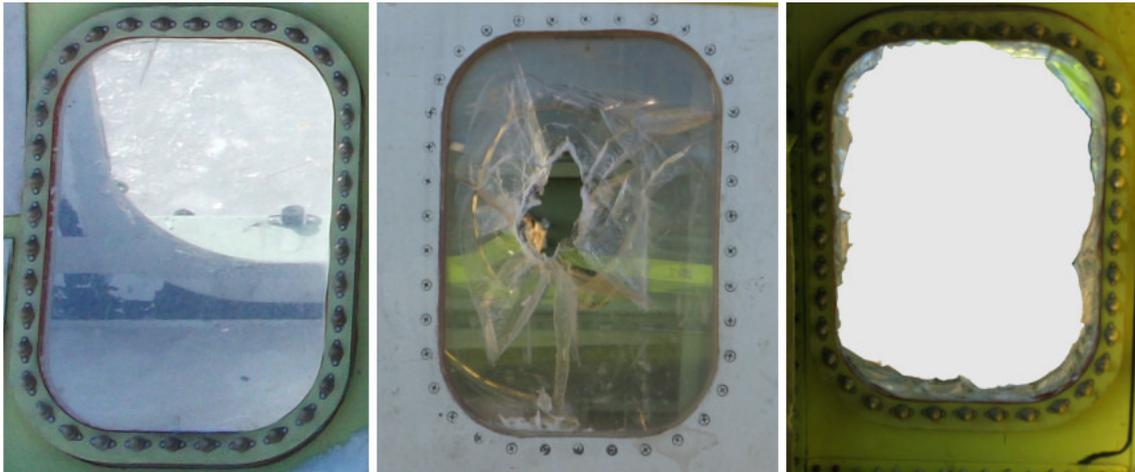
b) Outer, fire axe damage

c) sharp edge fragments

**Figure 6: Bombardier Challenger 601 with 31 bolts (similar to CRJ100/200).**

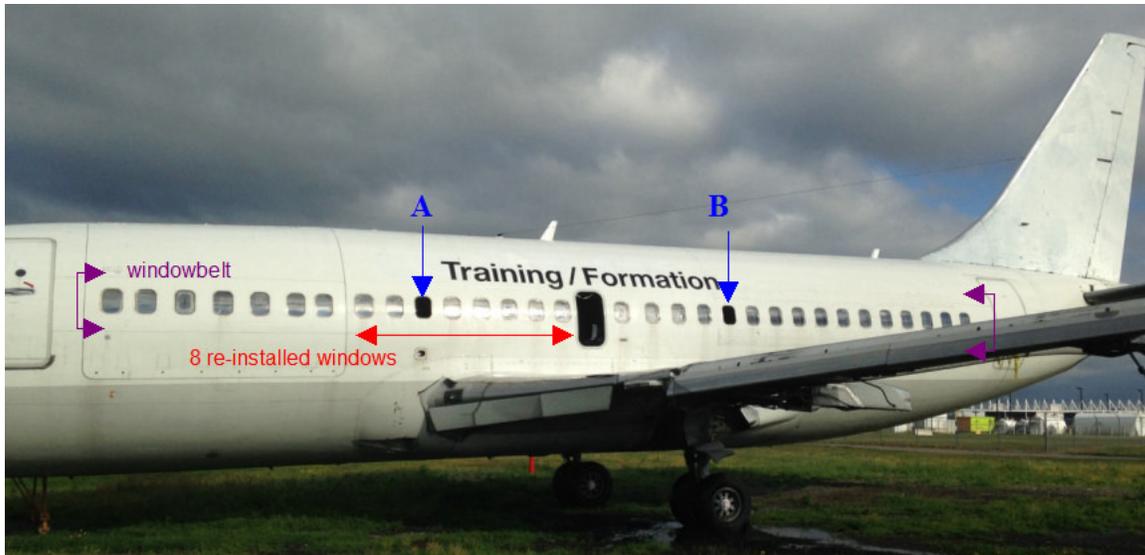
**Figure 8: Two cabin windows (at A & B) and OWE door pushed in by water stream.**

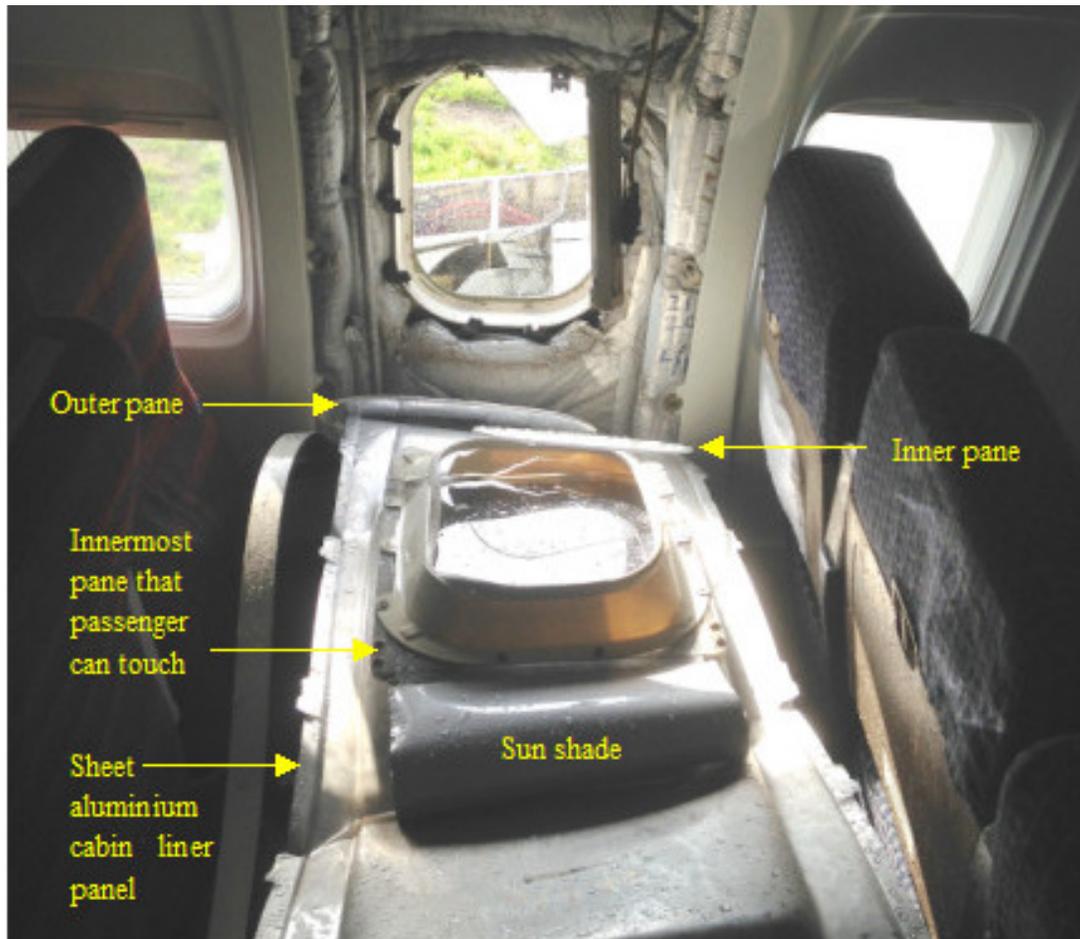
Figure 10 shows the interior view of the window pane and cabin liner damage and displacement caused by the water stream striking the window at location B. Figure 9 shows the inner surface of a section of B737 fuselage illustrating the bare structure of the windowbelt area.

**Figure 10: Results of water spray on the window panes and cabin liner panel at location B.**

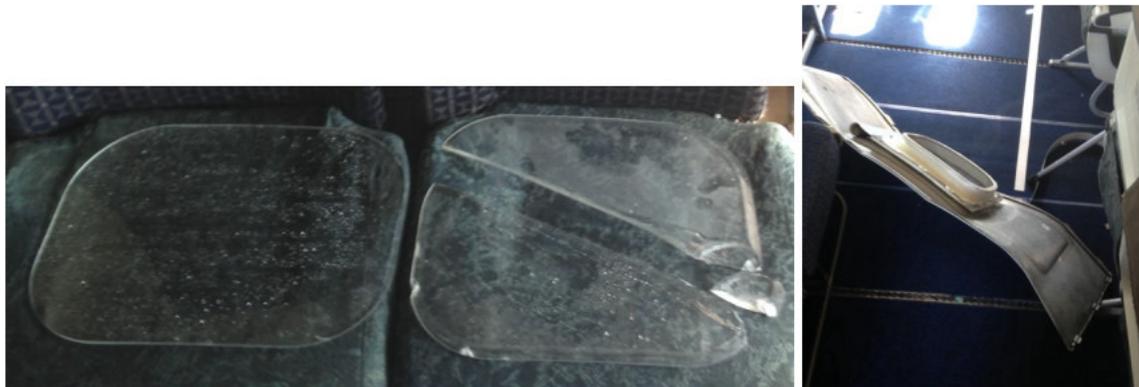
After the test the outer pane showed impact damage in two locations along the lower edge, having broken into three pieces. The cabin liner was completely displaced, bent and found almost in the centre aisle, as shown in Figure 12.

a) cabin window panes – L, inner: intact, R, outer: broken      b) cabin liner

**Figure 12: Post-test B737 cabin window damage.**

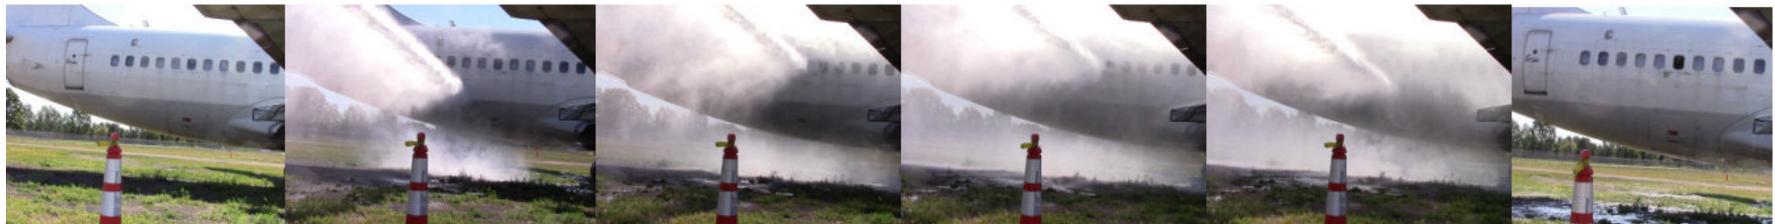
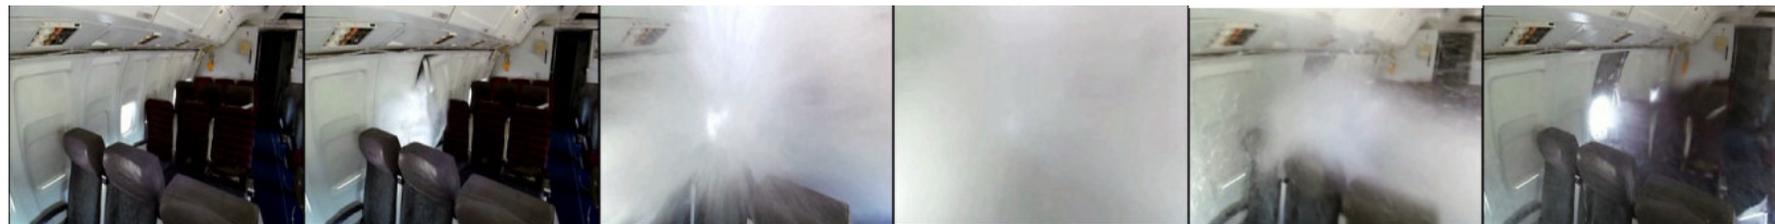
The fire truck driver's position in the cab relative to the turret on the cab roof made it difficult for the operator to target one specific window because the view was obscured by the water stream and spray once it deflected off the fuselage. Three attacks were conducted before the water stream was successfully directed onto the selected window. The camera records show that little water impacted on the window in the first two attempts from 100 and then 65 feet (30.5 and 19.8 m). Using hand signals, the operator was guided onto the window from 45 ft (13.7 m) – basically just beyond the wing tip. In this third attempt the truck pumped water for 12 seconds total, consuming 240 gallons (757 liters). Water was impacting in the area of the windowbelt for 6 seconds. The target window started to vibrate as the water impacted it and it failed within the first second of direct contact. Sequential screen shots from the exterior and interior videos are shown in Figure 13a) and b).

**Figure 13: Cabin side window trial on B732 Passenger ERS training aircraft.**

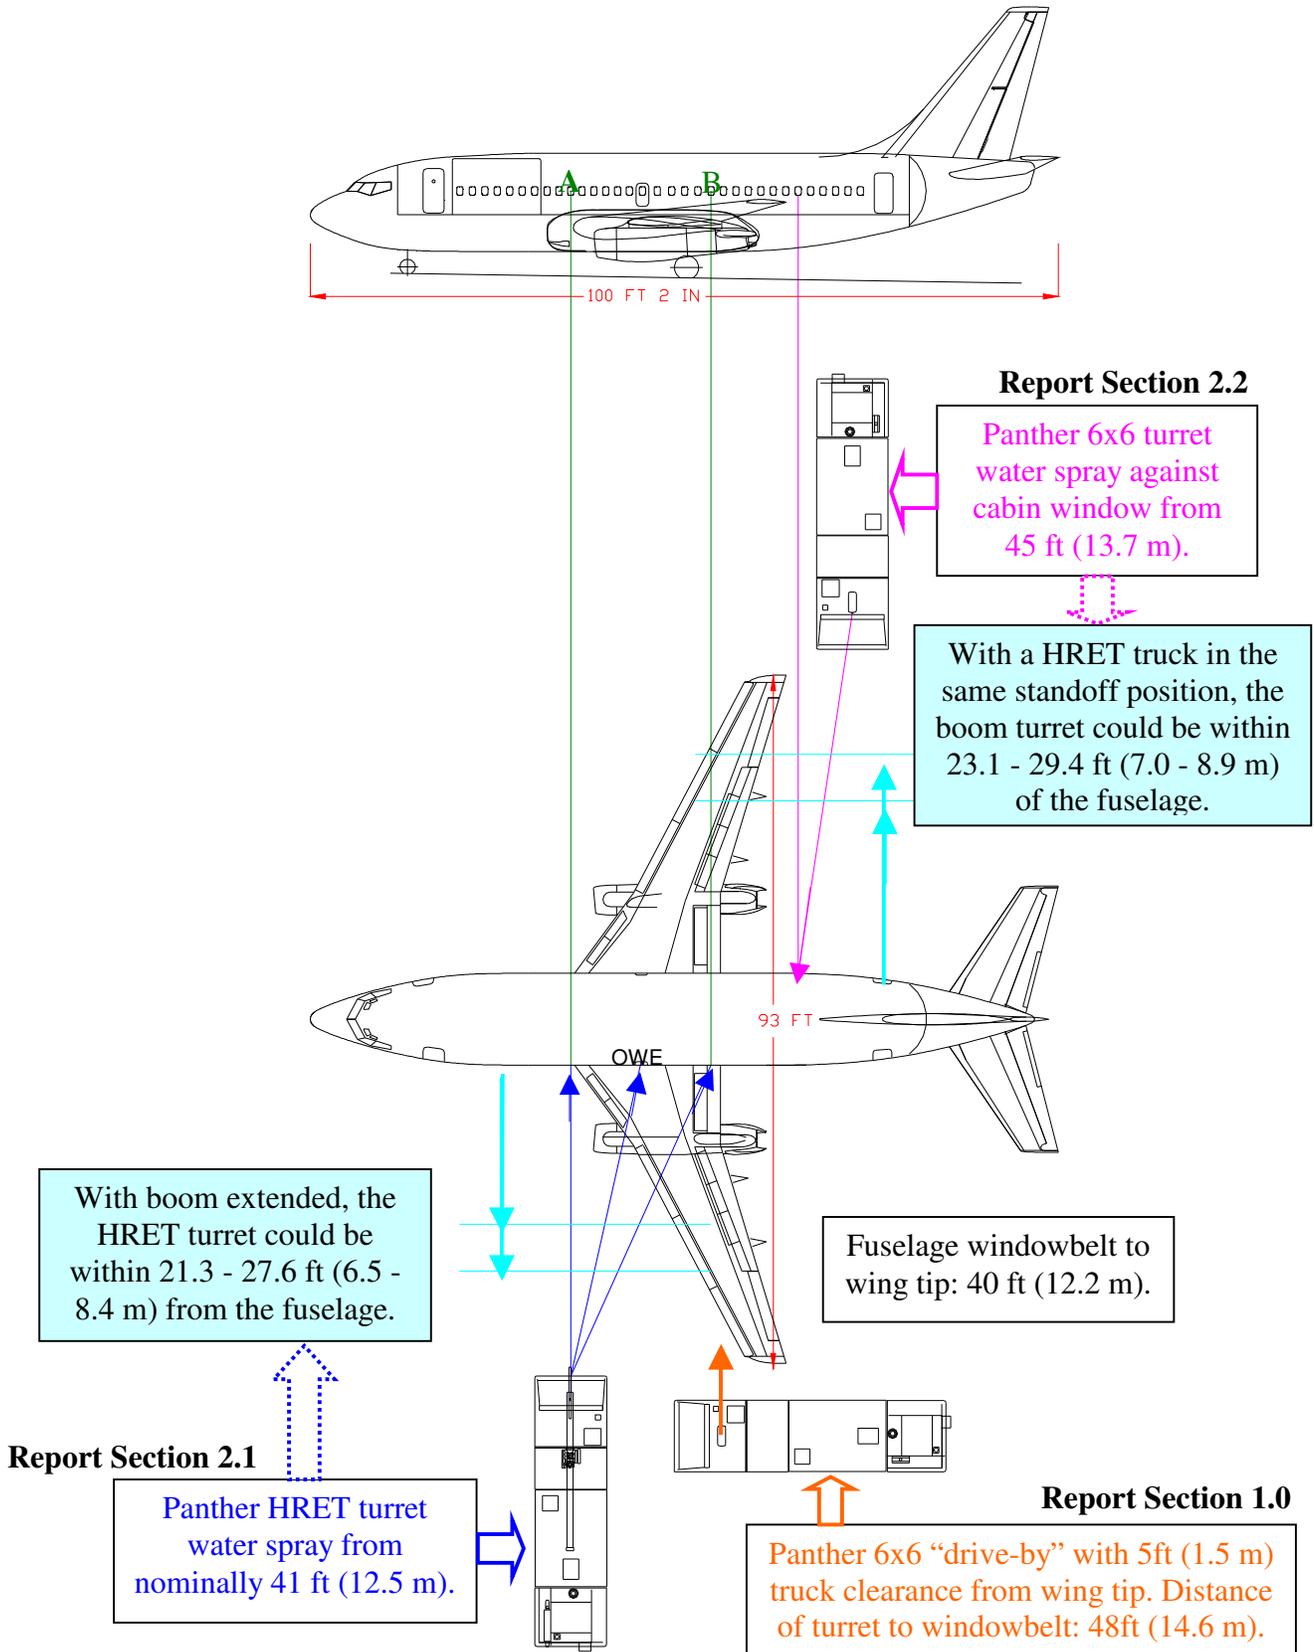
The truck positions for the cabin window and first OWE water penetrations on the B732 are summarized graphically in Figure 14.

Figure 14: B737 cabin window and OWE water penetration tests.

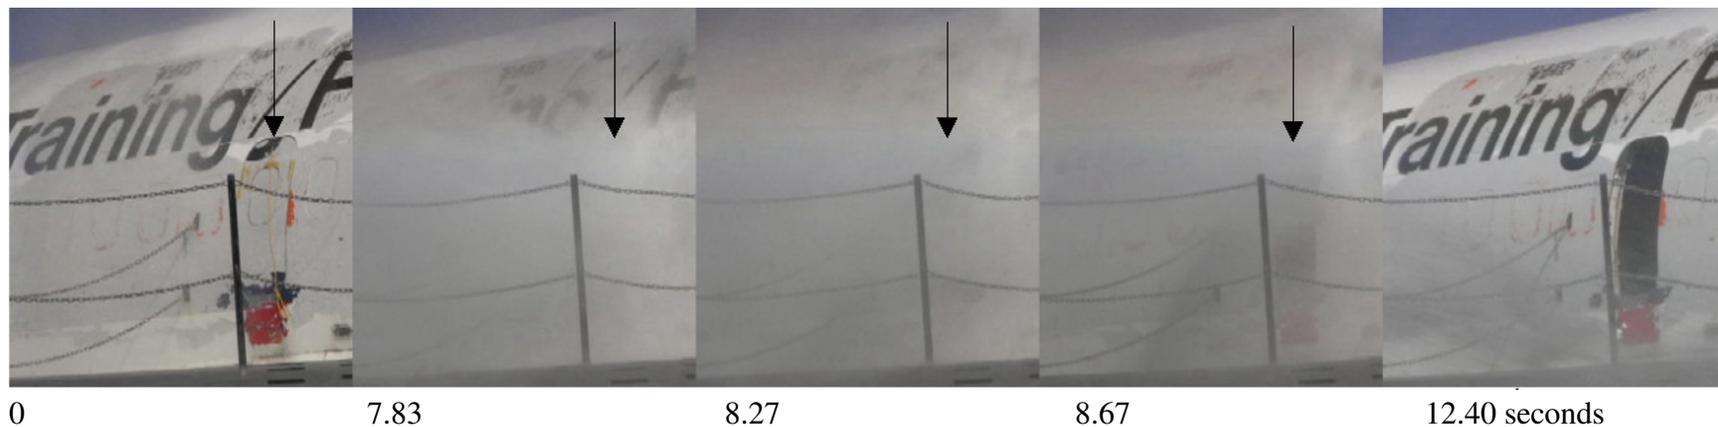
**Figure 15: B737 OWE door water displacement test – external video stills with time stamps.**

At 20 US gal/sec from a roof turret, the weight of water striking the door and presumably the exterior release panel is nominally 167 pounds (75.75 kg) per second (water density equals 8.345 pounds/US gal). In 0.44 seconds 8.8 US gallons (33.31 liters) would strike the release panel with a weight of 73.4 pounds (33.3 kg). The water pressure upon exiting the turret nozzle or at the fuselage surface is not known. The door, approximately 45 pounds (20.4 kg) in weight, was thrown to the opposite side of the fuselage.

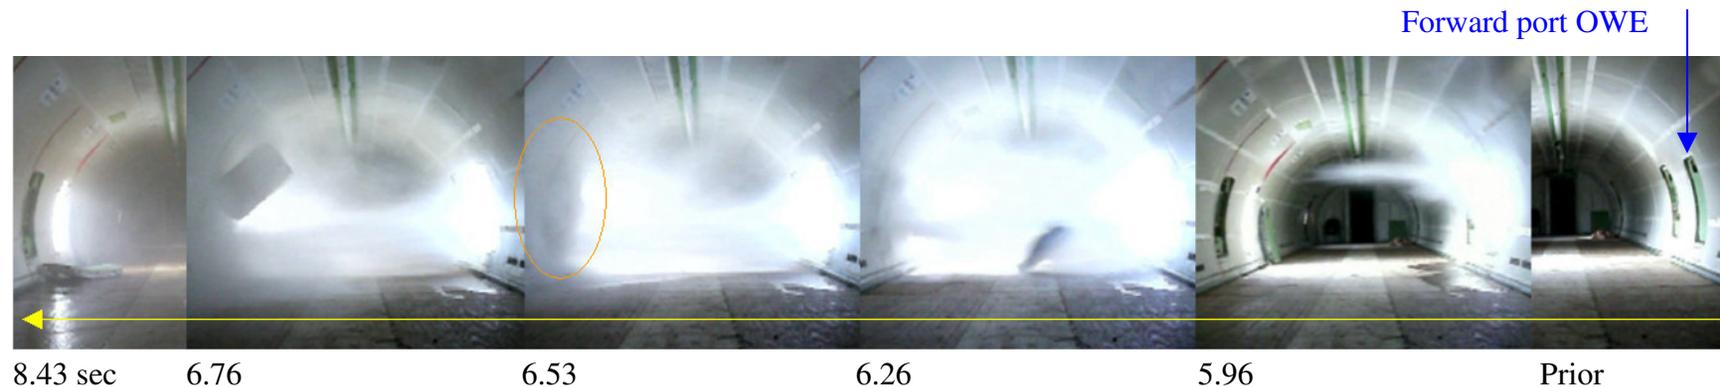
An interior view was recorded 18 Nov 2015, as part of a separate B737 OWE door water displacement test. A fire truck was positioned on the port side in front of the wing just inboard of the wing tip. A first attempt did not result in water contact on the forward port OWE external door release panel. On the second attempt, the door was displaced 5.96 seconds after the water pump started, shown in Figure 16. The OWE door travelled across the full width of the cabin and struck the opposite wall 0.57 seconds later (at 6.53 sec, circled) and then rotated up (6.76 sec), fell and was picked up again by the water stream such that it did not finally come to rest on the floor until 8.43 seconds. Water delivery lasted about 10 seconds utilizing approximately 200 gallons.

**Figure 16: B737 OWE door water intrusion test – internal video stills with time stamps.**

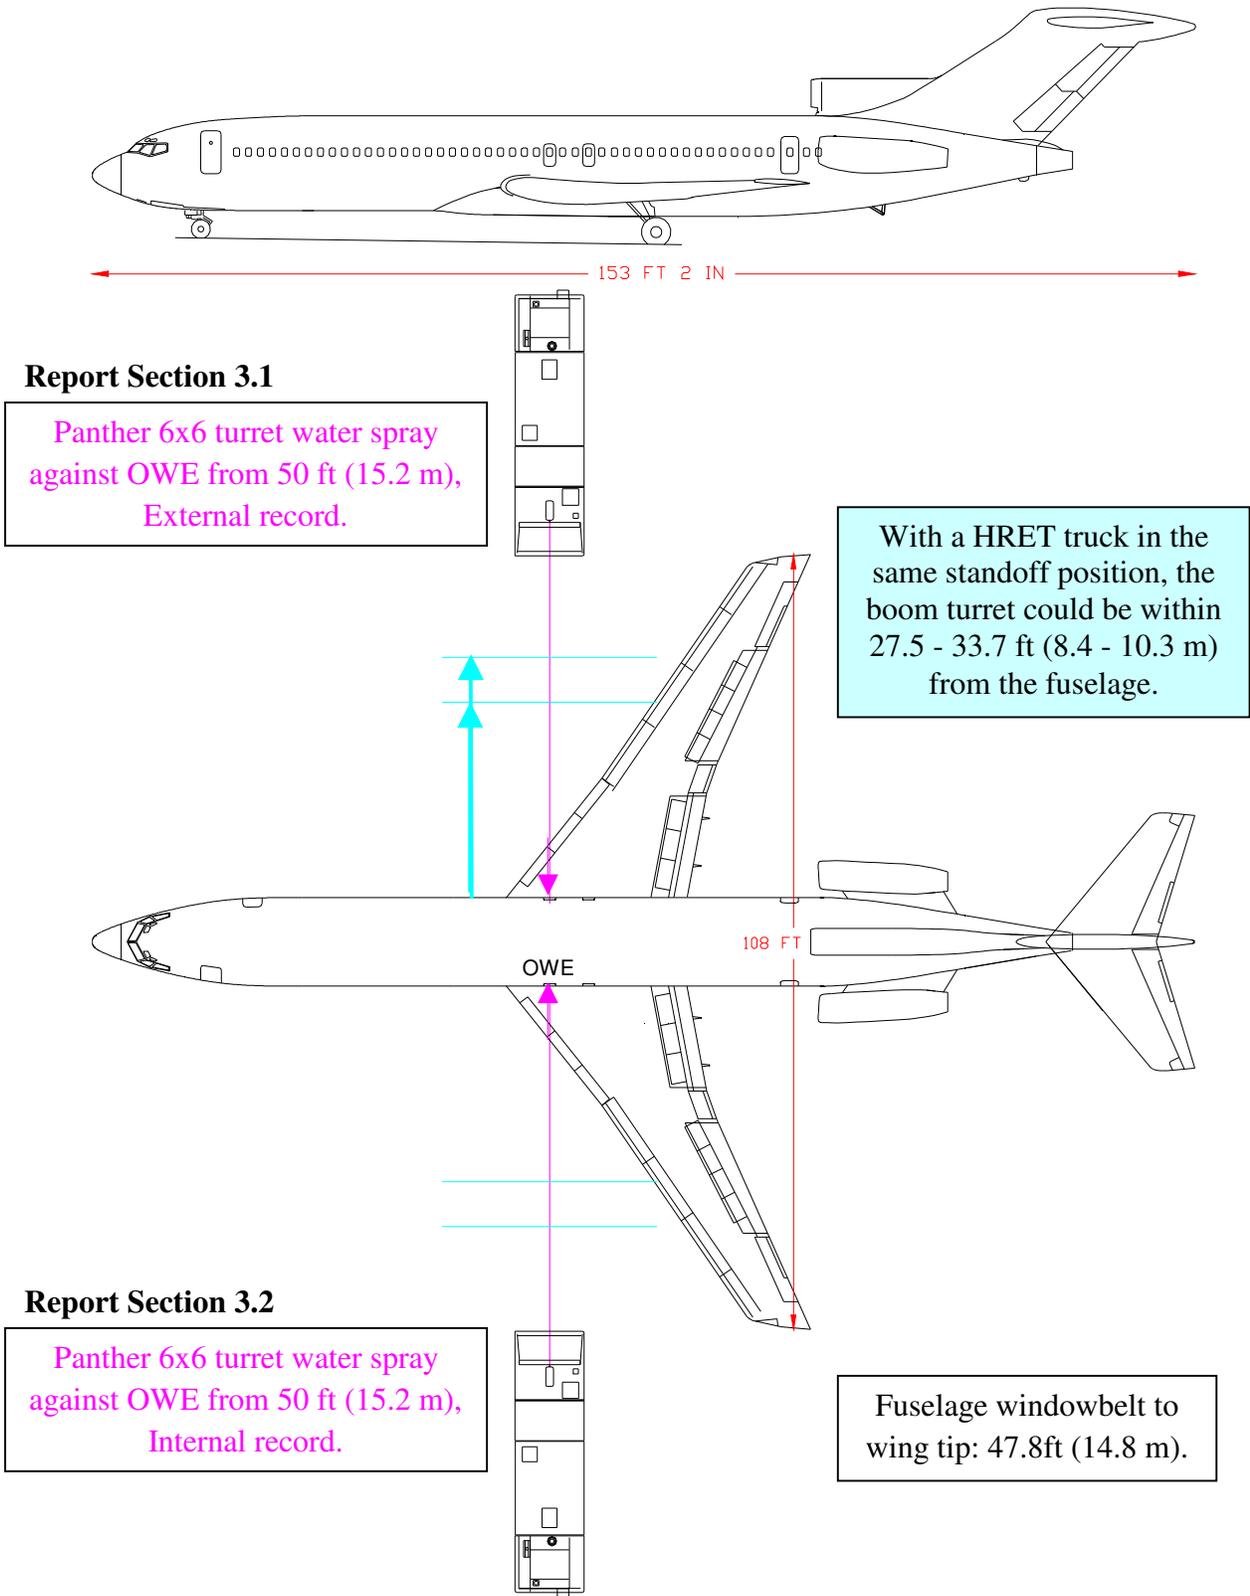
The truck positions for the OWE water penetrations on the B722 are summarized graphically in Figure 17.

Figure 17: B727 OWE water penetration tests.

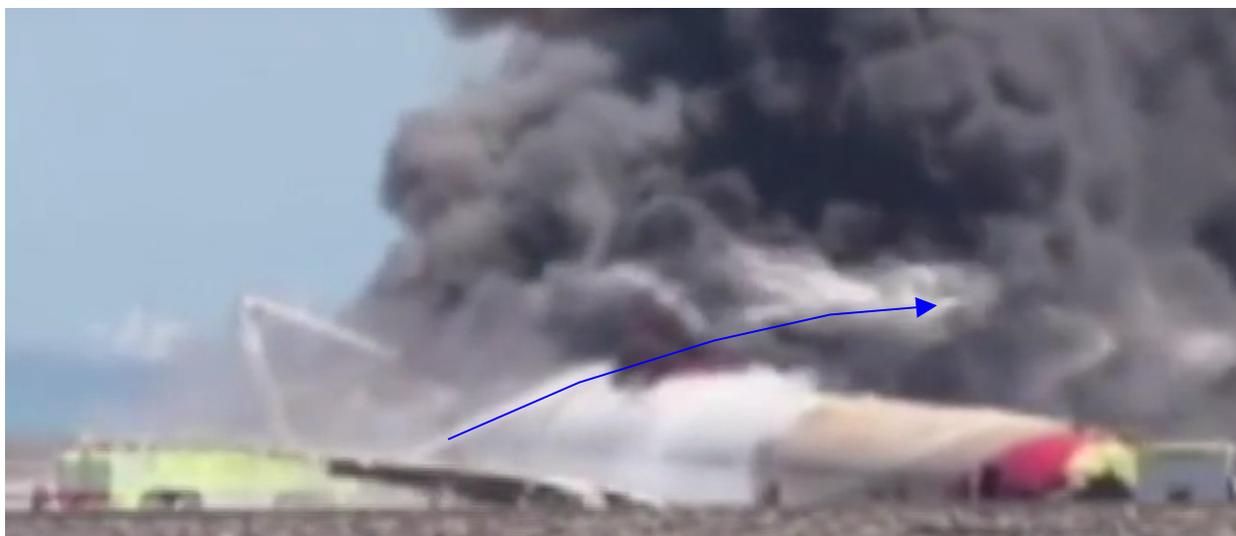
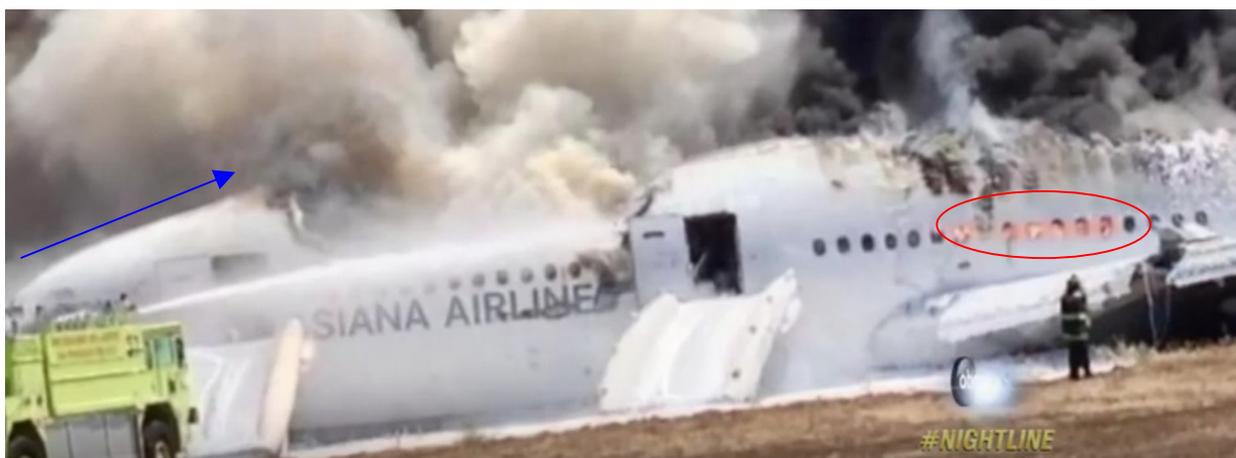
Very large aircraft make it difficult to loft water into the fuselage through the burned-through crown. The B777 crash in San Francisco illustrates the difficulty. Either penetrating intact cabin windows or flowing water through the burning (and shrinking) cabin windows may deliver firefighting agent more directly and efficiently to the inside of the fuselage, as shown in Figure 19a and 19b.

a) Water stream lofted over the top of the aircraft (arrow) from non-HRET ARFF truck

b) Water streams over structure (arrow), Cabin windows burning (circled)
