Degradation of the bird impact resistance of polycarbonate

LTR - ST - 1326

DEGRADATION OF THE BIRD IMPACT RESISTANCE OF POLYCARBONATE

6 JANUARY 1982 OTTAWA, CANADA

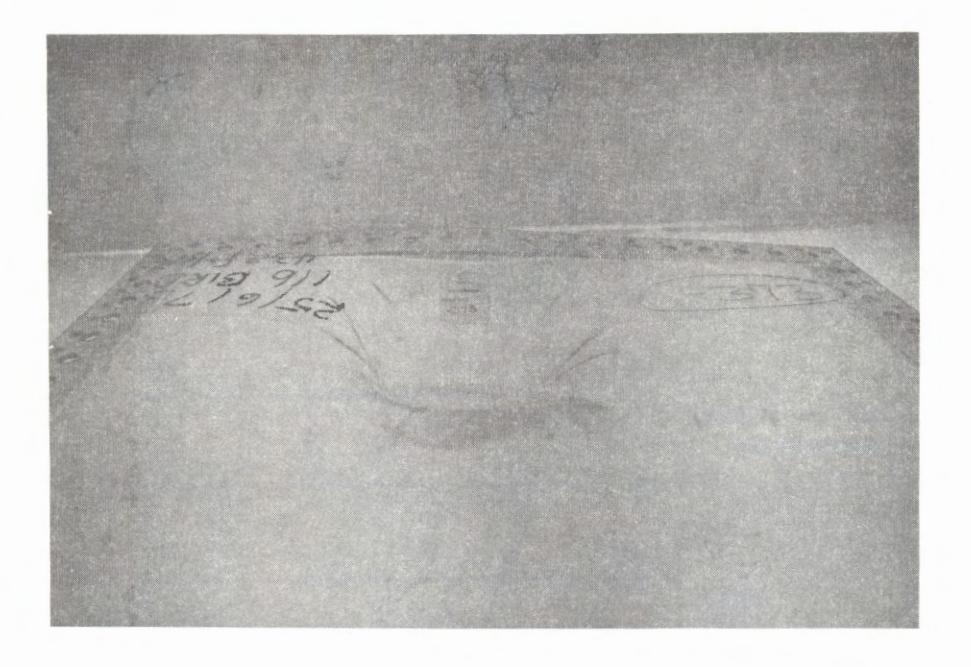
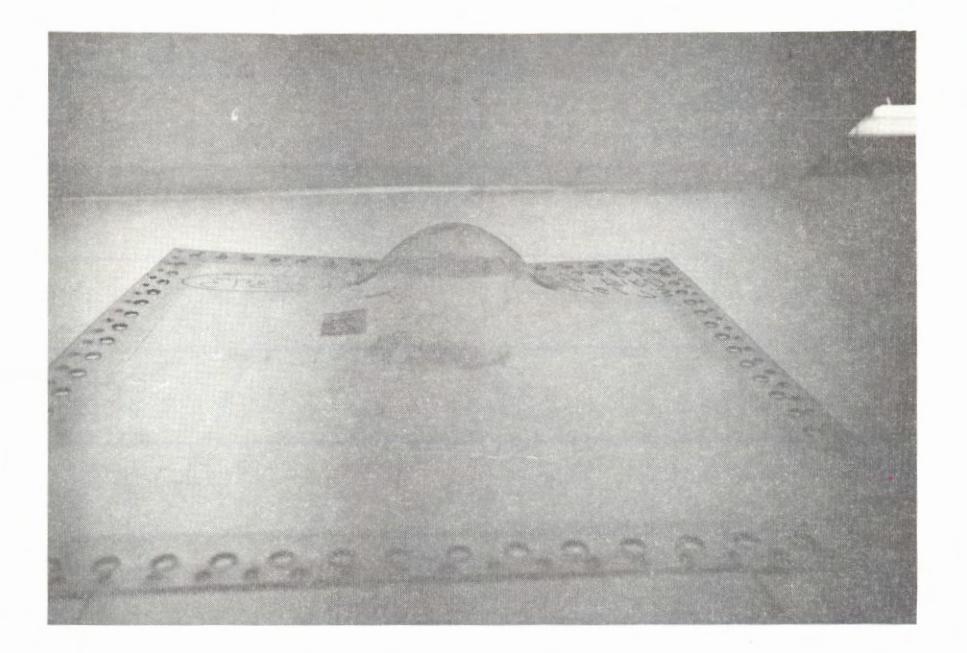
It should be noted that after two impacts on the 7 year old 0.125 inch thick material, (Table 3), there was no sign of material degradation due to loss of ductility (see Fig. 4). This result was not unexpected since other investigators have found that the material undergoes a ductile to brittle transition at a thickness between 0.140 and 0.180 inch (Ref. 5). Consequently further testing of 0.125 inch thick material was discontinued.

(a) VIEW OF OUTBOARD SURFACE

(b) VIEW OF INBOARD SURFACE

FIG. 4 0.125 IN.TK. POLYCARBONATE 7 YEARS OLD - TYPICAL FAILURE

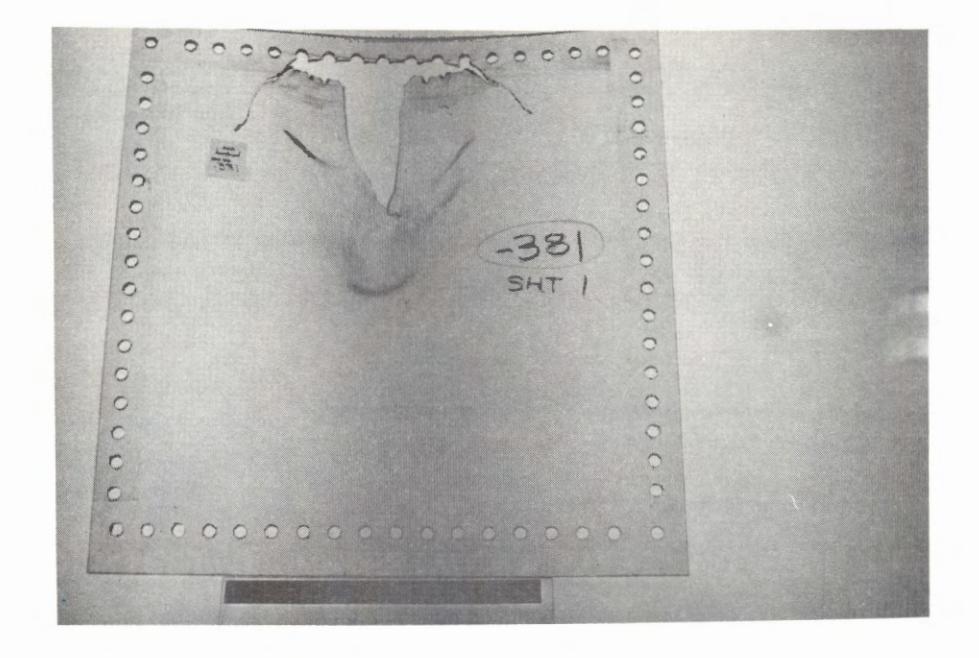
The radical change in failure mode with aging should be noted. New material exhibits high ductility, large deformations and a limited amount of fracture as shown in Fig. 7. In contrast, most of the aged material shatters on impact into a large number of fragments with little or no evidence of ductility as shown in Figs. 8 and 9.

(a) TEST 8 FAILURE INDICATES INSUFFICIENT CLAMPING

FIG.7 0.250 IN.TK. POLYCARBONATE NEW MATERIAL - TYPICAL FAILURE

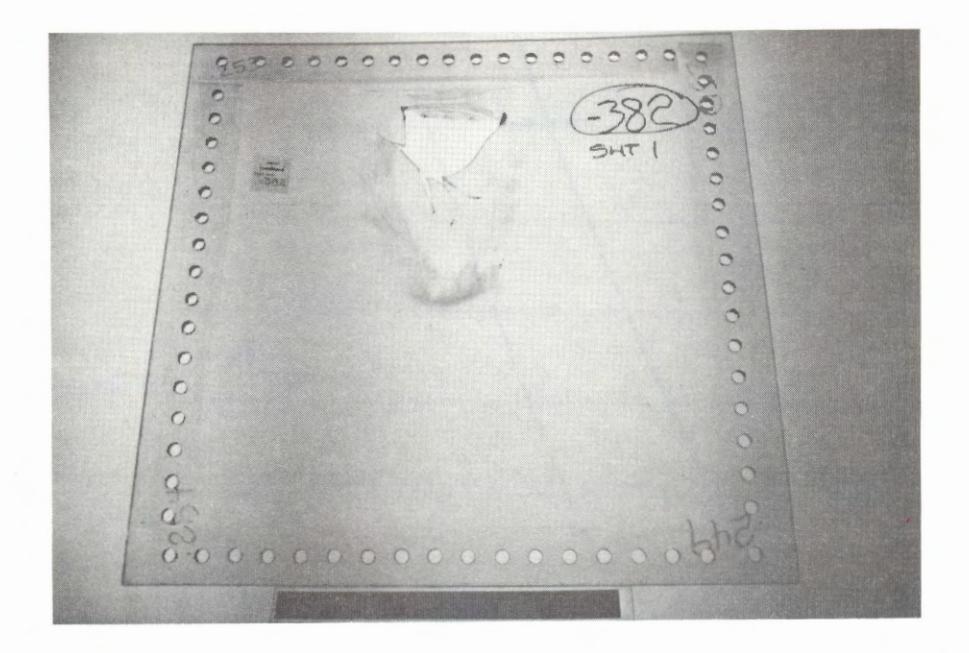
(b) TEST 9 MATERIAL FAILURE, NO EDGE EFFECT

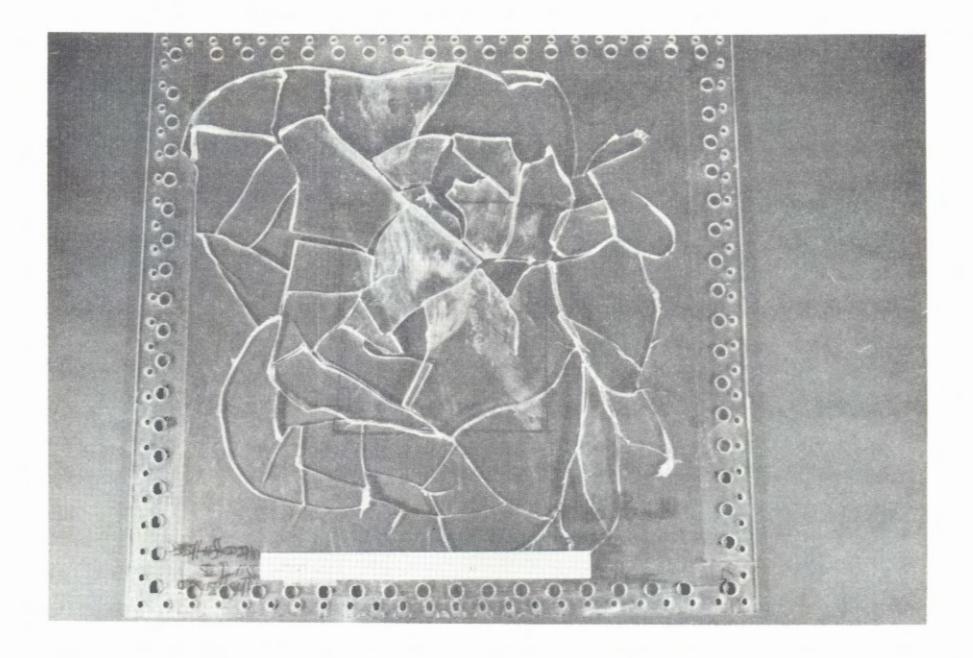
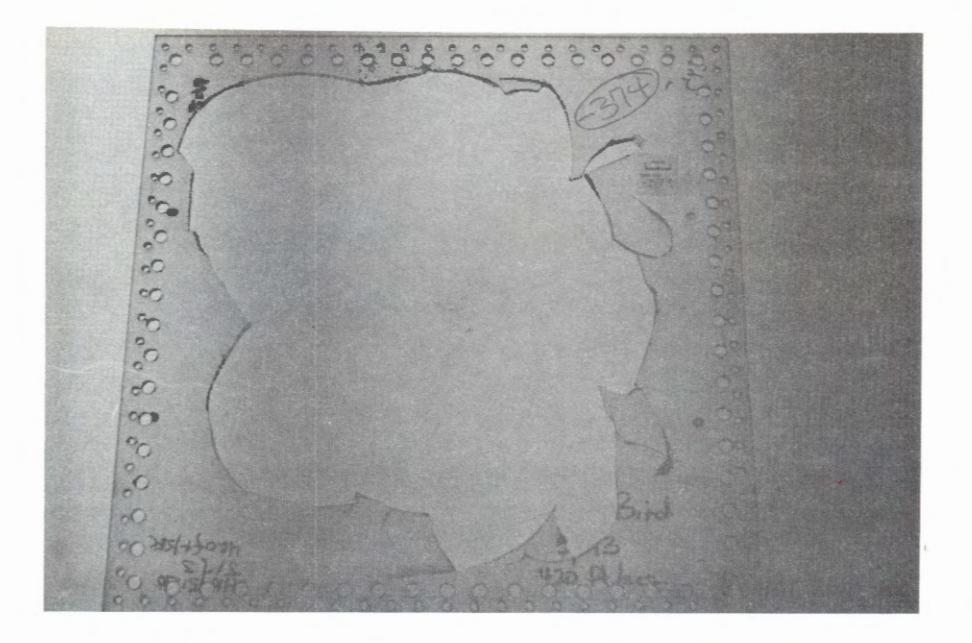
(a) TEST 1 (RECONSTRUCTED FRAGMENTS)

(b) TEST 1

FIG.8 0.250 IN.TK. POLYCARBONATE 7 YEARS OLD - TYPICAL FAILURE

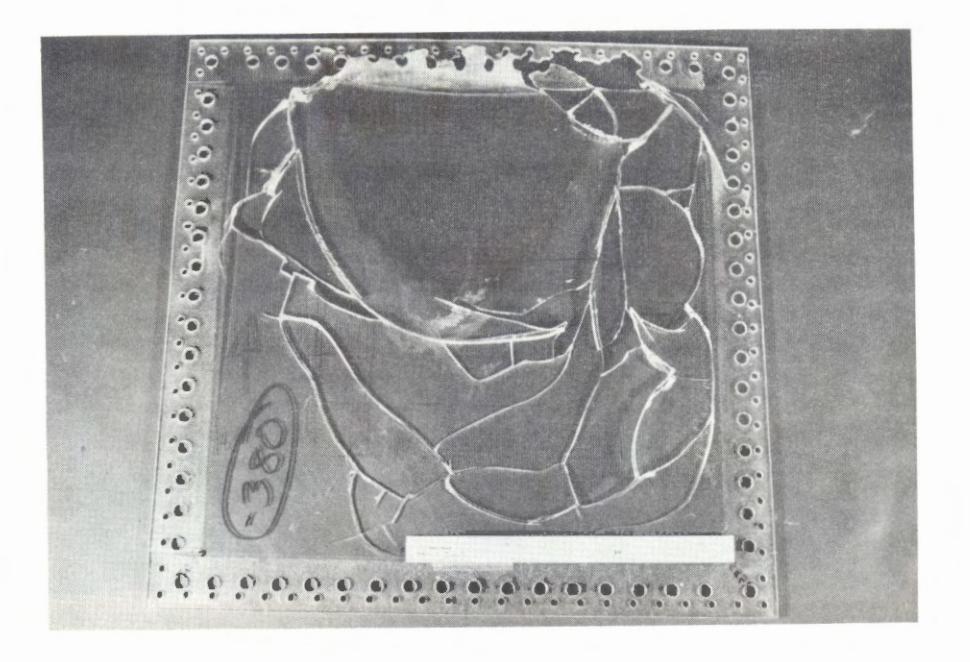
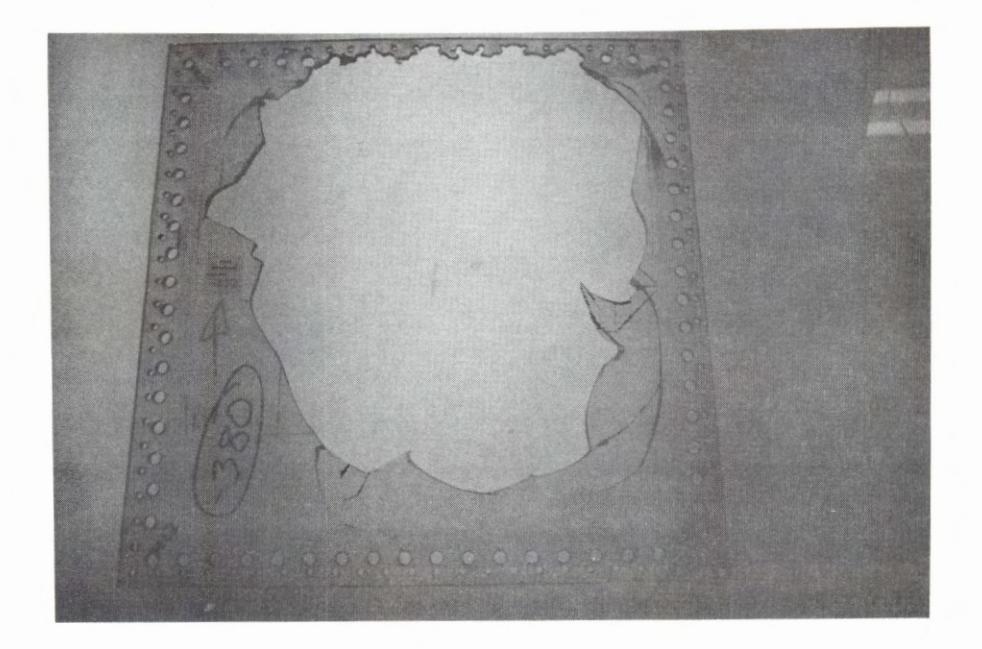
(a) TEST 7 (RECONSTRUCTED FRAGMENTS)

(b) TEST 7

FIG.9 0.250 IN.TK. POLYCARBONATE 5 YEARS OLD - TYPICAL FAILURE

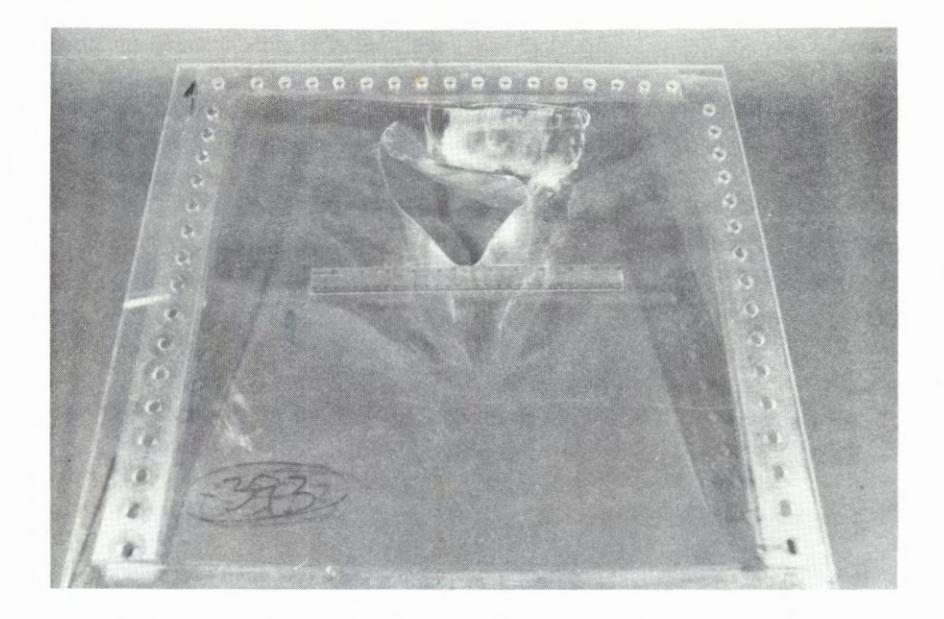
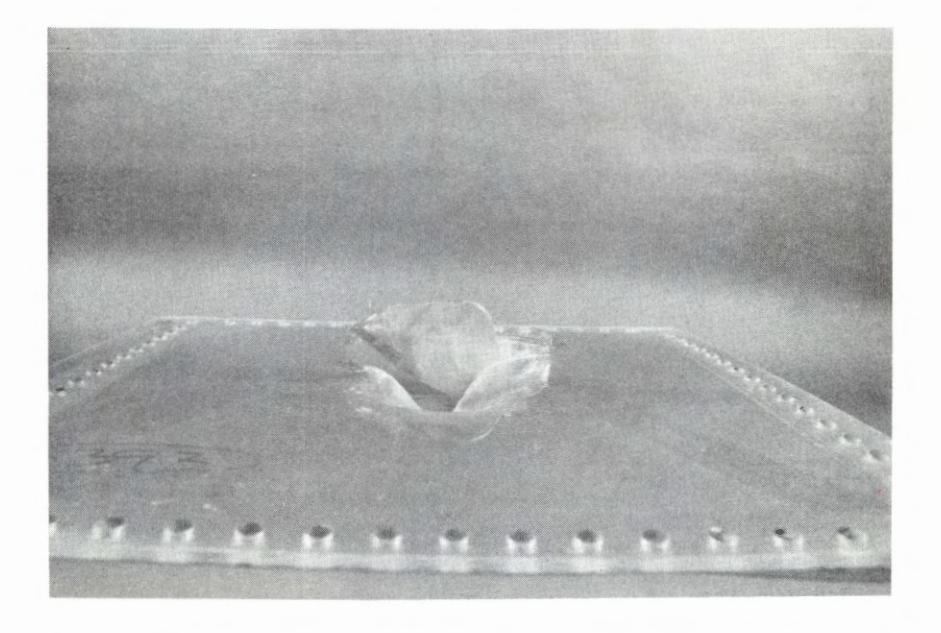
(a) TEST 20 OUTBOARD SURFACE

(b) TEST 20 VIEW ALONG OUTBOARD SURFACE

FIG. 10 0.250 IN. TK. POLYCARBONATE 2 YEARS OLD - TYPICAL FAILURE

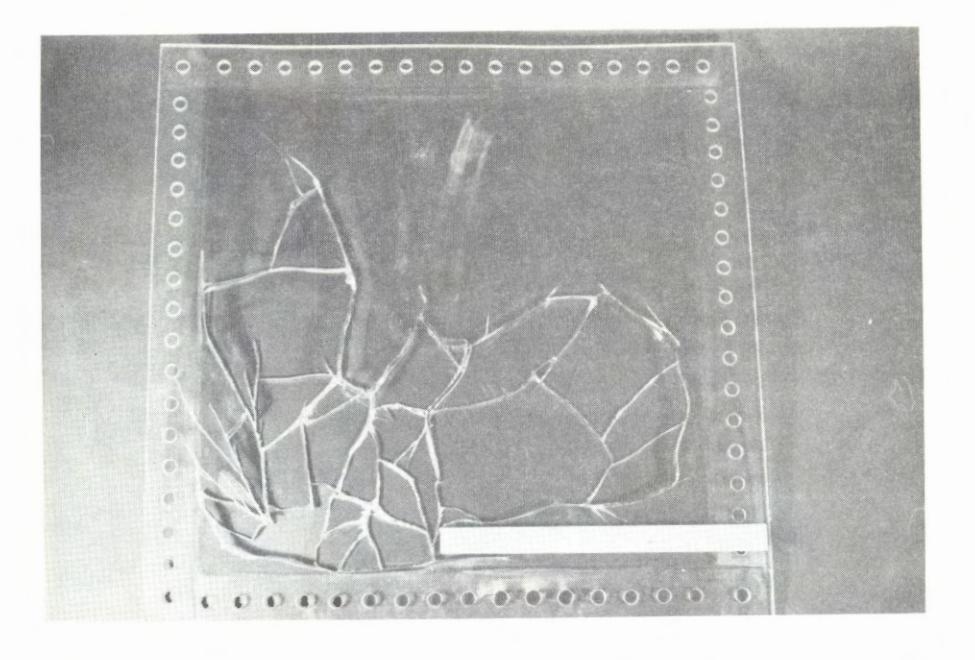
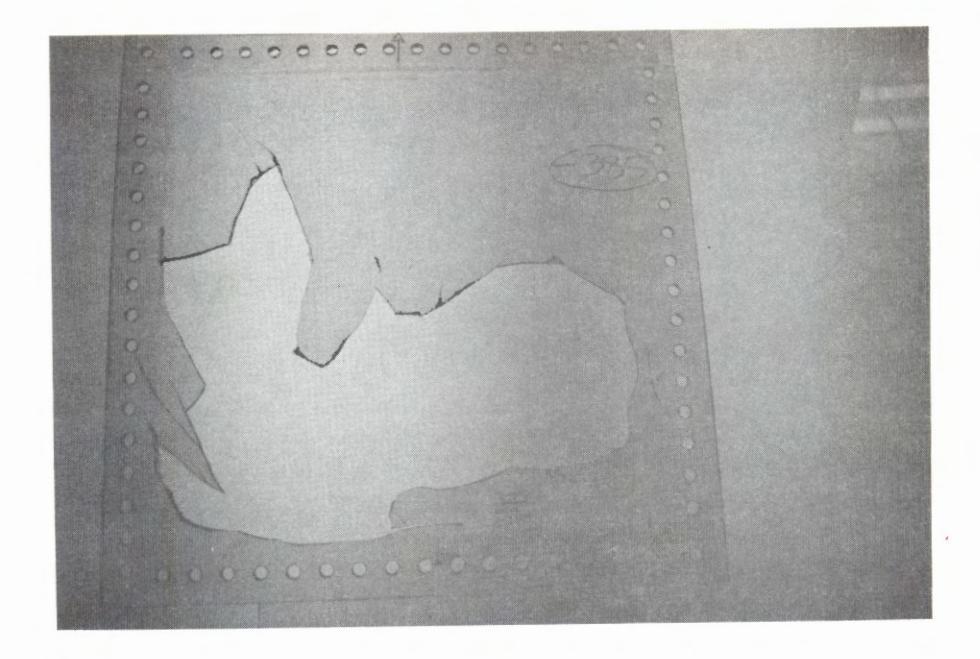
(a) TEST 12 (RECONSTRUCTED FRAGMENTS)

(b) TEST 12

FIG.11 O.250 IN.TK. POLYCARBONATE NEW MATERIAL - HEAT AGED TYPICAL FAILURE

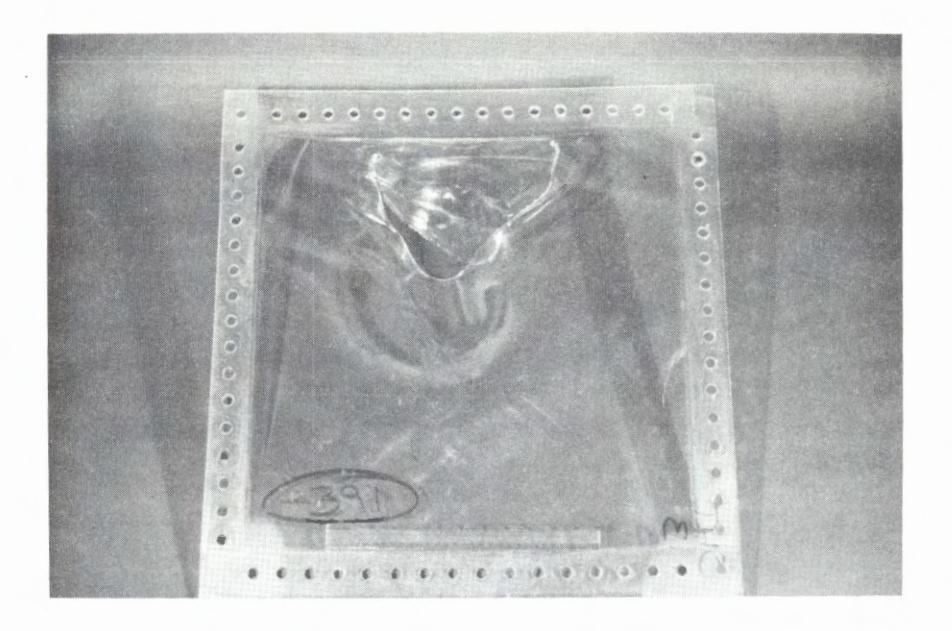
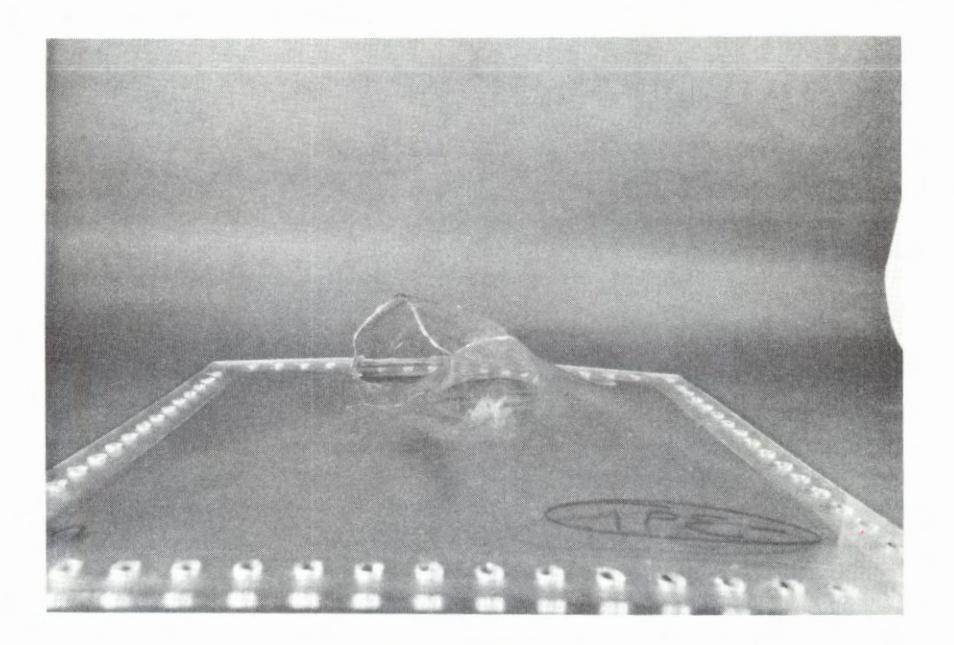
(a) TEST 18 OUTBOARD SURFACE

(b) TEST 18 VIEW ALONG INBOARD SURFACE

FIG. 12 O. 250 IN. TK. POLYCARBONATE, NEW MATERIAL - HEAT TREATED (DRY, POLISH, FORM) TYPICAL FAILURE

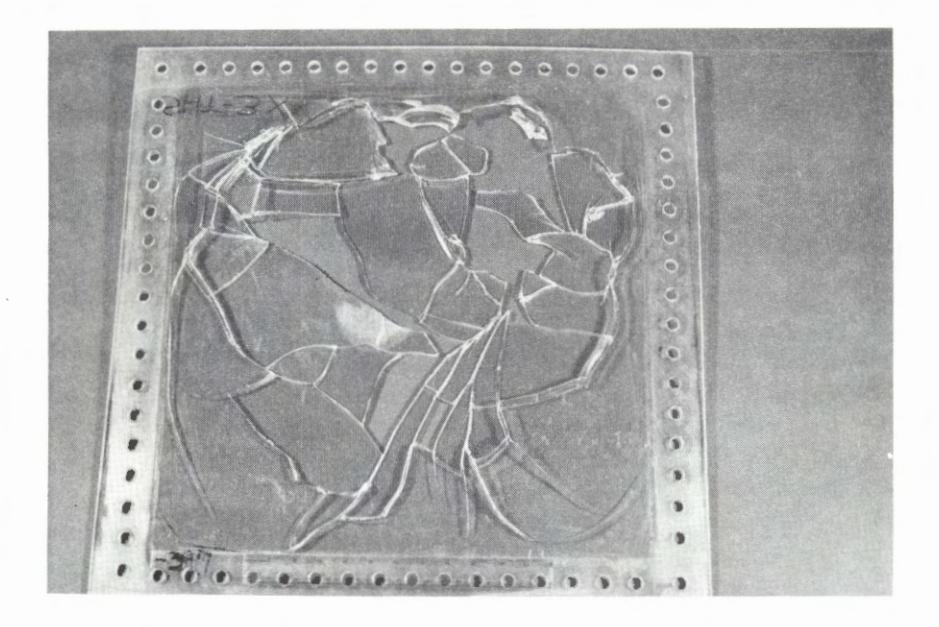
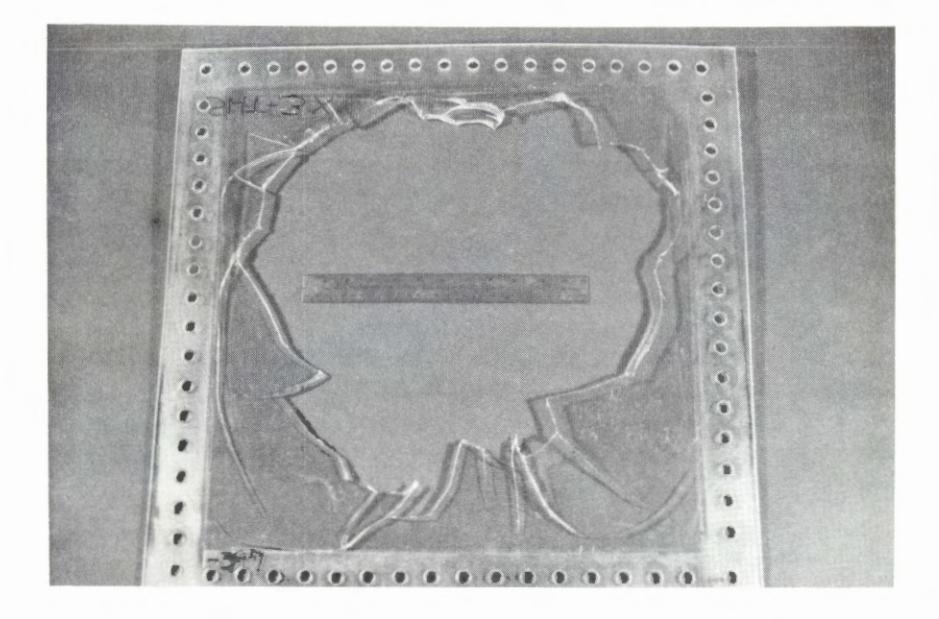
(a) TEST 24 (RECONSTRUCTED FRAGMENTS)

(b) TEST 24

FIG. 13 0.250 IN. TK. POLYCARBONATE, NEW MATERIAL - ARTIFICALLY AGED - HEAT TREATED (DRY, POLISH, FORM) - TYPICAL FAILURE
