Bursanescu, L., and Blais, F.  
May 1997

# Automated Pavement Distress Data Collection and Analysis: a 3-D Approach

## Abstract

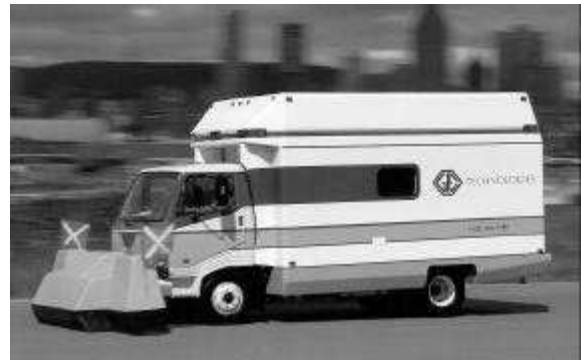
Figure 1 shows the vehicle which has been equipped with six Biris sensors and the necessary data acquisition and processing equipment to extract, at normal highway

**Figure 1. First prototype of the Road Inspection Vehicle**

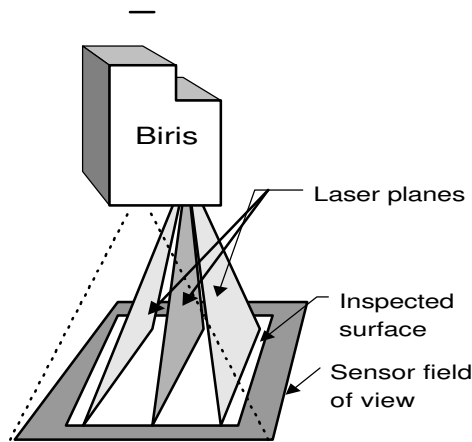
A preliminary evaluation showed that road sampling at every 11 cm in the traveling direction and continuous sampling in the wheel paths should provide enough information for the parameters under investigation. This conclusion led to the development of an enhanced Biris sensor that incorporates three laser plane projectors (instead of only one) simultaneously projected on the inspected surface. The laser planes are stationary with respect to the camera/vehicle and are generated using infrared ( $\lambda=790$  nm) laser diodes. The fan angle of each laser beam is  $52^\circ$  providing an intersection length with the inspected surface of approximately 90 cm at a nominal distance of 90 cm. Fine tuning of the fan angle of each laser beam permits the adjustment of the projection length on the inspected surface.

In the field of view of the detector, the three laser projections appear as three parallel lines spaced 11 cm at the nominal distance of 90 cm. The position and the spacing of the three laser lines in the field of view of the detector, at the inspected surface level, can be adjusted by modifying the orientation of the laser projectors with respect to the optical axis of the camera. Due to the Biris

mask, each of the three laser lines is seen by the CCD detector as a pair of lines whose separation and position vary with the relative distance between the Biris sensor and the inspected surface. These variations are measured and the optical distortions and sensor geometry calibrated, in real-time, to provide the range information. Photometric data is obtained by measuring the amount of laser light reflected by the road surface back on the CCD. A schematic layout of the sensor geometry is given in Figure 2. Figure 3 shows two of the six sensor heads mounted on the vehicle of Figure 1. Table 1 and 2 summarize the characteristics of the optical heads and system developed for this application.

**Figure 2: Enhanced Biris sensor with three laser planes**

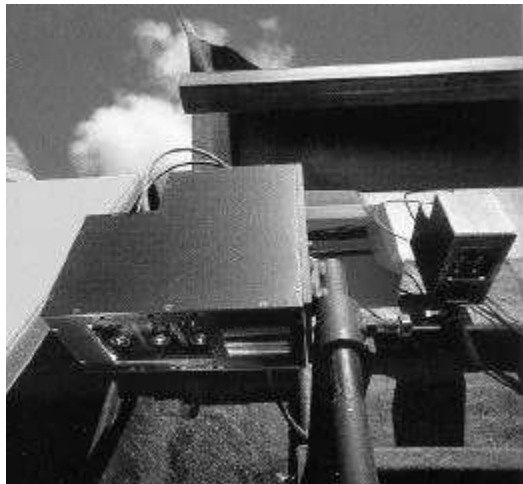
**Figure 3. Two of the sensor heads mounted on the vehicle of Figure 1**

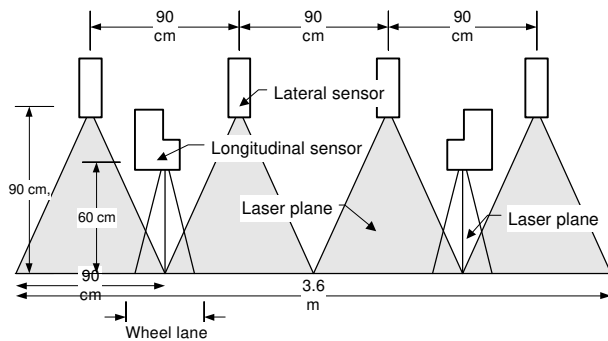
The full transversal profiles for a lane width of 3.6 m are collected by four sensors. These four sensors are currently positioned at a height of 90 cm and are used for longitudinal crack detection, rut depth measurement and cross section analysis of the road. Each lane profile is acquired with a total resolution of 1024 points (256 points per sensor-profile) which corresponds to 3.5 mm of transversal resolution. The longitudinal profiles are collected in both wheel paths by two sensors closer to the road surface (60 cm) providing a total of six profiles of 256 points each with a resolution better than 3 mm. They are used for transverse crack detection and longitudinal profile retrieving. Range resolution (elevation) better than 1 mm are obtained. The configuration of the sensors on the vehicle and the foot prints of the laser profiles on the surface under inspection are shown in Figures 4 and 5 respectively. This acquisition geometry and the number of sensors can be adapted to meet various specific requirements.

**Figure 4. Positioning of the sensors on the vehicle**

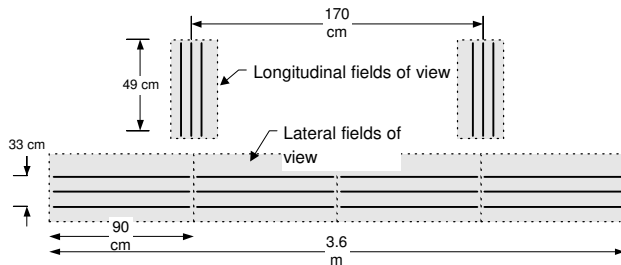
**Figure 5. Configuration of the sensors/laser profiles on the surface of the road (top view)**

72 km/h or 20 m/s and a sampling frequency of 60 Hz per video images, the collected pattern will be formed by parallel profiles of the road equally spaced by 11 cm. At higher speeds the relative distance between consecutive sets of three profiles increases and consequently a slightly lower density image will be collected. Even though the image sampling will not be perfectly uniform (regular) at higher vehicle speed, it is however not at all a problem for this type of application. At speeds lower than 72 km/h, real-time monitoring of the vehicle speed by the system controller removes the redundancy in the data collection and avoid an overlap of the profiles. This approach ensures there is no minimum speed for the data collection vehicle.

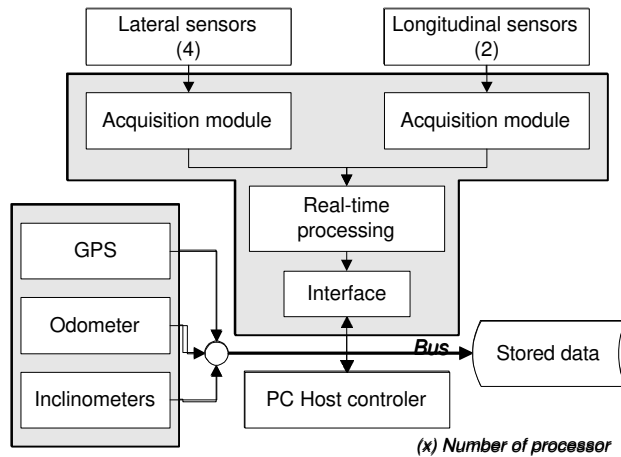
Complete automation of data acquisition and analysis is one of the key features of this system. Due to the huge amount of data collected (1.6 MB/s), real-time processing becomes a necessity in order to avoid problems of storage, speed, and data retrieval. Both automation and real-time processing require important computing resources, so the adopted solution was a parallel processing architecture array of Digital Signal Processors (DSP). This approach ensures the flexibility of an open architecture as well as the real-time processing capabilities and the possibility of expansion to meet new processing requirements. Obviously the DSP array configuration has evolved along with the application. The possibility to add processing modules and communication links as the application demands increase has proven to be very helpful. Figure 6 shows a simplified description of the parallel processing array. The host computer (PC) is used for storage purposes and for acquiring additional information such as the traveled distance, global positioning of the vehicle, inertial data, etc.

**Figure 6. Processing architecture**

The 3-D pavement inspection application is running on the DSP array. The profiles from different sensors are sewed, filtered and corrected for roll and pitch of the vehicle. Each acquired road profile is processed in real-time and every event detected (e.g. cracks) is stored with its characteristics: position, width, and depth. A variable amount of data is archived depending on the distress level of the inspected surface. Filtered profiles are averaged, based on the vehicle speed and stored for further analysis of the rutting profile for sections of the road specified by the user.

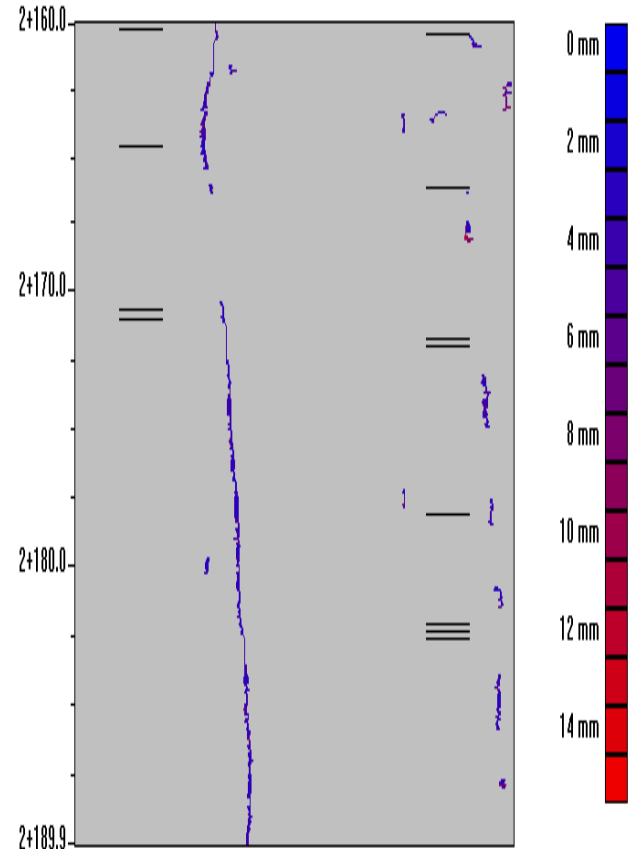
Figure 7 shows a cracks pattern as retrieved by the system. The image represents a 30 m road section. A longitudinal crack is identified along with several transversal cracks. The transverse cracks are represented by transversal segments on the image. A transversal crack, as opposed to local defects, is assumed to cover the whole lane width only when it is detected by both longitudinal sensors.

Figure 7. Results of road defects detection
