Proceedings of 19th International Conference on Offshore Mechanics and Arctic Engineering (OMAЕ), 14 - 17 February, 2000, New Orleans, Louisiana, pp. 1257-1264, 2000

OMAE-00-1007

SIMULTANEITY OF MEASURED ICE LOAD ON TWO LEGS OF A MULTI-LEG PLATFORM

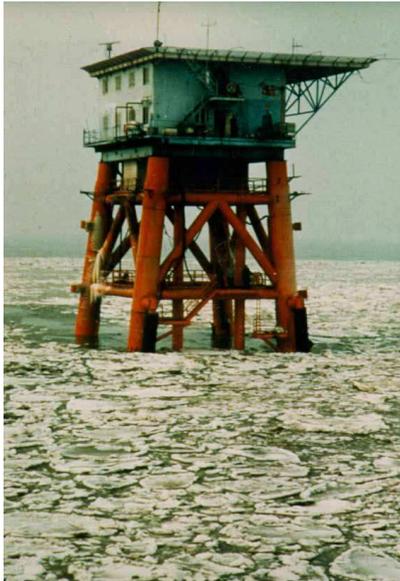
The JZ-20 is a multi-leg platform that has been used since 1987 in Liao Dong Bay (121°21'E, 40°30'N) of the Bohai Sea (Figure 1). The platform, oriented with the tidal current direction (38° bearing from due north), has a topside structure of 12 m x 9 m. The topside is supported by four-1.68 m diameter legs (Figure 2). The legs of the JZ-20 platform have a double pipe configuration, which consists of the leg column (in-filled with cement) and a 1.5 m diameter pile. There are two groups of conductor pipes between the legs on the north side of the structure. Support framing for the platform consists of 12 horizontal braces and 24 inclined braces.

Figure 2 JZ-20 Platform

leg (5.7° inclination, Figures 2 - 3). The shield, which increased the waterline diameter of the leg from 1.67 m to 2.02 m, provided a smooth surface on which to mount the load panels adjacent to one another. The HSVA load panels (1.5 m in height by 0.60 m wide) have been used previously to measure the loads on Norströmsgrund Lighthouse (Wessels et al., 1989).

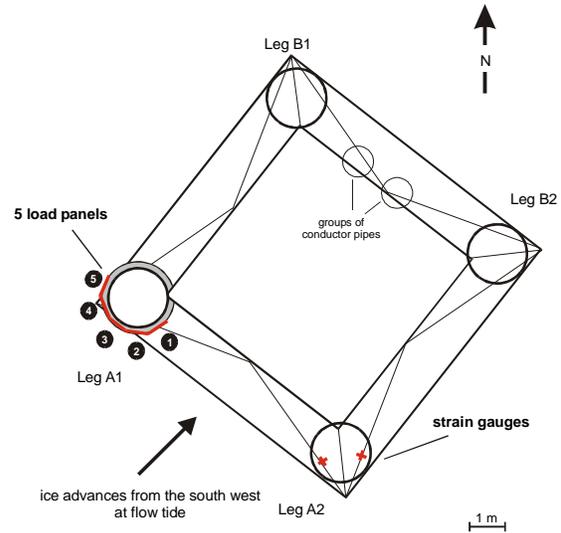
The waterline region of Leg A1 was outfitted with a polygonal steel shield which enabled five HSVA load panels to be attached to the circular perimeter of the

Figure 3 Instrumentation on JZ-20 Platform (to scale)

Each HSVA load panel relies upon four strain-gauged load cells (sampled at 30 Hz). Two uni-axial load cells record the normal load components and two bi-axial load cells record the normal and tangential components of the applied load. The measured load is averaged over the panel area. The panels cover half the perimeter of the south-facing side of Leg A1, which is exposed to advancing ice during rising tide. Since the maximum tidal elevation is 2.5 m, the 1.5 m high load panels could not measure the ice loads at peak tide. HSVA also installed a video camera on the platform so that the ice structure interaction with Leg A1 could be recorded. Since the video camera and the load measurement system were synchronized, information on the velocity and direction of the advancing ice, the ice thickness and the ice failure mode at Leg A1 were obtained.

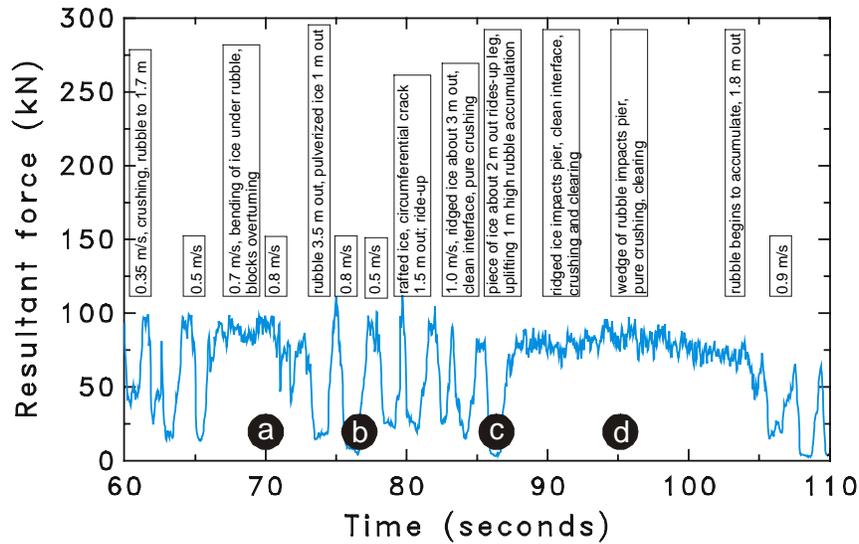
Figure 4 shows the measured load on Leg A1 for the 50-second duration of interest. The sampled interval begins at 21:01, when the video of the interaction with Leg A1 shows 0.20 - 0.25 m thick ice advancing towards Leg A1 at, initially, 0.35 m/s from the southwest. The measured load on Leg A1 provides a clear indication of low-oscillation, saw-tooth loading. The saw-tooth loading pattern is punctuated by two, well-defined periods of pure, high-frequency loading (65 - 74 seconds and 86 - 106 seconds).

Figure 4 Load-time series trace for selected Event

Since the video was synchronized with the load record, it provides a good indication of what is occurring when the time-series trace shifts from low-frequency to high-frequency loading. Figure 4 superimposes the notes obtained from the video analysis over the load-time series. During the 50-second interval the ice advanced at speed ranging from 0.35 m/s to 1.0 m/s. Considering that the average ice approach velocity was 0.8 m/s, Leg A1 “processed” about 40 m of ice over the 50-second interval.

Four snapshots were extracted from the video, at 70 s, 76 s, 86 s and 95 s (denoted by a - d in Figure 4 and shown pictorially in Figure 5). At 70 seconds (Figure 5-a), the ice is moving at 0.7 - 0.8 m/s. As the ice rides-up Leg A1, it fails simultaneously in crushing and bending, and therefore is characterized by mixed-modal ice failure. The ice failure produces a rubble matrix of large, discrete pieces of ice and pulverized

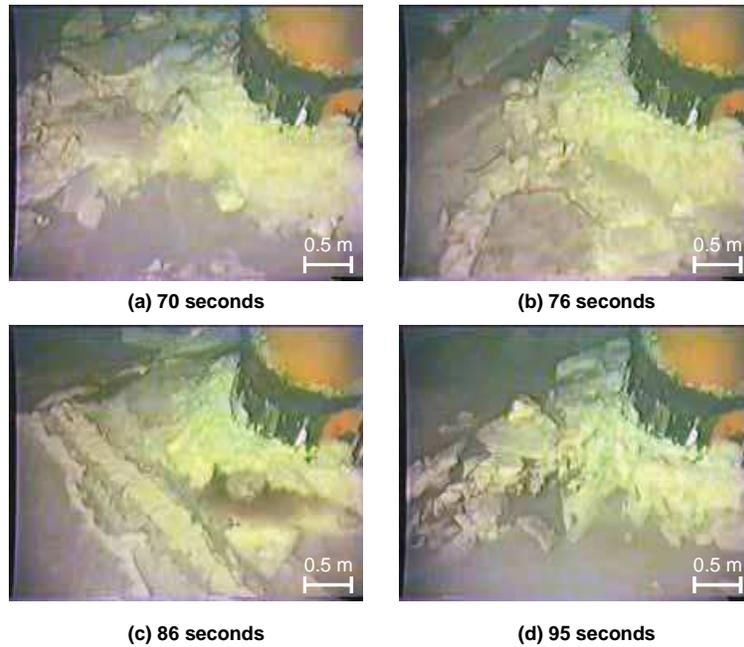
ice. Figure 5-b shows a snapshot taken at 76 seconds, during the period of low-frequency loading (see Figure 4). At this point, the ice advances at 0.8 m/s and the rubble extends 3.5 m from Leg A1, whereas the region of pulverized ice is in closer proximity to Leg A1 (1 m from the contact zone). At 86 seconds (Figure 5-c), ridged ice approaches Leg A1 at 1.0 m/s; in the far side of the snapshot, a large piece of ice rides-up Leg A1. This snapshot illustrates that, as the ice rides-up the leg, it uplifts an accumulation of rubble (1 m radial distance). At 88 seconds the fragmented piece jams between the contact zone and the advancing floe. Figure 5-d shows a snapshot of the contact zone at 95 seconds, during high-frequency loading, when the ice failure mode is characterized by crushing. The snapshot taken at 95 seconds shows the tip of a wedge-shaped piece of rubble beginning to impact Leg A1.

Figure 5 Ice conditions at snapshot intervals during the event

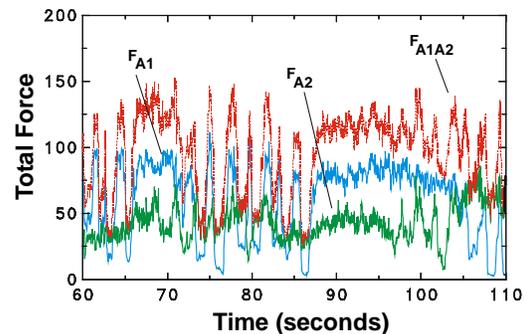
Figure 6 shows the comparison of loads on the two instrumented legs (F_{A1} and F_{A2}) as well as the total load on two legs (F_{A1A2}). The force record fluctuates from low- to high-frequency loading for Leg A1. However, Leg A2 exhibits something similar to the low-frequency loading oscillations only towards the end of the load record (from 97 - 103 seconds, just prior to the peak load that was measured on that leg).

Figure 6 Comparison of load on individual legs and total load

The highest total load that occurred during the 50-second interval was 153 kN, at 71 seconds (Figure 6). The lower loads measured on Leg A2 tend to moderate the total load on the platform, as illustrated clearly by the interval from 66 - 84 seconds shown in Figure 7. The 20-second close-up shows that the highest platform load of 153 kN occurred when the load spikes on legs A1 and A2 were synchronized (at 71 seconds). In contrast, the total load at 75 seconds was 142 kN. In that case, most of the total load resulted from Leg A1 (106 kN), as opposed to Leg A2 (45 kN).

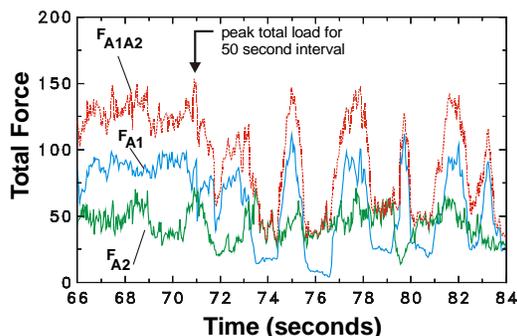
Figure 7 Portion of 50 second record showing time of peak total load

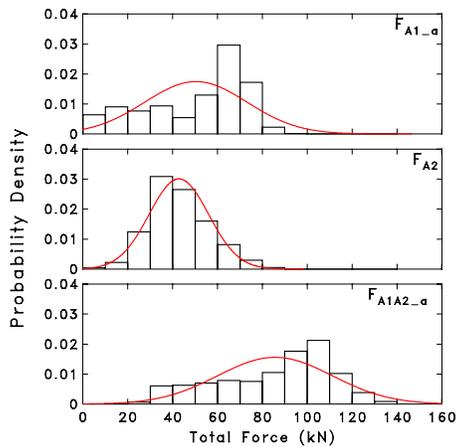
The measured loads on Leg A1 and Leg A2 were affected by their different diameters, as mentioned previously. To account for the different leg diameters, the load on Leg A1 was normalized and was then multiplied by the standard leg diameter of 1.67 m. In this case, linear scaling of the loads is justified, given the relatively small difference between the diameters of Leg A1 and Leg A2. (about 17%). Figure 8 presents histograms of the raw data for the loads on Leg A1 (F_{A1_a} , adjusted) and Leg A2 (F_{A2}). Figure 8 also shows the sum of loads on the two legs (F_{A1A2_a}), which takes into account the adjusted loads on Leg A1. Gaussian probability densities are superimposed on the histograms of the raw data, both of which take into account all data points within the 60 - 110 second sampling period. Note that the three panels in Figure 8 have the same x-axis scale.

The measured loads on Leg A1 are rather evenly distributed between 0 - 50 kN, after which there is an increase in the number of loads between 50 - 80 kN. Figure 8 shows that the Gaussian distribution is a rather poor fit for the sort of distribution that characterizes Leg A1. The highest loads experienced on Leg A1 are in the range 100 - 110 kN. The measured loads on Leg A2, which range from 0 - 90 kN, are approximated quite well by the Gaussian distribution. The sum of the measured load on two legs (F_{A1A2_a}) shows a distribution that is skewed to the right, with majority of loads being from 80 - 120 kN. The statistical distributions shown in Figure 8 give a good idea of the range of measured loads for the two legs. The distributions illustrate that the most numerous loads on Leg A1 are clustered around 60 - 70 kN, whereas Leg A2 experiences the largest number of loads from 30 - 40 kN.

Figure 8 Gaussian distributions for Leg A1, Leg A2 and load on two legs

Cumulative distribution functions of the raw histograms shown in Figure 8 were used to provide a better indication of what is happening in the tail of the load distribution. Figure 9 compares the cumulative distribution functions for the measured load on two legs (F_{A1A2_a} , adjusted) and load obtained by doubling the measured loads on Leg A1 ($2*F_{A1_a}$) and, in turn, Leg A2 ($2*F_{A2}$).

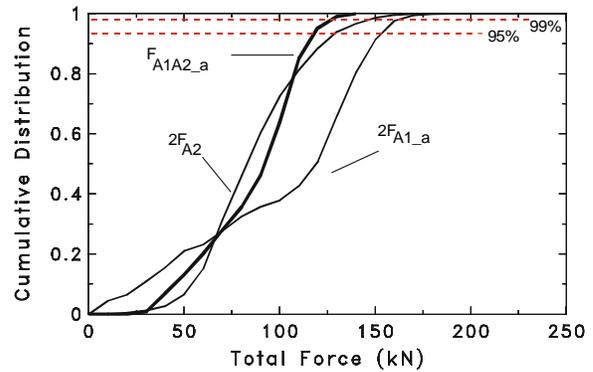
Figure 9 Cumulative distributions for total platform load: measured vs. extrapolated

Figure 9 shows that, in the tail of the distribution, the measured loads on two legs (F_{A1A2_a}) are less than the extrapolated loads based upon doubling the loads on either Leg A1 or Leg A2. For example, Table I shows the 95th percentile and 99th percentile loads on Leg A1 ($2*F_{A1_a}$), Leg A2 ($2*F_{A2}$) and the total load on two legs (F_{A1A2_a}). Doubling the load on Leg A1 results in an over-prediction of 28 - 30% for loads in the tail of the distribution. Extrapolation of the loads on Leg A2 over-predicts the measured total load on two legs by 11 - 18 %.
