Journal of Materials Research, 29, 17, pp. 2006-2020, 2014-09-14

Tensile properties of laser additive manufactured Inconel 718 using filler wire

Yi-Nan Zhang, Xinjin Cao,^{a)} and Priti Wanjara

A 5 kW continuous wave fiber laser welding system was used to deposit INCONEL[®] alloy 718 (IN718) on service-exposed IN718 parent metal (PM) substrates using filler wire addition. The microstructure of the deposits was characterized in the fully heat treated condition. The service-exposed IN718 PM and the direct laser deposited (DLD) specimens were then evaluated through room temperature tensile testing. The yield and tensile strengths were well above the minimum values, as defined in the aerospace specifications AMS 5596K and 5663M. However, the ductility at room temperature of the DLD and DLD-PM samples was slightly lower than that specified in AMS 5596K and 5663M. The tensile fracture surfaces of the service-exposed IN718 PM, DLD, and DLD-PM specimens were analyzed using scanning electron microscopy (SEM), and the tensile failure mechanisms are discussed in detail, particularly for the important roles of the secondary particles (MC carbides) and intermetallics (platelet Ni₃Nb- δ and L

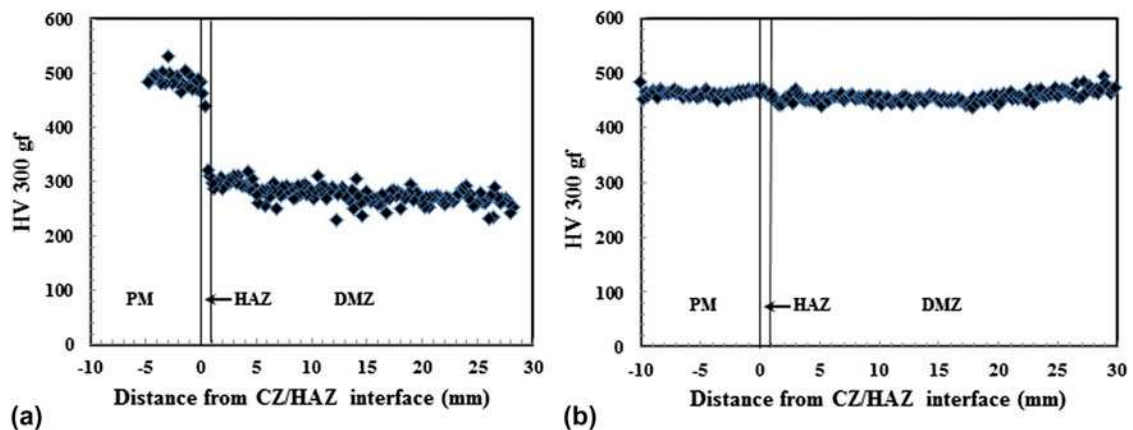
FIG. 6. Average hardness profiles in the (a) as-deposited and (b) PDHT conditions, which indicate that the hardness in the DMZ is nearly recovered to the value of the PM in the fully heat treated condition.

The average Vickers microindentation hardness profiles across the deposits (from DMZ to PM) in the as-deposited and PDHT conditions are shown in Fig. 6. The hardness of the DMZ in the PDHT condition (457 ± 15 HV) is much higher than that in the as-deposited condition (275 ± 30 HV). In the PDHT condition, the DMZ has a hardness that is similar to but slightly lower than the fully heat treated PM (463 ± 16 HV), indicating that the hardness can be essentially recovered to that of the PM. The slightly lower hardness is due to the presence of undissolved Nb-rich Laves particles and the formation of the needle-like Ni_3Nb - δ phase particles in the DMZ that lowers the amount of Nb available for reprecipitation of strengthening phases γ' and γ'' during the heat treatment after laser deposition.
