RESEARCH PAPER NO. 458
OF THE
DIVISION OF BUILDING RESEARCH

Examination of rock surfaces with the scanning electron microscope

by J. E. GILLOTT, *Materials Section, Division of Building Research, National Research Council of Canada, Ottawa*

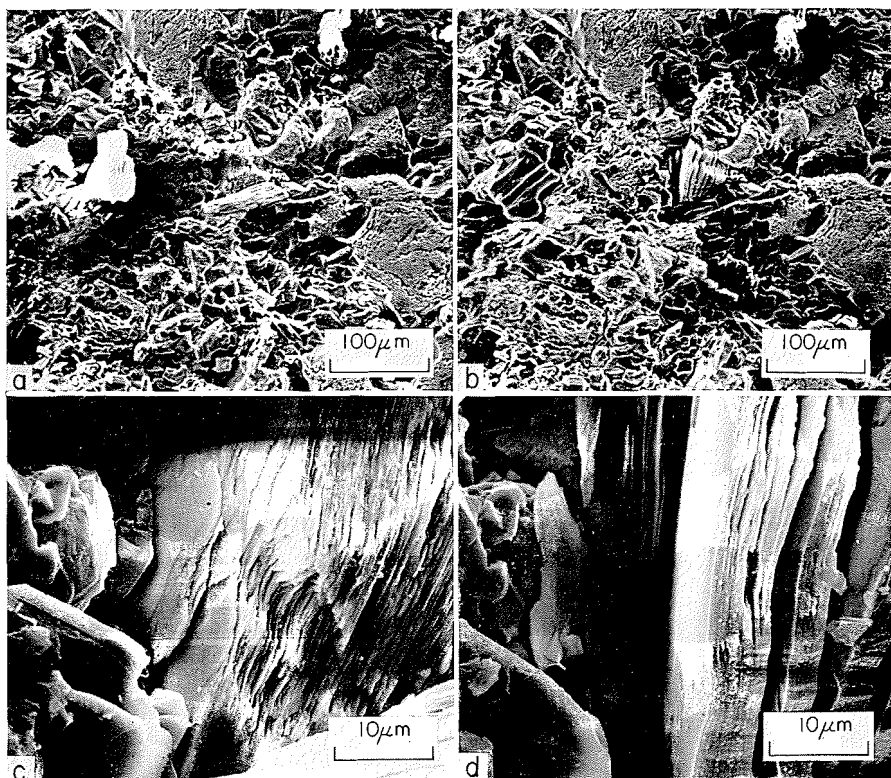
Fig. 1. Scanning electron micrographs of selected area of greywacke before and after treatment with alkali, taken at 20 kV accelerating potential on a Cambridge Stereoscan Mk II scanning electron microscope. (a, c) Untreated; (b, d) 1 month 2 M NaOH at 38°C.

Fig. 1 presents views of a fracture surface of untreated rock and views of the same area after 1 month in 2 M NaOH at 38°C (100°F). Fig. 1(a and b) represent one frame each of the respective mosaics; Fig. 1(c and d) are enlargements of the central portion of each. In the lower-power magnification there are feldspars, quartz and mica-type minerals. Comparison shows that many of the minerals are relatively unaffected by the alkali after 1 month though the layer-structure silicates show exfoliation. This is most clearly seen in the views taken at higher magnification (c and d). The significance of this work to the understanding of the mechanism of alkali-aggregate reaction involving greywackes and phyllites (Duncan & Swenson, 1969) will be described in detail elsewhere.
