Analysis of multi-year ice loads Molikpaq data (1985-86 winter deployment): final report

Controlled Technical Report (National Research Council of Canada. Canadian Hydraulics Centre); no. CHC-CTR-068, 2010-01

ANALYSIS OF MULTI-YEAR ICE LOADS MOLIKPAQ DATA (1985-86 WINTER DEPLOYMENT)

FINAL REPORT

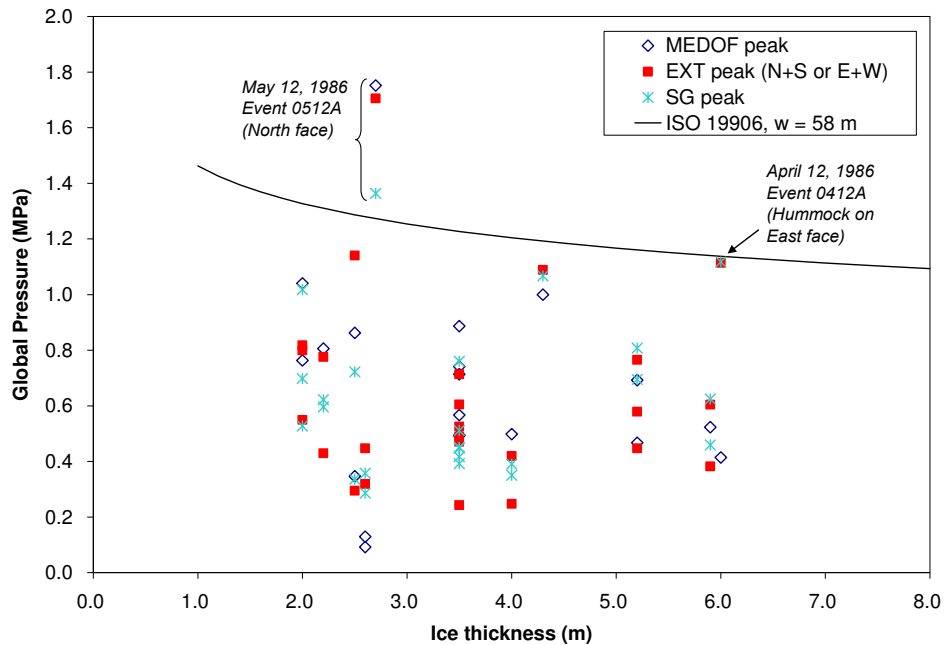
Global pressures from the “Historical Case” approach are plotted as a function of ice thickness and compared to predictions of equation [A.8-22] of the *ISO DIS 19906 Arctic offshore structures* standard for a 58 m wide structure in Beaufort Sea conditions.

Global pressure “Historical Case” values compared with ISO DIS 19906 Eqn. [A.8-22]

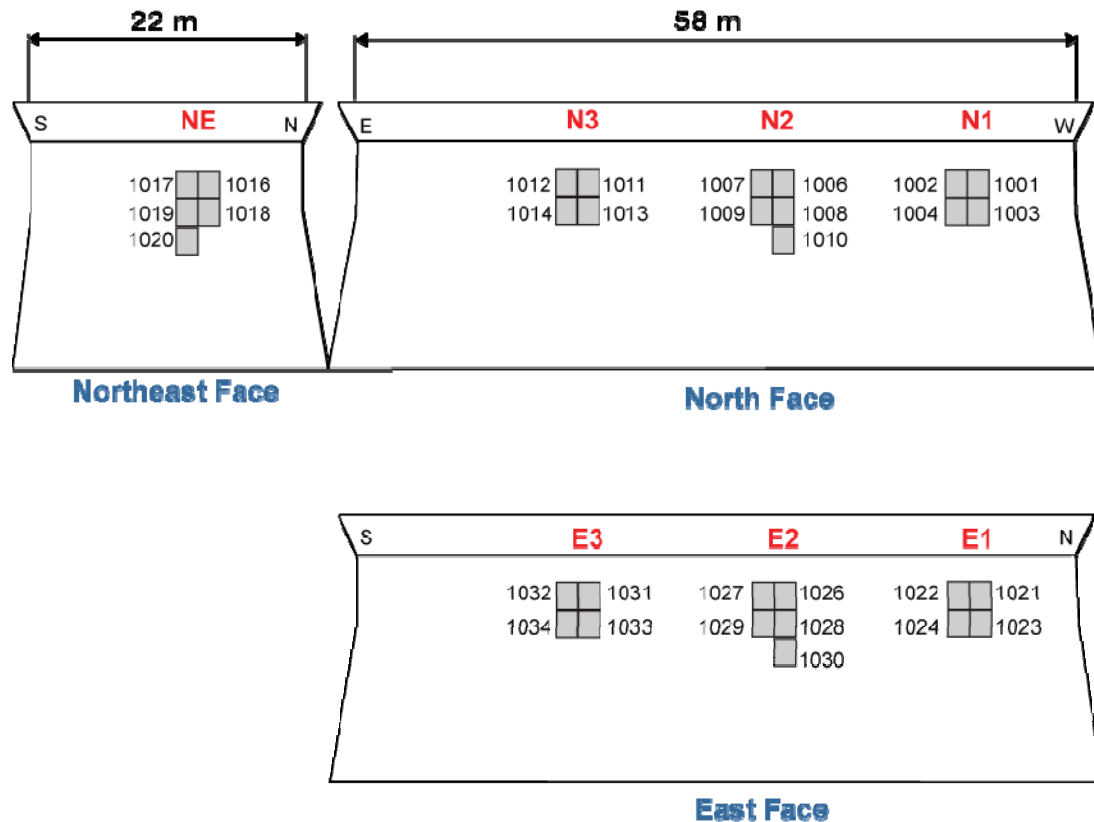
The panels were 1.135 m wide and 2.715 m high, with a capacity of 20 MN, and were configured so that they measured the total force acting on the plate, regardless of how it was distributed or where it acted (Metge et al., 1983). The panels were clustered in groups of four or five as shown in Figure 2. Each array was two panels across and two panels vertically, with the water line passing across the lower part of the upper level of panels. One array on each of the faces had a fifth panel directly beneath the other four. The spacing between the centre of group N1 and N2 was 19.5 m and between N2 and N3 it was 17 m. The centres of E1, E2 and E3 were spaced 19.5 m apart. Panel groups N2 and E2 are offset from the centre of the north and east faces by 2.44 m to the west and north, respectively. Slightly more than 10% of the waterline length of each of the north and east faces were covered with panels.

Figure 2 MEDOF panels on the North, Northeast and East faces of the Molikpaq

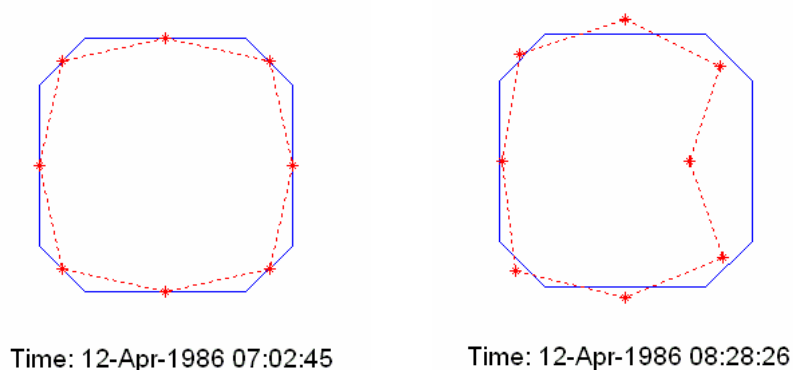
The deformation of the caisson has been termed “ovalling”, but the actual deformed shape is more a distorted ellipse. The loaded face moves away from the load, and the opposite (back) face also moves towards the centre, but not by as much. The two perpendicular faces move outwards, but also a lesser amount than the loaded face. The changing ellipsoidal shape based on extensometer measurements is illustrated in Figure 4.

Figure 4 Relative deformation of the caisson from extensometer measurements under no-load condition (left), and with loading mainly on the east face (right). Extensometers are shown as red stars in the centre of each face. The deformation is scaled up by a factor of 667:1.

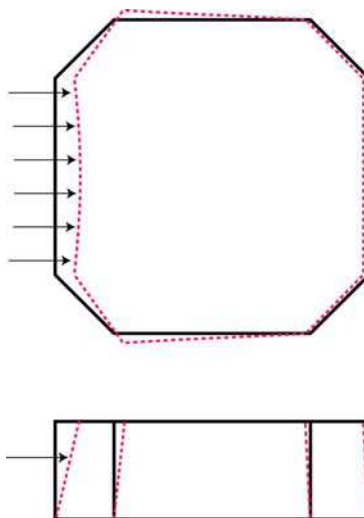
Ice load is applied across the face near the waterline on the caisson. It is expected that the top of the caisson, where the extensometers are located, will deform more than the base, which has a deeper section (see Figure 1) and whose movement is resisted by friction. Tilt measurements confirm that the caisson face does tilt inwards in response to ice loading. The actual deformed shape can be represented by the schematic of Figure 5. There are undoubtedly deformations of the caisson base, but these are probably small, and the in-place inclinometers that straddle the interface between the core and berm did not detect any relative movements. Slope indicator measurements, which were conducted periodically, did detect some localized movements at the interface between the core and the berm.

Figure 5 Plan and section views of caisson deformation

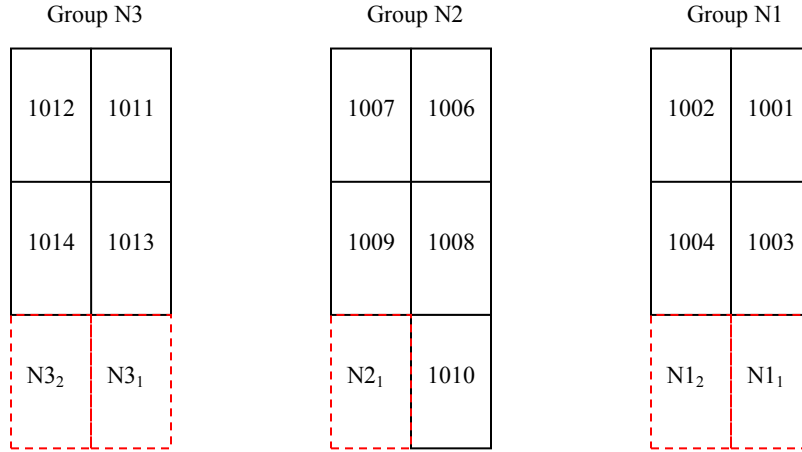
Data from the single deep panel on each long face are used to attribute a load to the missing panel in group E2 or N2, as well as to the panel groups without any deep panels. A proportion of the load measured by panel 1010 can be assigned to the missing panel N2₁. A proportion of the lower panel load recorded at location N2 can also be assigned to the missing panels N1₁ and N1₂ in group N1, and N3₁ and N3₂ in group N3. The same technique can be used with the east face panels.

Figure 6 Panel groups on north face with pseudopanel shown in red

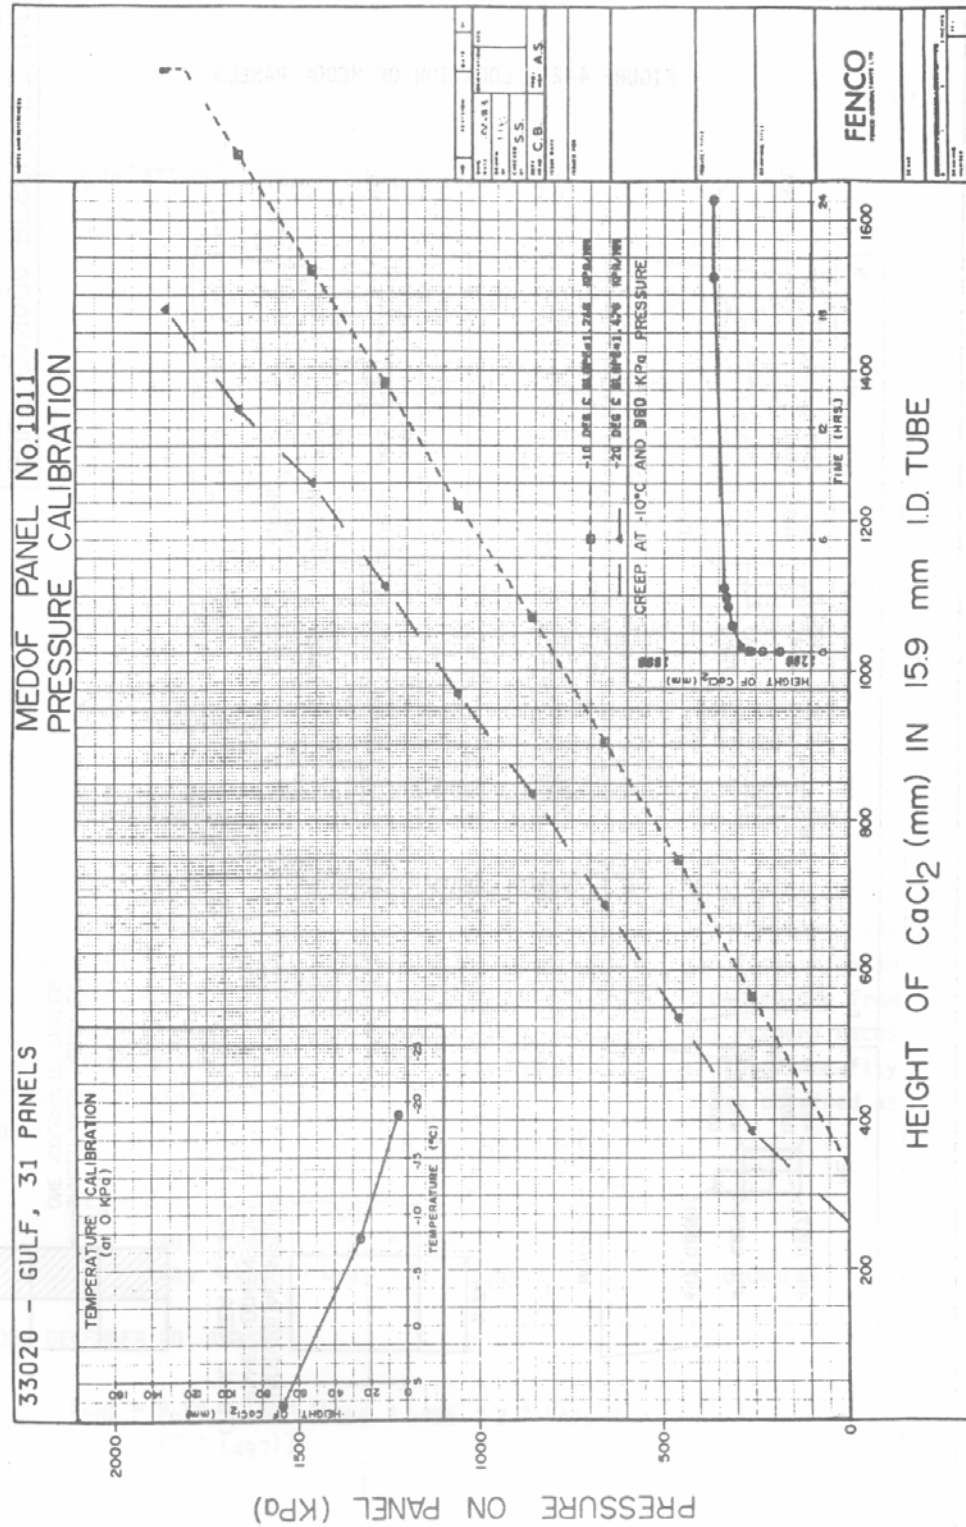
Figure 7 Example of calibration of a MEDOF Panel (Gulf Canada Ltd., 1987b)

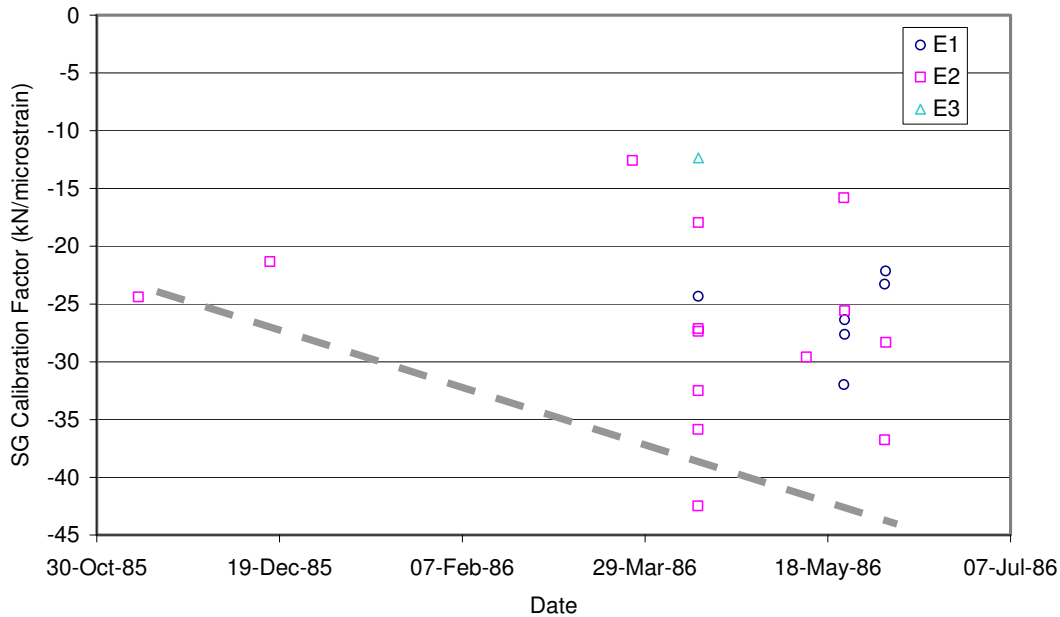
function of time is plotted in Figure 8 and Figure 9 for the east or north faces respectively. A softening trend with time would tend to follow the dashed line shown in the figures. Although there is quite a bit of scatter in the data, there is no trend of decrease in calibration factors. As stated earlier, most of the MEDOF panel softening occurred during the initial loading episodes in November 1984.

Figure 8 Strain gauge-MEDOF calibration factors for the east face over the 1985-86 season.

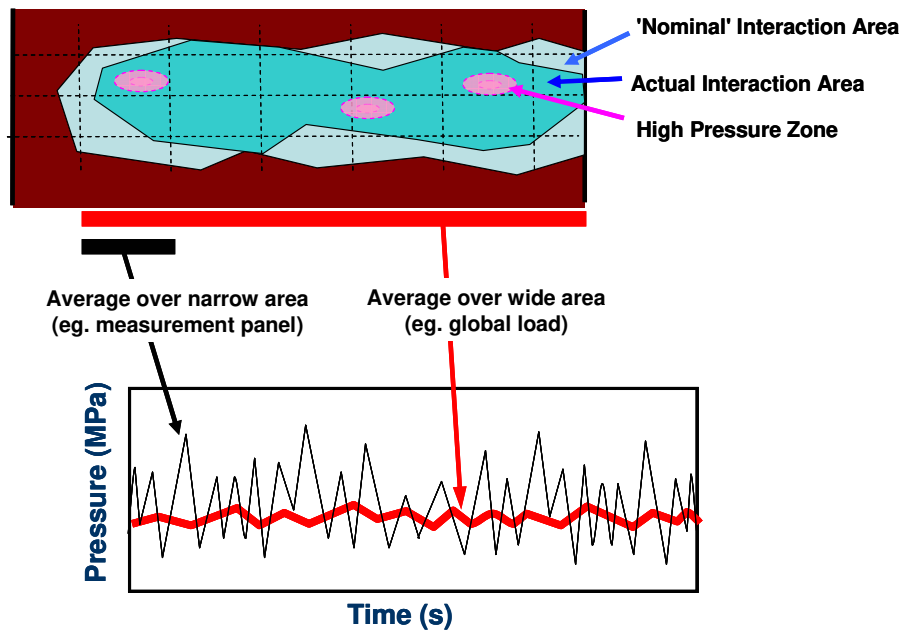
To illustrate application of the method, an interaction involving mainly crushing is considered (Figure 10). The nominal interaction area represents the contact area that would occur without spalling of ice. The actual interaction area represents the area of contact with intact ice (after spalling). The high pressure zones represent areas of high pressure which are observed during crushing events. These high pressure zones can reach pressures up to the order of 70 MPa over smaller areas. Given the nature of the pressure distribution during crushing events, one expects the average pressure over a wide structure (shown in red) will have significantly less variance than the pressure measured over a single panel (shown in black).

Figure 10 Pressure Averaging for Crushing Failure Model

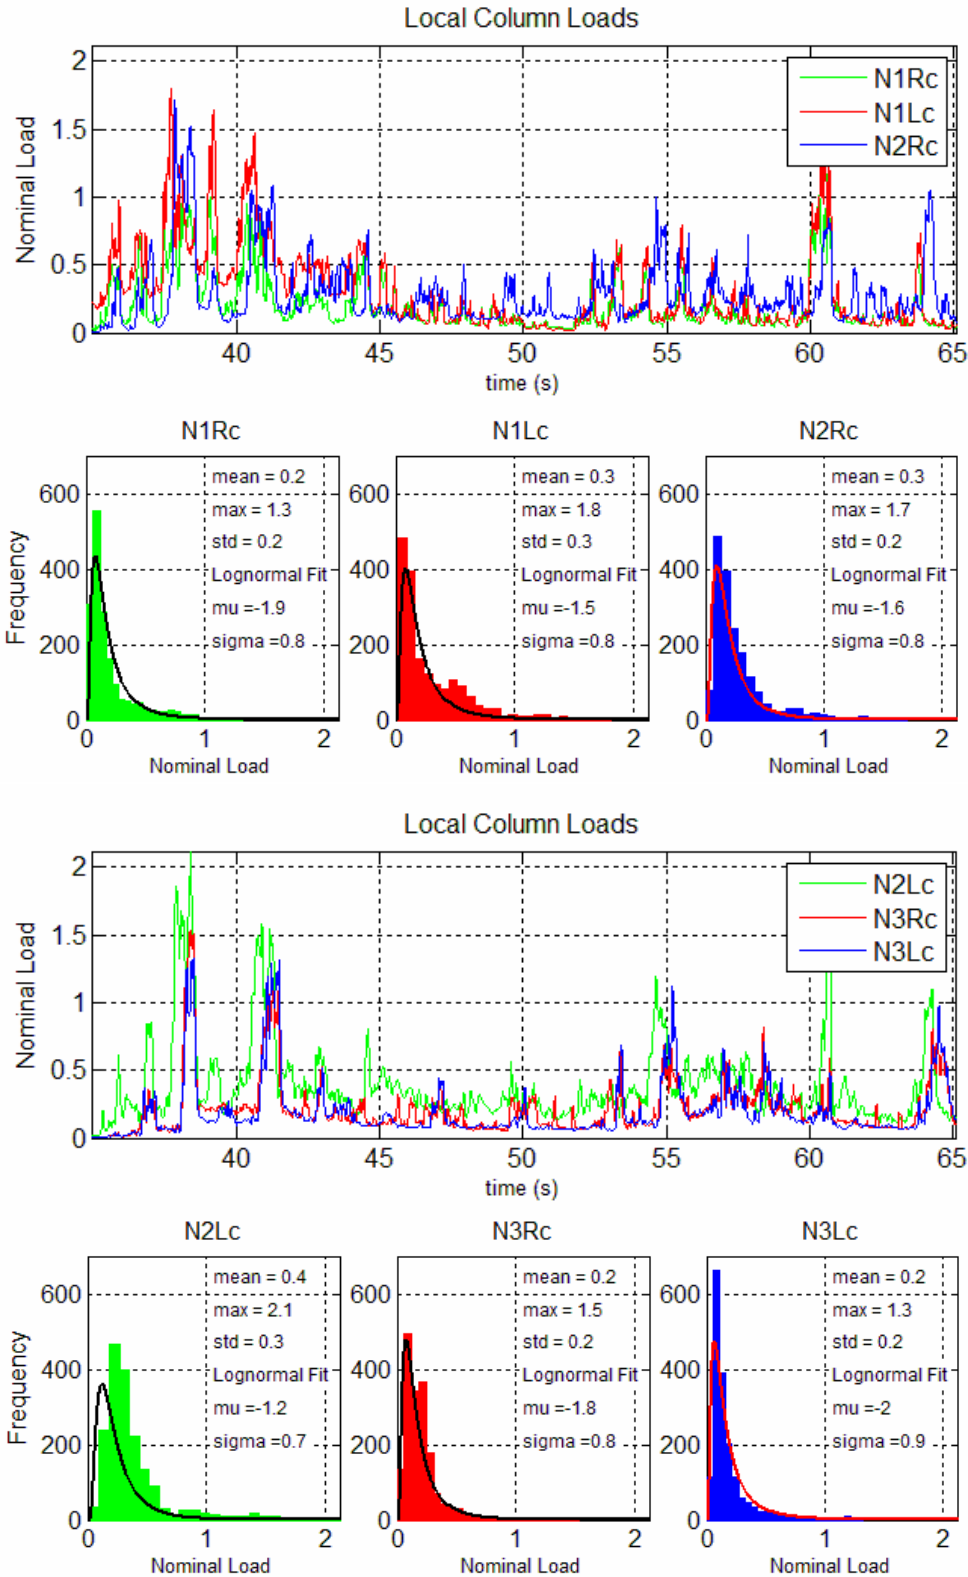
For each of the above events, histograms of loads acting on each column of the north face were generated and distributions were fitted to these data. Results of this analysis are shown in Figure 11, Figure 12 and Figure 13 for events 01, 23 and 58, respectively. The local column loads show a skewed and non-normal distribution. In the figures the data have been fitted to lognormal distributions, although other distributions such as Weibull or gamma may also be considered. Column to column variation in the load distributions are observed for all events. This likely results from local variations in ice thickness, physical properties, as well as from randomness of the failure processes.

Figure 11 Histograms of nominal loads of columns for the North face during event 01

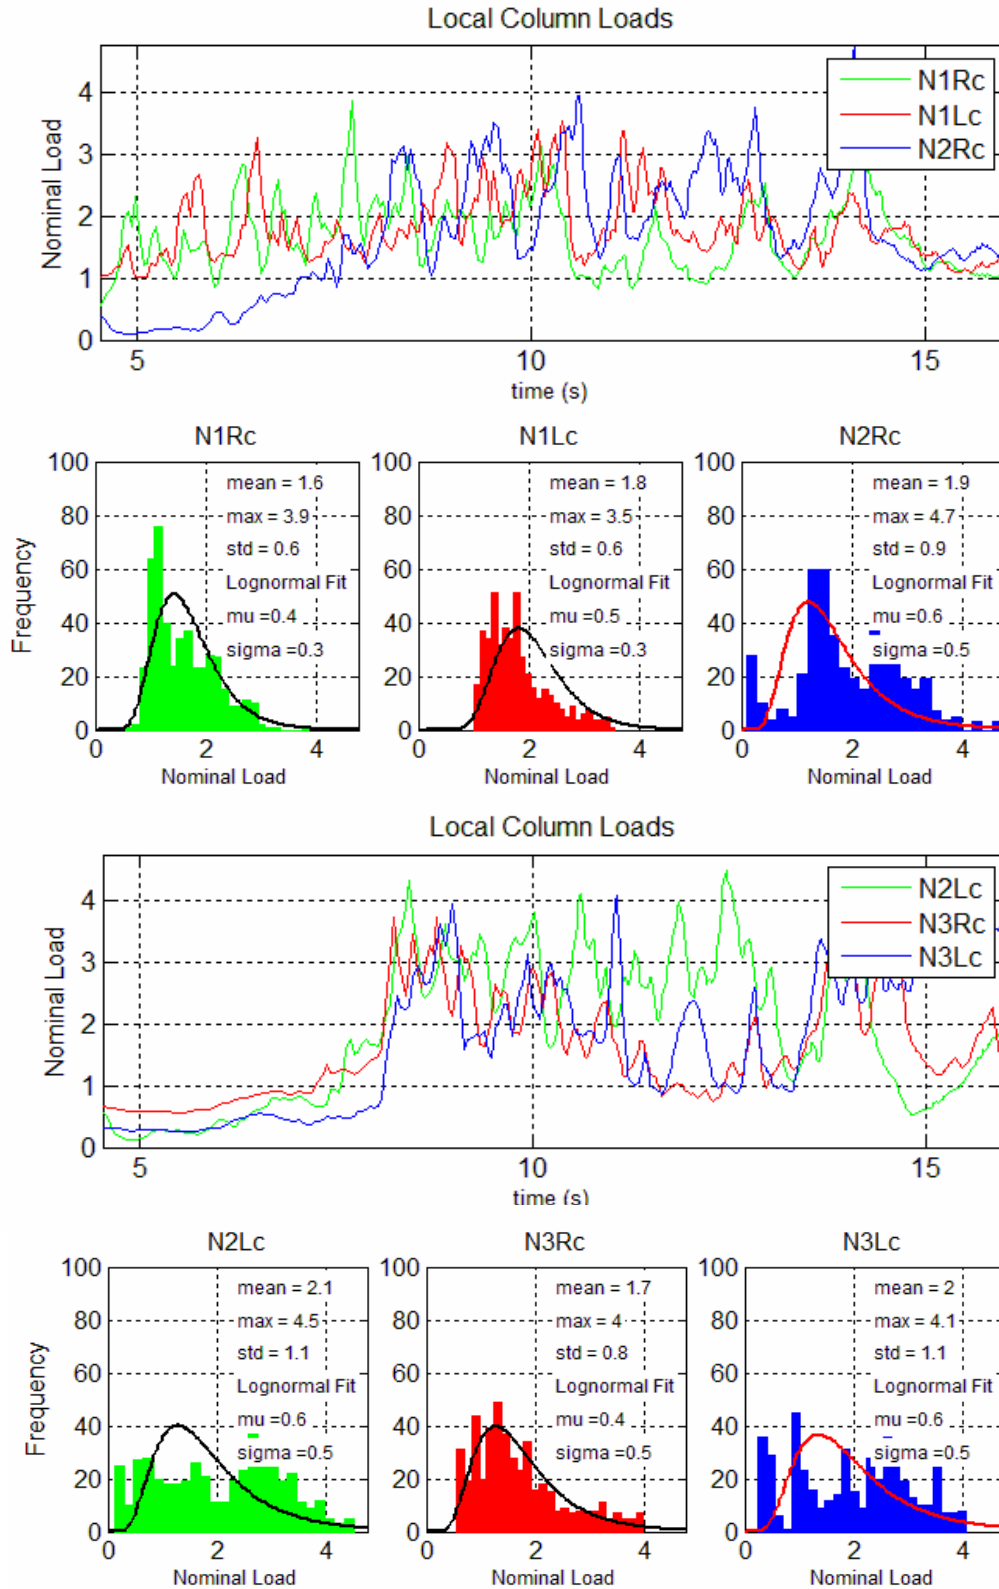
Figure 12 Histograms of nominal loads of columns for the North face during event 23

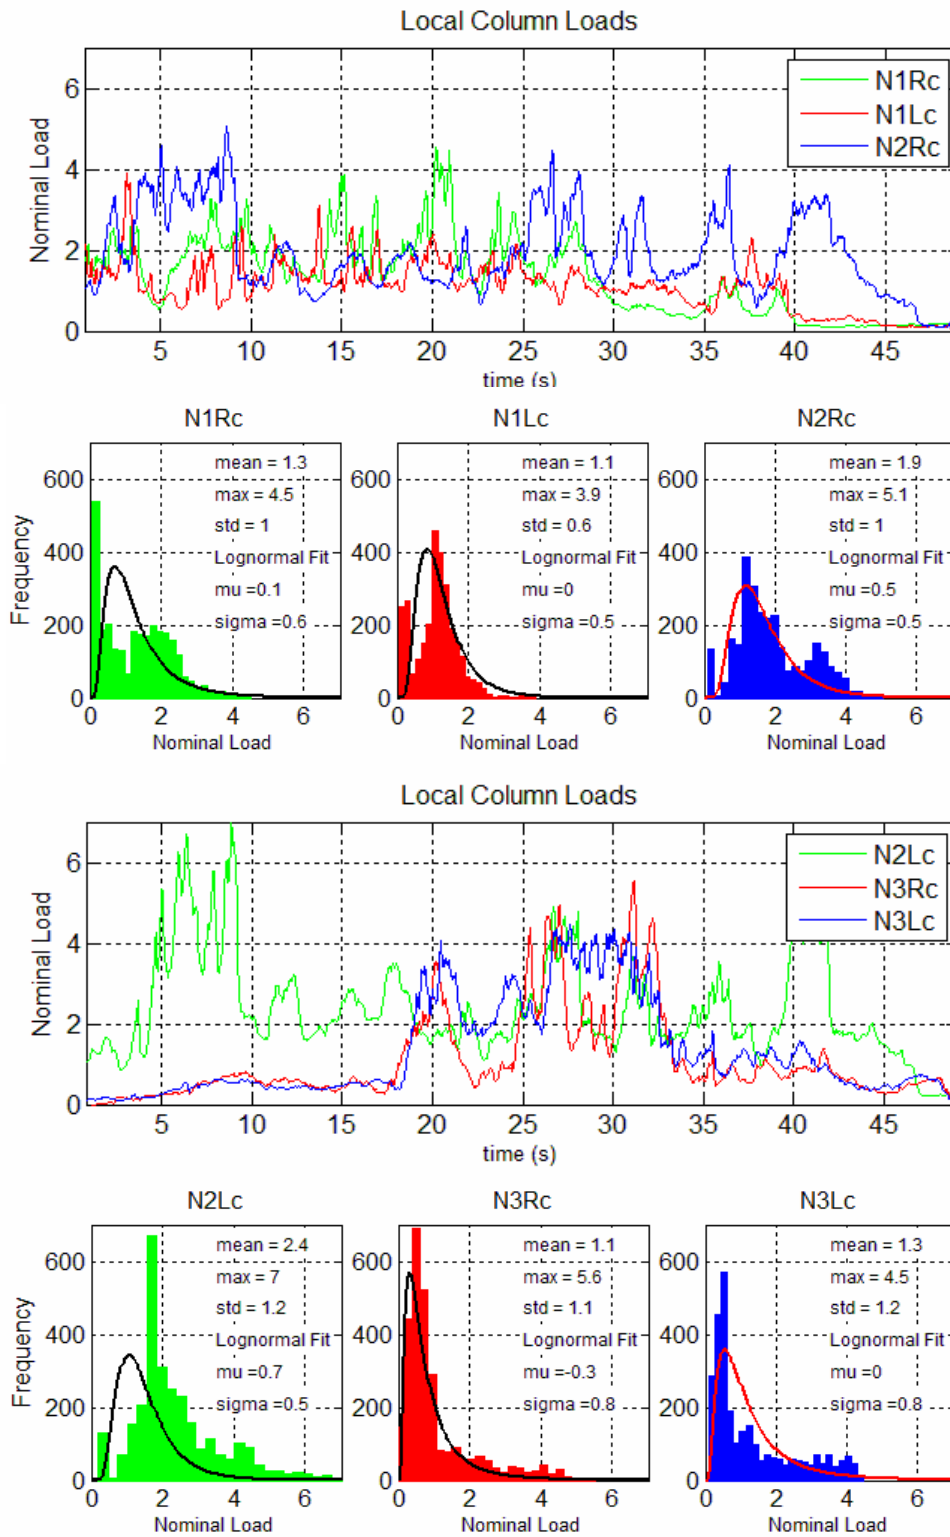
Figure 13 Histograms of nominal loads of columns for the North face during event 58

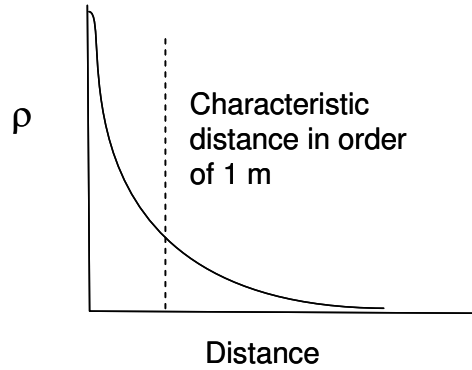
to represent the correlation between pressures at separation distances τ , where c is a characteristic spacing which can be calibrated based on measured loads at different separation spacings c . The pressures considered were average pressures over the contact height. Based on analysis of a number of load events, Jordaan et al. (2005) recommended values of c in the range 0.82 to 1.37, corresponding to correlations of 0.6 to 0.8 between MEDOF panels at a spacing of 1.135 m.

Figure 15 Illustration of exponential correlation function

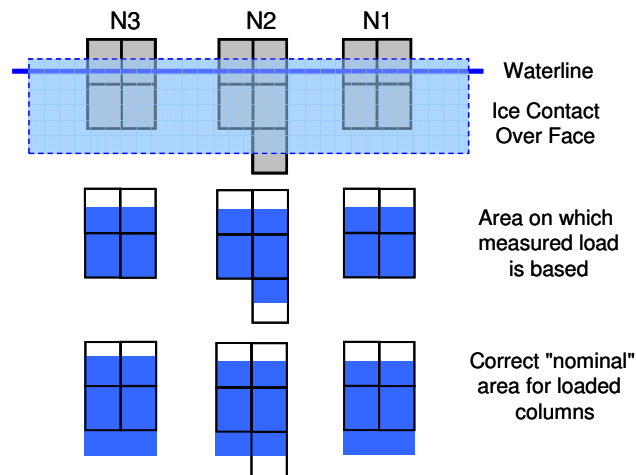
Where loads were observed on the bottom panel of the middle right column on the east or north faces (Figure 18), the loads time traces columns without bottom panels were increased to include estimated bottom panel loads. The possibility of loads below the bottom panels was not considered and is unlikely given the quoted ice thickness values.

Figure 18 “Nominal” Contact Area for Columns given Uniform Thick Ice

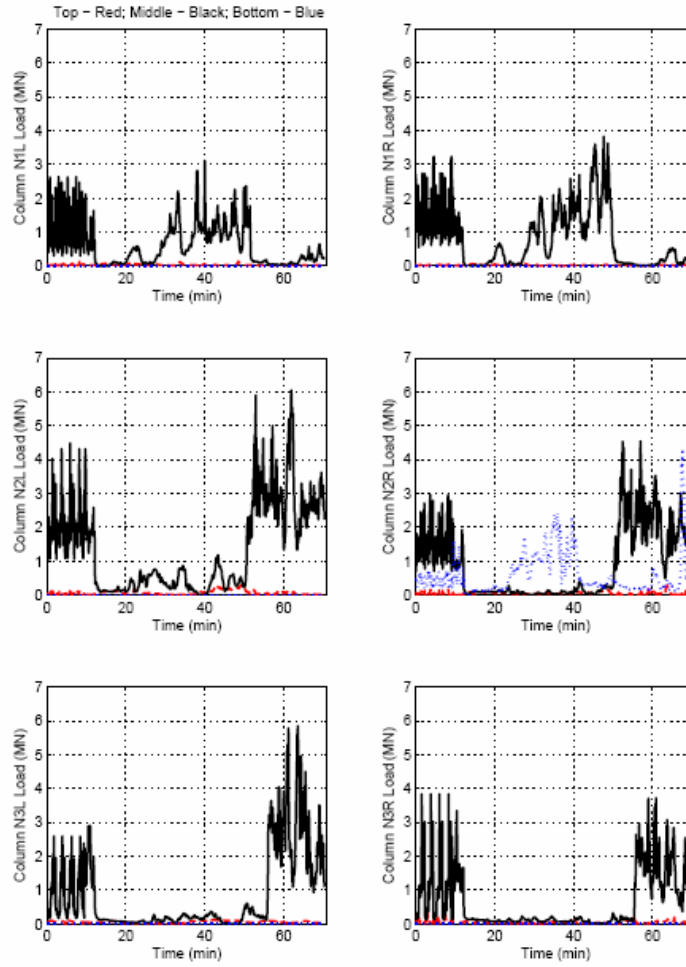
Neither of these methods is satisfactory, particularly for ice crushing. The ice failure process in a crushing failure consists of high pressure zones generally concentrated near the centre of the ice sheet, with occasional excursions towards the edges. Both methods fail to recognize this. Figure 19 illustrates the potential problems regarding bottom panel loads. The left and right columns of group N1 show significant middle panel loads at 40 minutes, whereas the middle group columns show moderate to small middle panel loads. At the same time, the lower panel of the middle right column shows a significant bottom panel load. Using the Ratio method can result in very large assumed loads on the N1 columns at 40 minutes.

Figure 19 Illustration of effect of bottom areas with no panels

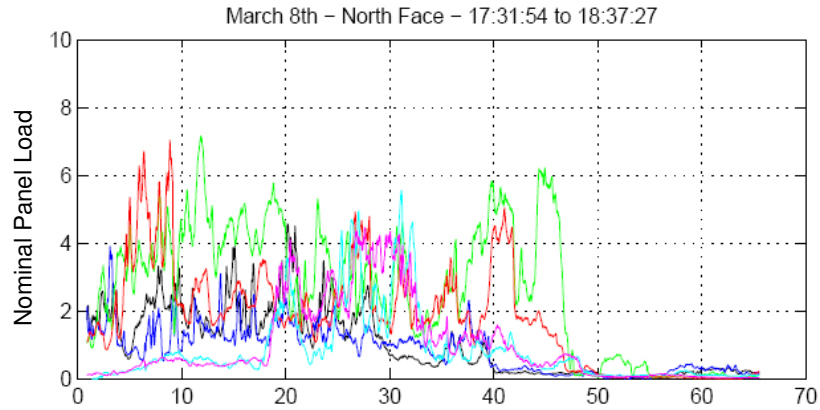
Crushing events are characterized by random load traces on different panels that generally are uncorrelated as shown in Figure 20.

Figure 20 Example Crushing Event

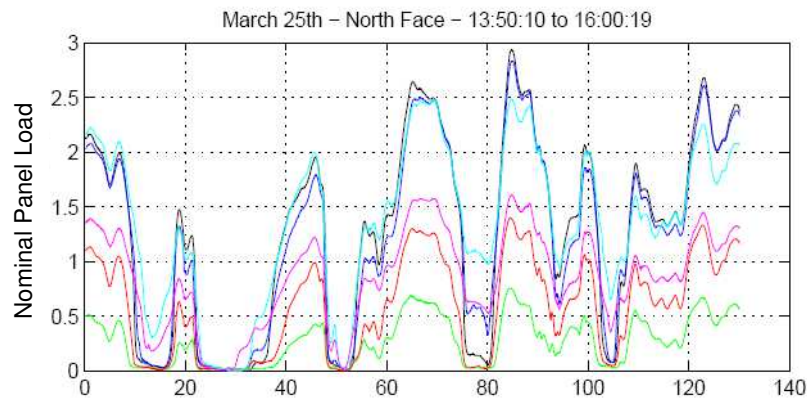
Creep failure occurs at low velocities and shows highly correlated variations in pressure at different locations as can be seen in Figure 21. The characteristic distance in such cases can be as large as the structure width.

Figure 21 Example Creep Event

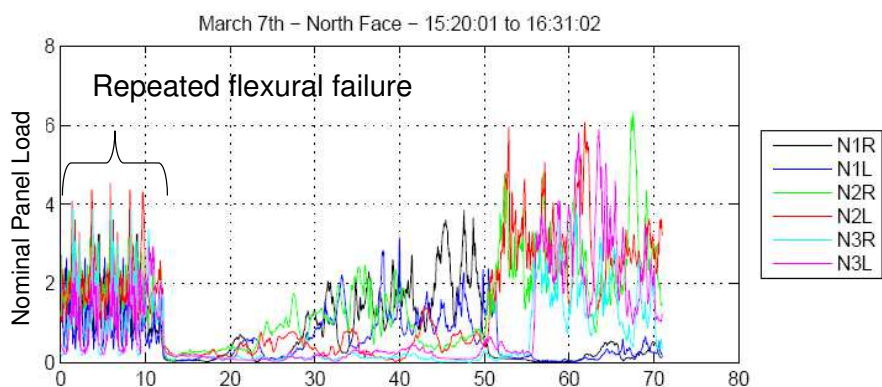
Repeating flexural failures can result from buckling of the advancing ice or failure due to build-up and submersion of rubble and can occur across the width of the structure or locally (Figure 22).

Figure 22 Example Flexure Event

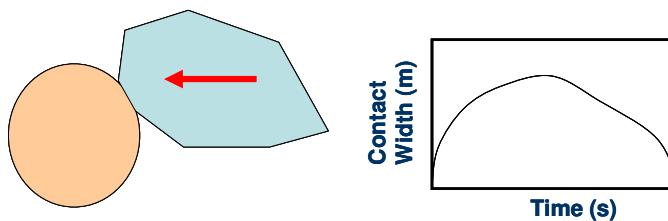
As a feature impacts the contact width will increase, enveloping additional panels (Figure 24). This can appear as negative or positive correlation in the load on different panels.

Figure 24 Variation in Contact Width

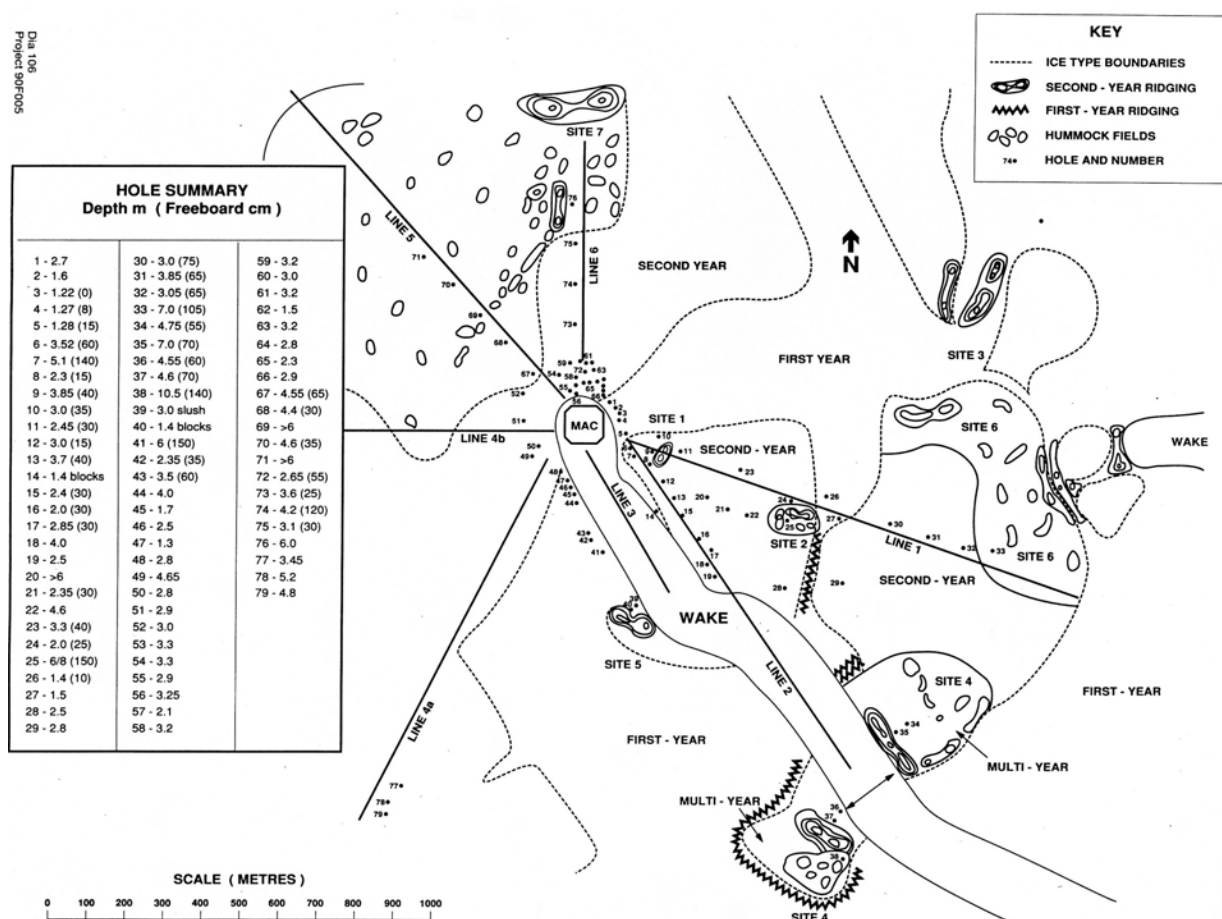
drill hole numbers in Appendix H refer to the location numbers in Figure 27. With the exception of a few clearly first-year ice areas, the ice thickness measurements were of second-year or multi-year ice. A probability distribution of the 62 thicknesses is presented in Figure 28. The median ice thickness was 3.25 m, the average 3.8 m, the minimum 2 m and the maximum 10.5 m. There were 7 thicknesses measured at between 5 and 7 m. Ice thickness data from the same area as that measured March 9 indicated thicknesses greater than 3.2 m (presumably by this time a longer drill was available) and resulted in an average of 3.5 m and a standard deviation of 1.3 m, significantly greater than the March 9 results. The thickness measurements, even though taken after the March 7 and 8 events, provide a guide for quantitative estimates of thickness for the March 7, 8 and 25 events as well as April 12. We will try to relate specific ice thicknesses to particular events; however in a general sense these data provide an indication of multi-year ice thicknesses and their variability. Individual ice thickness measurements were accurate to about ± 0.1 m. There is considerable uncertainty, however in the average ice thickness attributed to individual events, ± 0.5 m for ice around 2 m thick, and ± 1 m for ice 3 m and thicker.

Figure 27 Survey of ice thicknesses surrounding the Molikpaq, March 1986

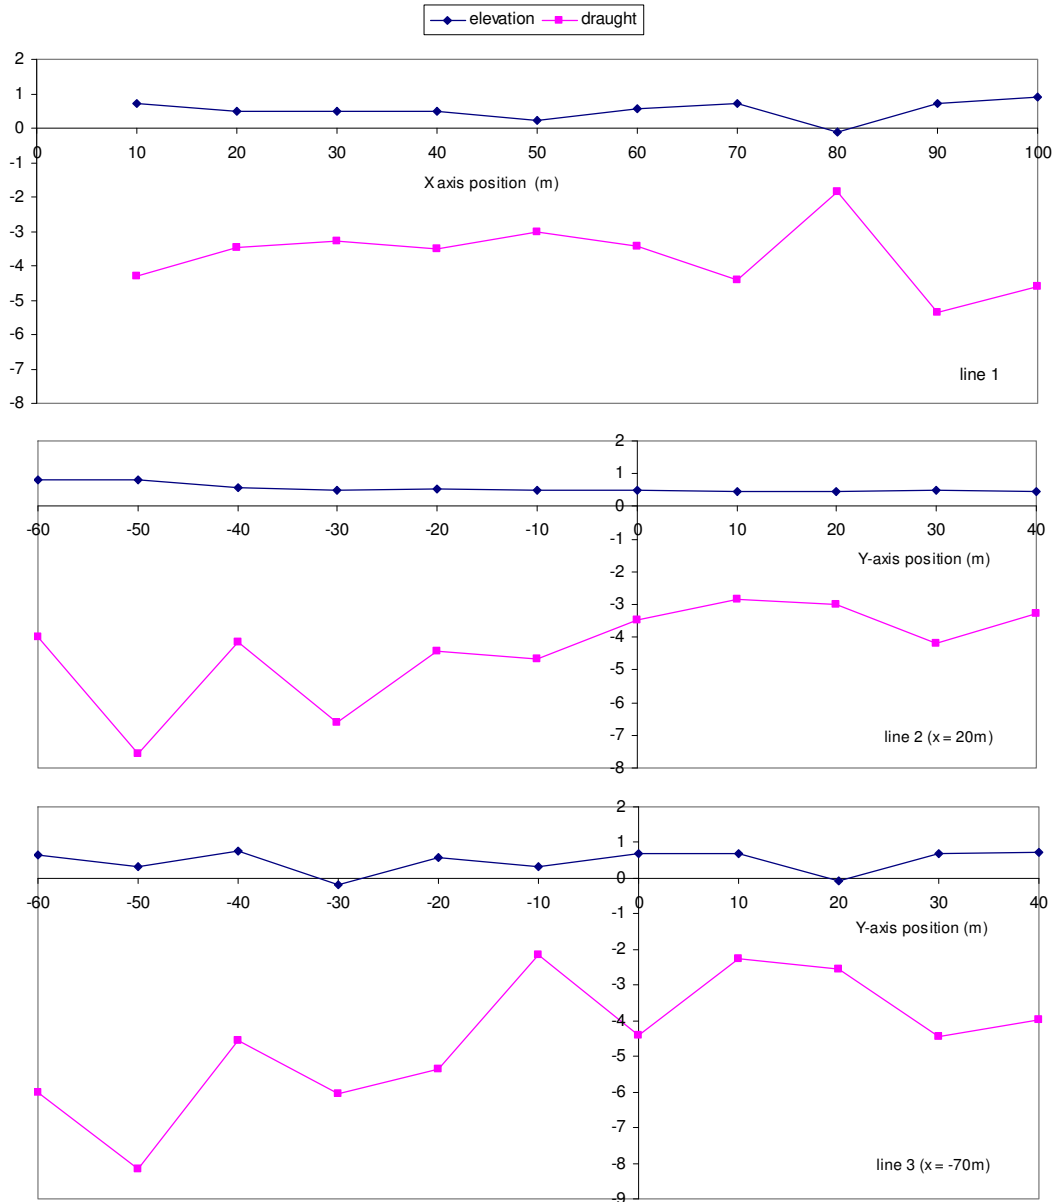
The ice thicknesses measured around the Molikpaq were 20 to 100 m apart, so while they are useful for establishing average values, they do not provide much information about spatial variability over distances comparable to the width of the Molikpaq, 100 m. Recently multi-year ice thickness surveys have been carried out in Nares Strait (Johnston, 2008). Thicknesses were measured on 10 m spacing, and provide a good indication of thickness variability. Figure 29 plots the elevation and draught of the top and bottom surface of a multi-year floe. Measurements are referenced to the water line. Lines 2 and 3 were at right angles to line 1 and at positions 20 m and 70 m with respect to the x-axis of line 1. The first point to observe is that the top surface of the ice does not give any indication of the thickness. The average of the 30 thicknesses was 4.8 m and the standard deviation 1.6 m, for a coefficient of variation of 0.33. Note that her COV of 0.33 is less than the COV of 0.37 obtained from the ice thickness measurements at the Amauligak I-65 site. For some events that will be presented in Section 11, only a few ice thickness measurements were available, so Johnston's results give an indication of the likely variability over distances equivalent to the width of the Molikpaq.

Figure 29 Plot of ice thickness variation

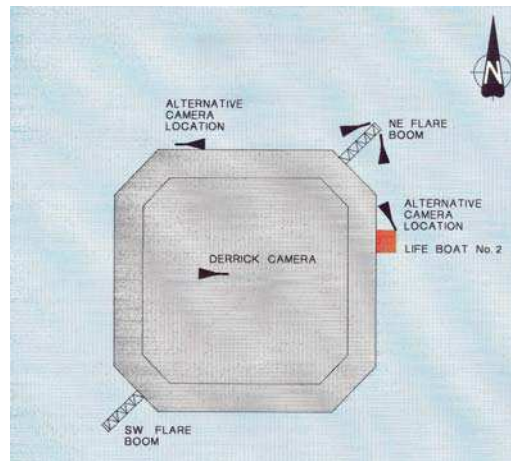
Figure 30 is a schematic illustration of the three camera locations and the approximate fields of view of the two cameras that were mounted on the flare boom. When the NE flare boom was in use, the two fixed cameras were relocated as shown. Figures 31 to 33 provide representative examples of individual frames taken from the time lapse video records.

Figure 30 Schematic illustration of the primary and secondary locations of the three time lapse video cameras that were placed on the Molikpaq.

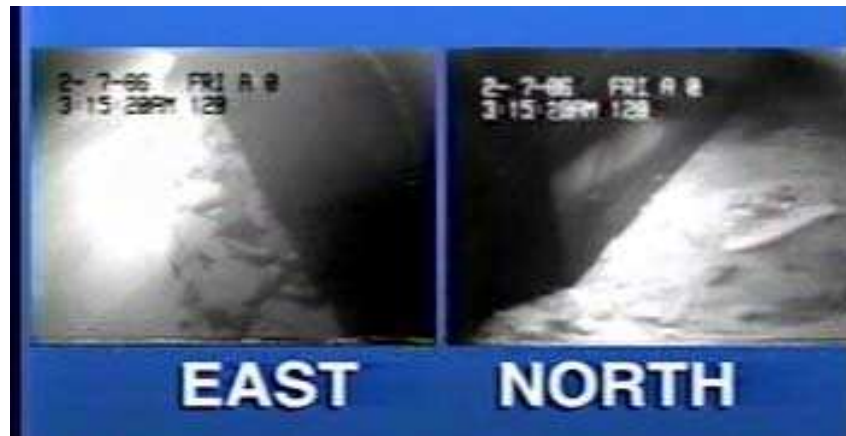
Figure 33 A similar view of the north and east faces of the caisson during darkness hours. In this case, the ice was failing against the east face in mixed modes, with broken ice debris sliding westwards along the caisson's north face.

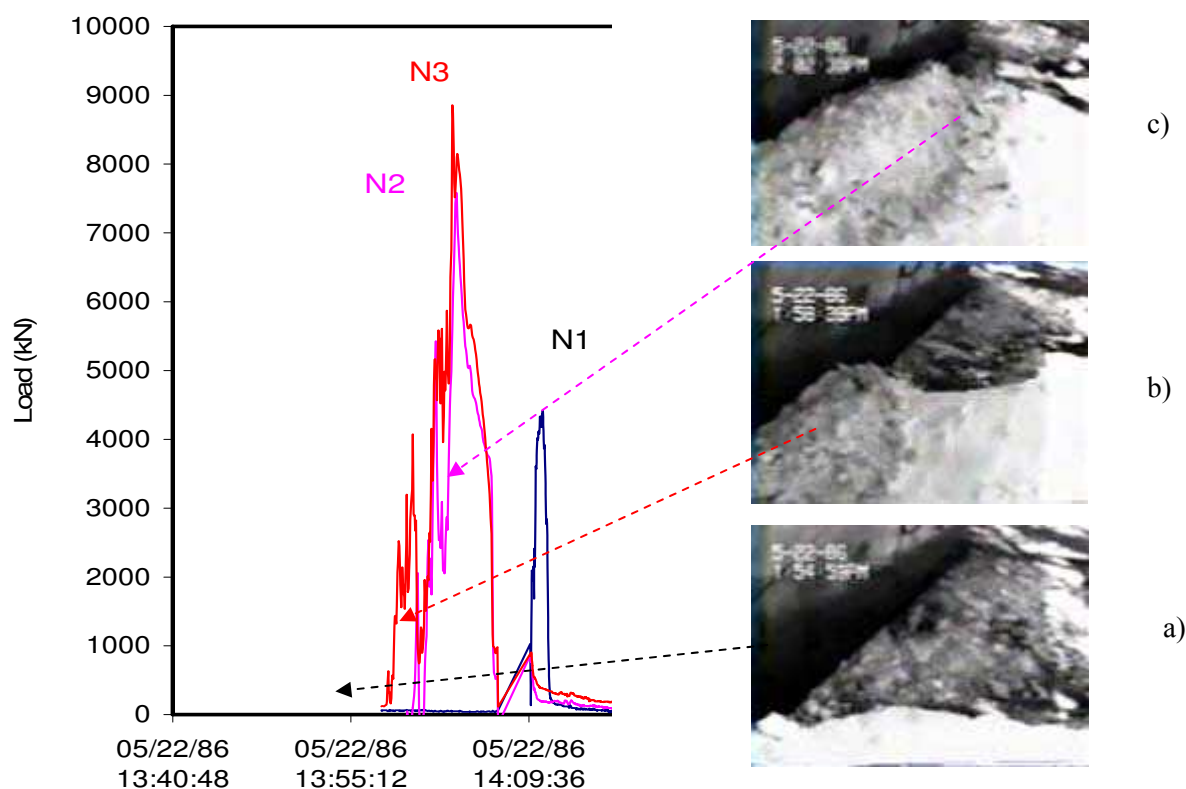
Figure 35 shows a “slice” of the ice load time series that was recorded by the instrumentation system for the May 22 PM event. Here, individual ice load traces are given for MEDOF panel groups N1, N2 and N3. Several time lapse video frames are also included for specific times, to illustrate the type of ice action that the caisson was experiencing along its north face. This comparison also indicated a very good time correspondence between the details of the ice failures observed on the video records and the ice loads seen on the panel group plots, again to within a few seconds.

- a) no ice action on the N face just prior to the event
- b) crushing begins at the E end of the N face and spreads west to cover N3
- c) crushing continues to spread west and reaches the N2 panel group (but not N1)

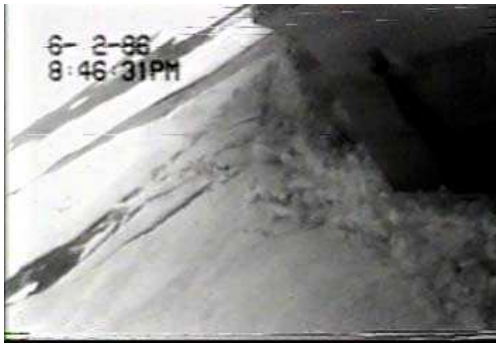
bending and splitting failures along the east face of the caisson

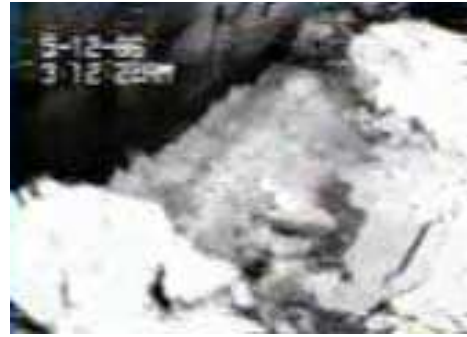
spatially varying bending and crushing failures against the north caisson face

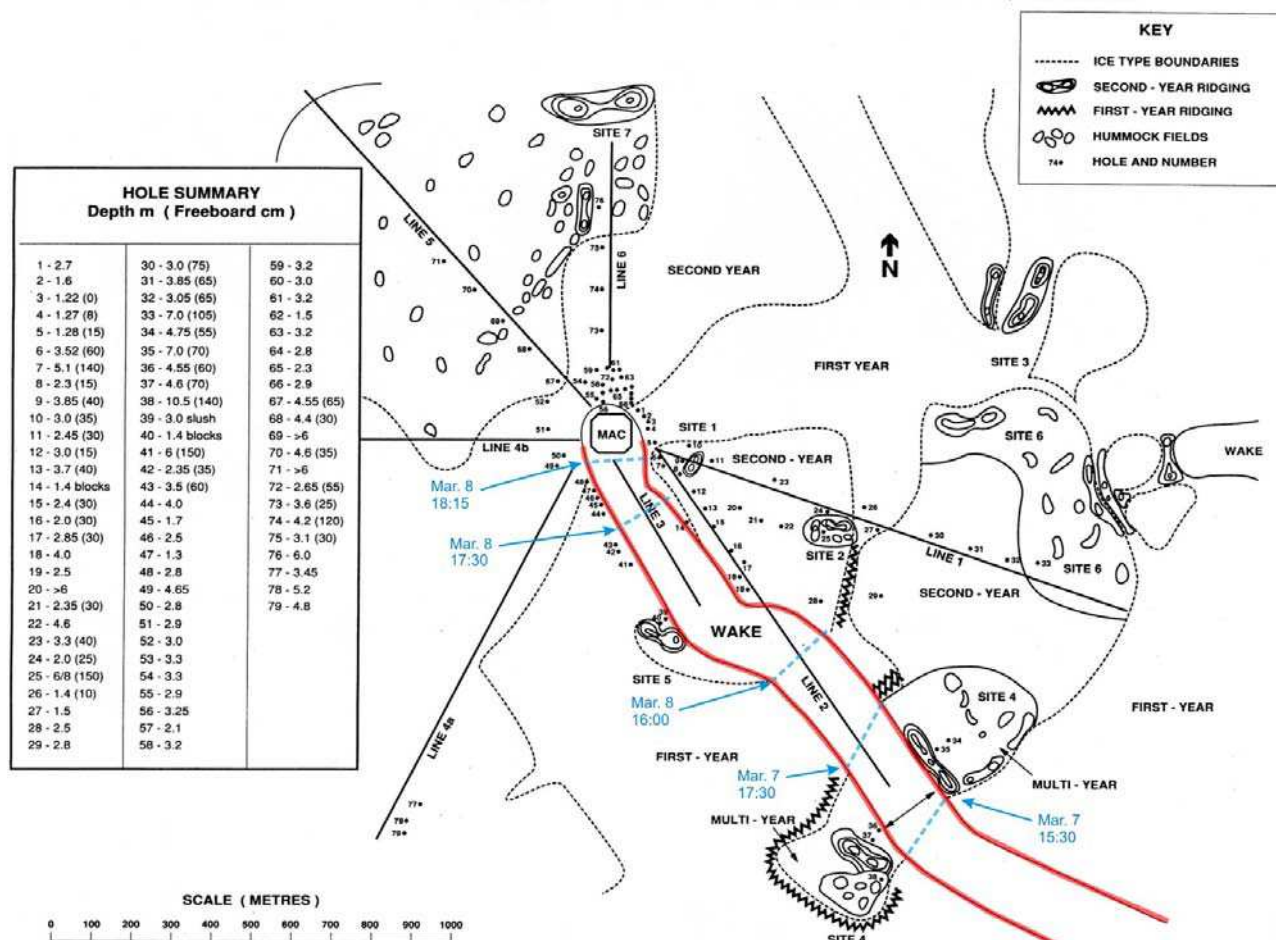
Figure 36 Survey of ice conditions surrounding the Molikpaq for March – April 1986. The wake or track of the ice past the structure on March 7 - 8, 1986 is outlined in red.

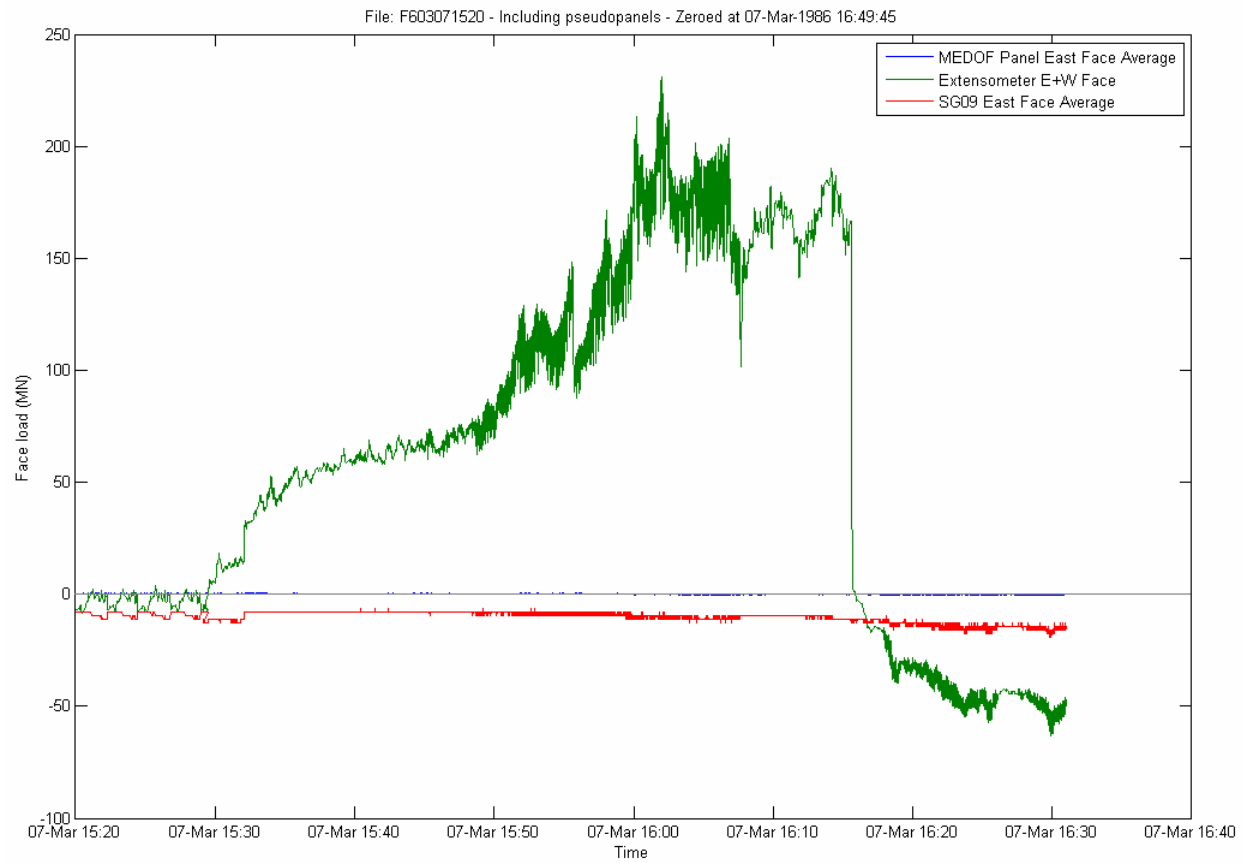
Figure 37 March 7 – West face loading, Event 0307A
