Analysis of multi-year ice loads Molikpaq data (1985-86 winter deployment): final report

Controlled Technical Report (National Research Council of Canada. Canadian Hydraulics Centre); no. CHC-CTR-068, 2010-01

ANALYSIS OF MULTI-YEAR ICE LOADS MOLIKPAQ DATA (1985-86 WINTER DEPLOYMENT)

FINAL REPORT

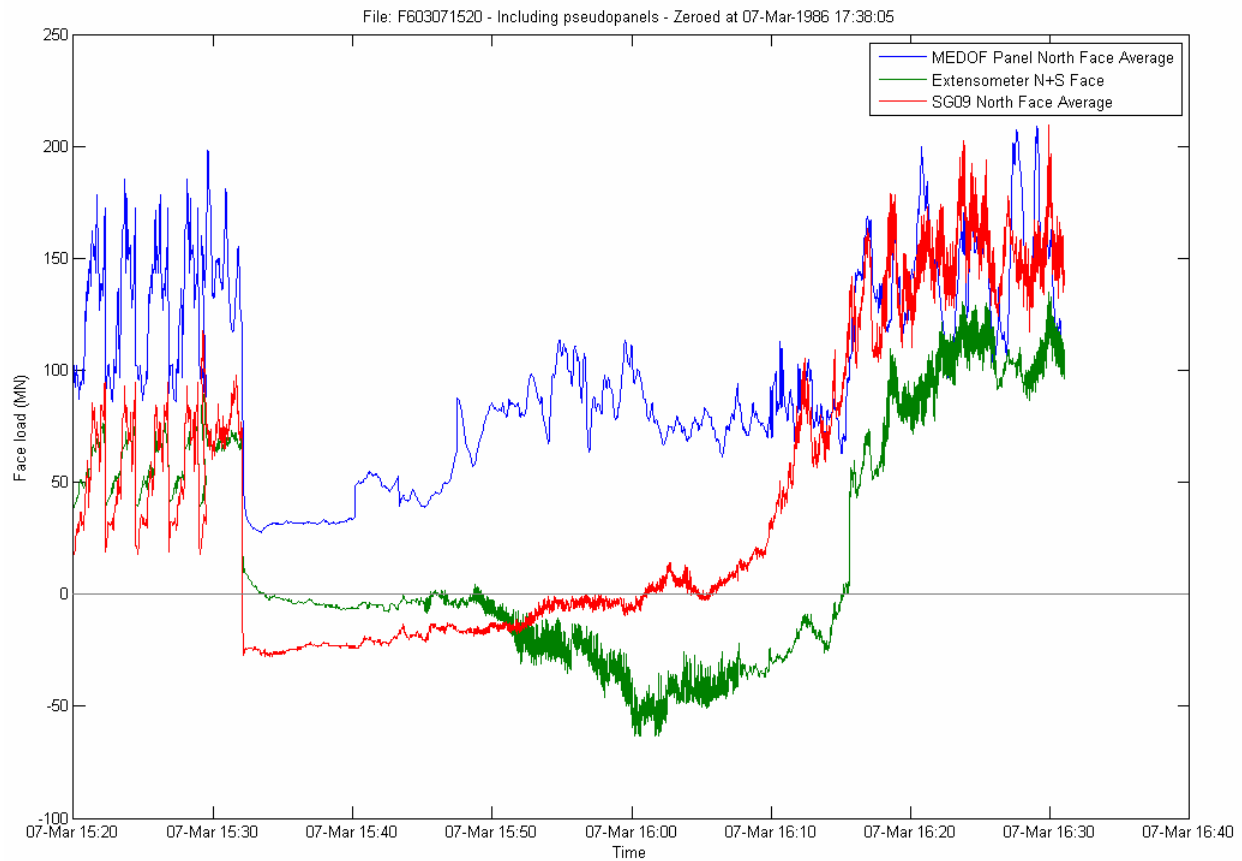
Figure 38 March 7 - North face loading, Event 0307A

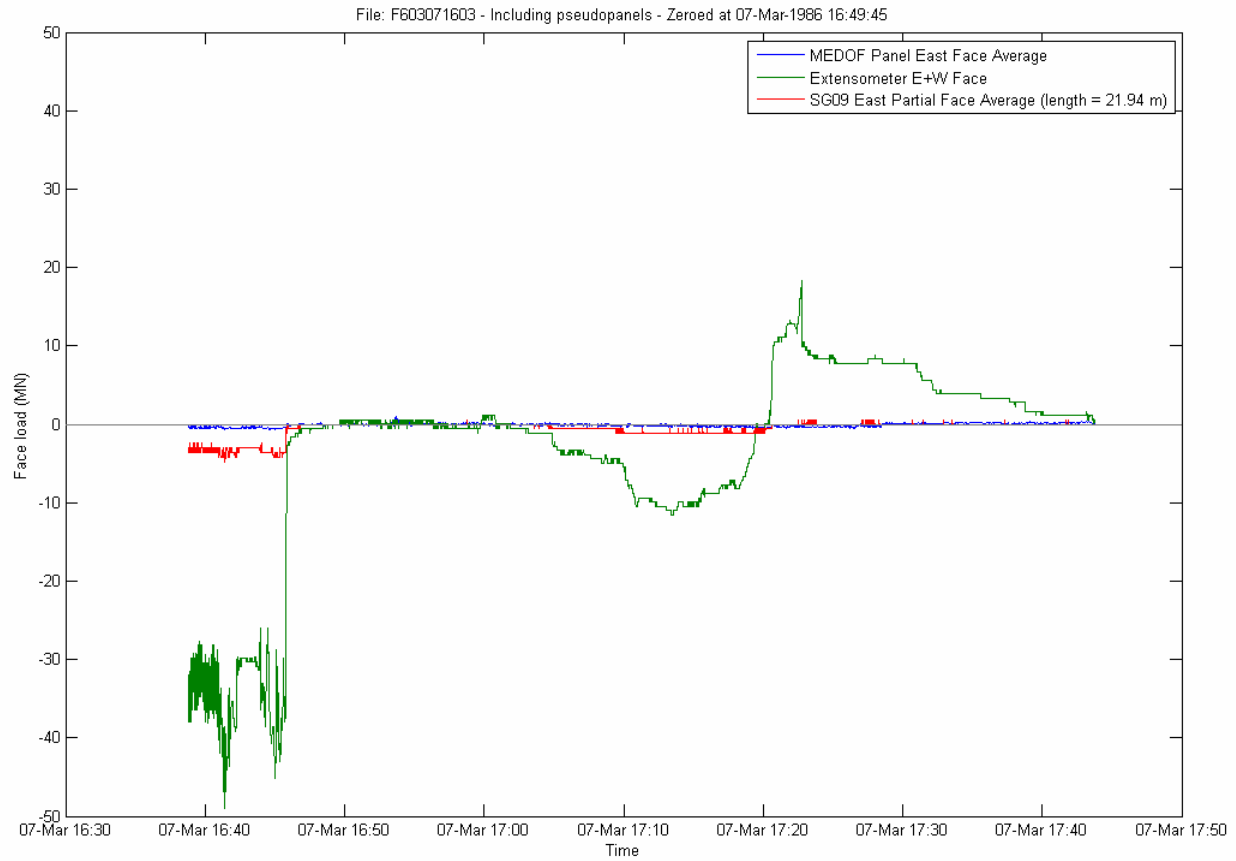
Figure 39 March 7 - East face loading, Event 0307B

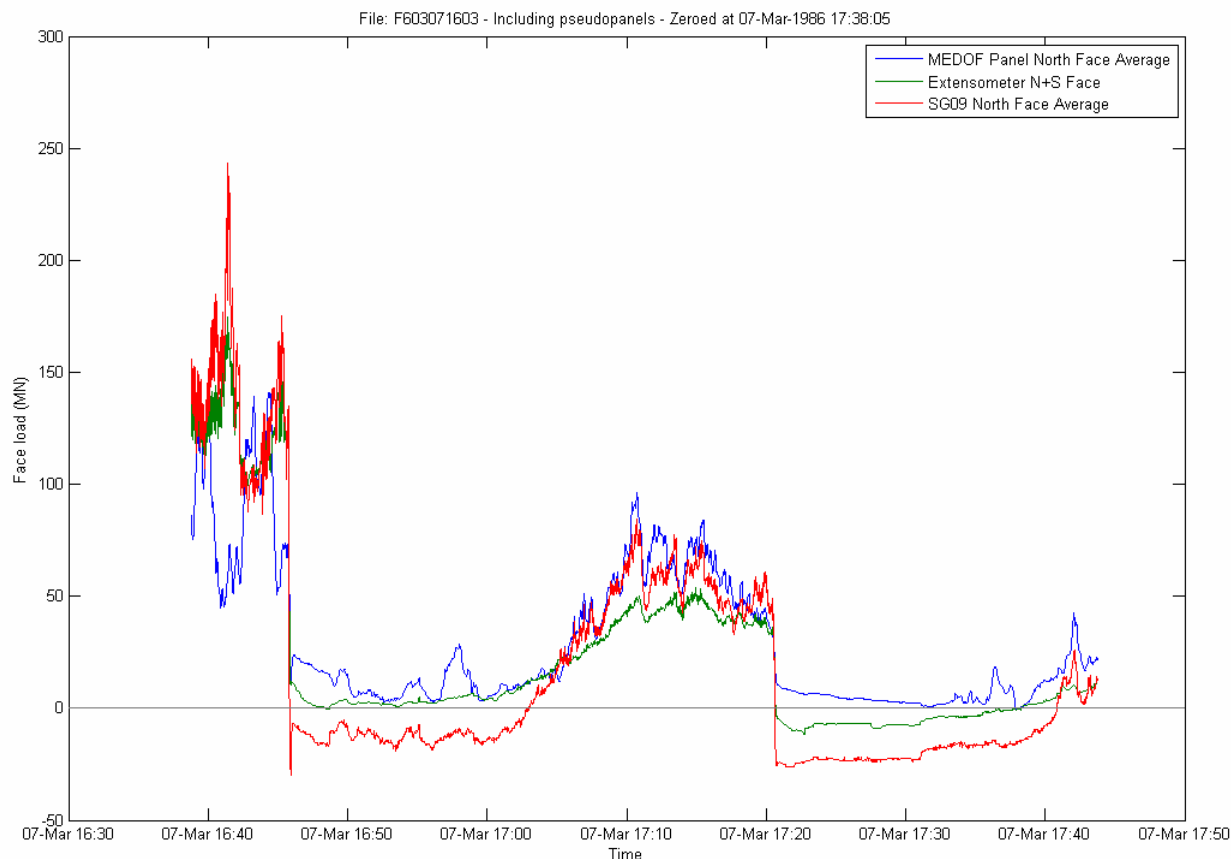
Figure 40 March 7 - North face loading, Event 0307B

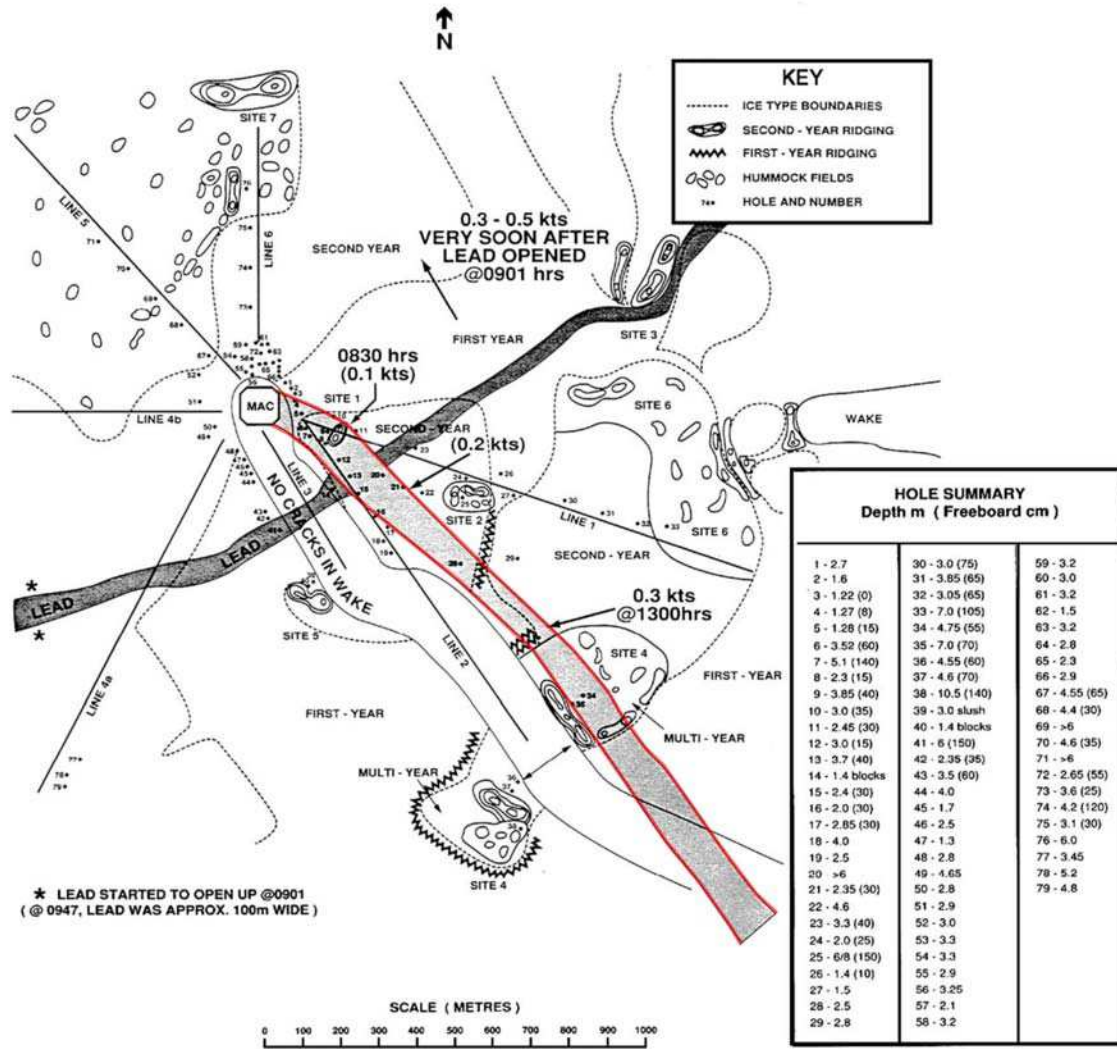
Figure 50 Survey of ice conditions surrounding the Molikpaq for March – April 1986. The track of the ice past the structure on April 12, 1986 is outlined in red

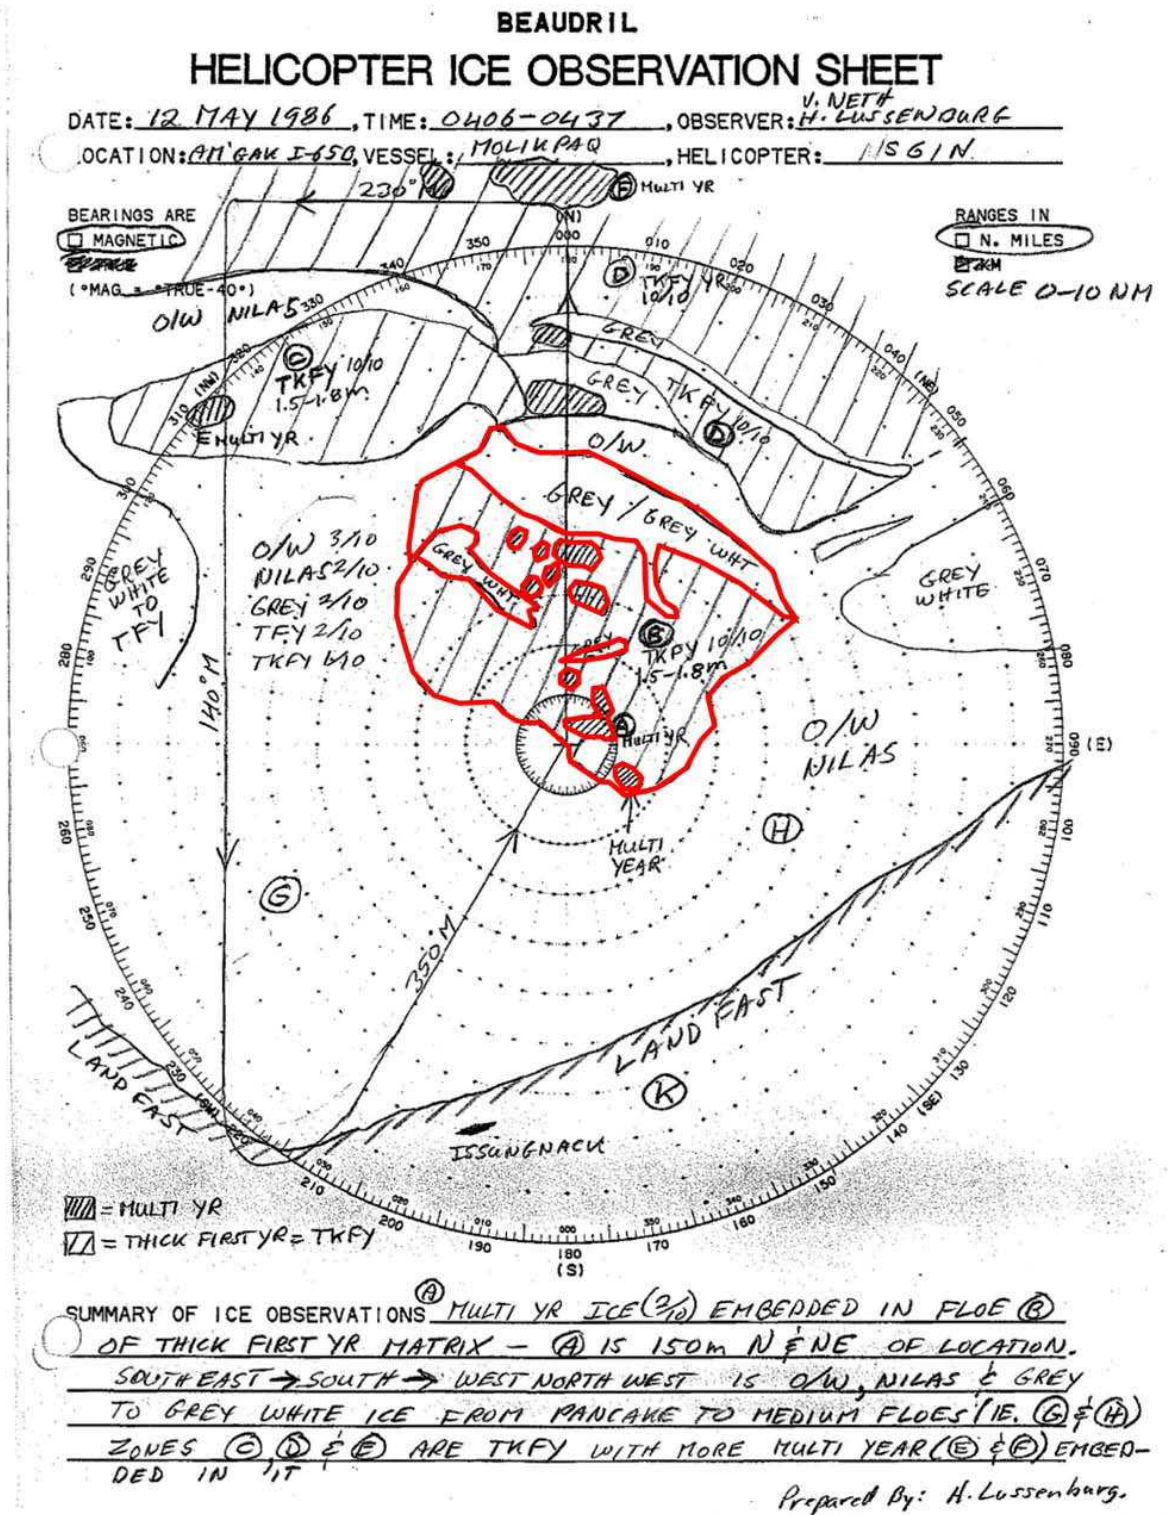
Figure 60 Description of floe impact Molikpaq on May 12

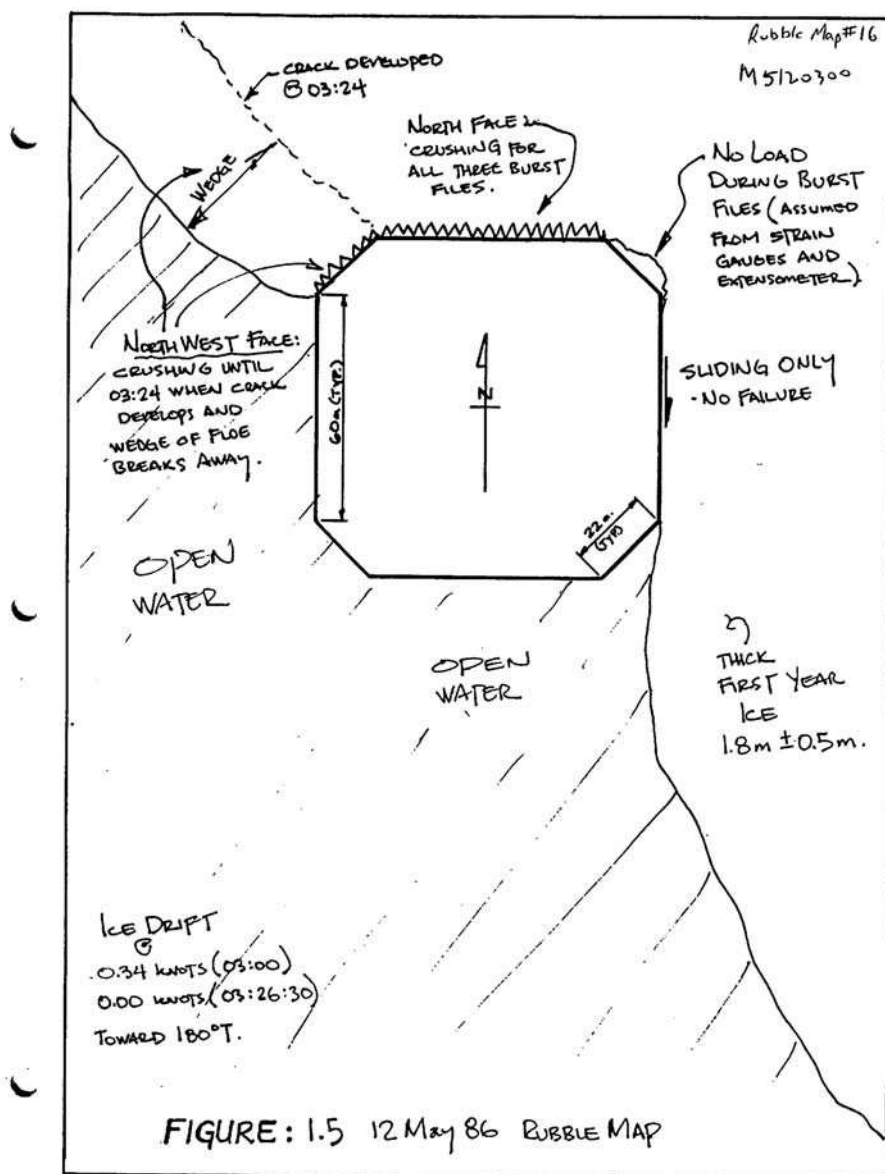
Figure 61 Sketch of the floe edge impact with Molikpaq.

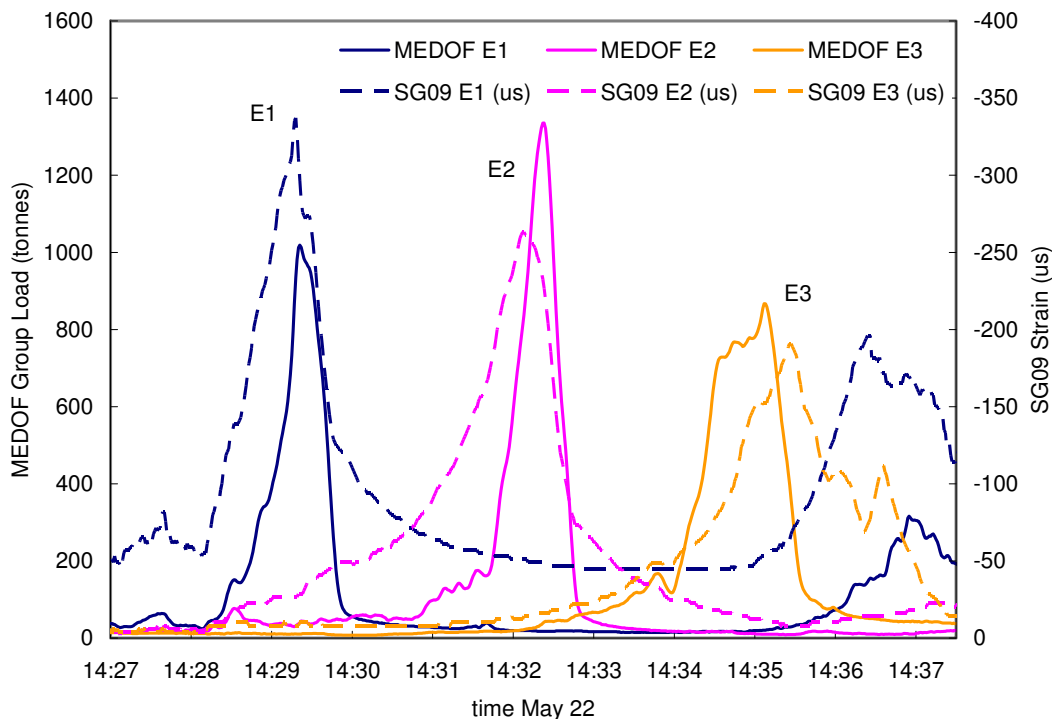
Figure 71 May 22 East Face moving load (time expansion of Event 0522B)

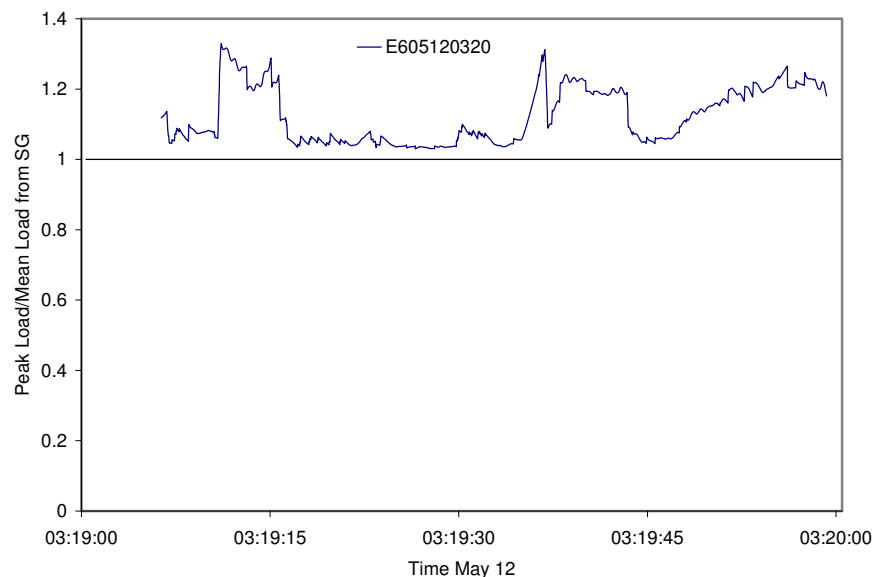
Figure 79 Ratio of peak load to one-minute average load

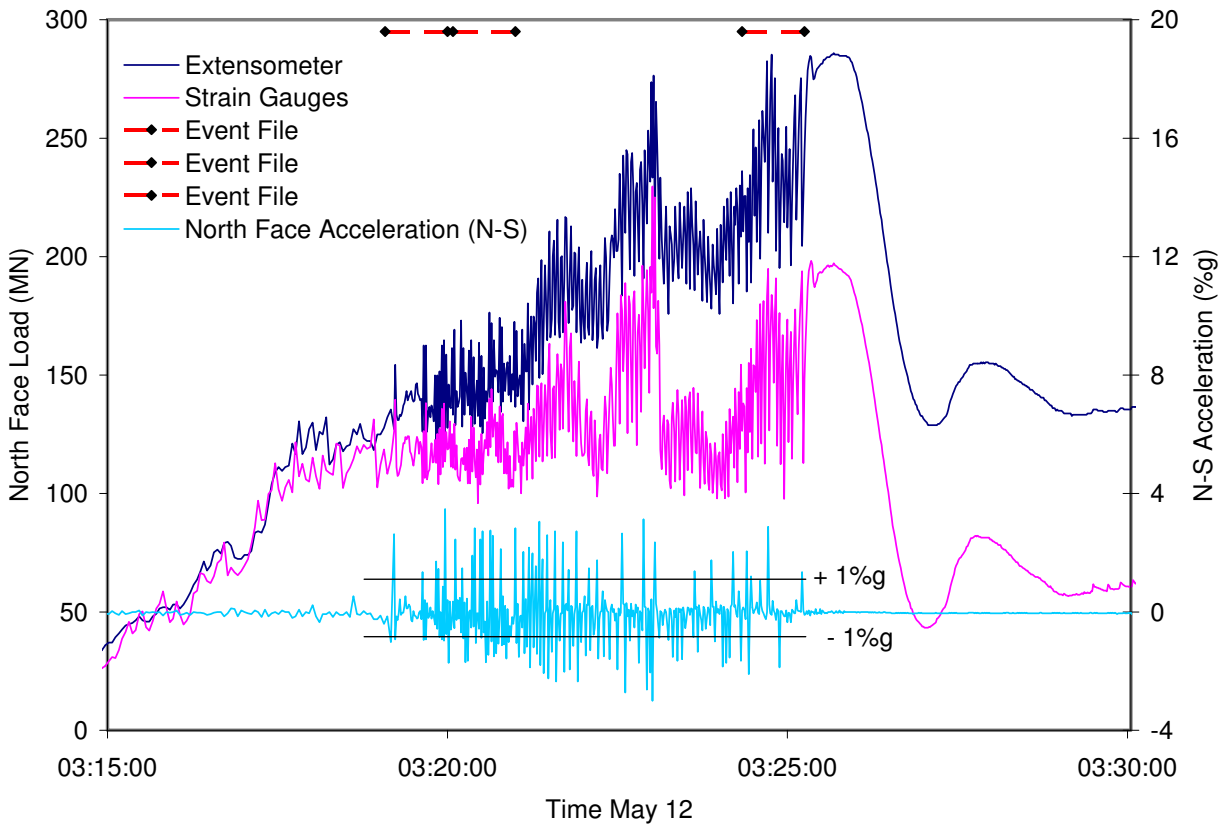
Figure 80 Comparison of May 12 loads and acceleration for phase lock

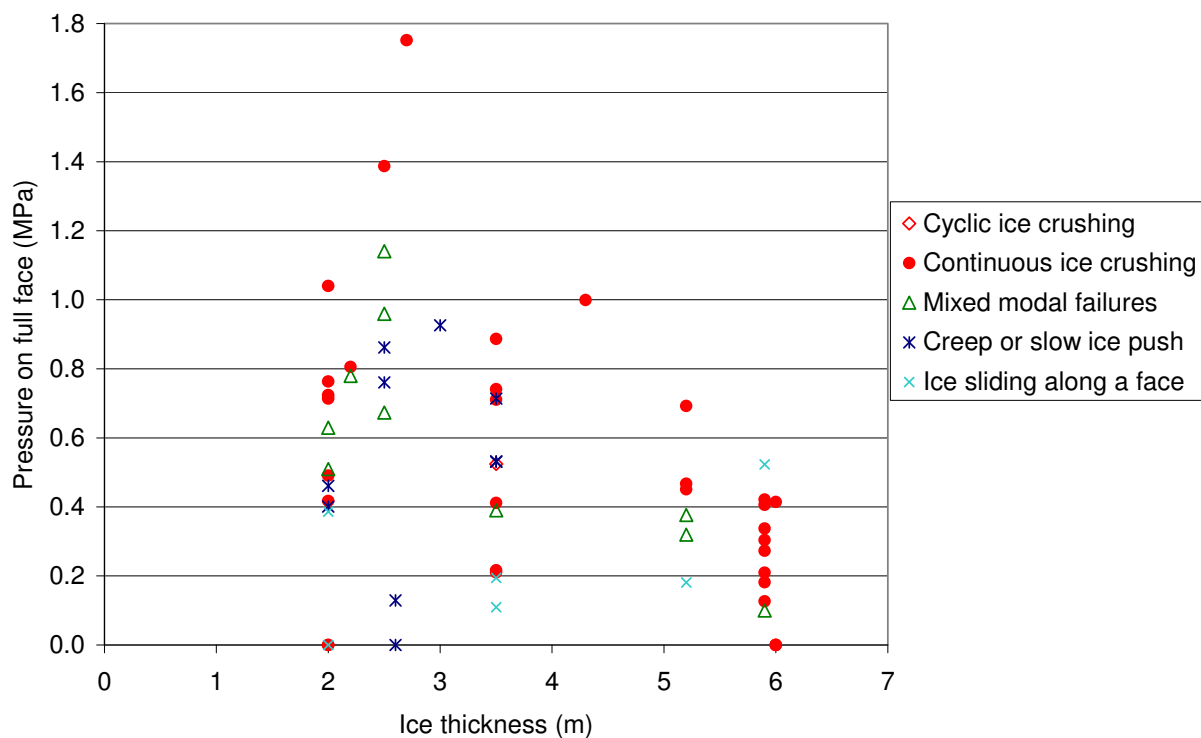
Figure 83 “Historical Case” pressures based on MEDOF panel loads, categorized by failure mode

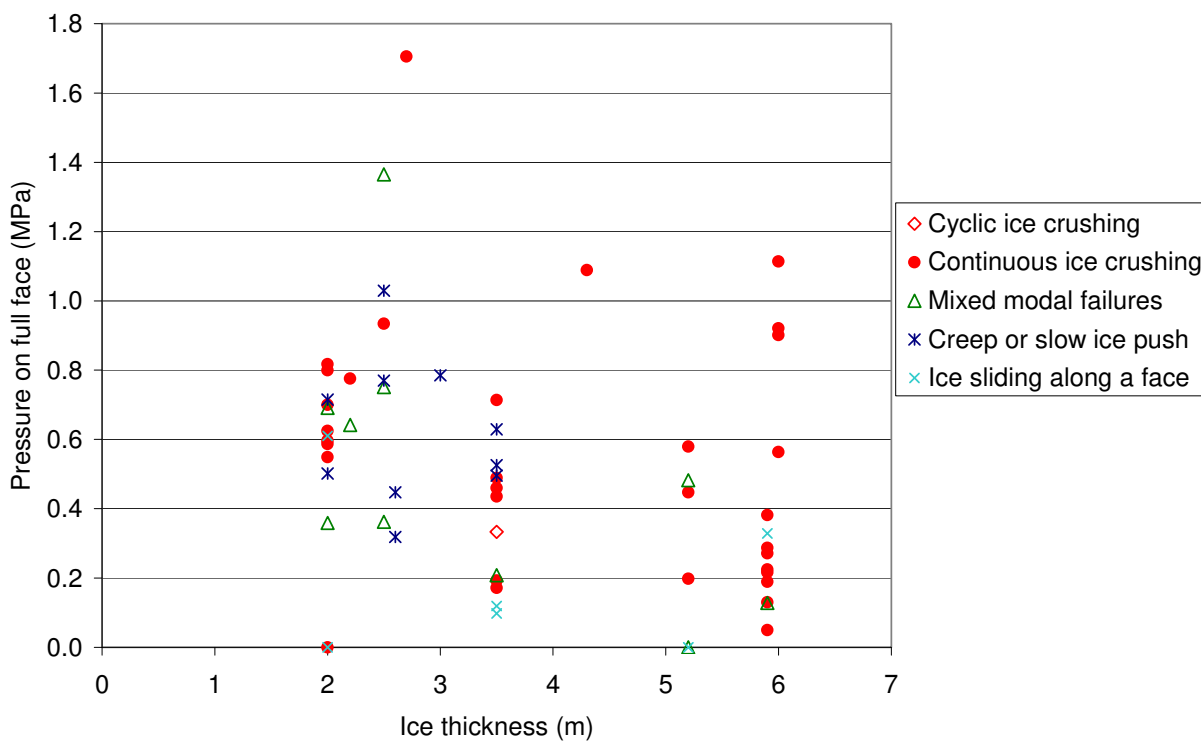
Figure 84 “Historical Case” pressures based on extensometer results, categorized by failure mode

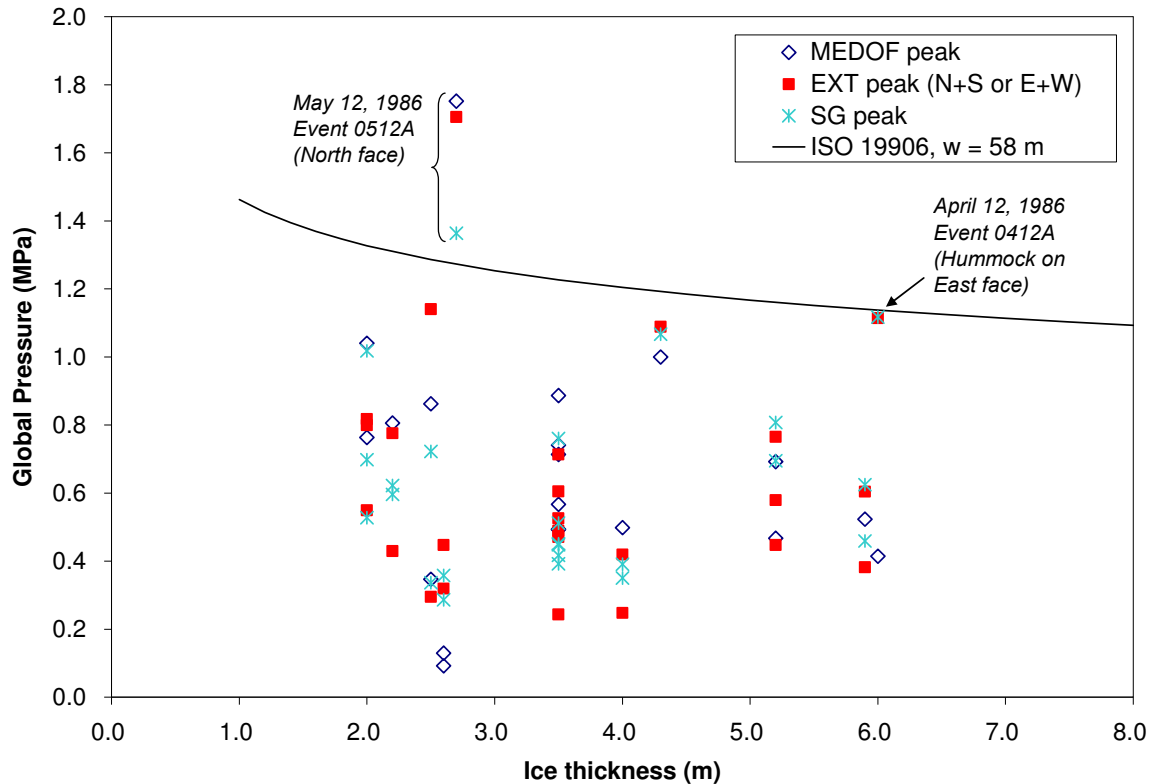
Figure 88 Comparison of “Historical Case” global pressures with global pressure curve from ISO/DIS 19906 for a structure of the same face width as the Molikpaq, 58 m

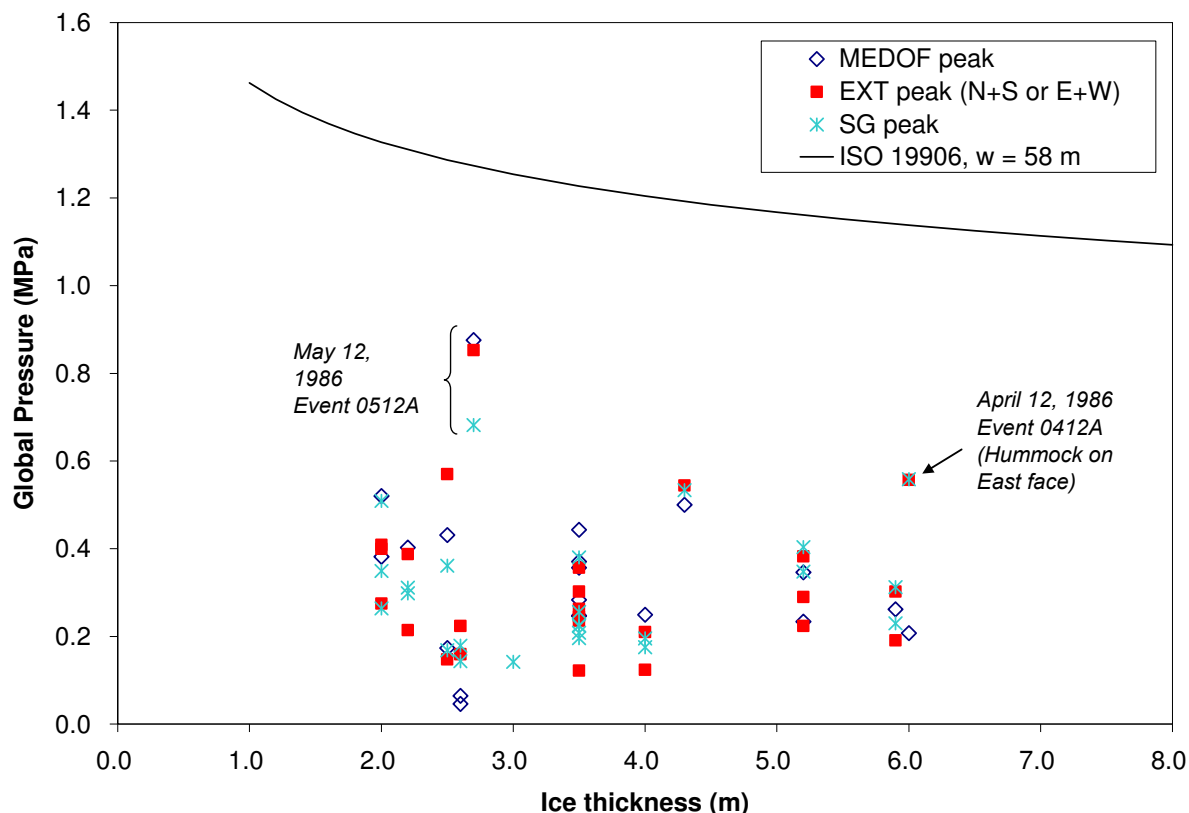
Figure 89 Comparison of “Best Estimate” global face pressures with global pressure curve from ISO/DIS 19906 for a structure of face width 58 m
