TESTS ON THE LATERAL STRENGTH OF  
CONCRETE BLOCK WALLS AT AULTSVILLE

W. G. Plewes

Internal Report No. 239  
of the  
Division of Building Research

November 1961

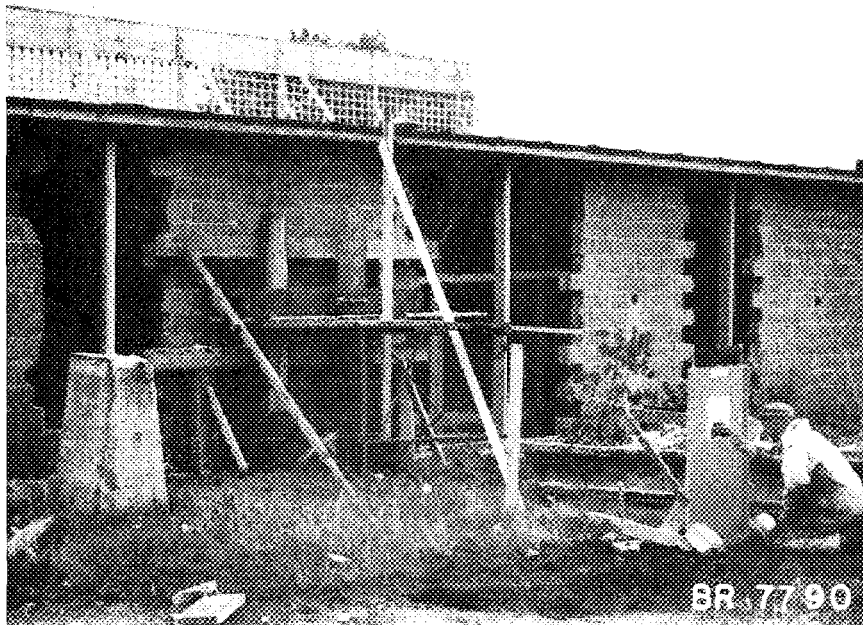
Figure 6 Wall panel 1 showing loading and deflection apparatus

At the test panel the loading assembly was supported on rollers to avoid any addition to the normal vertical wall loads (Fig. 6).

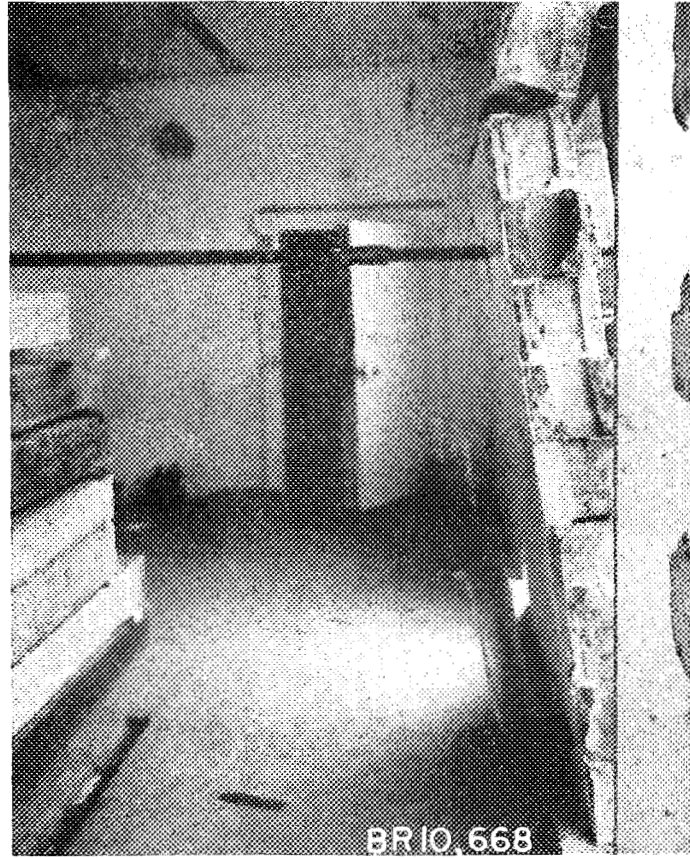
Figure 10 Wall panel 3 just before collapse

Panel 3 was tested in essentially the same way except that loading was continued to actual collapse. Fig. 10 shows panel 3 under load at an advanced state of deflection.
