**Evaluation of Thermal and Moisture  
Response of Highly Insulated Wood-  
Frame Wall Assemblies – Part I:**

**Experimental trials in the  
Field Exposure of Walls test Facility**

**Report A1-006035**

*Bartko, M., Lacasse, M. A., G. Ganapathy and  
M. Nicholls*

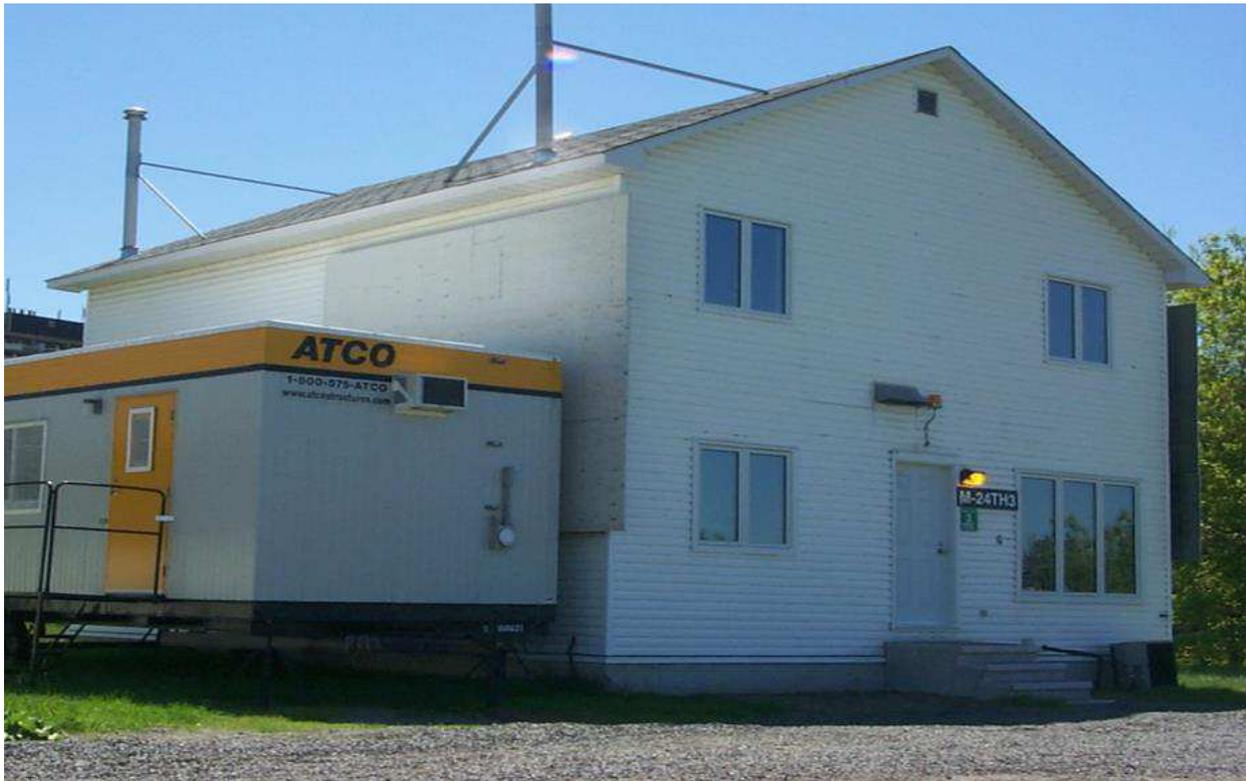
**Figure 1. NRC-Construction's Field Exposure of Walls (FEWF) test facility, located at the NRC Montreal Road campus in Ottawa**

In collaboration with the Canadian Wood Council (CWC), NRC-Construction developed proposals for 3 wall assemblies to be tested in NRC-Construction's Field Exposure of Walls (FEWF) test facility, shown in FIGURE 1, over a period of 8-months in a yearly cycle where the walls were exposed to outdoor conditions.

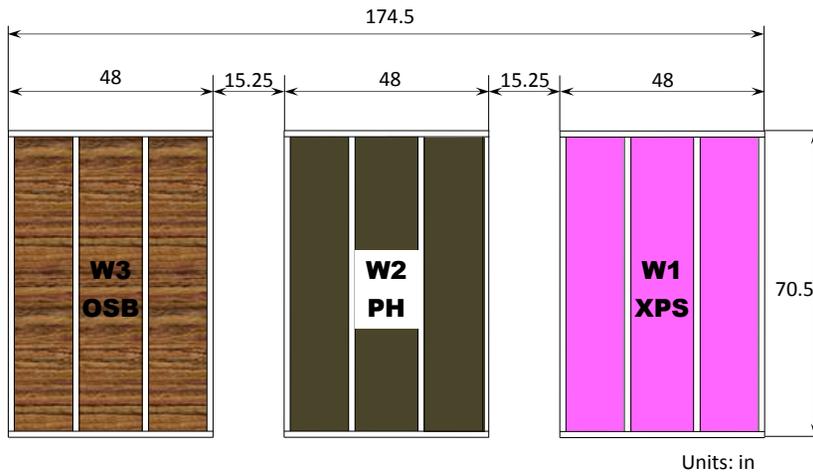
Figure 2. Schematic of three 2x6-in. (38 mm x 140 mm) wood-frame wall (residential) test specimens installed side-by-side in FEWF

Each of the three test specimens was isolated from each other by a vertical chase that provided effective control of heat, air and moisture flow (Figure 2) and as well provided room for running wires for instrumentation (Figure 9). The test specimens were also isolated from the surrounding building envelope of the test house with effective heat, air and moisture control materials (e.g. thermal insulation and self-adhered airtight membranes were used), as well as flashings where warranted.

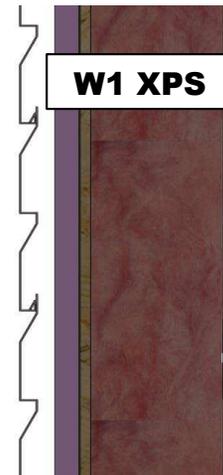
**Total R-29**

- Vinyl siding
- 3 x 0.75 in. nominal vertical furring strip
- 1 in. XPS rigid foam insulation (R5)
- Sheathing membrane
- 11 mm OSB wood-sheathing
- 1.5 x 5.5 in. nominal wood stud cavity
- R24 glass fiber batt insulation for 6 in. cavity
- 6 mil poly air/vapour barrier
- 0.5 in. painted drywall

Figure 3. Wall 1 (W1: XPS) - Horizontal cross-section through XPS wall assembly

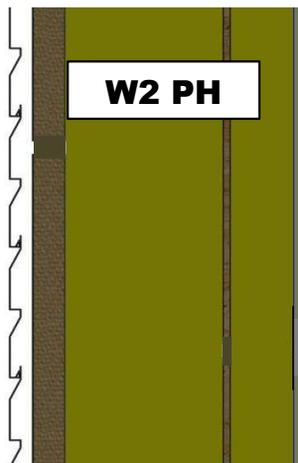
**Total R-43**

- Vinyl siding
- 3 x 0.75 in. nominal vertical furring strip
- Sheathing membrane
- 24mm Diffusion board
- 1.5 x 9.25 in. nominal wood stud cavity
- R30 Wood fibre insulation for 10 in. cavity
- 11 mm OSB wood-sheathing; joints taped
- 1.5 x 3.5 in. studs (Service wall interior)
- R13 Wood fibre insulation for 4 in. cavity
- 0.5 in. painted drywall

Figure 4. Wall 2 (W2: PH) - Horizontal cross-section through Passive Haus wall assembly

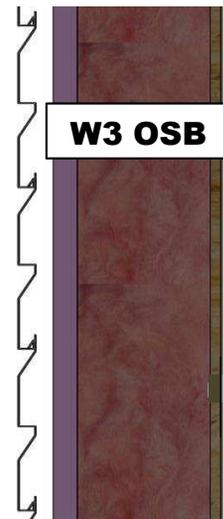
**Total R-29**

- Vinyl siding
- 3 x 0.75 in. nominal vertical furring strip
- 1 in. XPS rigid foam insulation (R5)
- 1.5 x 5.5 in. nominal wood stud cavity
- R24 glass fiber batt insulation for 6 in. cavity
- 11 mm OSB wood-sheathing; joints taped
- 0.5 in. painted drywall

Figure 5. Wall 3 (W3: OSB) - Horizontal cross-section through wall assembly with OSB as smart vapor barrier

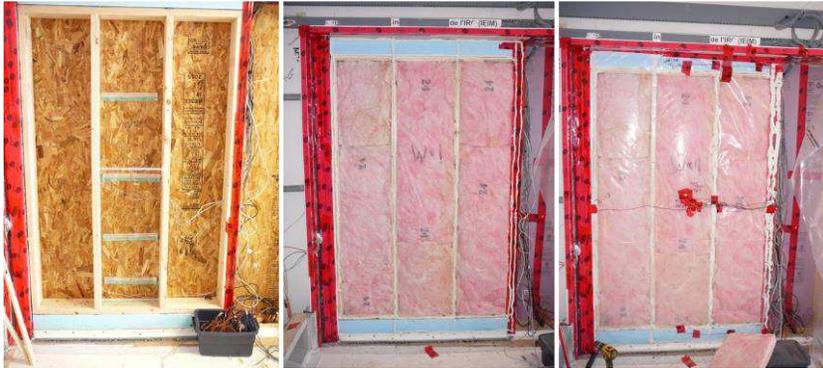
**Figure 6. Wall 1 (XPS) – (i) Stud wall wood frame with OSB, (ii) GF batt insulation in stud cavities, (iii) poly vapour barrier**

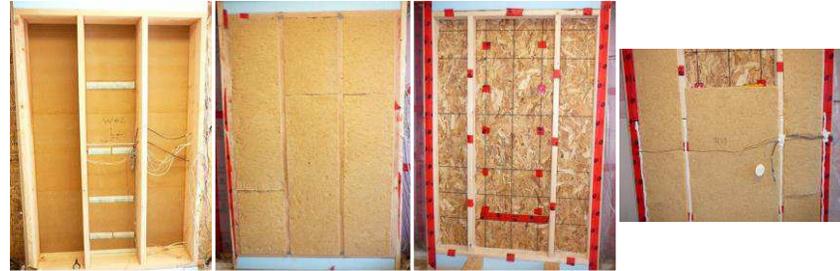
**Figure 7. Wall 2 (PH) - (i) Stud wall wood frame with diffusion board, (ii) wood fiber insulation in stud cavities, (iii) OSB smart vapour retarder (iv) interior wood fiber insulation**

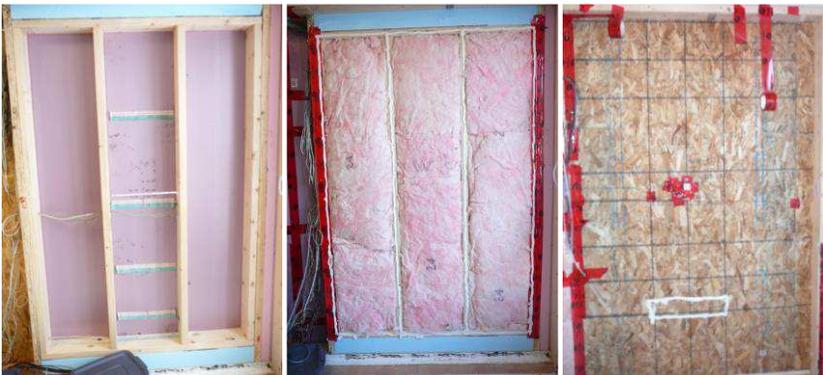
**Figure 8. W3 (OSB) – (i) Stud wall wood frame with external XPS board, (ii) GF batt insulation in stud cavities, (iii) OSB smart vapour retarder**

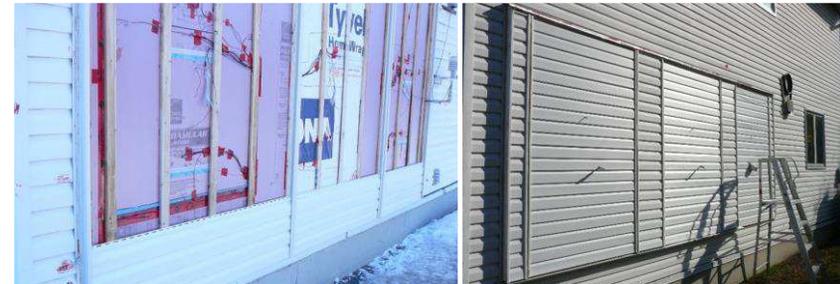
**Figure 9. Installation of W1, W2, & W3 in FEWF showing (i) exterior layers under air cavity, furring strips & (ii) exterior cladding (vinyl siding)**

The final sequence, provided in Figure 9, shows the installation of wood furring strips to which was affixed the exterior cladding.

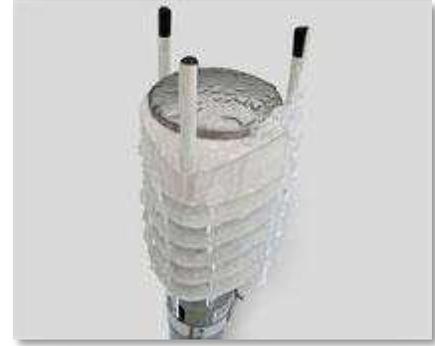
**Vaisala Model WXT**

A local weather monitoring device (Vaisala Model WXT 510) that included a rain gauge, sensors for air temperature, relative humidity, air pressure, wind speed and wind direction, was installed in close proximity to the wall specimens and provided information on hourly ambient exterior conditions. The combined package permitted determining the response of the respective wall assemblies to changing weather conditions over hourly, daily and seasonal periods.

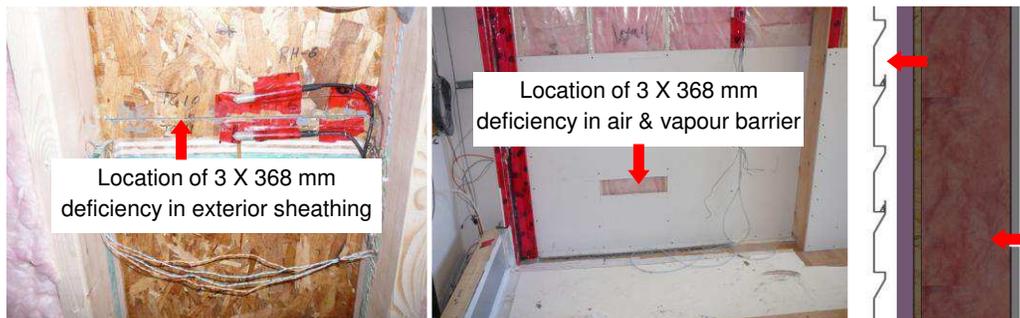
**Figure 10 – Deficiencies in wall test specimens showing location & size of deficiency in W1 (XPS)**

**Deficiencies in the wall assembly** — Each test specimen included a deficiency through which air from the interior was meant to exfiltrate through the test specimens. The size and location of the respective deficiencies are shown in Figure 10. Pressure differences across the assemblies, occurring either naturally or through forced air flow from the interior enclosure, induced the flow of air through the deficiencies as suggested in the schematic on the right of the photos in Figure 10. The location of the deficiencies at the interior of the test specimens and at the exterior sheathing panel, in principal, permitted a path for air to flow. The air leakage rate at several different enclosure pressures for each of these deficiencies was determined the results of which are given in Table 4. These are given as the air leakage rate (L/sec m<sup>2</sup>). Of importance are the values of air leakage at the exfiltration mode when the deficiencies were present in the walls (Period B-“Deficiency state”).

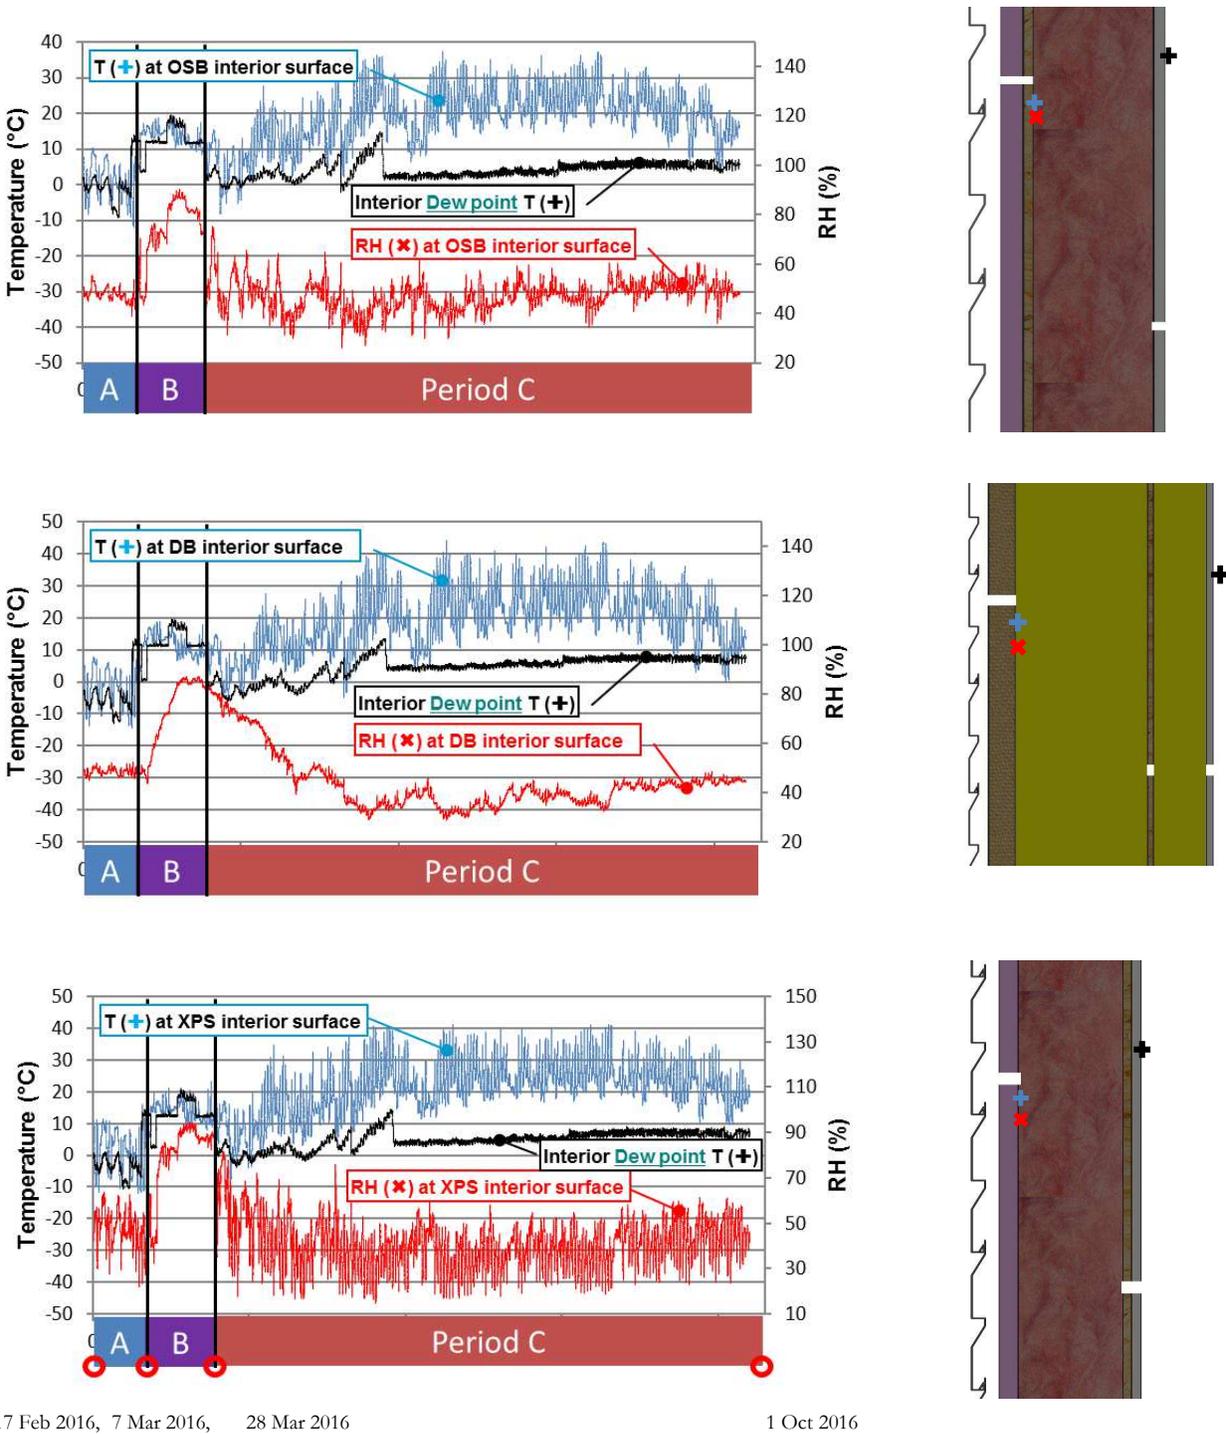
Figure 11– Response of respective wall assemblies (Temperature [T]; RH at exterior insulation surface and dew point T) over monitoring period (2016); (i) W1 (XPS); (ii) W2 (PH); (iii) W3 (OSB)

The hygrothermal response of the test specimens over the monitoring period of 8 months is shown in Figure 11 for the respective test specimens: (i) W1-with XPS exterior insulation; (ii) W2-PH with wood fibre insulation, and; (iii) W3-with OSB as a smart vapour retarder. The location of the temperature and relative humidity sensors for which values are provided in the figure are shown in the diagram adjacent to the plots. In the plot, values recorded for the 3 periods of the test protocol (i.e. A, B and C) include the: (i) interior surface temperature (black lines); (ii) temperature (T / blue lines) and relative humidity (RH / red lines) of the sheathing panel (OSB for W1, wood fiber based diffusion board for W2, and XPS for W3) at mid-height of the wall, and (iii), the same T and RH in proximity to the 3 mm slit through which air could exfiltrate the wall.

It can be generalized for all three types of walls tested, that the temperature at the interior surface of the respective sheathing panels gradually rise from below  $-10^{\circ}\text{C}$  in February to upwards of  $35^{\circ}\text{C}$ , with maximum values attaining  $> 40^{\circ}\text{C}$  in Period C (May -August). The relative humidity (RH) at the interior surface of the respective sheathing panels varies over the monitoring period between 30% and 60% RH, with significant increase in values up to 90% RH recorded during period B of the monitoring program (i.e. induced air exfiltration). The corresponding temperatures at this same location were quite low, reaching  $-10^{\circ}$ ; as such, the propensity to the formation on condensation was high.

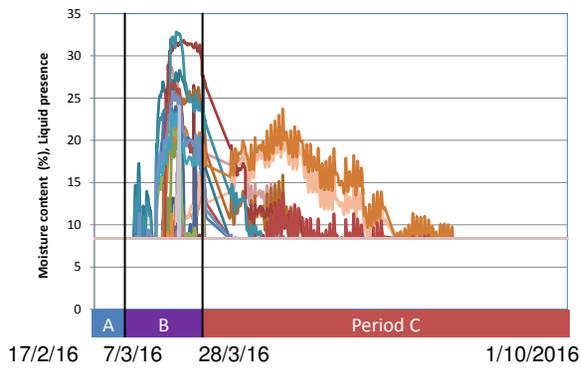
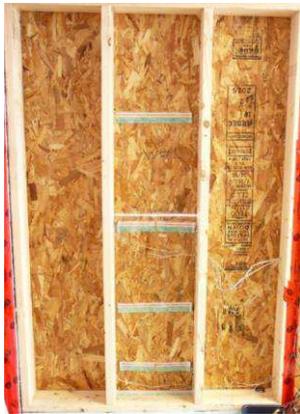
**Figure 12 – W1 : Response of moisture detection strip to the presence of moisture in the wall**

Period B of the monitoring program was intended to bring about occurrences of condensation within the wall assembly. This was the “deficiency state” when warm moist air from the interior was to exfiltrate to the exterior of the test specimens under forced flow conditions. Period B was completed over a three week period during the month of March (i.e. 7 to 28 March 2016). As is perhaps obvious from Figure 12 to Figure 14, significant moisture uptake occurred for all three wall assemblies during the deficiency state, period B, this period being defined by the slits being open to air movement. The response of the moisture detection strips to the presence of moisture is marked with a decrease in electrical resistance which manifests itself by an increase in the value for conductivity. The increase in values for conductivity during period B denotes the presence of condensation.

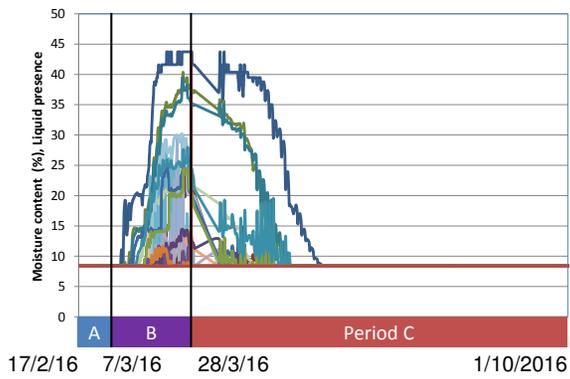
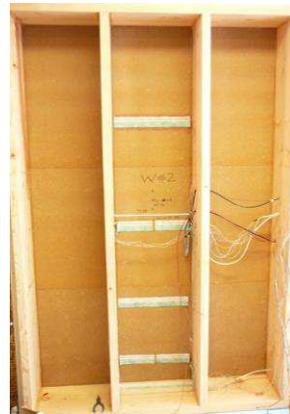
**Figure 13 – W2: Response of moisture detection strip to the presence of moisture in the wall**

The rate of moisture dissipation (Figure 13) and degree of reduction in value for the mould index (Figure 15 center) over time are considerably greater (approximately two-fold decrease) than that of wall W1; hence this assembly if properly constructed, is quite robust as compared to wall W1 in respect to managing moisture deposition with the wall assembly.

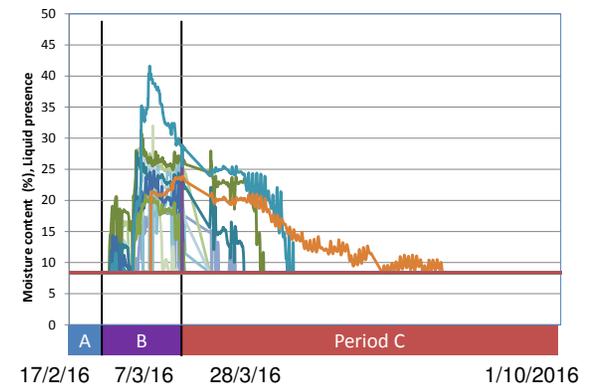
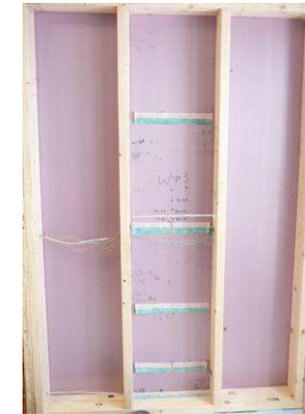
**Figure 14 – W3: Response of moisture detection strip to the presence of moisture in the wall**

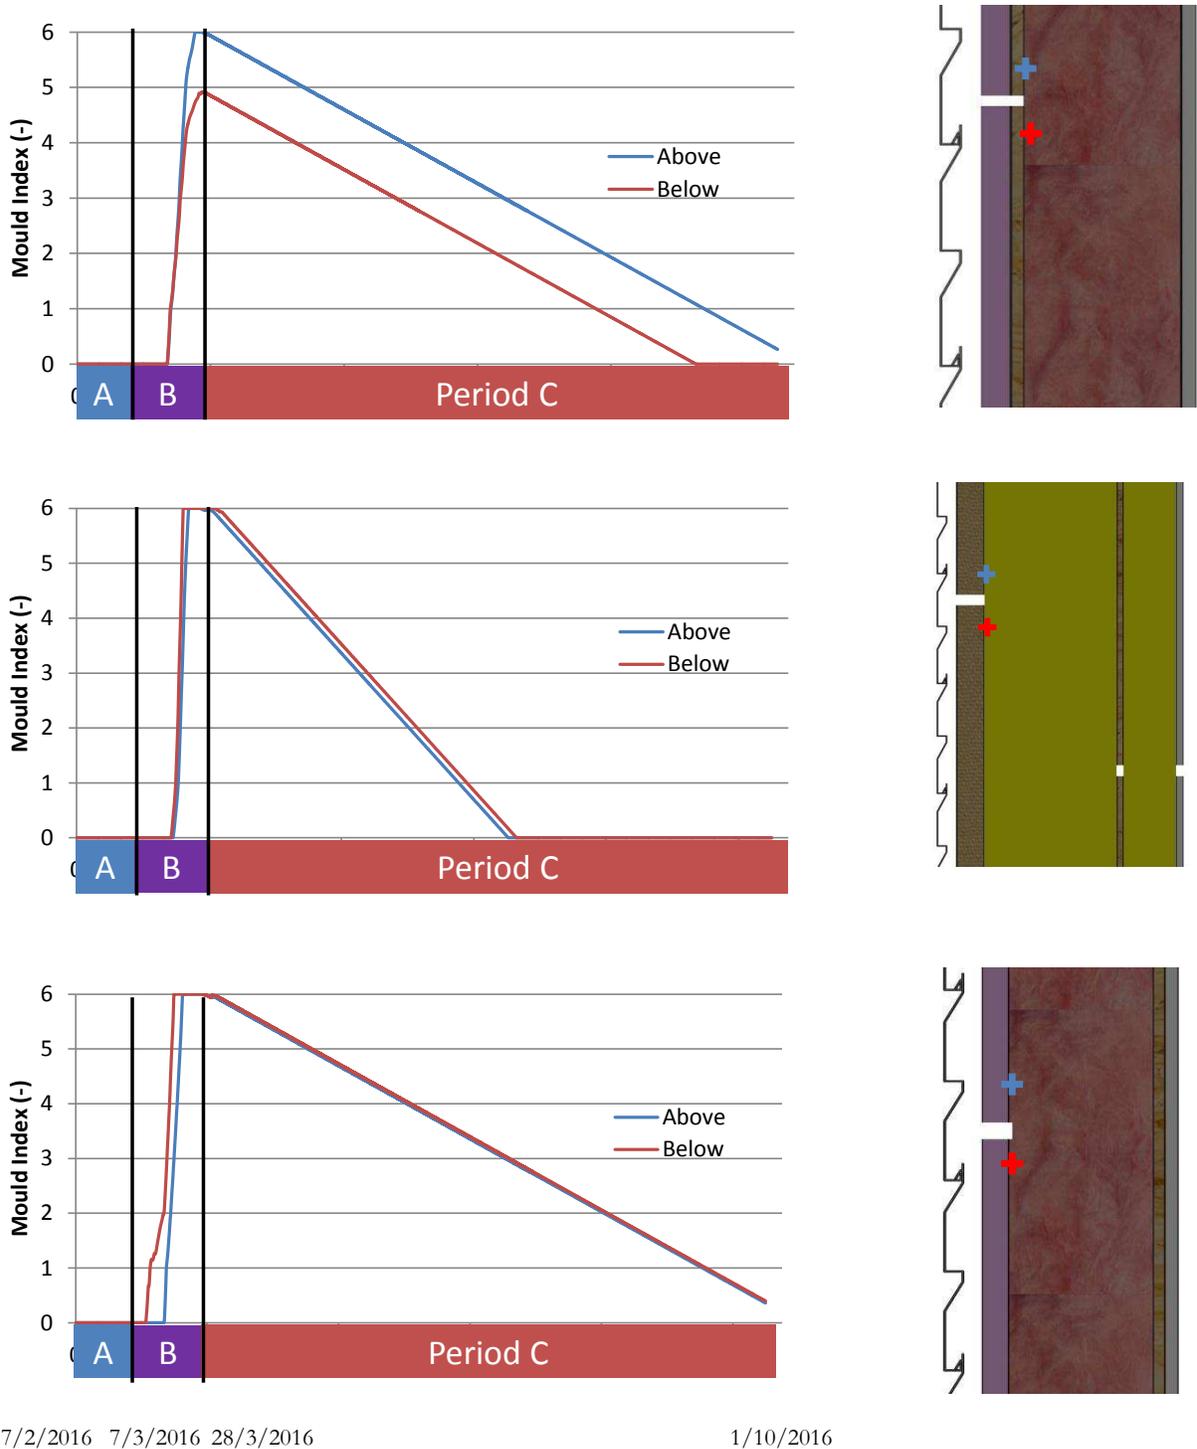
**Figure 15 – Mold Index calculation results by Viitanen for monitoring period (2016) above and below the deficiency slits on exterior side; (i) W1 (XPS); (ii) W2 (PH); (iii) W3 (OSB)**

The propensity for the growth of mould inside the three test walls is shown in Figure 15. Here, values of mould index are given as a function of the monitoring period, in days. The mould index value is based on a mathematical relationship developed by Hukka and Viitanen [8], Viitanen and Ojanen [9], and Ojanen et al. [10] in which values for relative humidity (RH) and temperature (T) and information on the type of surface onto which mould may grow permits establishing the susceptibility to mould growth; values for mould index may range between 0 and 6, where 0 represents no mould growth and 6, very heavy (100% coverage) and tight growth. Its application to providing information on wall performance is more fully described in [4]; additional details regarding the mould index is provided in Appendix 4.

Given the relative humidity and temperatures on the sheathing surface were rising during the Period B, the propensity for mould growth towards the end of Period B increased significantly attaining maximum values of 6 in all three tested assemblies. With lower levels of RH over the Period C, the mould index values slowly abated. However it would be premature to exclude the risk of the occurrence of mould entirely at this stage of testing.

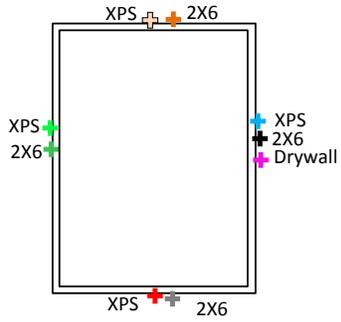
W1 – Location of thermocouple (T)	Designation	
<ul style="list-style-type: none"> <li><span style="color: orange;">—</span> Mid XPS insulation top middle temperature B1_TC_05</li> <li><span style="color: green;">—</span> Mid XPS insulation left middle temperature B1_TC_06</li> <li><span style="color: blue;">—</span> Mid XPS insulation right middle temperature B1_TC_07</li> <li><span style="color: red;">—</span> Mid XPS insulation bottom middle temperature B1_TC_08</li> <li><span style="color: orange;">—</span> Mid 2X6 stud top middle temperature B1_TC_12</li> <li><span style="color: green;">—</span> Mid 2X6 stud left middle temperature B1_TC_13</li> <li><span style="color: black;">—</span> Mid 2X6 stud right middle temperature B1_TC_14</li> <li><span style="color: grey;">—</span> Mid 2X6 stud bottom middle temperature B1_TC_15</li> <li><span style="color: magenta;">—</span> Interior drywall right middle temperature B1_TC_19</li> </ul>

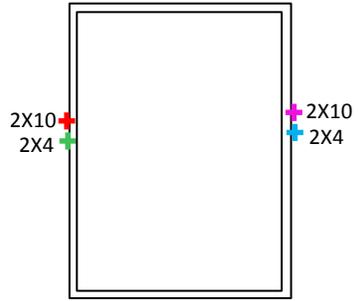
W2 – Location of thermocouple (T)	Designation	
<ul style="list-style-type: none"> <li><span style="color: magenta;">—</span> Mid 2X10 right middle temperature B2_TC_11</li> <li><span style="color: red;">—</span> Mid 2X10 left middle temperature B2_TC_12</li> <li><span style="color: green;">—</span> Mid 2X4 left middle temperature B2_TC_15</li> <li><span style="color: blue;">—</span> Mid 2X4 right middle temperature B2_TC_16</li> </ul>

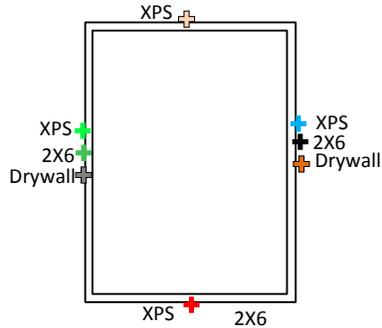
W3 – Location of thermocouple (T)	Designation	
<ul style="list-style-type: none"> <li><span style="color: orange;">—</span> Mid XPS top middle temperature B3_TC_05</li> <li><span style="color: green;">—</span> Mid XPS left middle temperature B3_TC_06</li> <li><span style="color: blue;">—</span> Mid XPS right middle temperature B3_TC_07</li> <li><span style="color: red;">—</span> Mid XPS bottom middle temperature B3_TC_08</li> <li><span style="color: green;">—</span> Mid 2X6 stud left middle temperature B3_TC_12</li> <li><span style="color: black;">—</span> Mid 2X6 stud right middle temperature B3_TC_13</li> <li><span style="color: grey;">—</span> Interior drywall left middle temperature B3_TC_15</li> <li><span style="color: orange;">—</span> Interior drywall right middle temperature B3_TC_18</li> </ul>

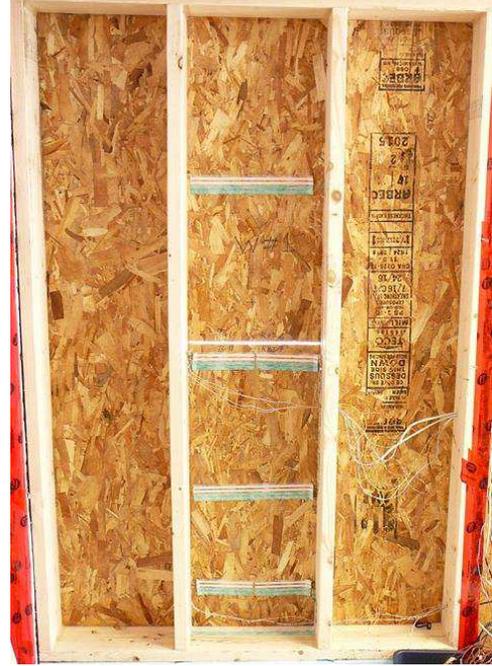
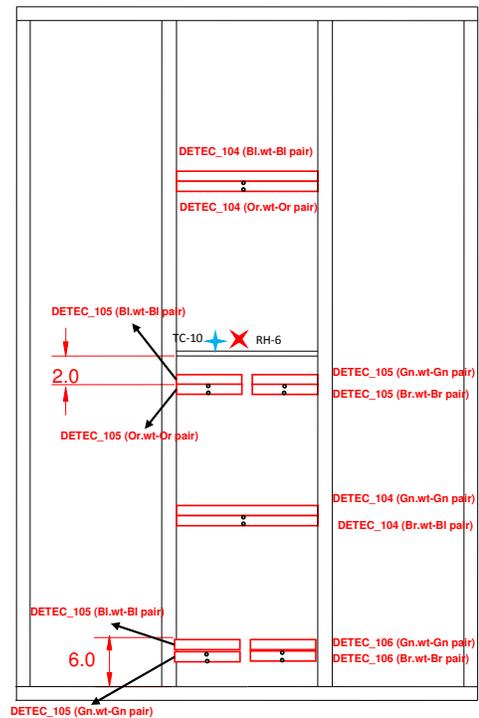
LAYER 5 - Interior Face of OSB

### W1 - Location of DETEC moisture sensing tapes in stud cavity

View from interior of specimen.  
All dimensions in inches.

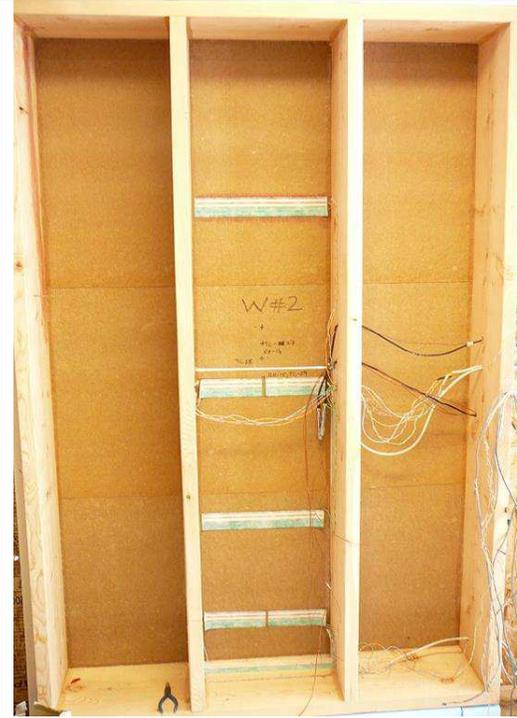
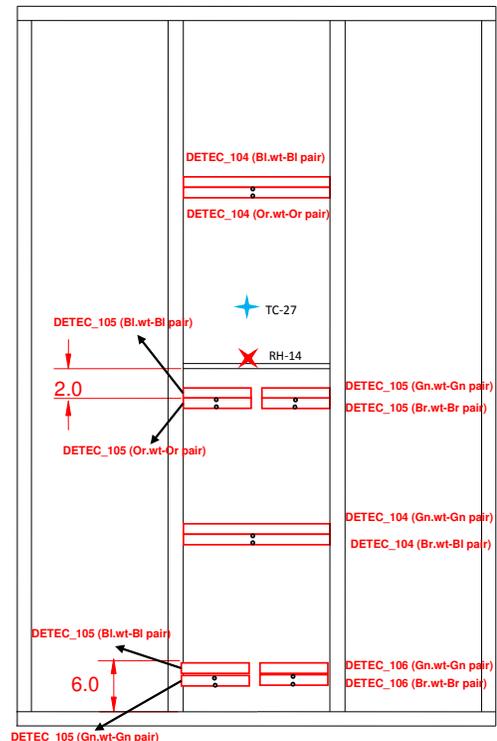
LAYER 4 - Interior Face of diffusion board

## W2 - Location of DETEC moisture sensing tapes in stud cavity

View from interior of specimen.  
All dimensions in inches.

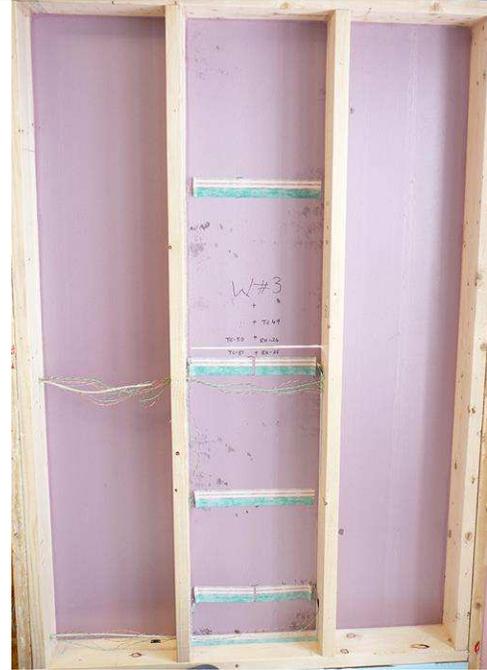
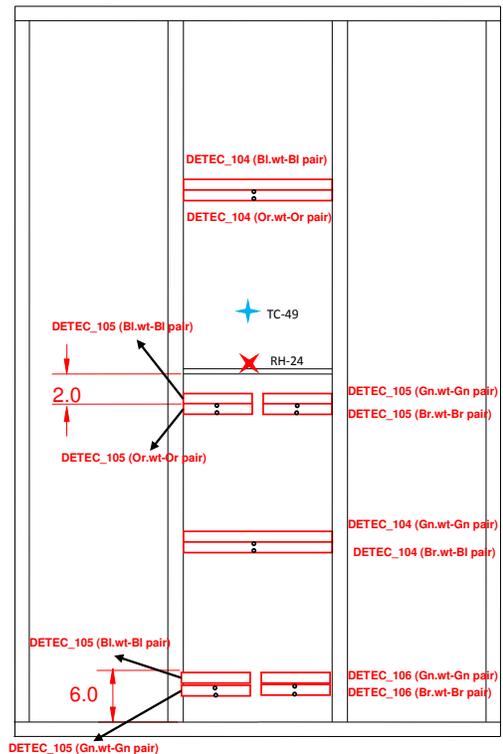
**LAYER 3 - Interior Face of XPS insulation**

### W3 - Location of DETEC moisture sensing tapes in stud cavity

View from interior of specimen.  
All dimensions in inches.

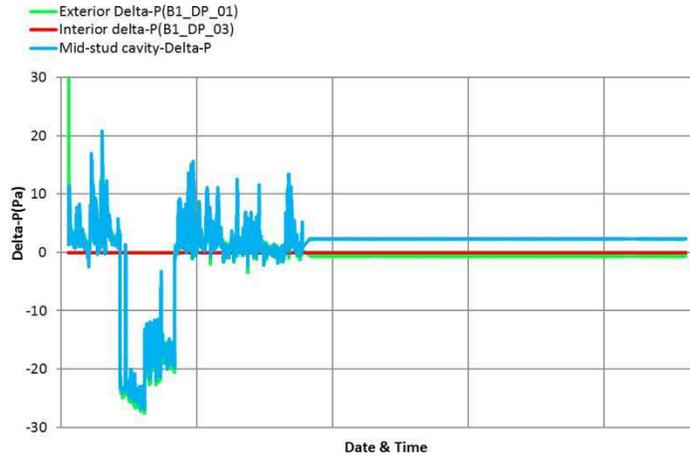
**Wall-1 Delta-P across interior chamber**

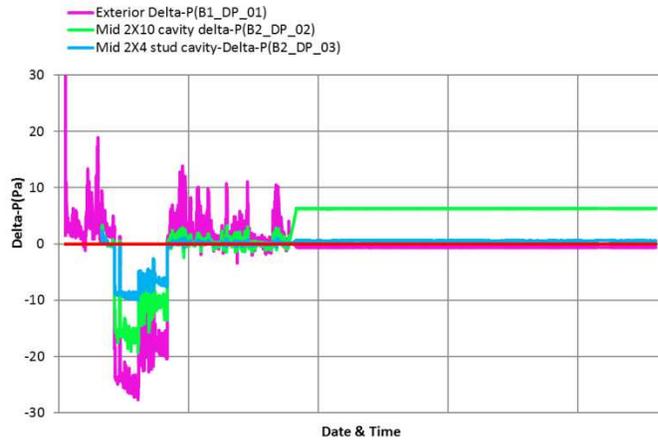
**Wall-2 Delta-P across interior chamber**

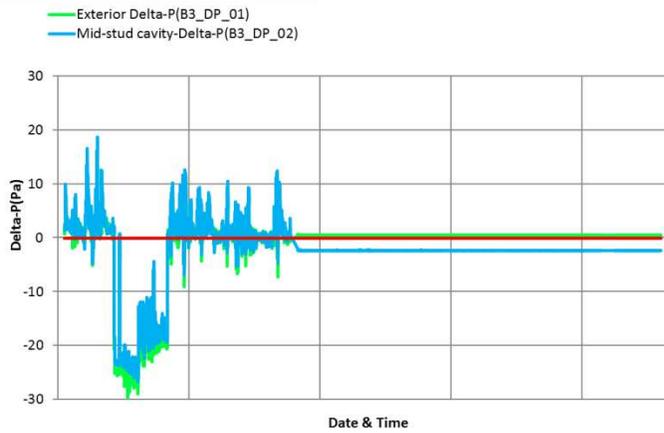
**Wall-3 Delta-P across interior chamber**

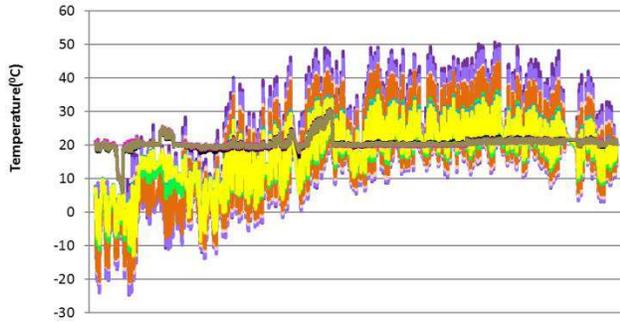
### Wall-1 Temperature(TC)

- Exterior Vinyl siding top temperature B1\_TC\_01
- Exterior XPS insulation top temperature B1\_TC\_03
- Exterior sheathing membrane top temperature B1\_TC\_09
- Interior OSB 1" below slit temperature B1\_TC\_11
- Interior drywall top temperature B1\_TC\_17
- Exterior Vinyl siding top(stud) temperature B1\_TC\_02
- Exterior XPS insulation bottom temperature B1\_TC\_04
- Interior OSB 1" above slit temperature B1\_TC\_10
- Exterior drywall top temperature B1\_TC\_16
- Interior drywall top(stud) temperature B1\_TC\_18

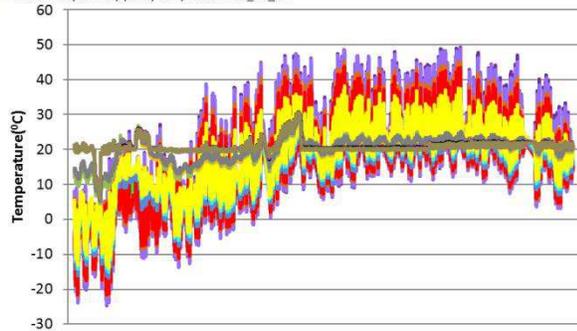
### Wall-2 temperature

- Exterior vinyl siding top temperature B2\_TC\_01
- Exterior sheat.membrane top temperature B2\_TC\_03
- Exterior diff.board top temperature B2\_TC\_05
- Interior diff.board top temperature B2\_TC\_07
- Interior diff.board 1" below slit temperature B2\_TC\_09
- Exterior OSB bottom temperature B2\_TC\_13
- Exterior drywall top temperature B2\_TC\_17
- Interior drywall top(stud) temperature B2\_TC\_19
- Exterior vinyl siding top(stud) temperature B2\_TC\_02
- Exterior sheat.membrane bott. temperature B2\_TC\_04
- Exterior diff.board bottom temperature B2\_TC\_06
- Interior diff.board 1" above slit temperature B2\_TC\_08
- Exterior OSB top temperature B2\_TC\_10
- Interior OSB top temperature B2\_TC\_14
- Interior drywall top temperature B2\_TC\_18

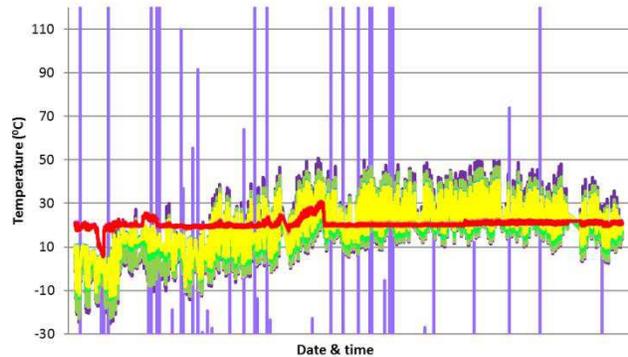
### Wall-3 temperature

- Exterior vinyl top temperature B3\_TC\_01
- Exterior XPS top temperature B3\_TC\_03
- Interior XPS top temperature B3\_TC\_09
- Interior XPS 1" below slit temperature B3\_TC\_11
- Interior drywall top temperature B3\_TC\_16
- Exterior vinyl top(stud) temperature B3\_TC\_02
- Exterior XPS bottom temperature B3\_TC\_04
- Interior XPS 1" above slit temperature B3\_TC\_10
- Interior OSB top temperature B3\_TC\_14
- Interior drywall top(stud) temperature B3\_TC\_17
