# **Fire Testing of Rooms with Exposed Wood Surfaces in Encapsulated Mass Timber Construction**

Authors: Joseph Su, Patrice Leroux, Pier-Simon Lafrance,  
Rob Berzins, Karl Gratton, Eric Gibbs, Mark Weinfurter

Report No.: A1-012710.1

First edition: 8 August 2018

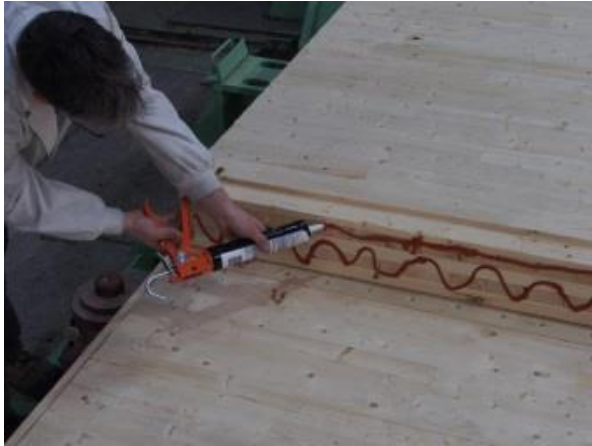
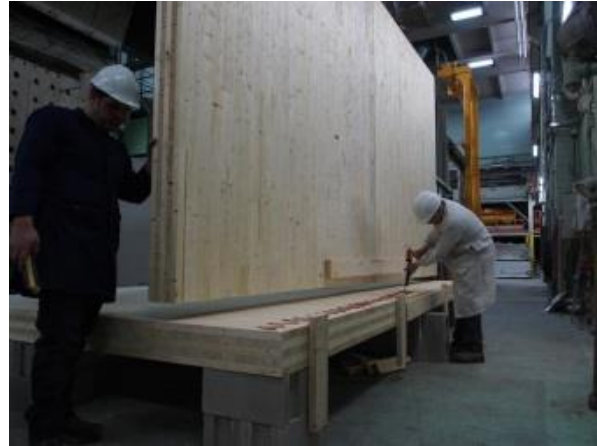
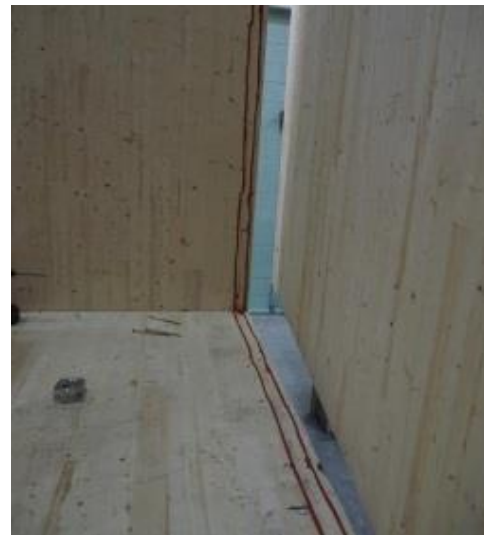
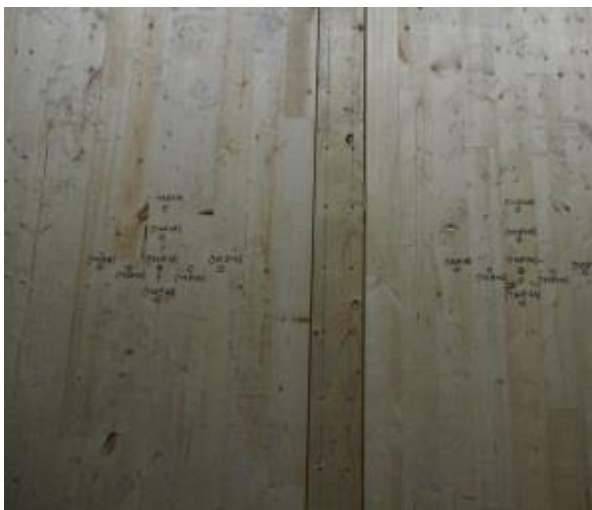
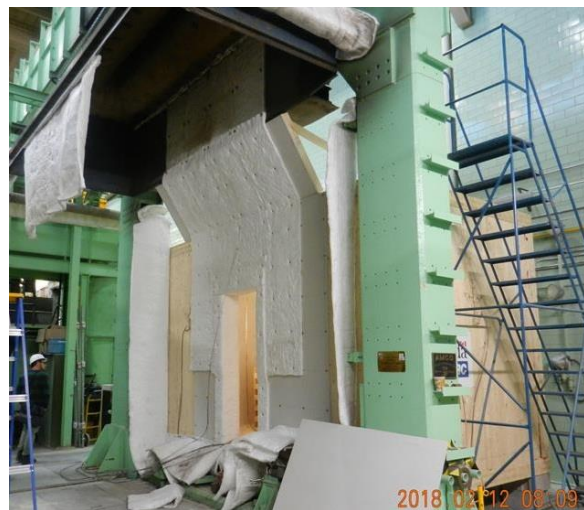
(a) sealant along spline joint

(d) sealant along butt joint

(b) sealant along spline joint

(e) sealant along butt joint

(c) finished spline joint

(f) front view of test room

construction and details of the CLT panel connection are shown in Figure 6 and Figure 7. The interior dimension of the CLT enclosure was 4.53 m long x 2.44 m wide x 2.78 m high (without gypsum board lining).

X gypsum board followed by a layer of 25 mm thick ceramic fiber insulation wrapped around. An extension was added on top of Wall C, as shown in Figure 7(f).

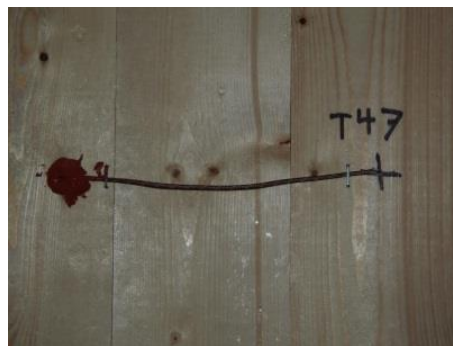
(b) 150 mm wire run along CLT interior surface

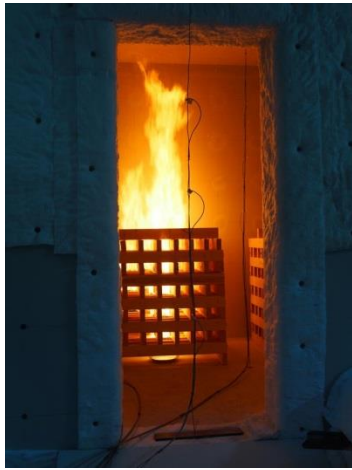
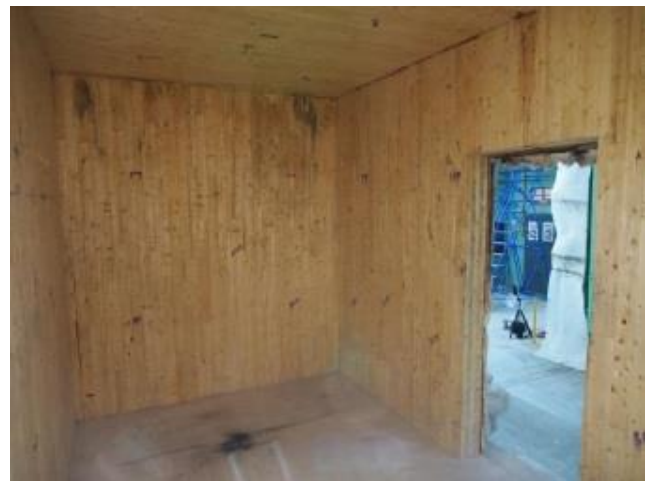
(a) at 2 min after ignition

(e) after Test 1 – gypsum board remained:  
2 layers on ceiling; 3 layers on walls

(f) after Test 1 – CLT interior surfaces after cleanup  
and removal of gypsum board

The fire was started by igniting the middle wood crib. Flame started to come out from the top of the doorway opening at 3.6 min. The fire then spread to the two adjacent cribs and large fire plume was issued from the doorway opening. Flashover occurred at 6.4 min after ignition. The fire plume ceased to issue from the opening at 23 min. The fire later reached a total burnout to self-extinguishment at 150 min. The data collection was terminated at 167 min. Figure 19 shows some photographs during and after Test 1.

After Test 1, as shown in Figure 19(e), two layers of gypsum board largely remained on the ceiling and three layers on the walls. The face layer gypsum board fell off the ceiling. The face layer gypsum board on the walls had cracks but did not fall.

Post fire cleanup was conducted with removal of remaining gypsum board from the room. Figure 19(f) shows interior surfaces of the CLT room after cleanup and removal of gypsum board. There was no char or damage by the fire. The room was re-used for Test 2.

As shown in Figure 19 (e), two layers of gypsum board remained on the ceiling except that small pieces of the mid layer fell off during the cooling phase. All three layers of gypsum board remained on the walls, although some cracks occurred on the face layer. Figure 19 (f) shows CLT room after Test 1 with gypsum board removed, indicating no char was developed during the test. This CLT structure was re-used in subsequent Test 2.

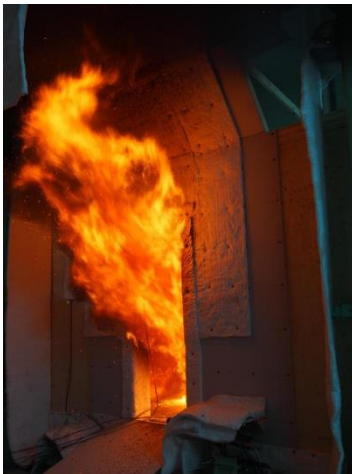
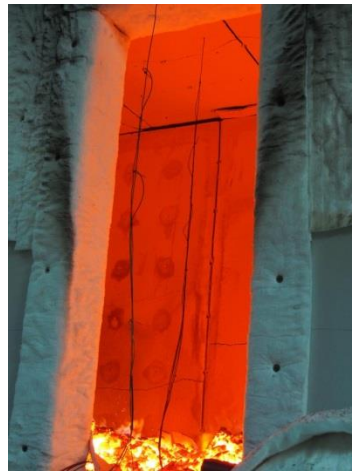
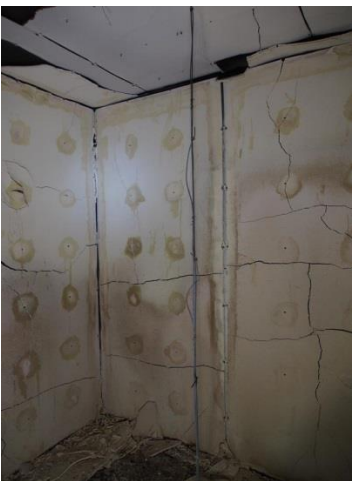
(c) at 9 min – flashover

(d) at 40 min

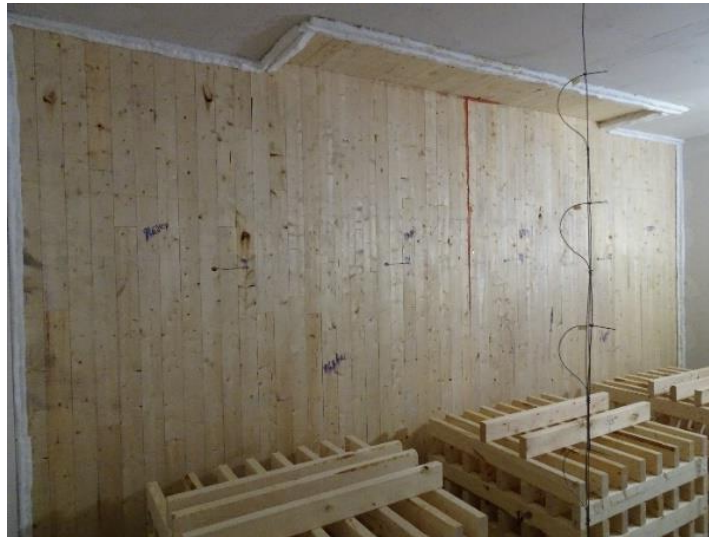
**Figure 24. CLT room with Wall A and 10% ceiling exposed for Test 2.**

After Test 1, a cleanup operation was conducted in the CLT room and all the remaining gypsum board was removed. Test 2 re-used the CLT room structure. Wall B, Wall C, Wall D and 90% of the ceiling were relined with two layers of 12.7 mm (1/2 in.) thick Type X gypsum board. The entire Wall A and 10% of the ceiling were exposed – bare CLT surfaces without protection. The 10% exposed CLT ceiling surface was located along the junction with the exposed CLT Wall A as shown in Figure 24. The CLT floor was covered by three layers of the new gypsum board. Test 2 was conducted on February 20<sup>th</sup>, 2018.

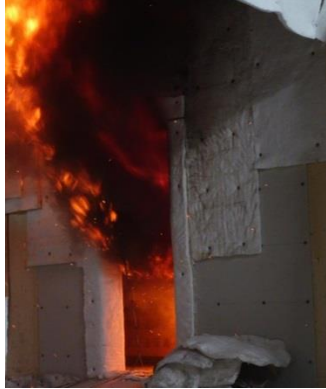
(a) flashover at 3.3 min

The fire started to decay after an intense burning period of the wood cribs and exposed ceiling portion and Wall A. Fire plume ceased to issue from the opening at 45 min and the room became visible inside. The exposed ceiling portion and Wall A were noticeably charred but visible flames on the exposed CLT surfaces were decreasing as shown in Figure 25 (c) to (h). A large amount of the gypsum board face layer was seen to fall off the ceiling in the vicinity of two hours during the cooling phase of the fire. A horizontal crack on the face layer gypsum board was observed on Wall B, through which flame came out (47-130 min) as the CLT panel burnt behind gypsum board. The fire was eventually burnout to self-extinguishment. The test was terminated at 247 min (over 4 hours). At the end of the test, the face layer of gypsum board was largely gone but the base layer was still on Wall B, Wall C, Wall D and the ceiling although with some cracks.

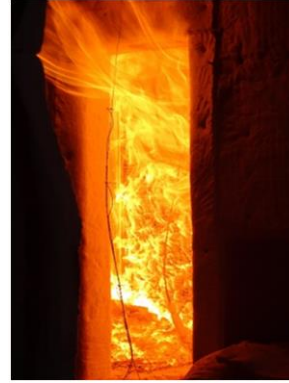
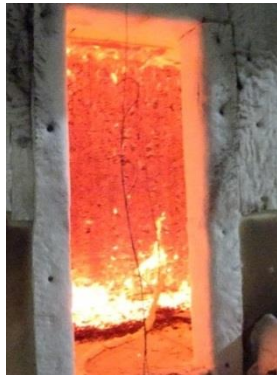
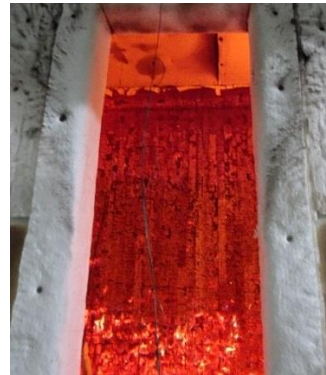
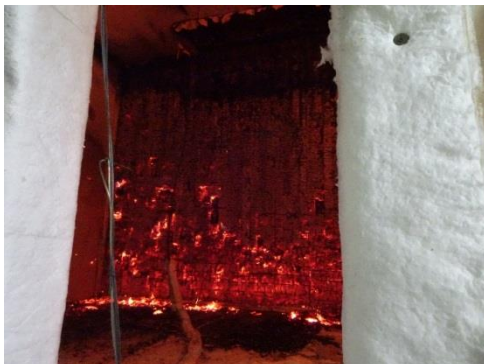
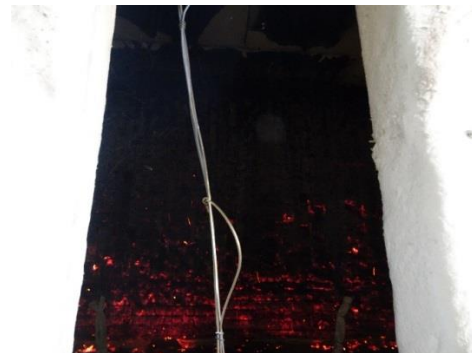
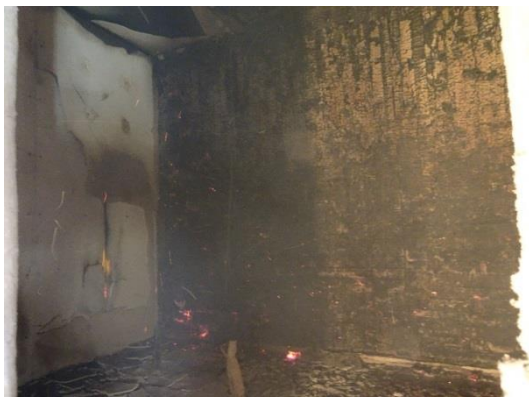
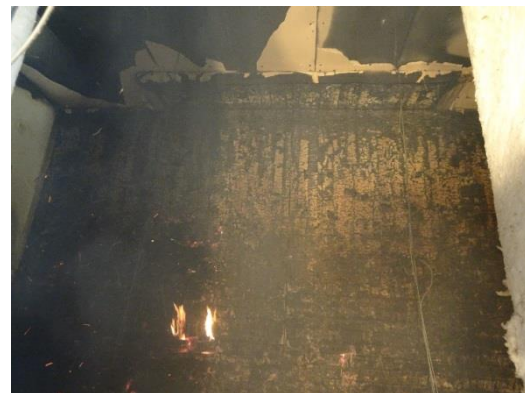
**Figure 25. Photographs of the CLT room during Test 2.**

(b) at 30 min

(c) Wall A and ceiling at 60 min

(d) Wall A and ceiling at 90

(e) Wall A and ceiling at 110 min

(f) Wall A and ceiling at 140 min

(g) Wall A and Wall D at 210 min

(h) Wall A and ceiling at 240 min

The test started with ignition of the middle wood crib. At 2.6 min, the fire ignited the exposed portion of the ceiling and the Wall A. Flame started to come out from the top of the doorway opening at 3.2 min. The fire then spread to the two adjacent cribs and large fire plume issued from the doorway opening. Flashover occurred at 4.7 min. With the exposed CLT, flashover occurred earlier than in the baseline test. Figure 25 shows some photographs of the CLT room during Test 2.

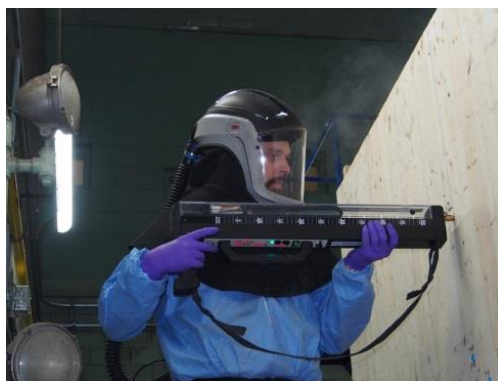
**Figure 31. A Resistograph drill used to determine CLT char depth after Test 2.**

After Test 2, the CLT room was examined for char depth using the Resistograph drill as shown in Figure 31. The drilling resistance was recorded to determine the remaining CLT thickness. By subtracting the remaining thickness from the original CLT dimension (175 mm), the char depth was determined. A total of 60 sampling locations were drilled through for char measurements.

Table 7 lists the total char depths measured using the Resistograph at the sampling locations. Imagining the CLT room as a cardboard box, Table 7 represents the unfolded cardboard box for an interior view of the charred CLT surfaces in the room. The positions of the char depth values in the table also illustrate the sampling locations for the char measurement on the walls and ceiling.

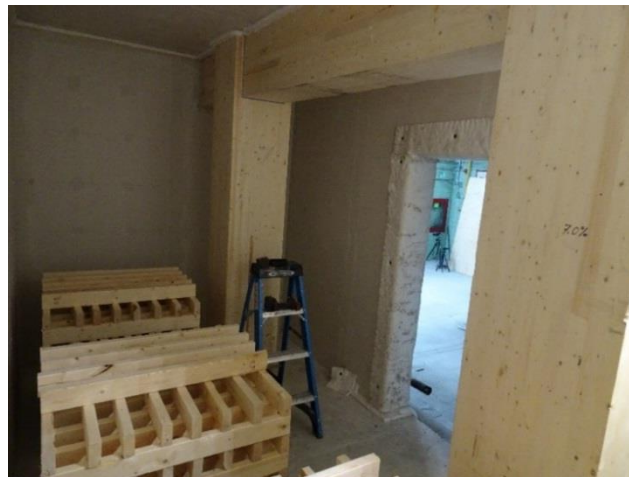
**Figure 32. Mass timber room with fully exposed beams and columns for Test 3.**

Test 3 was conducted on February 28<sup>th</sup>, 2018 with a fully encapsulated CLT room incorporating fully exposed Glulam beams and columns. The CLT room was rebuilt with new CLT panels for Wall A and the ceiling. Walls B, C and D were reused CLT panels from the preceding test which were turned around with the undamaged side as the interior side. The CLT room was lined with two layers of 12.7 mm (1/2 in.) thick Type X gypsum board on all CLT interior surfaces. The CLT floor panels were reused and covered by three layers of the new gypsum board. The Glulam beams were exposed from three sides with a total exposed surface area of 4.54 m<sup>2</sup>; the Glulam columns were exposed from four sides with a total exposed surface area of 9.62 m<sup>2</sup>. The combined exposed surface area was equal to 36% of the perimeter walls. Figure 32 is a photograph of the mass timber room before Test 3.

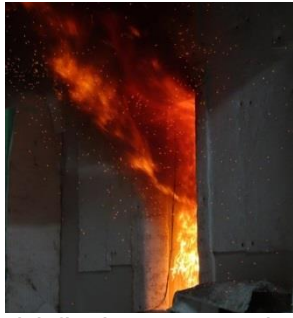
(a) flashover at 7 min

**Figure 33. Exposed beams and columns in the fire room during Test 3.**

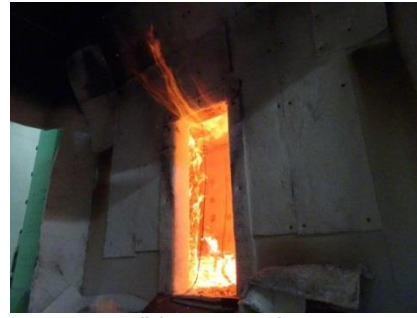
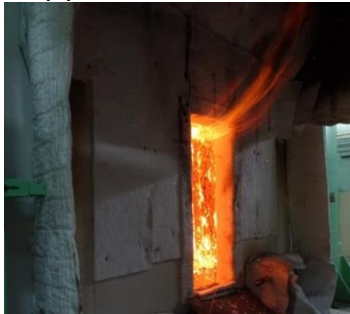
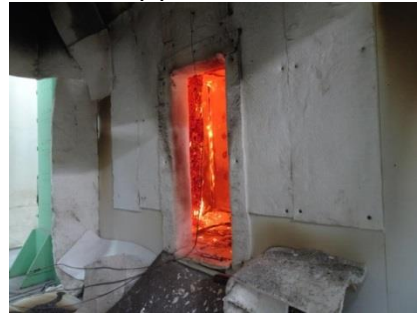
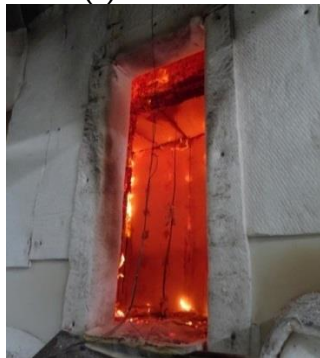
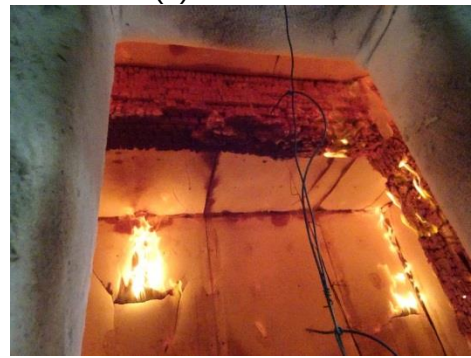
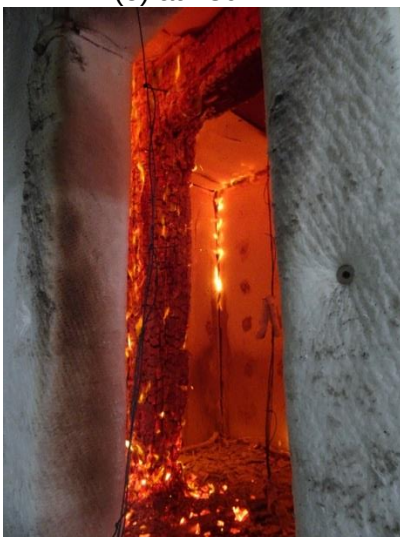
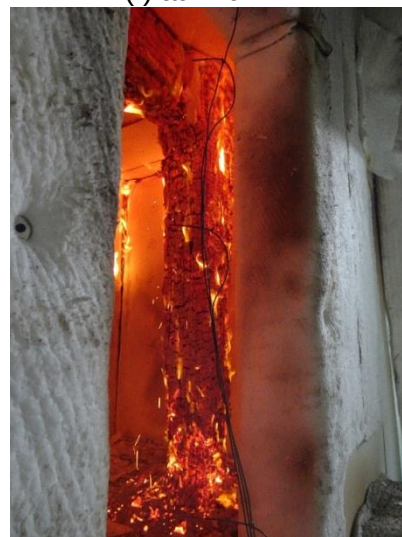
(b) at 50 min

(c) at 60 min

(d) at 130 min

(e) at 180 min

(f) at 240 min

(g) at 240 min

(h) at 240 min

Figure 33 shows some photographs of the mass timber room during the fire test. Test 3 started with ignition of the middle crib. The fire ignited the Glulam beams above at 3.5 min. Flame started to come out from the top of the doorway opening at 3.9 min, followed by large fire plume issuing from the doorway opening. Flashover occurred at 7.0 min. By 50 min, the fire plume from the opening reduced significantly and the interior of the room became visible. The face layer gypsum board started to fall off the ceiling at 100 min. The fire plume ceased to issue from the opening after two hours. The glulam beams and columns were seen burning steadily until the end of the test. The test was terminated at 245 min by spraying water mist to the room using a garden hose. At the end of the test, two layers of gypsum board were largely on the walls and one layer of gypsum board on the ceiling.

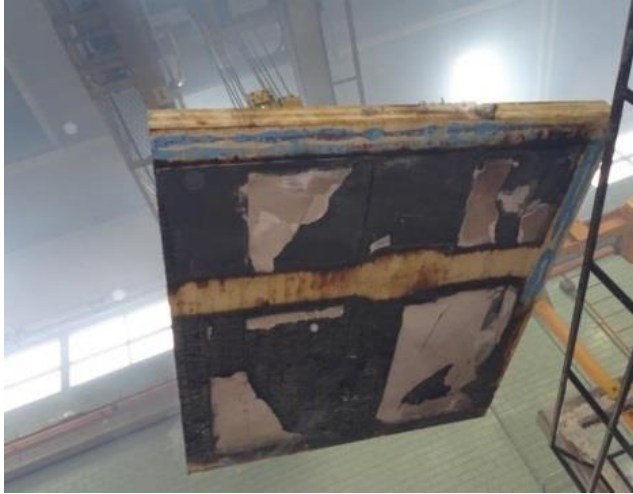
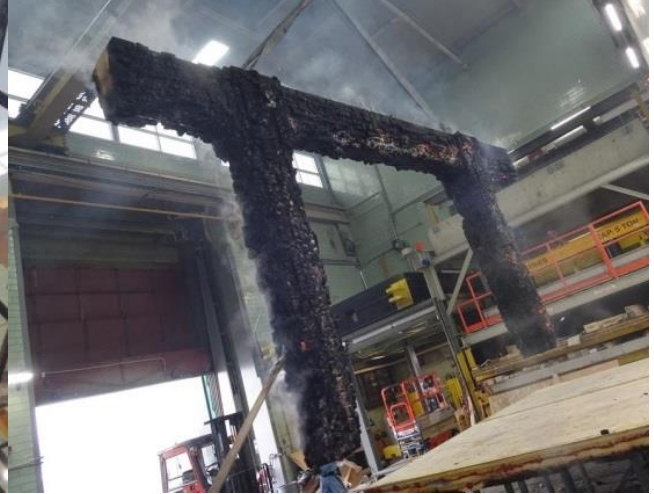
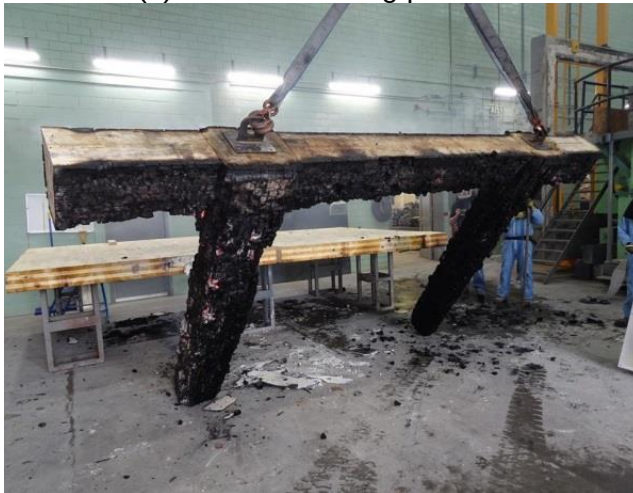
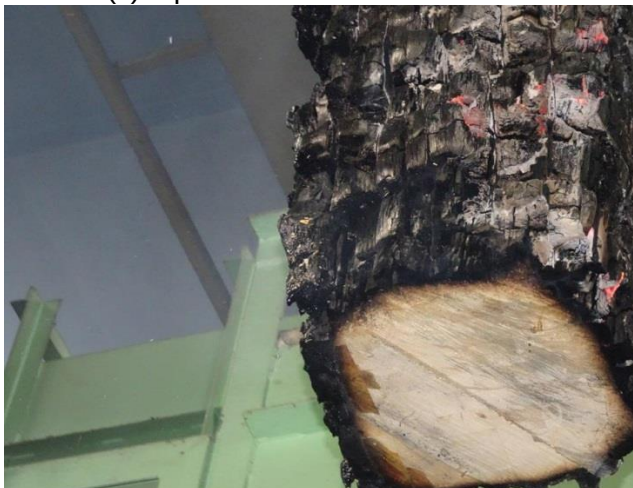
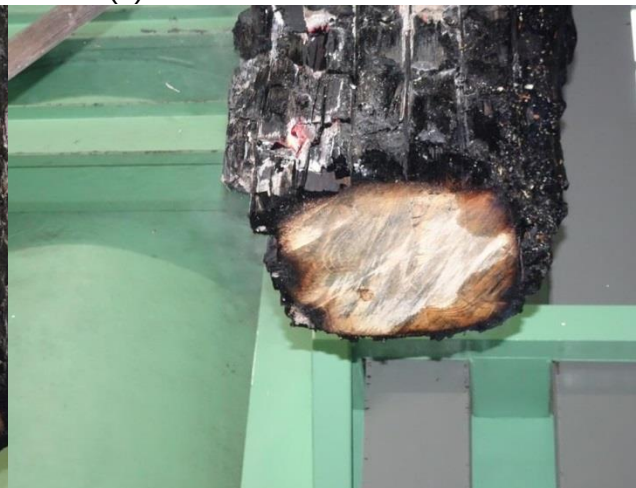
(a) lifted CLT ceiling panel

(b) lifted Glulam beam and columns

(c) top surface of Glulam beam

(d) end surface of Glulam beam

(e) cross section of Glulam column cut

(f) cross section of Glulam column cut

**Figure 38. Photograph of mass timber elements after Test 3.**

As shown in Figure 38 and Table 9, the CLT ceiling panels had no char in the CLT-Glulam contacting surface. In other area of the ceiling, the CLT panels charred 28-66 mm (average of 44 mm). The CLT wall panels had an average char of 47 mm. Using data from Table 8 (time to reach 300°C in CLT), the char front inside CLT is plotted versus time in Figure 40, assuming that CLT started to char at 300 °C. The plots show that the CLT char rate was approximately 0.15 mm/min with the gypsum board protection.

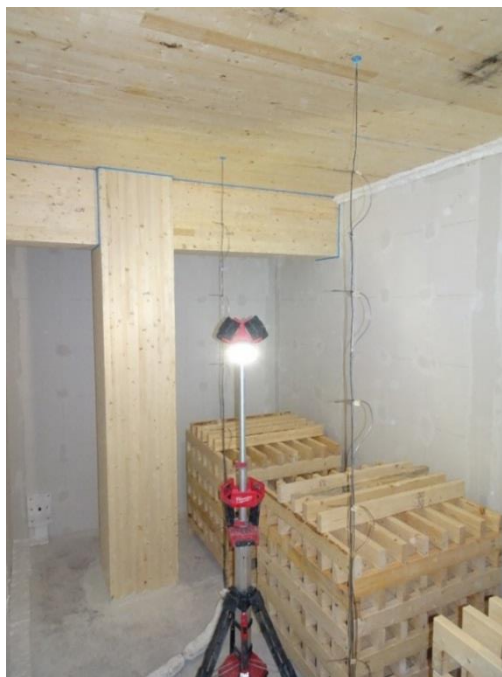
**Figure 41. Mass timber room with fully exposed CLT ceiling, Glulam beam and column for Test 4.**

Test 4 was conducted on March 13<sup>th</sup>, 2018 with a fully exposed CLT ceiling and fully exposed Glulam beam and column. The CLT room was rebuilt. The CLT floor panels were reused and flipped over with the undamaged side as the floor surface covered by three layers of the new gypsum board. New CLT panels were used for Wall A, Wall C and the ceiling. Walls B and D were reused CLT panels from the preceding test with the undamaged side as the interior side. The CLT walls were all lined with two layers of 12.7 mm (1/2 in.) thick Type X gypsum board. The entire ceiling was exposed – bare CLT surface on the ceiling. The Glulam beam was exposed from three sides with a total exposed surface area of 2.46 m<sup>2</sup>; the Glulam column was exposed from four sides with a total exposed surface area of 4.81 m<sup>2</sup>. The combined exposed surface area of the beam and column was equal to 19% of the perimeter walls. Figure 41 is a photograph of the mass timber room before Test 4.

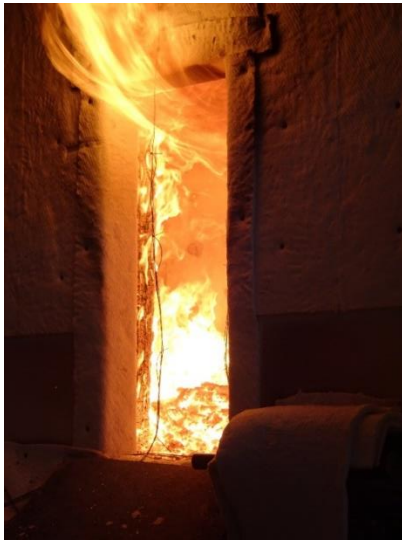
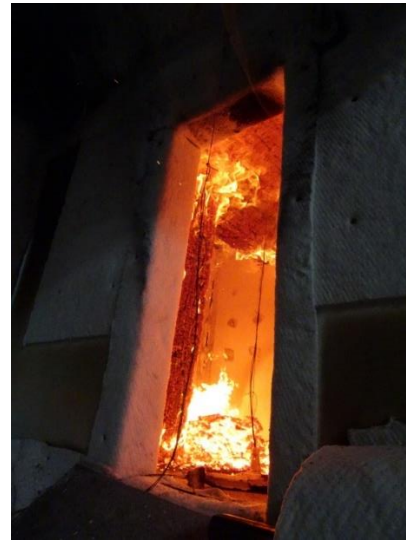
(a) at 40 min

(b) at 55 min

Figure 42 shows some photographs of the mass timber room during the fire test. Test 4 started with ignition of the middle crib. The fire ignited the ceiling above at 3.0 min. Flame started to come out from the top of the doorway opening at 3.5 min, followed by large fire plume issuing from the doorway opening. Flashover occurred at 4.9 min. By 40 min, the fire plume from the opening reduced significantly and the interior of the room became visible. The plume ceased to issue from the opening at 55 min. Char was observed to have formed on the CLT ceiling and Glulam beam and column with reduced flame as time elapsed; also, the flame on the CLT ceiling surface was less than on the Glulam beam and column. The face layer gypsum board on the walls was observed to have flame along the gypsum board joints and there were also some horizontal cracks with flame coming out. By 150 min, the flame on the CLT ceiling and Glulam beam and column were self-extinguished with flame remaining only along the gypsum board joints and cracks. At 170 min, the fire was complete self-extinguished. The test was terminated at 240 min by stopping the data acquisition. At the end of the test, two layers of gypsum board were still on the walls.

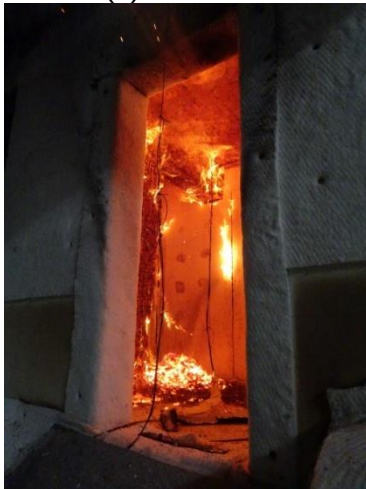
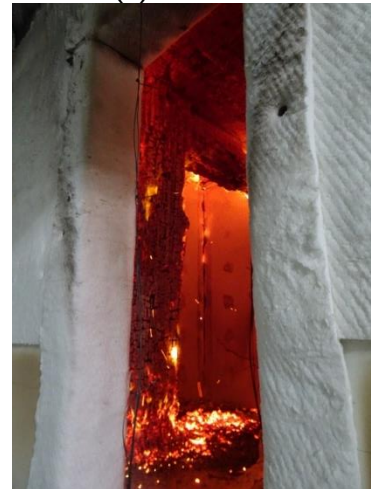
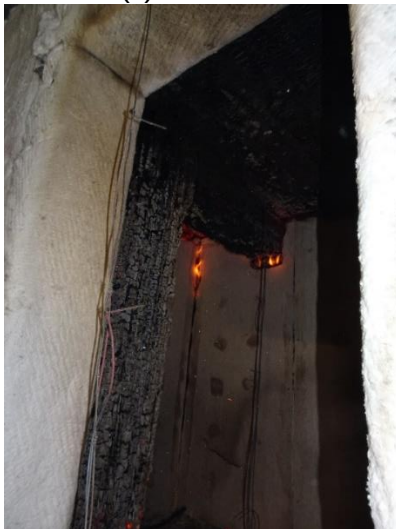
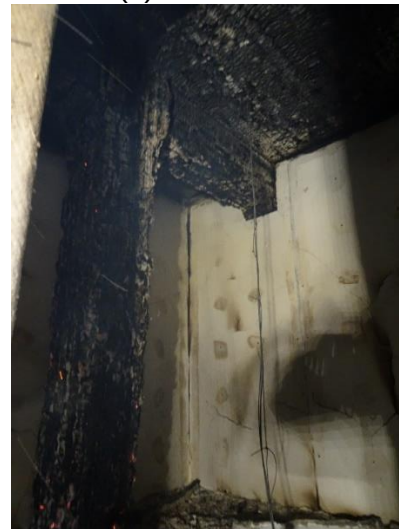
**Figure 42. Fully exposed ceiling, beam and column in mass timber room during Test 4.**

(c) at 90 min

(d) at 130 min

(e) at 150 min

(f) at 220 min

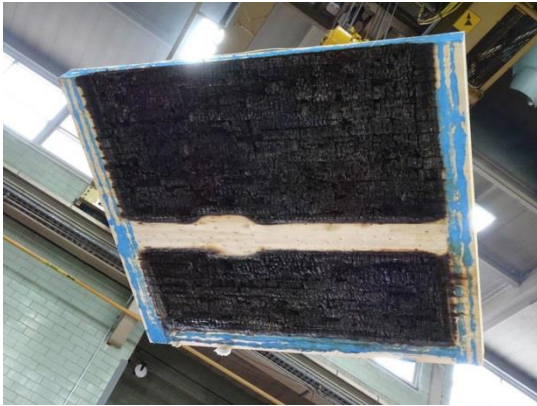
(a) lifted CLT ceiling panel

After Test 4, the Glulam beam and column and CLT panels were examined for char. Figure 47 shows photographs of the CLT and Glulam elements after Test 4. A total of 74 sampling locations were drilled through for char depth measurements using the Resistograph.

As shown in Figure 47(a), the CLT ceiling panels had no char in the CLT-Glulam contacting surface. In other area of the ceiling, the CLT panels charred 47-66 mm (average of 54 mm). The CLT wall panels had an average char of 30 mm. Using data from Table 10 (time to reach 300°C in CLT), the char front inside CLT is plotted versus time in Figure 49, assuming that CLT started to char at 300 °C. The plots clearly show that the char rate slowed down with the increasing char depth, which acted as a thermal barrier to stop the advance of the char front. For the exposed ceiling, the CLT char rate was changed from 0.8 mm/min initially to 0.4 mm/min as the char front moved closer to the first bond line (at 35 mm). For the wall assemblies with the gypsum board protection, the CLT char rate was approximately 0.14 mm/min.

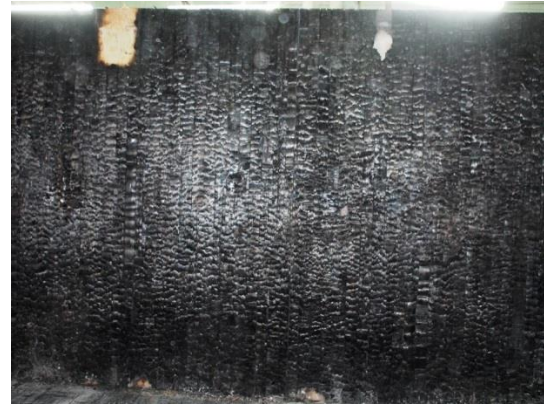
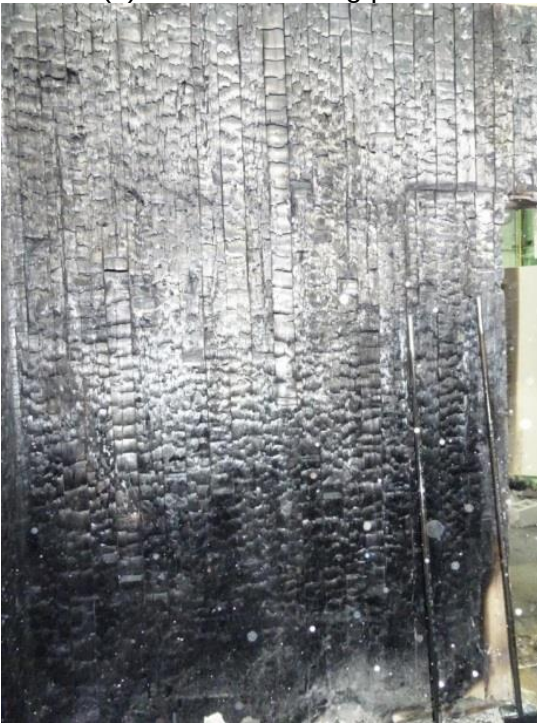
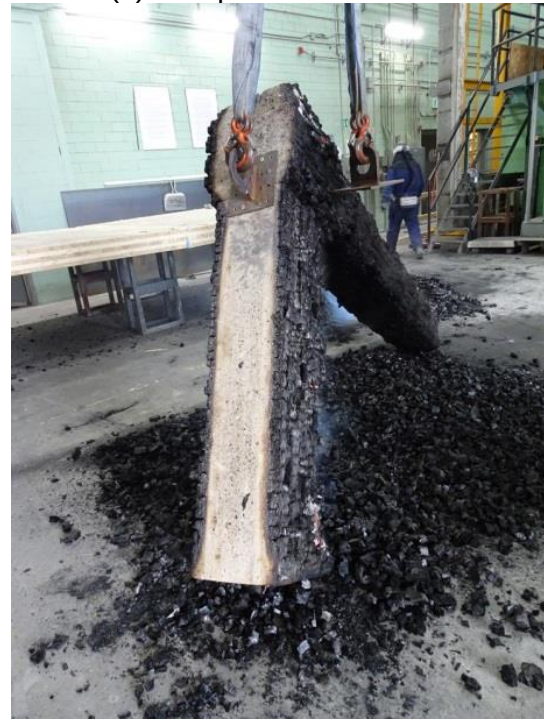
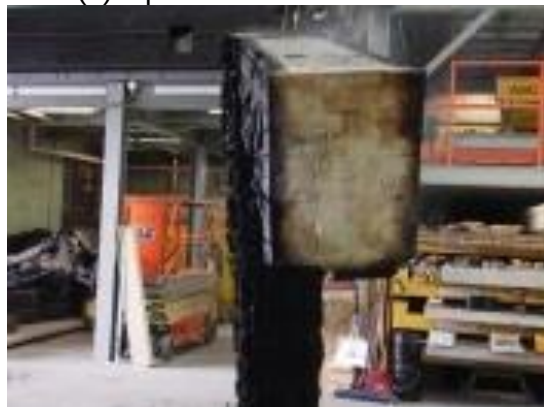
(b) CLT panel from Wall A

(c) CLT panel from Wall C

(d) top surface of Glulam beam

(f) end surface of Glulam beam

**Figure 47. Photograph of mass timber elements after Test 4.**

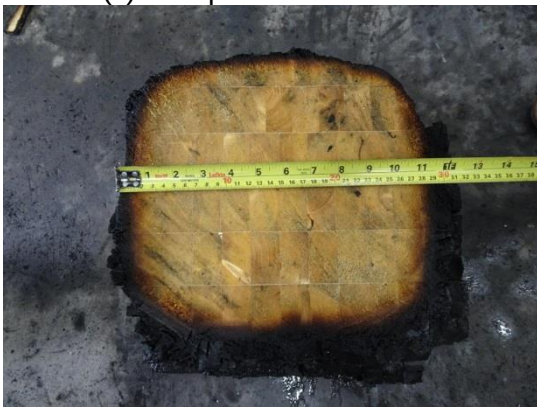
(e) cross section of Glulam column cut

Figure 48 shows the sampling locations and remaining depths of the Glulam beam and column after the fire test. Given the original cross section of 327 mm x 457 mm for the three-side exposed beam and 457 mm x 457 mm for the four-side exposed column, the char depth was in a range of 60 mm to 90 mm for each exposed side of the Glulam in four hours, translating to a char rate of 0.26 to 0.38 mm/min. The average char depth was 70 mm for each exposed side and the average Glulam char rate was 0.30 mm/min in Test 4.

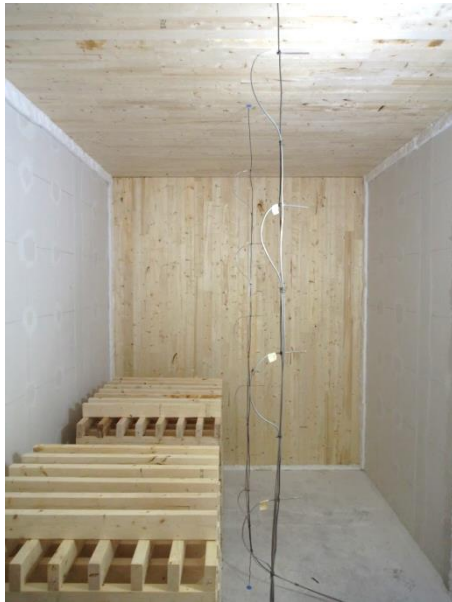
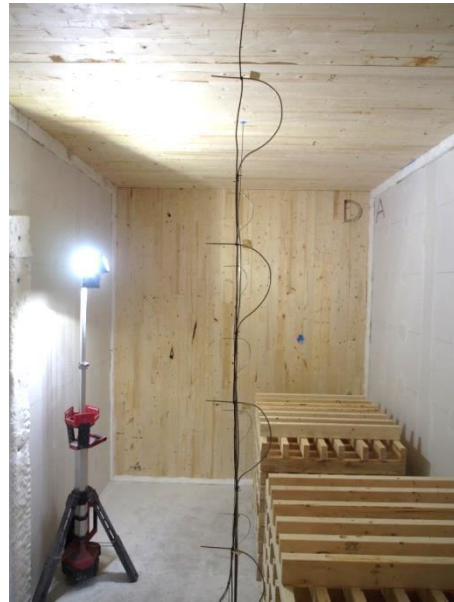
(a) view of exposed Wall B and ceiling

(b) view of exposed Wall D and ceiling

Test 5 was conducted on March 28<sup>th</sup>, 2018 with a fully exposed CLT ceiling, Wall B and Wall D. The room was rebuilt with new CLT panels for the ceiling, Wall B and Wall D. Wall A and Wall C were reused CLT panels from the preceding test with the undamaged side lined with two layers of 12.7 mm thick Type X gypsum board as the interior. The CLT floor panels were reused and covered by new gypsum board. Figure 50 shows photographs of the CLT room before Test 5.
