Helicopter icing and de-icing flight trials on a bristol sycamore type 171, MK.3

LABORATORY REPORT LR-221

HELICOPTER ICING AND DE-ICING FLIGHT TRIALS
ON A BRISTOL SYCAMORE TYPE 171, MK. 3

A Sycamore helicopter fitted with an electro-thermal de-icing system was tested under different simulated conditions of icing severity over a wide range of temperatures. The effect of icing on handling and performance was assessed and power requirement for clean shedding was determined.

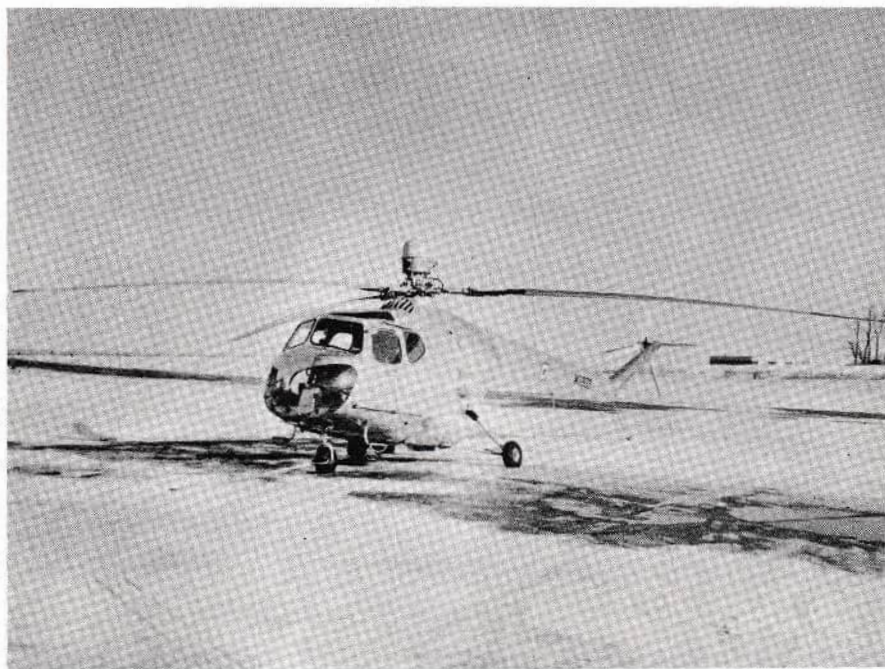
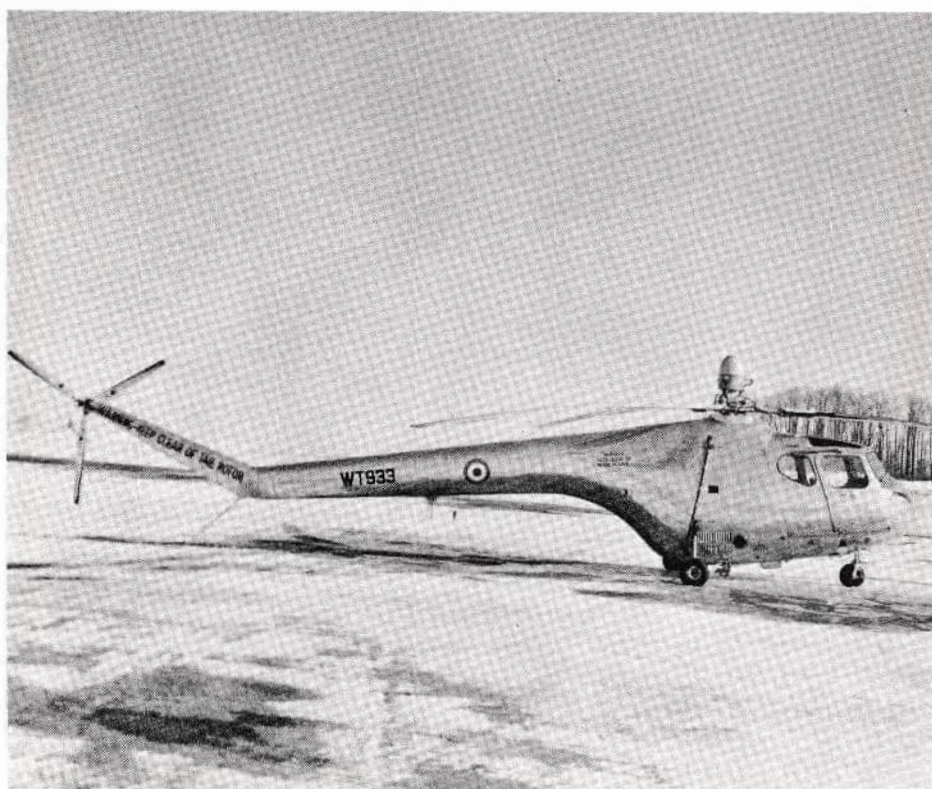
FIG. 1
LR-221

BRISTOL SYCAMORE TYPE 171, MK. 3
(WITH MAIN ROTOR DE-ICING EQUIPMENT)

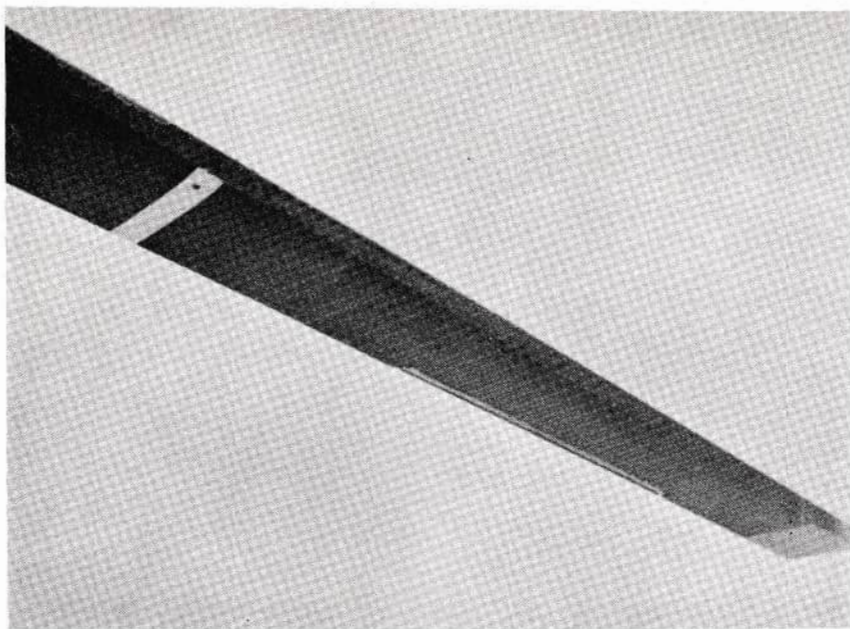
STANDARD ROTOR BLADE SHOWING 4-IN. BRASS STRIPS

Flights with the standard blades were made to investigate the effect of icing on the unprotected aircraft. The aircraft was flown for periods of up to 30 minutes in icing without exceeding the maximum power. This was possible because self-shedding occurred readily with the highly flexible standard blades. Concentration of stress in the ice over the gaps between the 4-inch nose caps caused it to crack at these points and facilitated shedding.

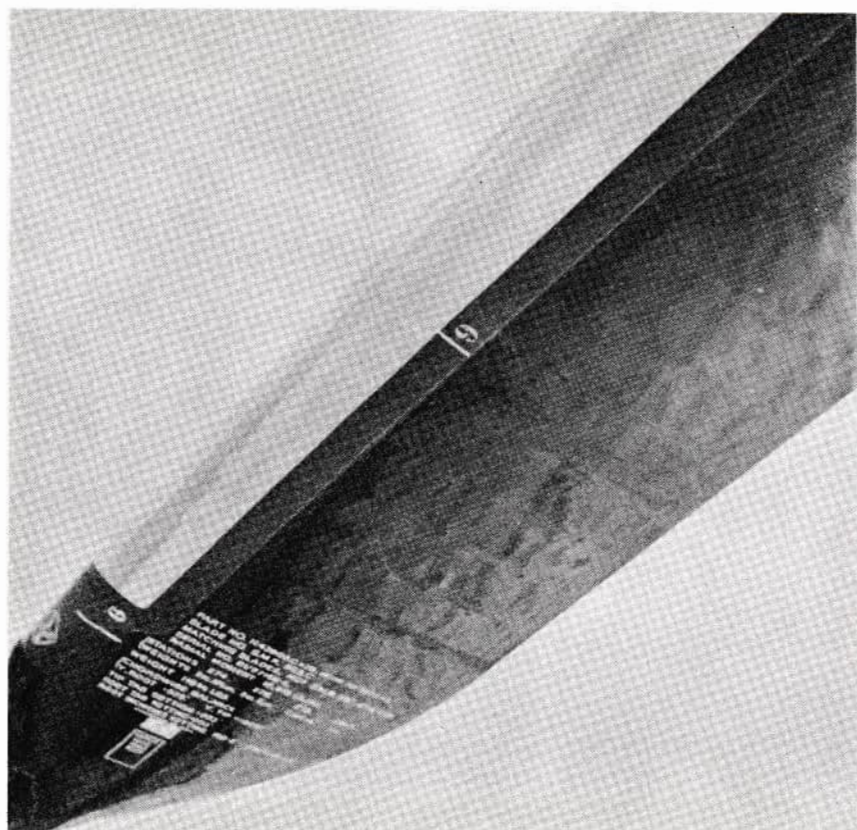
ROTOR BLADE WITH DE-ICER PAD INSTALLED
MAIN ROTOR BLADES USED DURING TRIALS

Tests were made to cover the meteorological conditions laid down by the test schedule of Reference 1. Two sets of rotor blades were used, standard blades not equipped for de-icing, and a second set having de-icing pads installed along the leading edge (Fig. 2).

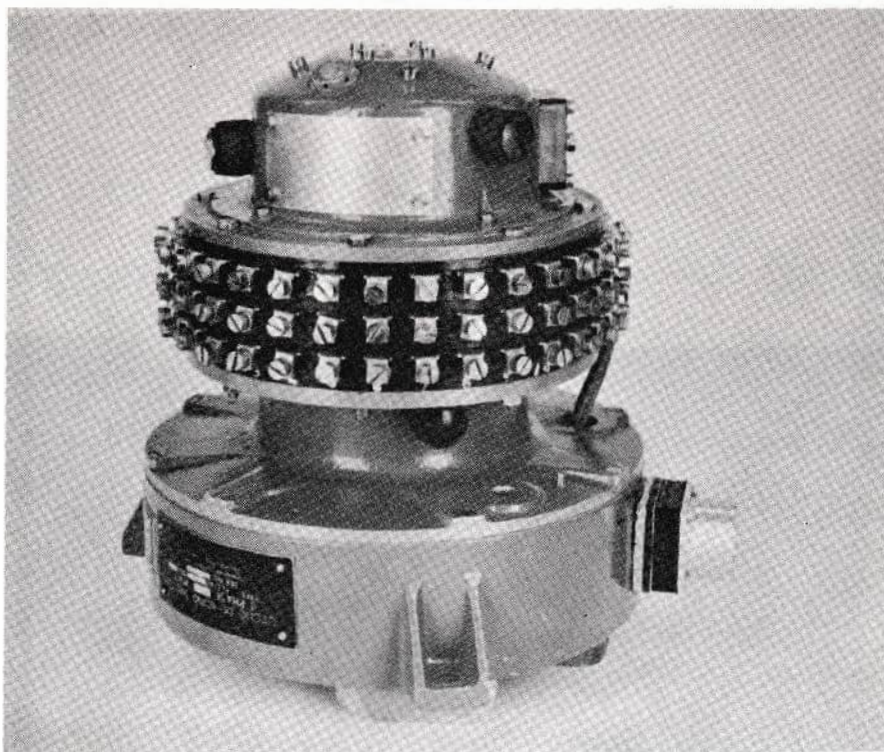
SLIPRING AND CYCLIC SWITCH MOUNTED ON ROTOR HUB

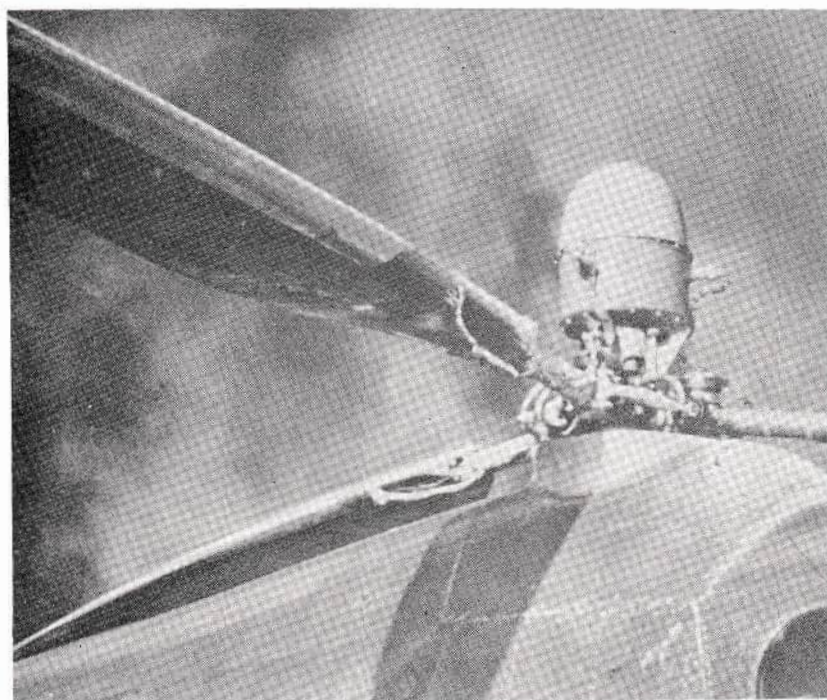
DOMES INSTALLATION WITH CYCLIC SWITCH INSIDE

CYCLIC SWITCH INSTALLED ON AIRCRAFT

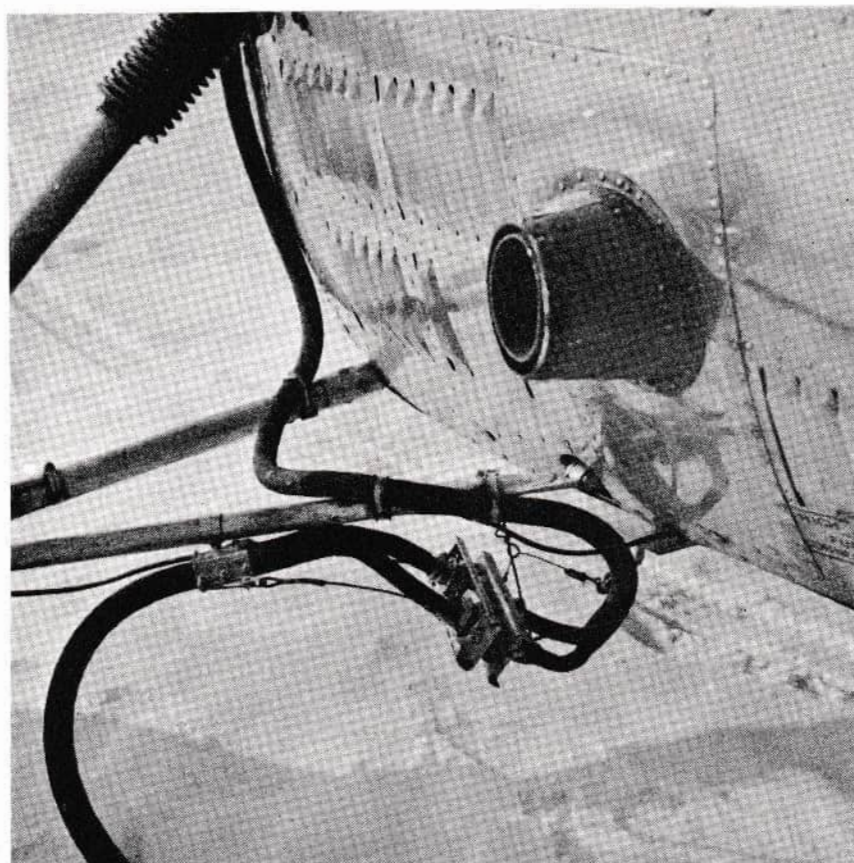
SNATCH PLUG ARRANGEMENT FOR EXTERNAL POWER SUPPLY

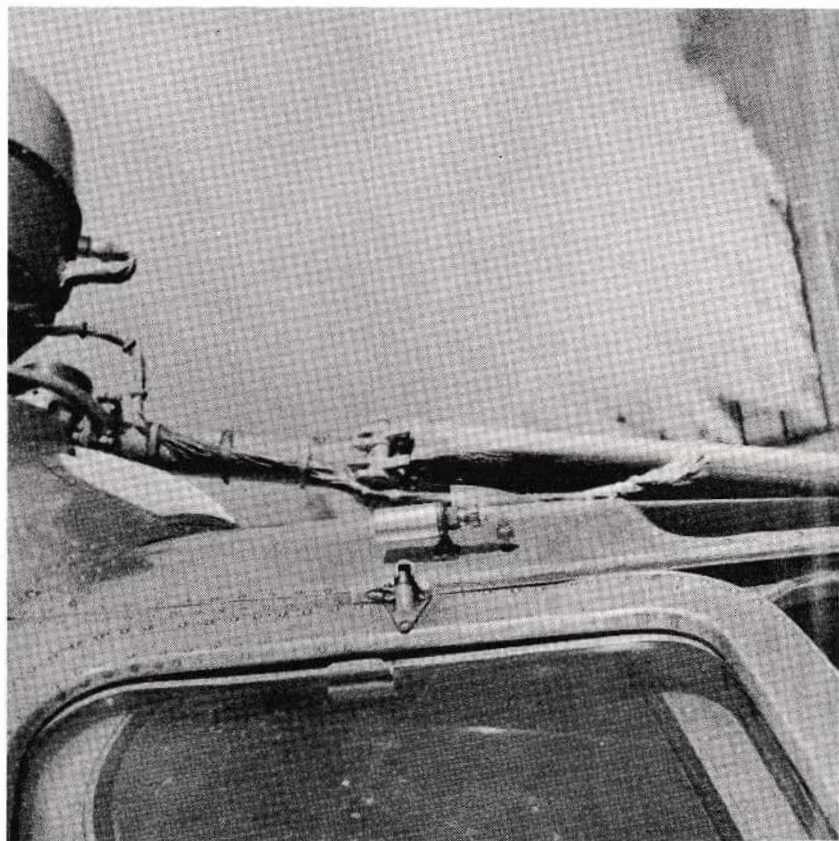
SHIELDED TEMPERATURE BULB ON TOP OF CABIN

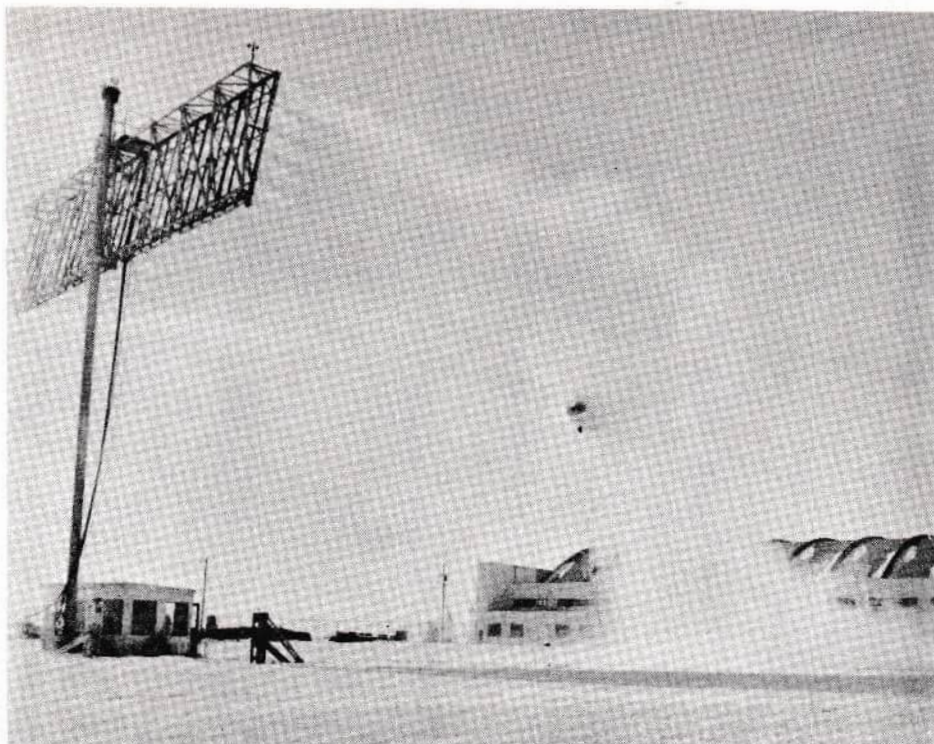
CORRECT AIRCRAFT POSITION FOR ICING FLIGHT

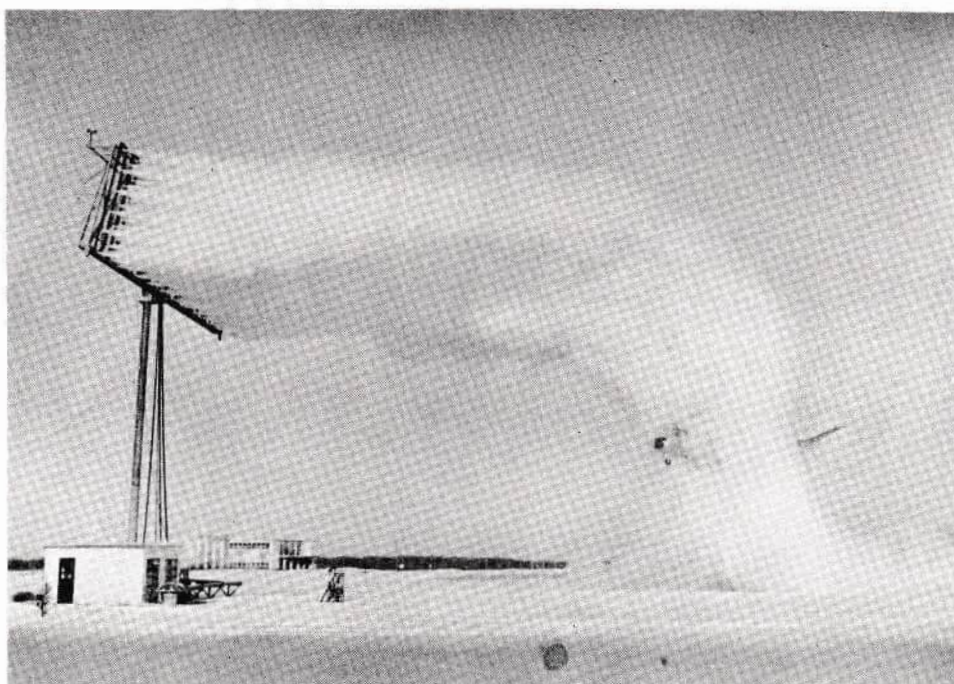
WINDSPEED IS SLIGHTLY TOO LOW (NO TAIL ROTOR ICING)

HELICOPTER DURING ICING FLIGHTS

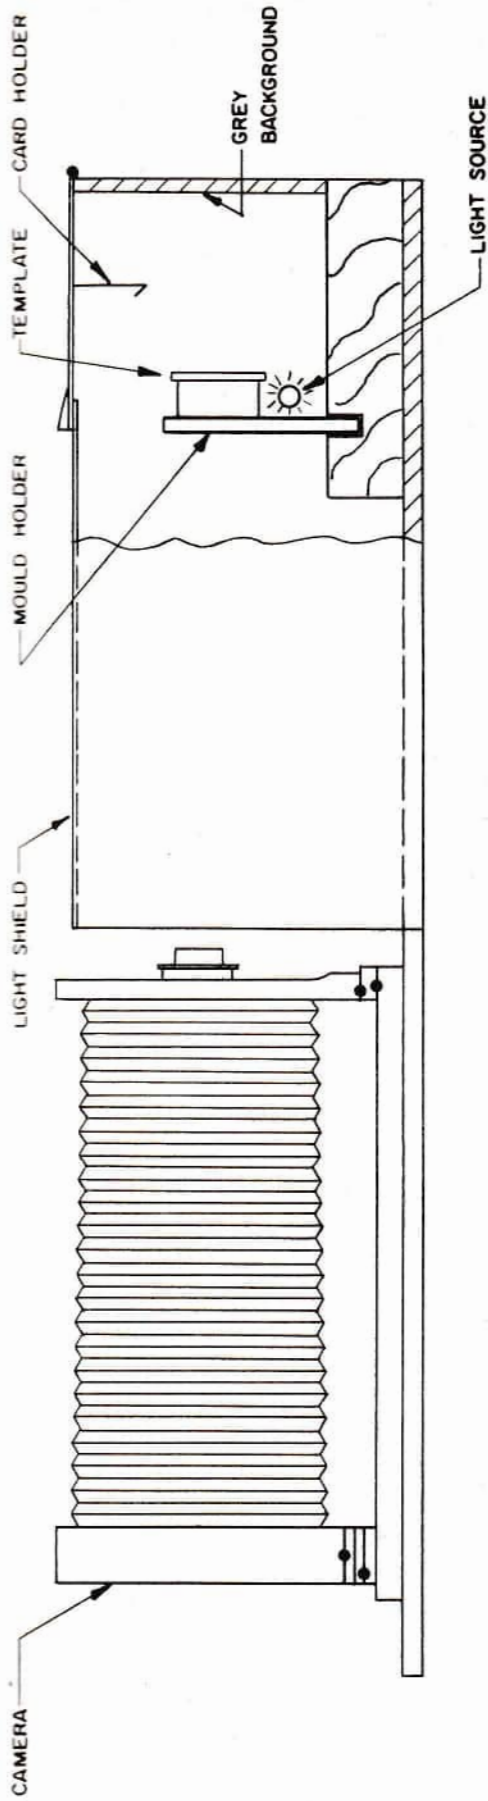
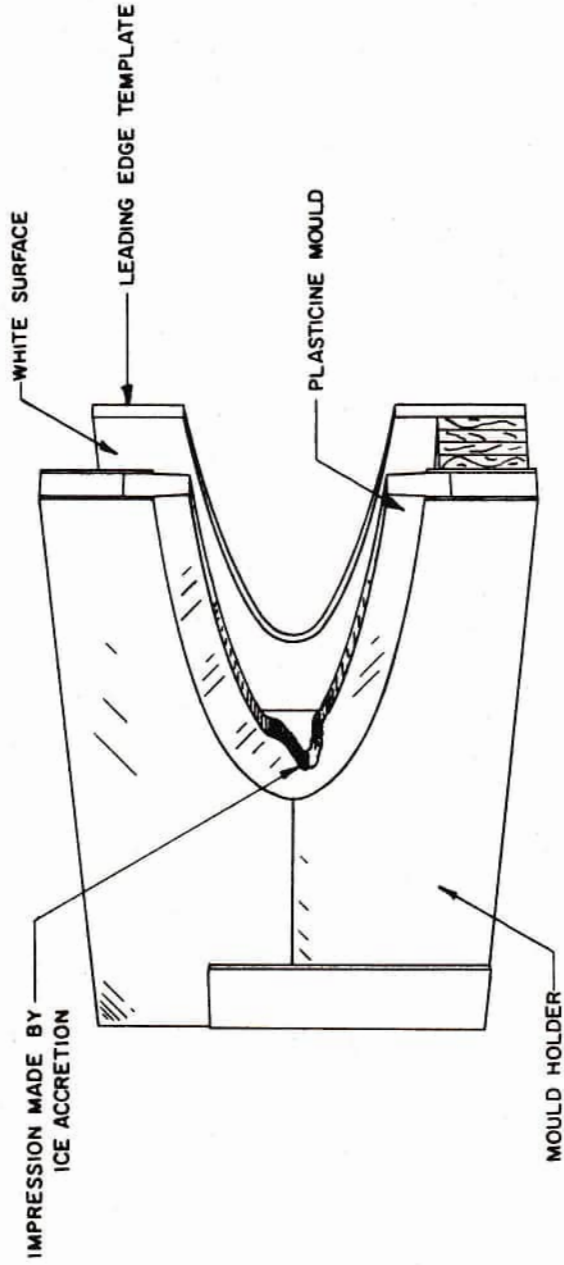
ICE PROFILE MOULD AND CAMERA.

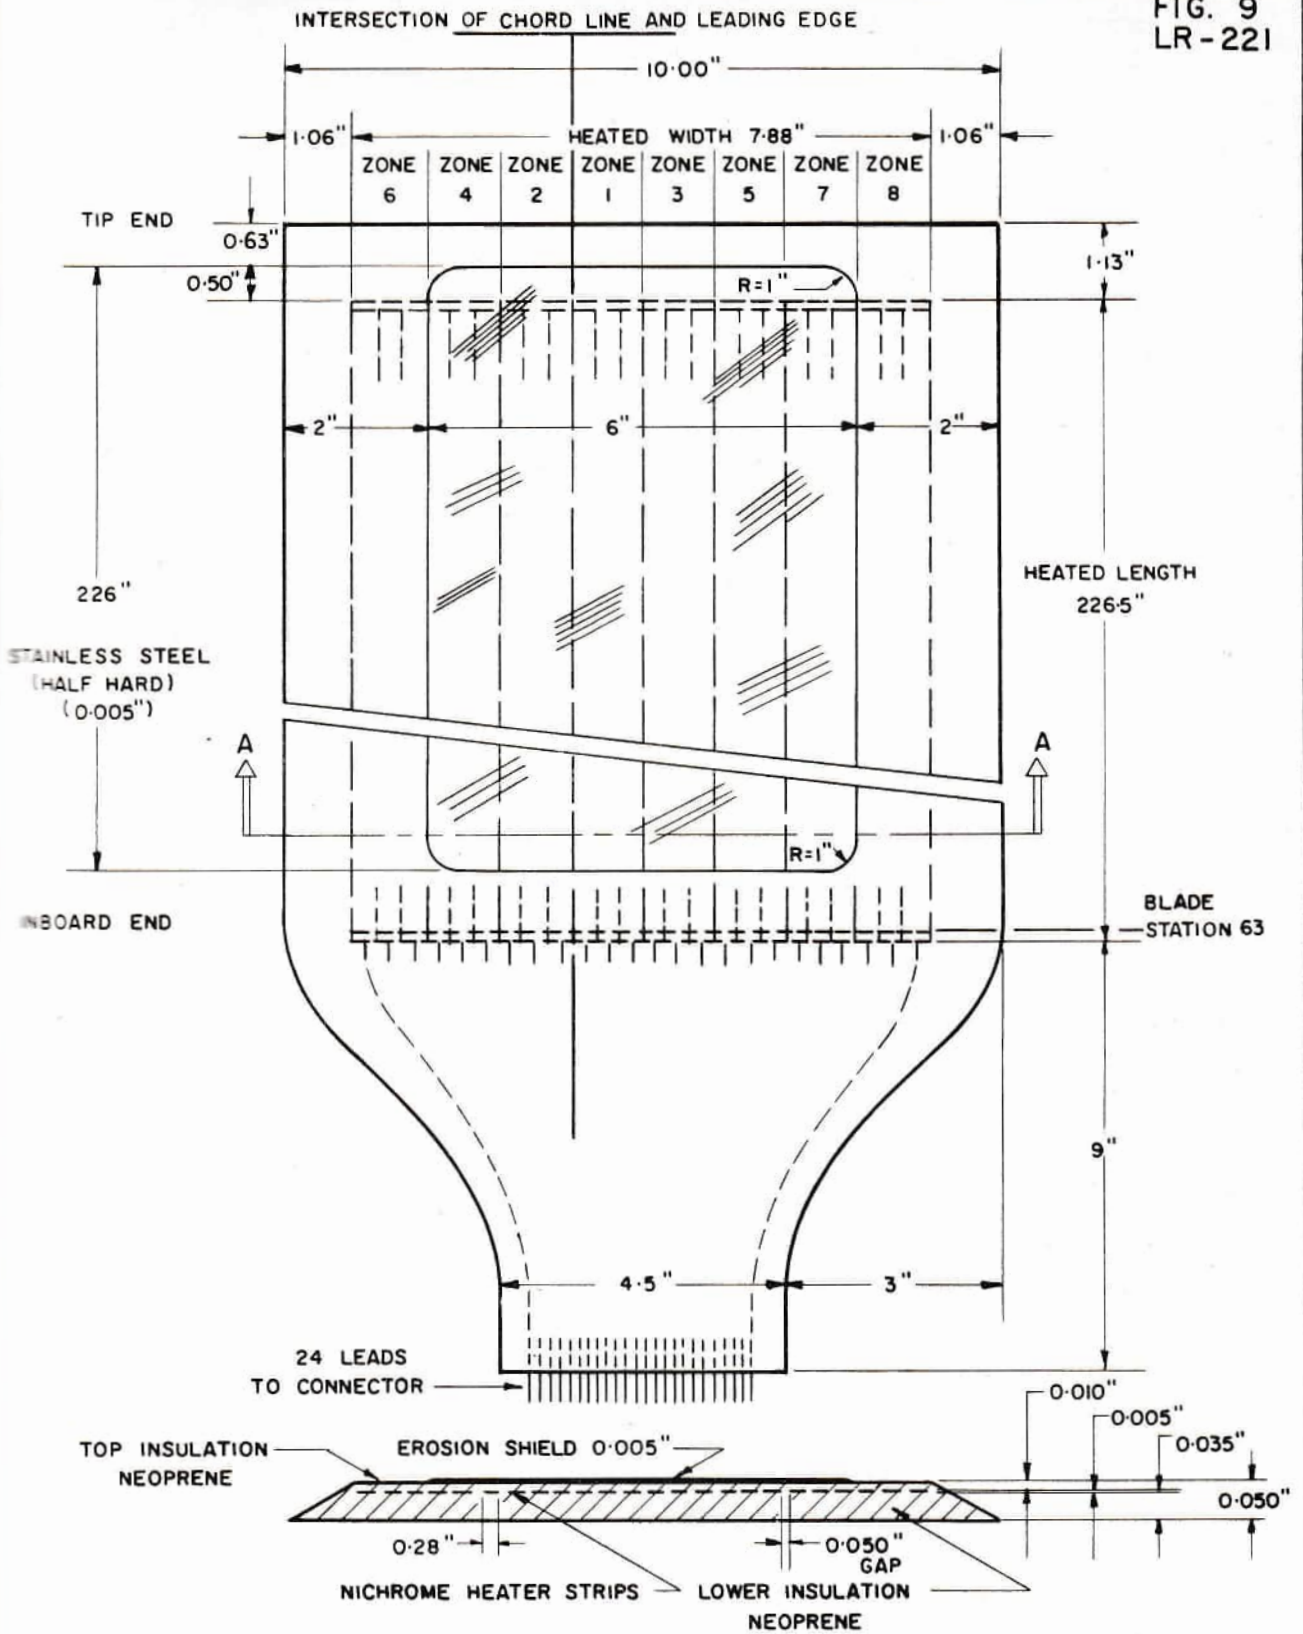
SECTION A-A

RESISTANCE OF EACH HEATER STRIP : $8.03 \Omega \pm 5\%$
 WEIGHT OF PADS : 9.9 lbs. (6 lbs./ft.²), 13.8 lbs. WITH LEADS (16 GA.)

LAYOUT OF DE-ICER PADS

The zones were heated in different sequences to check the effect of shedding performance and run-back. Variation from the numerical sequence shown in Figure 9 showed an increase in power requirements. Zone 6 was omitted as it was outside the impingement area found during the icing flights. During the later tests zones 7 and 8 became inoperative because of failure.

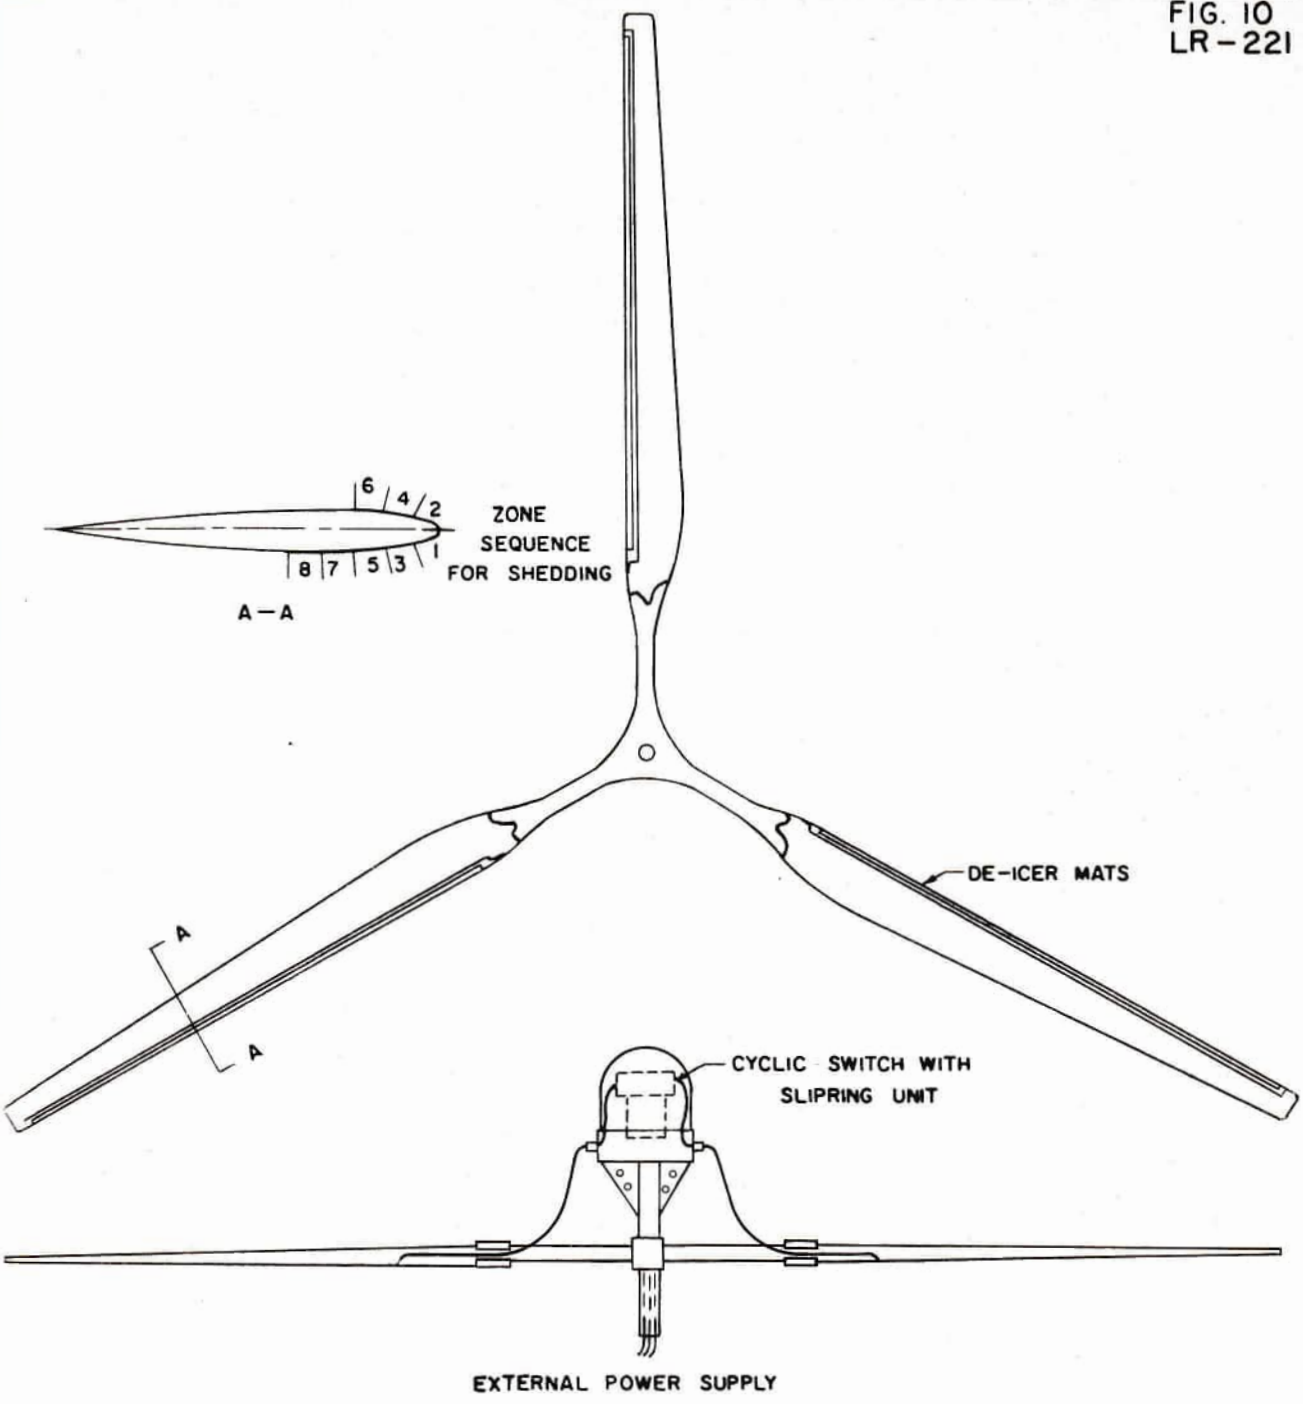
MAIN ROTOR WITH DE-ICER PADS INSTALLED

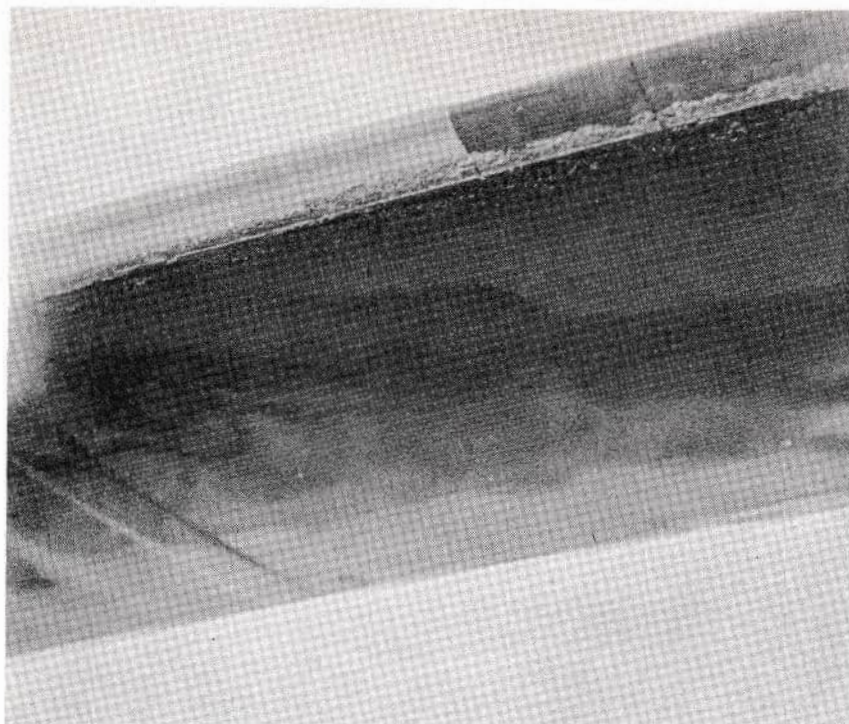
SELF-SHEDDING ON STANDARD BLADES (NOTE CRACKING
OF ICE ACCRETION OVER GAPS BETWEEN BRASS NOSE CAPS)

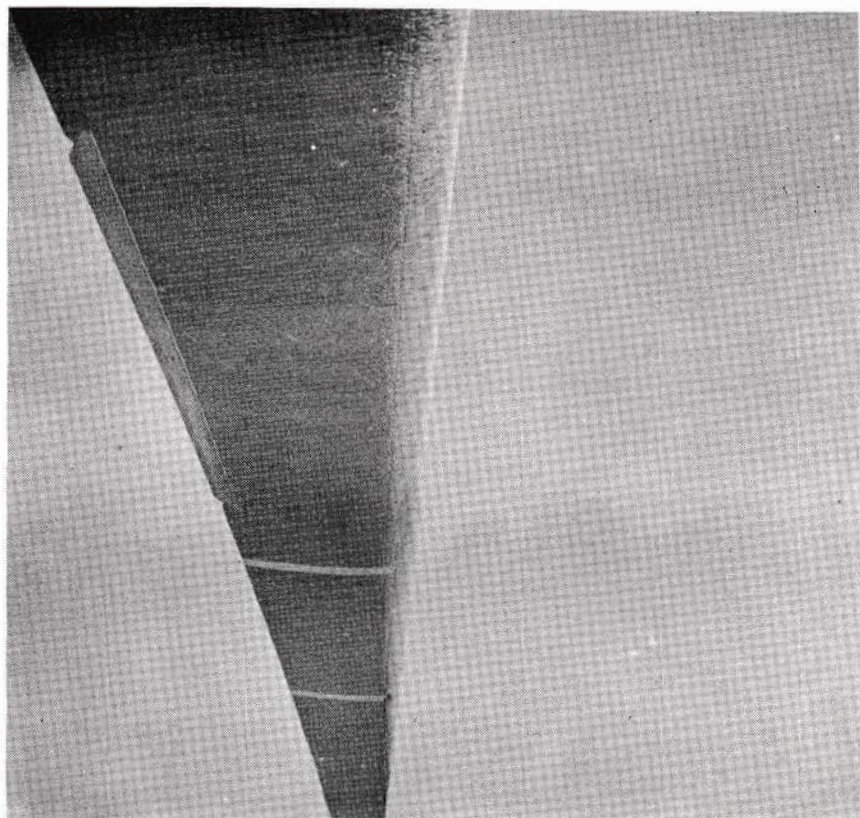
ICE ACCRETION COLLECTED DURING FLIGHT VI-5
TYPICAL ACCRETION COLLECTED DURING ICING
FLIGHTS WITH STANDARD BLADES

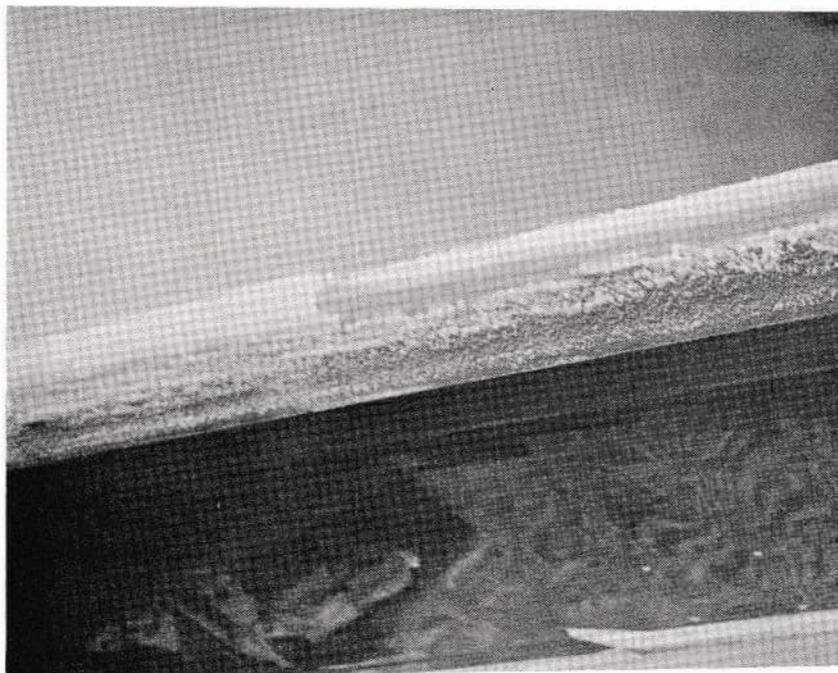
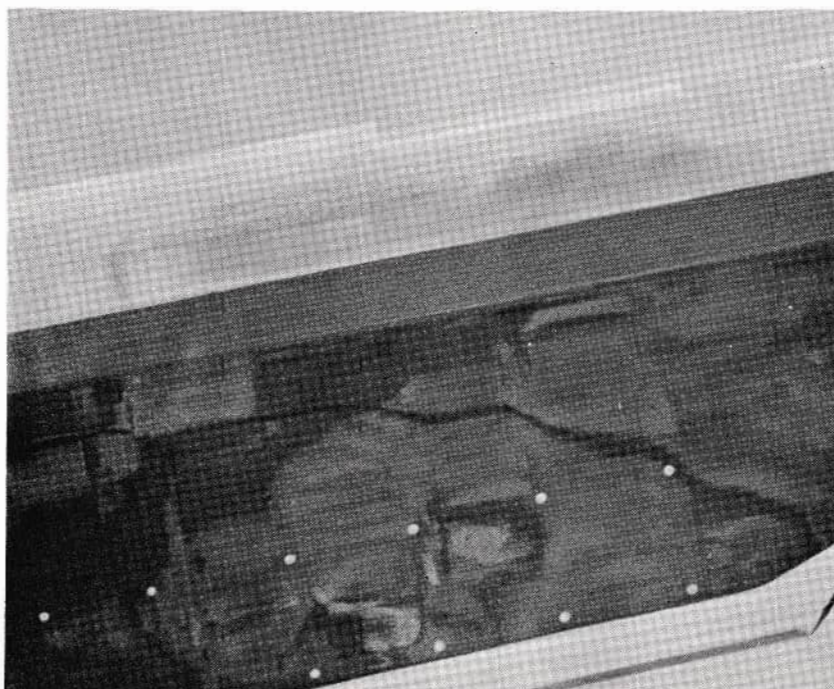
ICING FLIGHT II -13
SELF-SHEDDING UP TO STATION 115. ICE ACCRETION 7/8 IN.
AMBIENT AIR TEMPERATURE -9°C

ICING FLIGHT II -18
SELF-SHEDDING UP TO STATION 140. ICE ACCRETION 3/4 IN.
AMBIENT AIR TEMPERATURE -8.5°C
SELF-SHEDDING OF ICE ACCRETIONS ON PROTECTED BLADE

The actual extent of self-shedding was almost impossible to determine because, when the rotor was slowing down, the pronounced droop of the rotor blades cracked the ice accretion and more self-shedding took place than would occur in normal flight. Examples of self-shedding with the protected blades are shown in Figure 12.

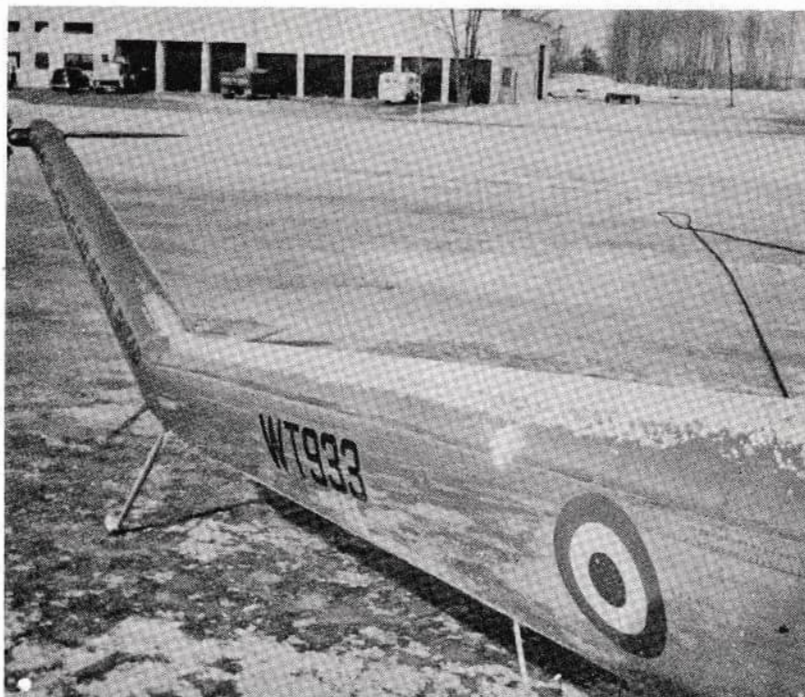
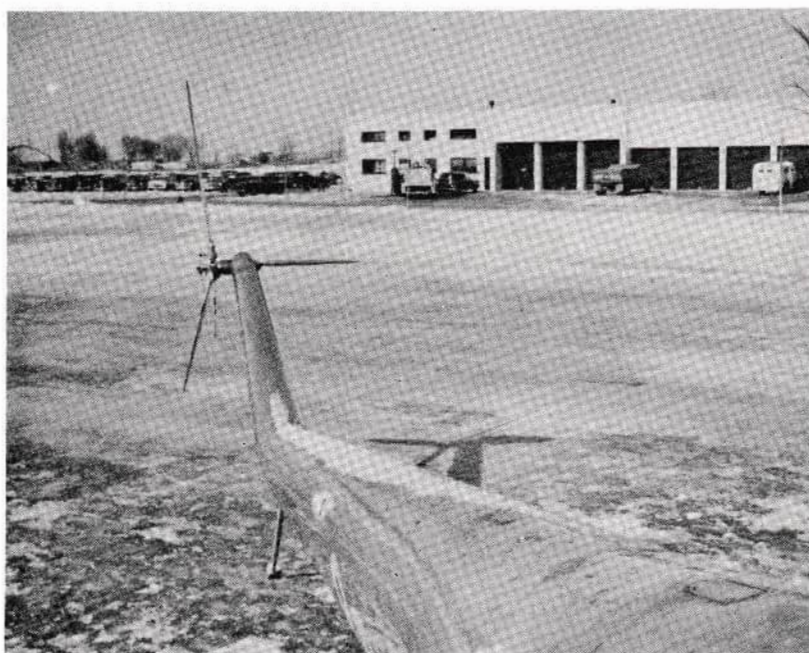
ISOLATED RIME FINGERS ON TAIL CONE

EXTENT OF ICE ON TAIL CONE AT -16°C

ICE EXTENT ON TAIL CONE

Some nodules of ice formed on the tail cone (Fig. 13), but were not large enough to create a problem. This accretion was largely caused by rotor downwash.

Tailcone icing was the result of rotor downwash; at no time did it have any effect on the handling of the aircraft. It is possible with higher forward speeds that the accretion would be extensive enough to cause a significant change in weight and centre of gravity and require consideration.

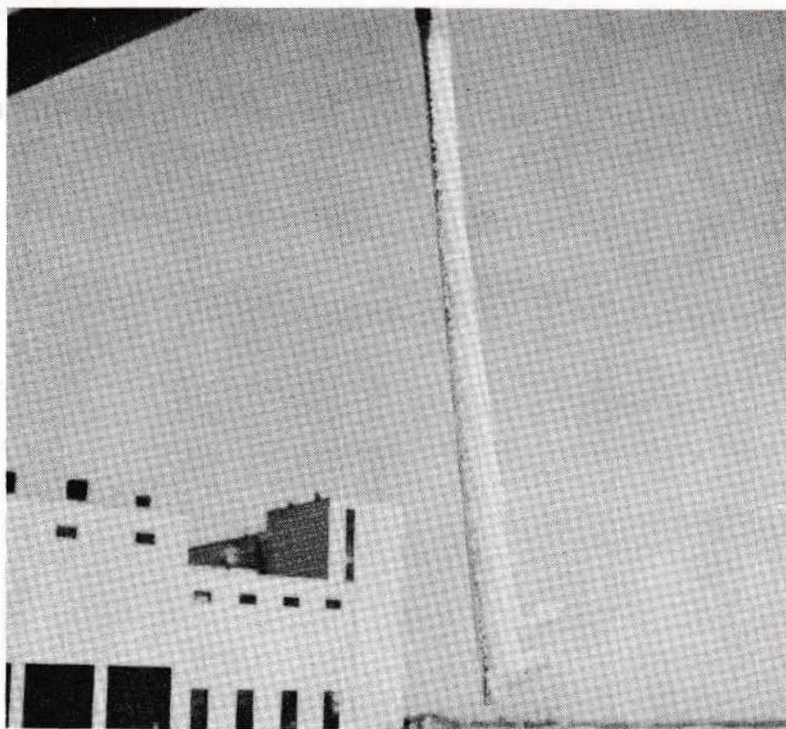
ICE ACCRETION ON AERIAL

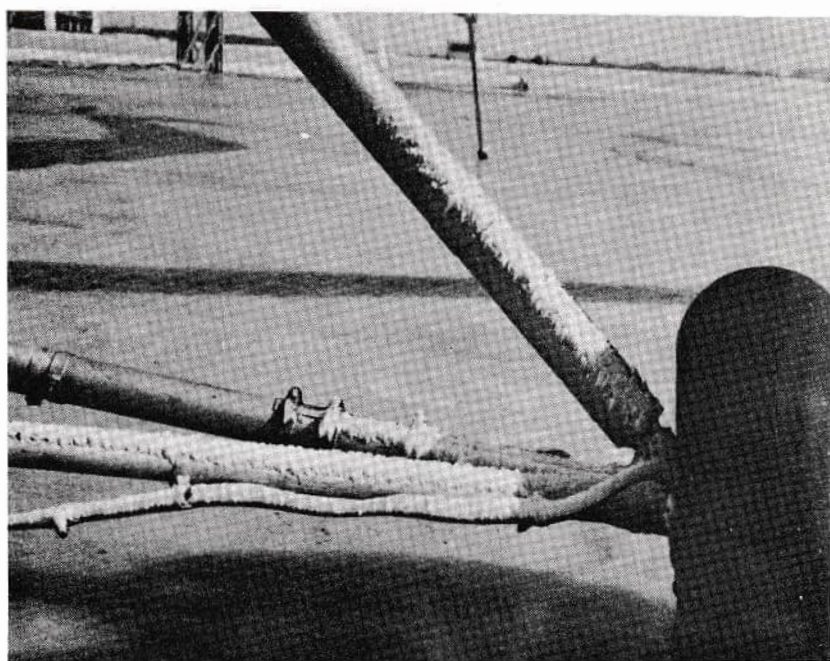
UNDERCARRIAGE ICING

COMPONENT ICING

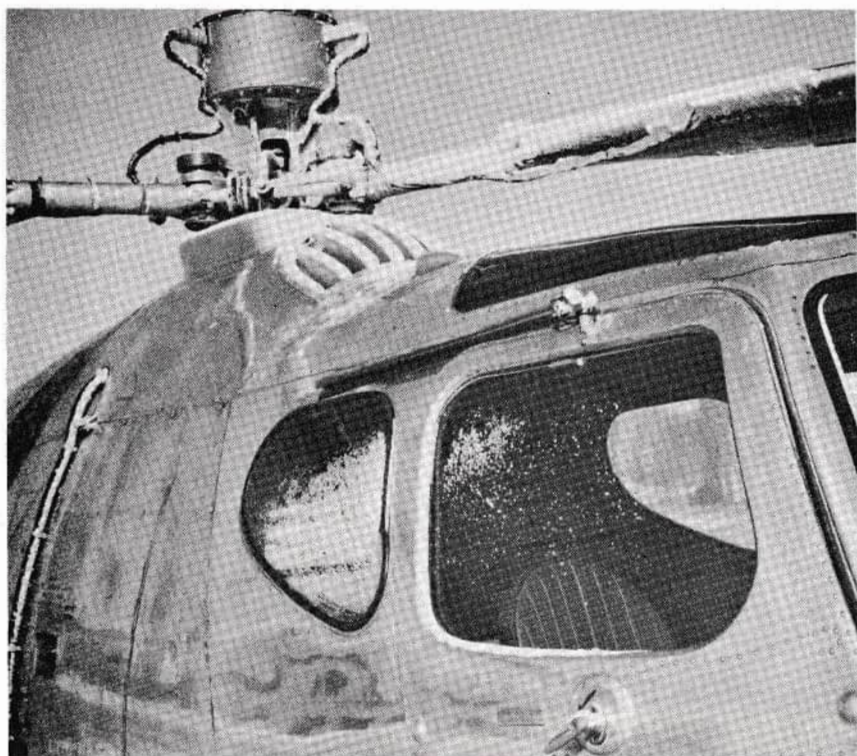
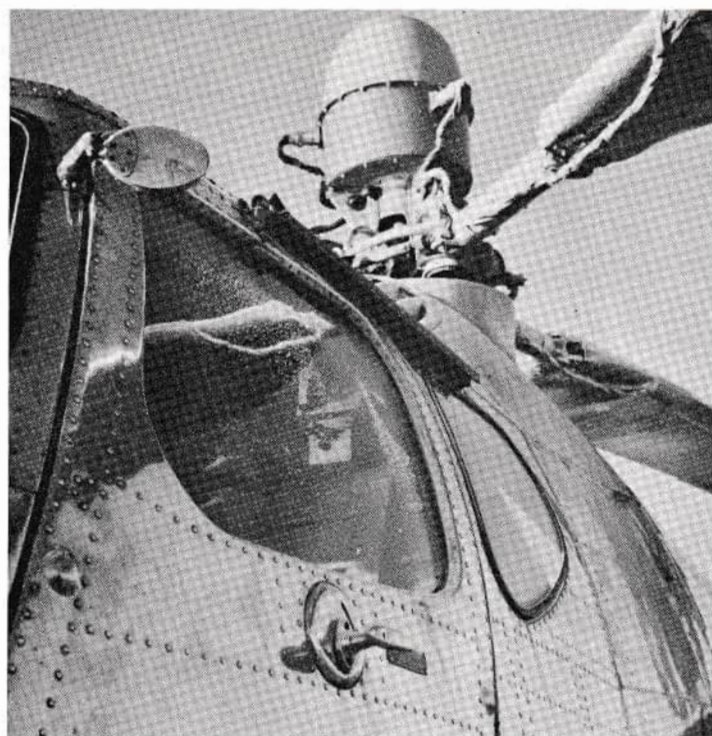
ICE ACCRETION ON SIDE WINDOWS

Ice formed on the side windows and doors, especially at lower temperatures (Fig. 16), and restricted vision. Flights in freezing rain caused almost complete icing of windows, and on one occasion difficulty was experienced in opening the door from the inside.

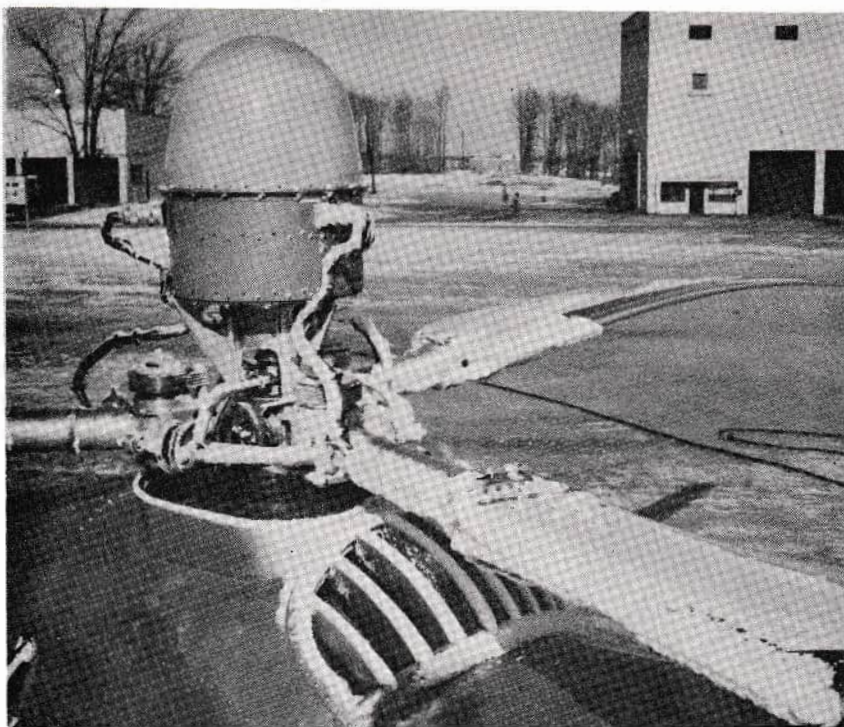
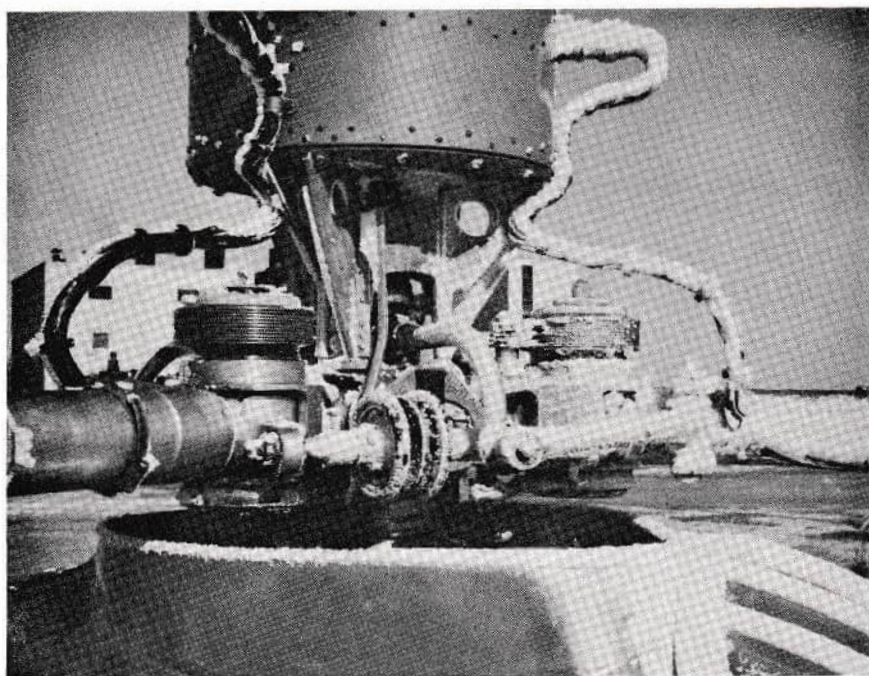
ICE ACCRETION ON UNPROTECTED PART OF ROTOR AND HUB MECHANISM

ICE ACCRETION ON CONTROL MECHANISM AND DAMPERS
ICING ON ROTOR HEAD AT -16°C O.A.T.

The rotor head and controls collected ice but never to a point where it created a serious problem. Ice did form on the bob weights of the droop stops, increasing their centrifugal weight, and so decreased the r. p. m. at which they cut in. This meant that it was seldom possible to get the main rotor blades on to any but the first step. On longer flights at higher forward speeds the larger accretions which would result might begin to have an effect and require that some form of protective cover be provided.

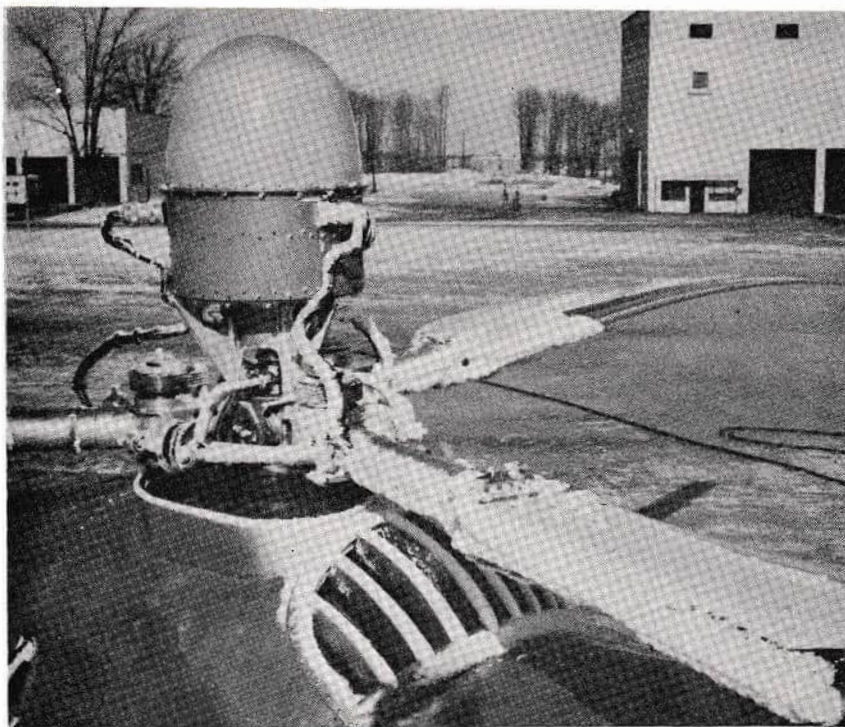
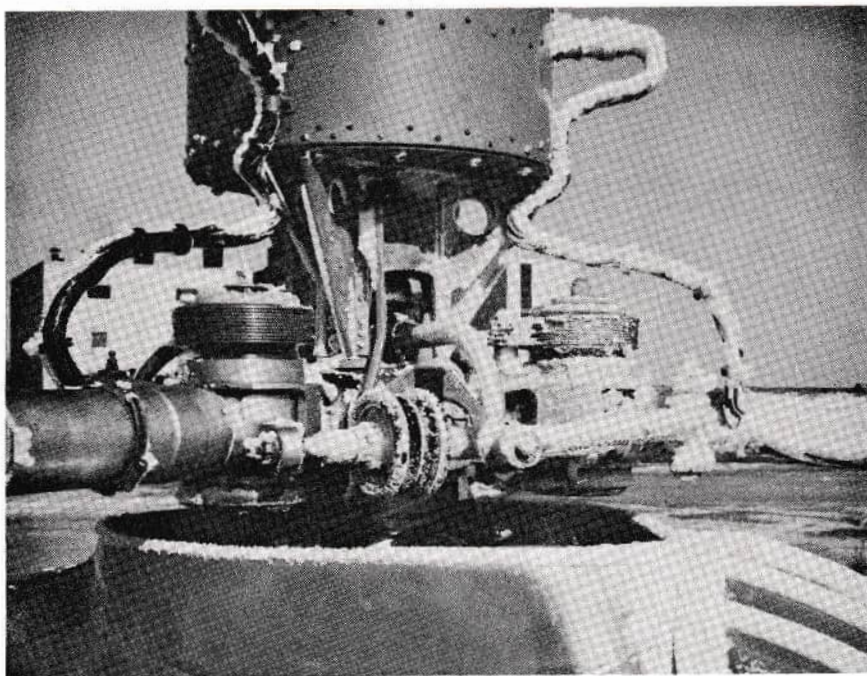
ICE ACCRETION ON UNPROTECTED PART OF ROTOR AND HUB MECHANISM

ICE ACCRETION ON CONTROL MECHANISM AND DAMPERS
ICING ON ROTOR HEAD AT -16°C O.A.T.
