Helicopter icing and de-icing flight trials on a bristol sycamore type 171, MK.3

LABORATORY REPORT LR-221

HELICOPTER ICING AND DE-ICING FLIGHT TRIALS
ON A BRISTOL SYCAMORE TYPE 171, MK. 3

A Sycamore helicopter fitted with an electro-thermal de-icing system was tested under different simulated conditions of icing severity over a wide range of temperatures. The effect of icing on handling and performance was assessed and power requirement for clean shedding was determined.

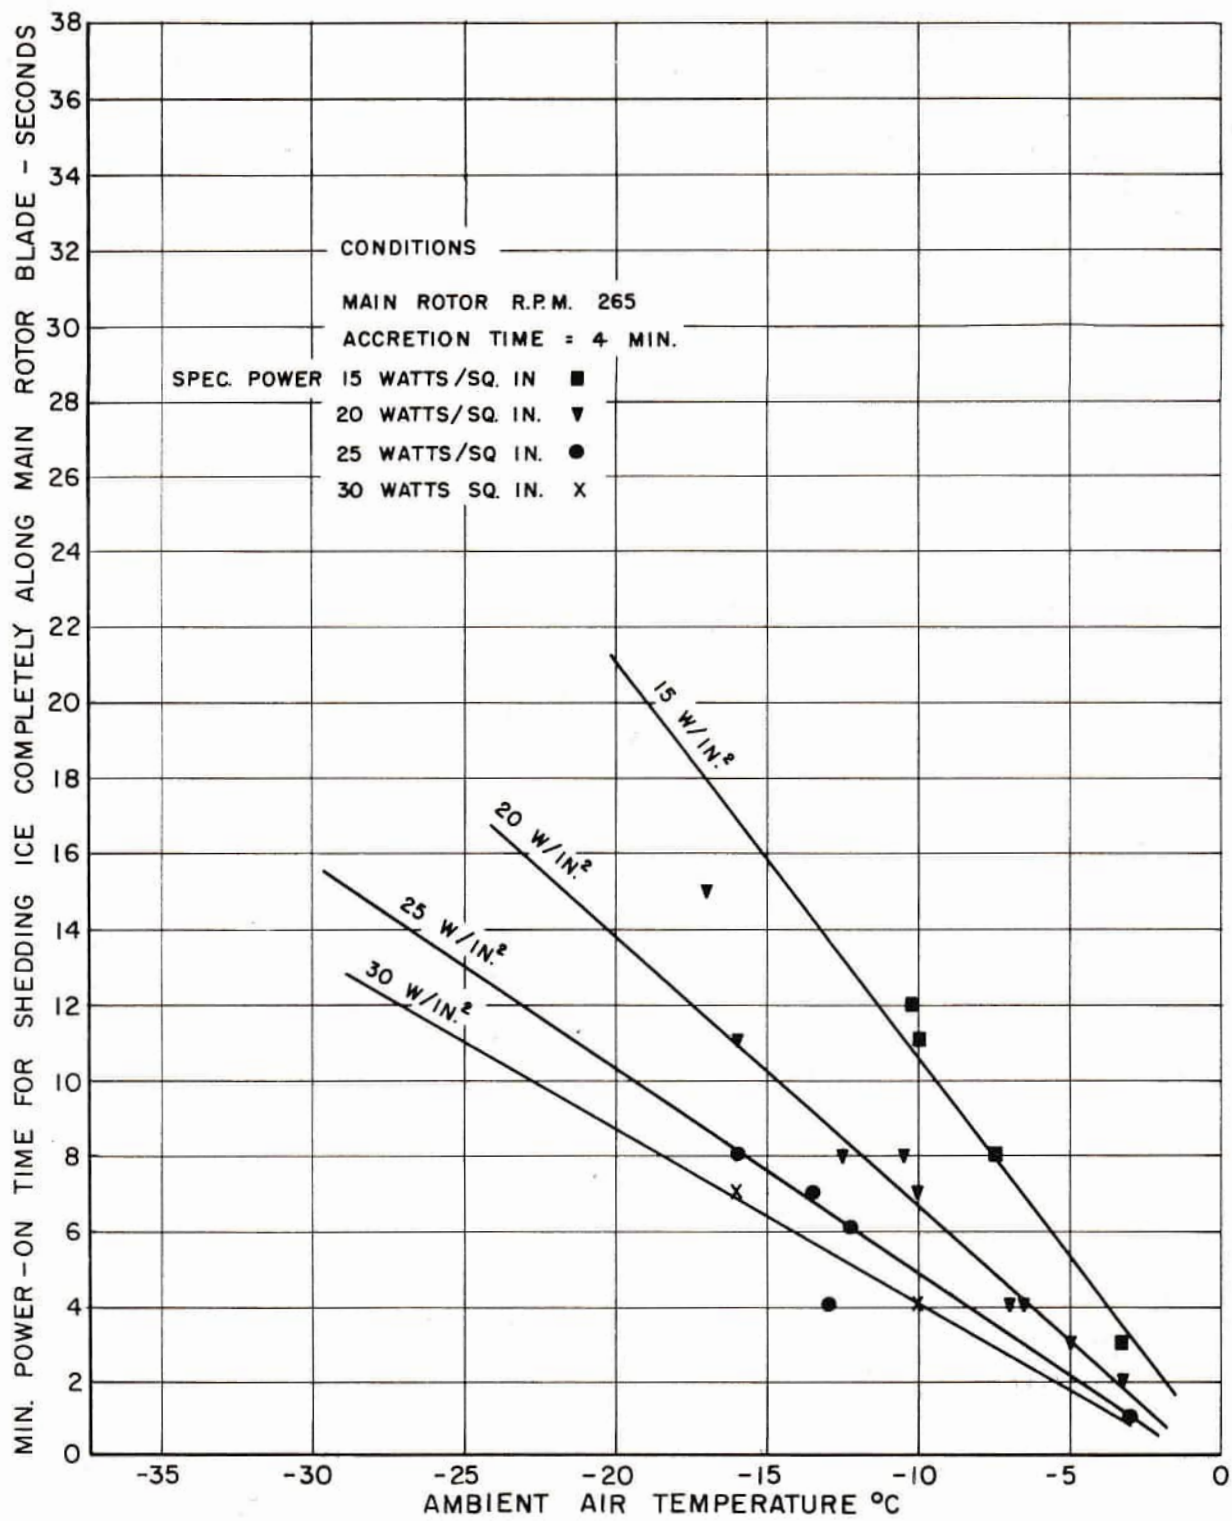
VARIATION OF POWER-ON TIME WITH AMBIENT AIR TEMPERATURE

De-icing was normally attempted as a single heating cycle outside of the cloud as this is the more severe condition. The aircraft then landed and the extent of the shedding was noted. This method of testing is necessarily a lengthy procedure as several flights may be required to establish the minimum power-on time for a particular combination of power density and temperature. Shedding was attempted at specific power densities of 15, 20, 25 and 30 watts/sq. in. over the full range of temperatures. Shedding was accepted as successful if ice shed cleanly to Station 63, and the corresponding power-on times were plotted in Figure 18. It will be seen that power-on time increases linearly with the decrease in ambient temperature.

The variation of power-on time with temperature indicates that a temperature controlled variable power-on time system is desirable. Failing this, a two- or three-step system may be satisfactory. A controlled system will prevent pad overheating which will occur at higher ambient temperatures if a fixed power-on time is used.

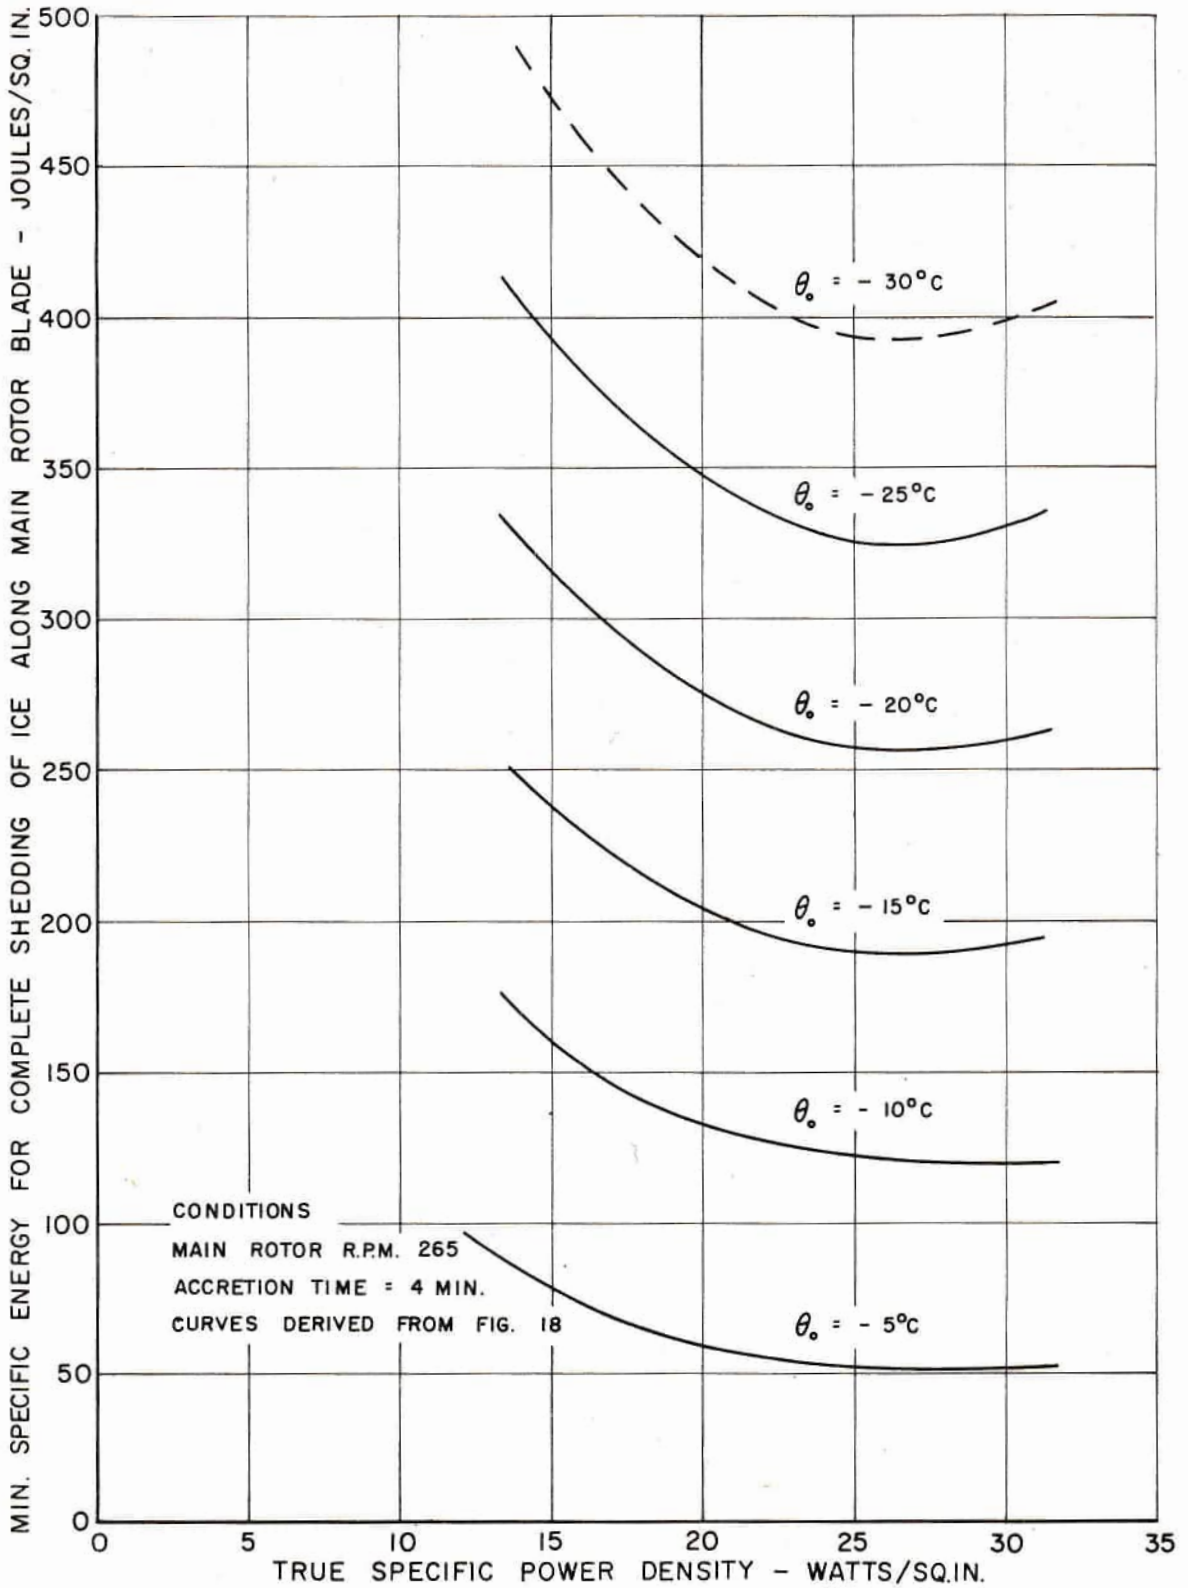
MINIMUM SPECIFIC ENERGY TO SHED ICE ALONG
 SPAN OF MAIN ROTOR AT VARIOUS SPECIFIC
 POWER DENSITIES AND AMBIENT TEMPERATURES

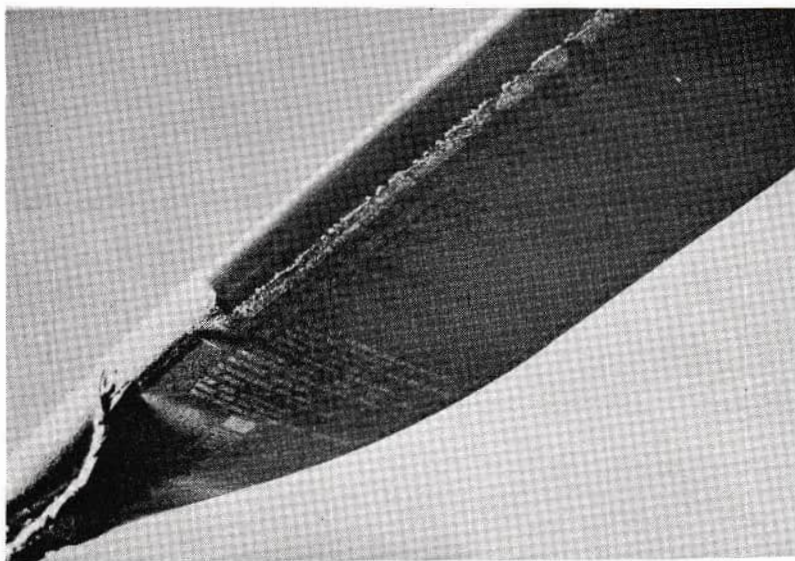
SIMULATED FAILURE OF ZONES 7 AND 8 AFTER SHEDDING

Zones 7 and 8 did become inoperative during the tests, so that this failure was not a simulated one. Figure 20a shows the accretion left on these inoperative zones after a shedding cycle.

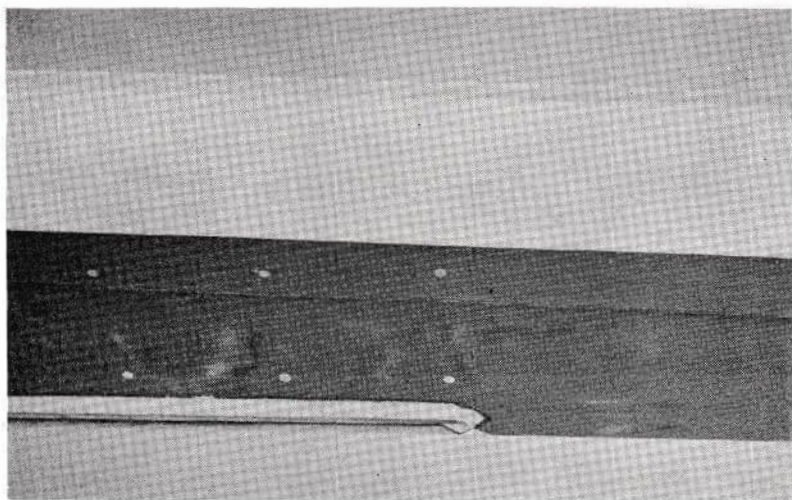
SIMULATED FAILURE OF ZONE 2 AFTER SHEDDING

SIMULATED ZONE FAILURES

Failure of zone 2 was considered to be the most serious zone failure as any accretion left would form a ridge of ice and cause a turbulent flow over the upper side of the blade. Under the test conditions this expectation did not materialize. The ice on the outer part of zone 2 shed when zone 1 was heated, and that left on the inner part of the blade had little effect.

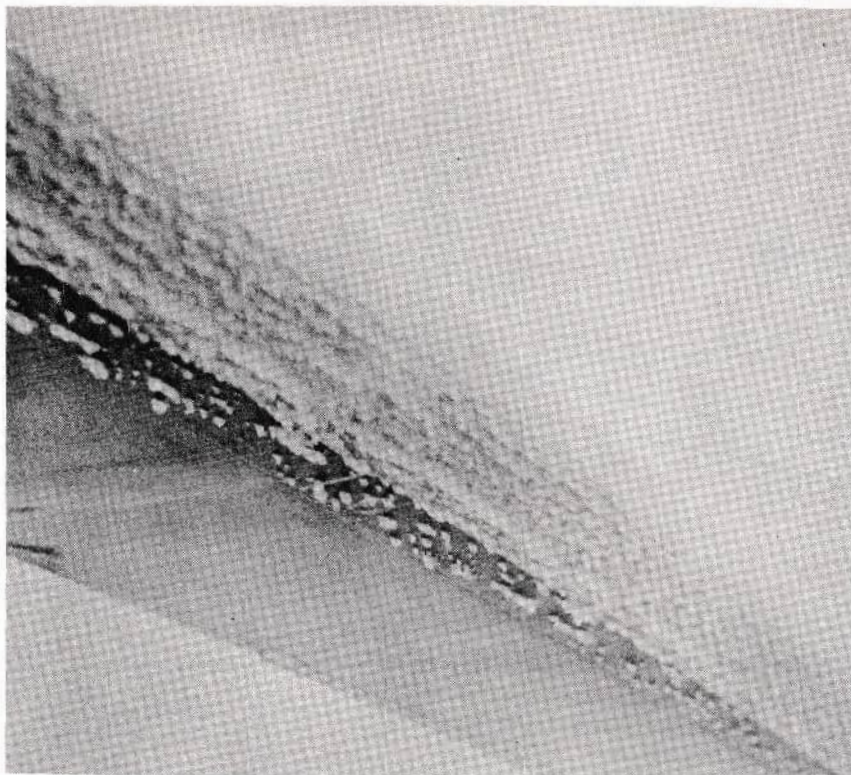
ACCRETION COLLECTED DURING GROUND RUN AT ZERO PITCH

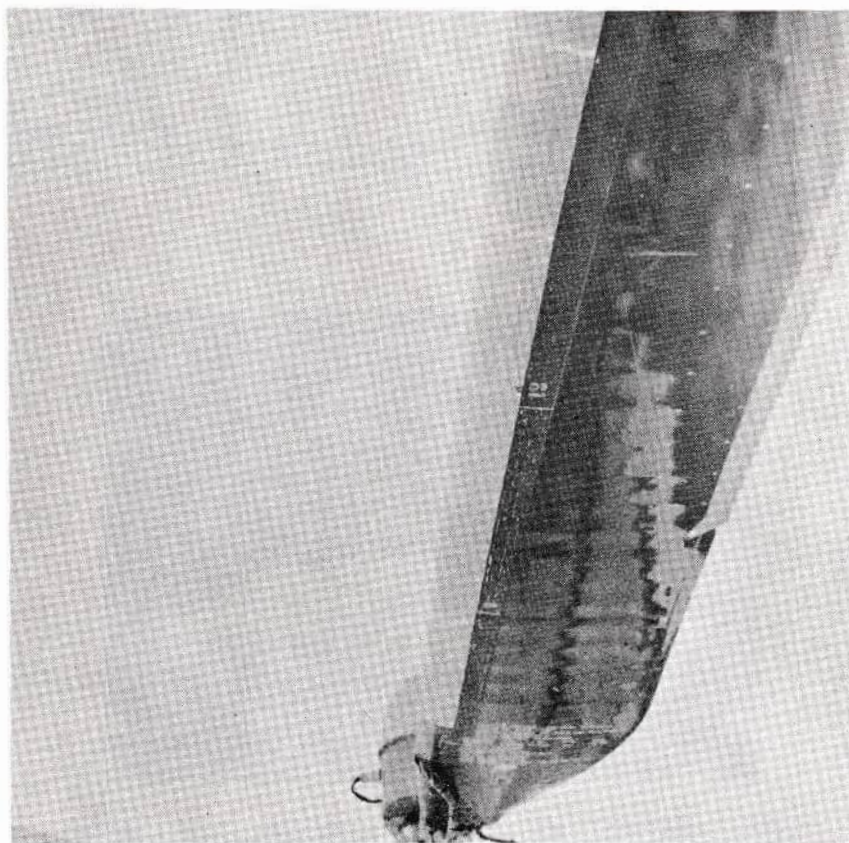
EXTENT OF ICING COLLECTED DURING FLIGHT VII-1
ACCRETIONS COLLECTED IN SIMULATED FREEZING RAIN

These tests were made in conjunction with the windscreen anti-icing tests. The ice accretions were similar but heavier and slightly more extensive than those under normal icing conditions. Figure 21a shows the accretion collected during a ground run with zero pitch, while Figure 21b shows the accretion collected during Flight VIII-1. Two sheddings were attempted with satisfactory results. Table V gives details.

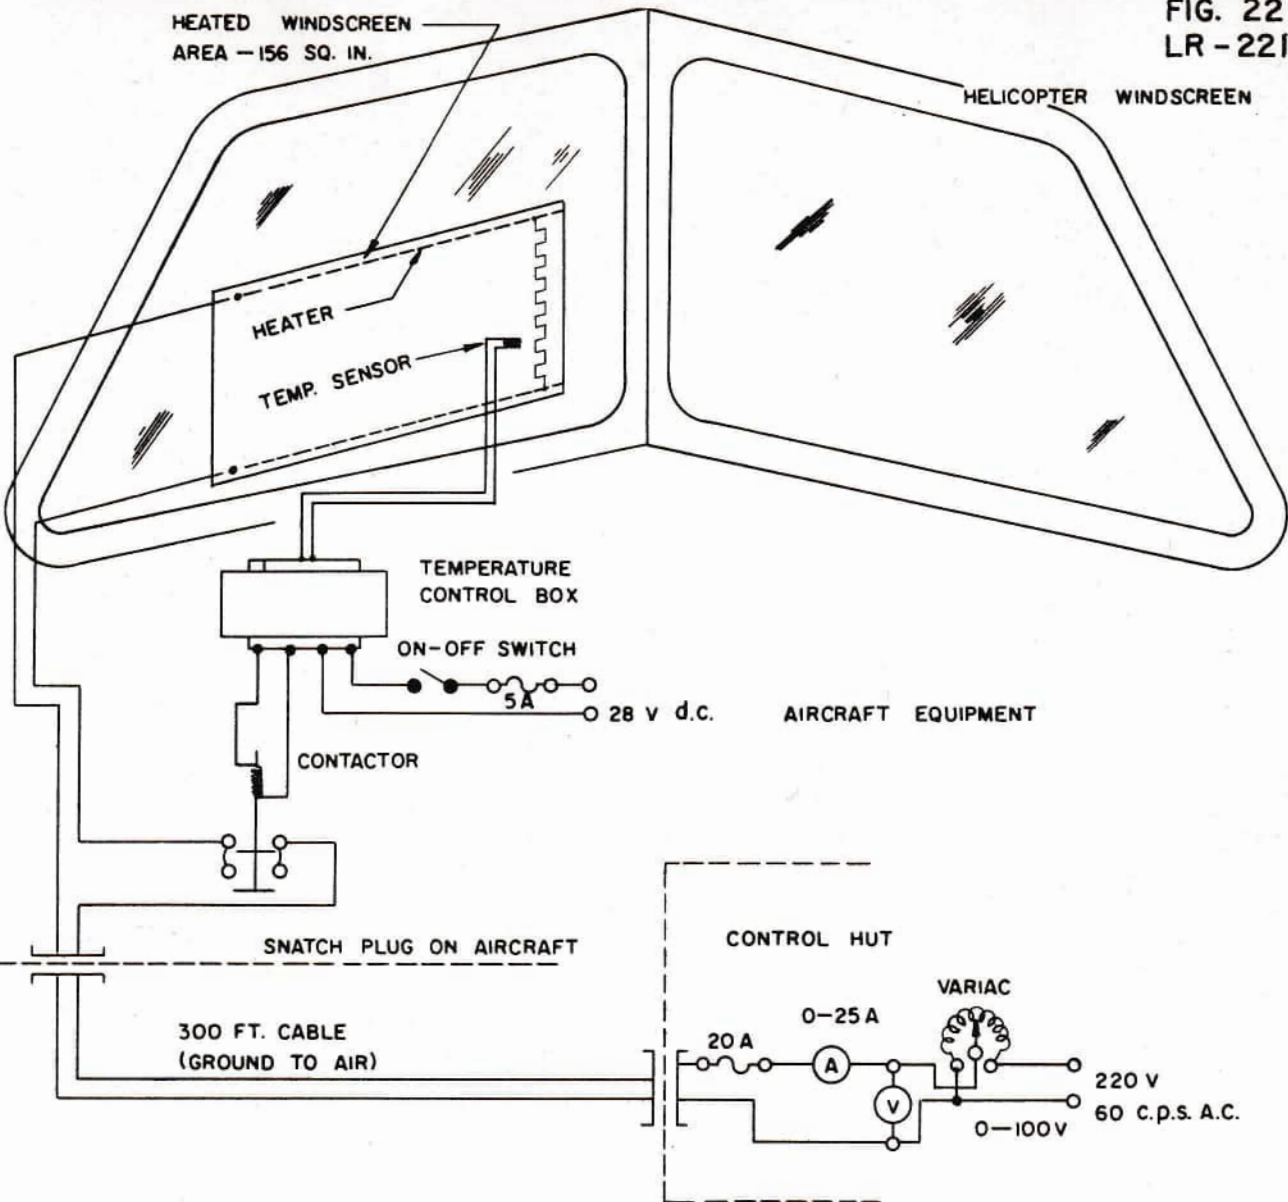
VARIAC AND INSTRUMENTATION IN CONTROL HUT
DIAGRAM OF WINDSCREEN ANTI-ICING SYSTEM

Windscreen tests, therefore, were made under simulated conditions of freezing rain at -15°C . Both systems worked satisfactorily and the results of the different tests are given in Table VI. Figure 22 shows details of the electro-thermal system.

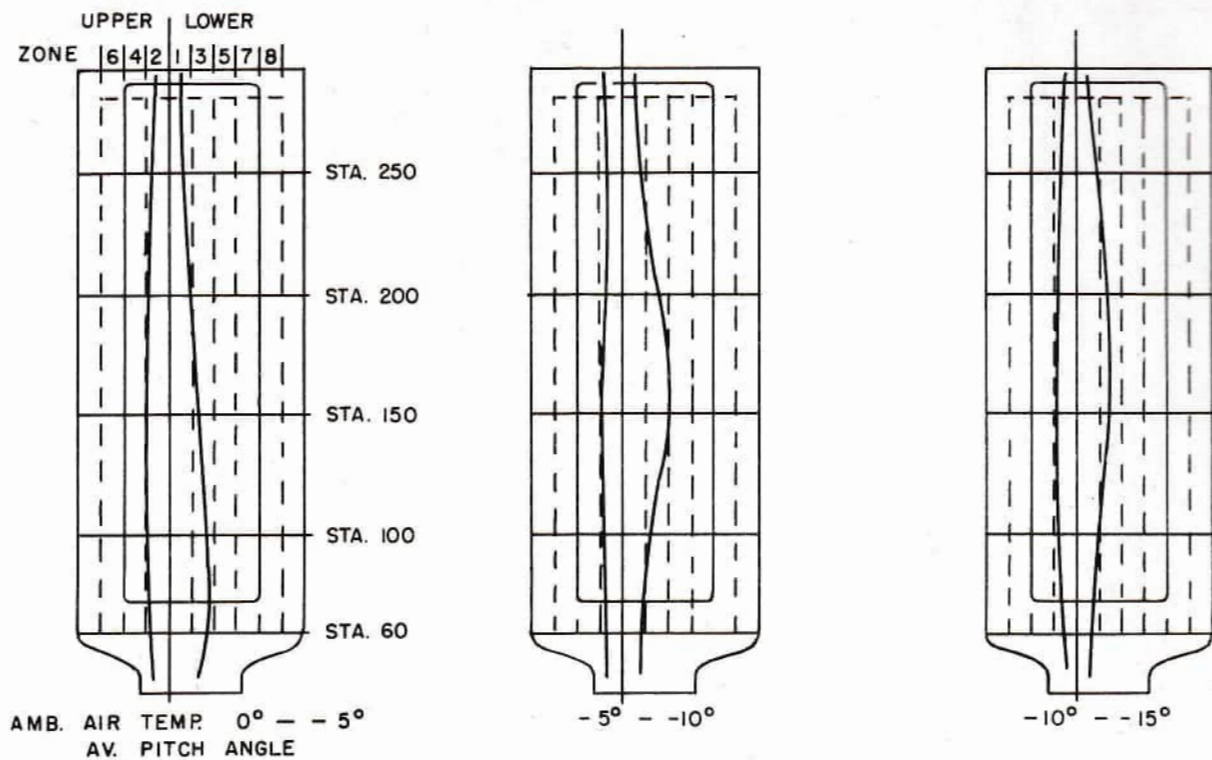
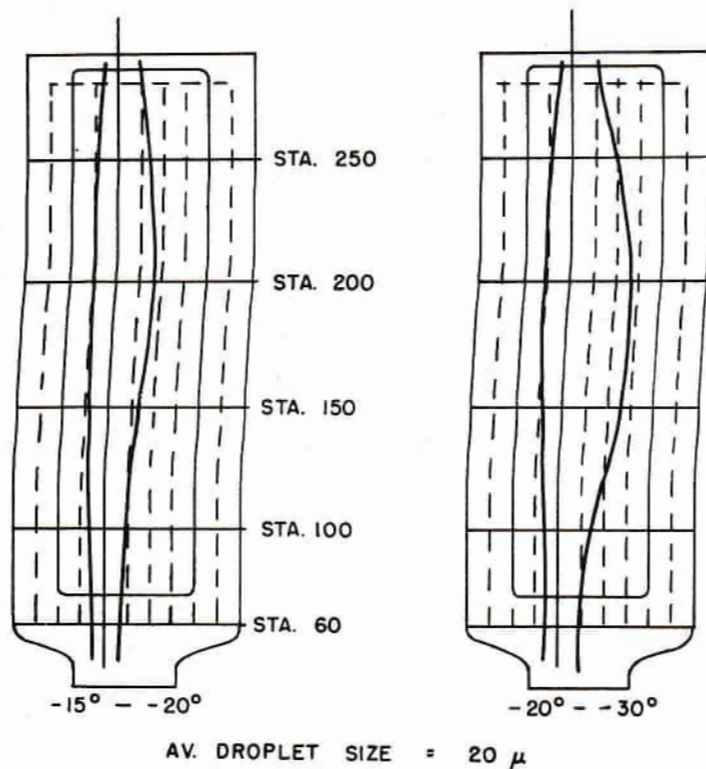
CHORDWISE EXTENT OF ICE ACCRETIONS
ON MAIN ROTOR DE-ICER PADS

The impingement data collected show that the installed pads are wider than necessary. Zones 6 and 8 could be removed without affecting shedding performance. Extent of impingement for the various temperature ranges is shown in Figure 2. For a given water content and time of accretion, the maximum ice thickness along the blade varied linearly with temperature. Figure 24 shows this relationship particularly well defined for the condition of high liquid water content. The effect is less clear at lower water concentrations because of the difficulty of exact measurement of liquid water content.

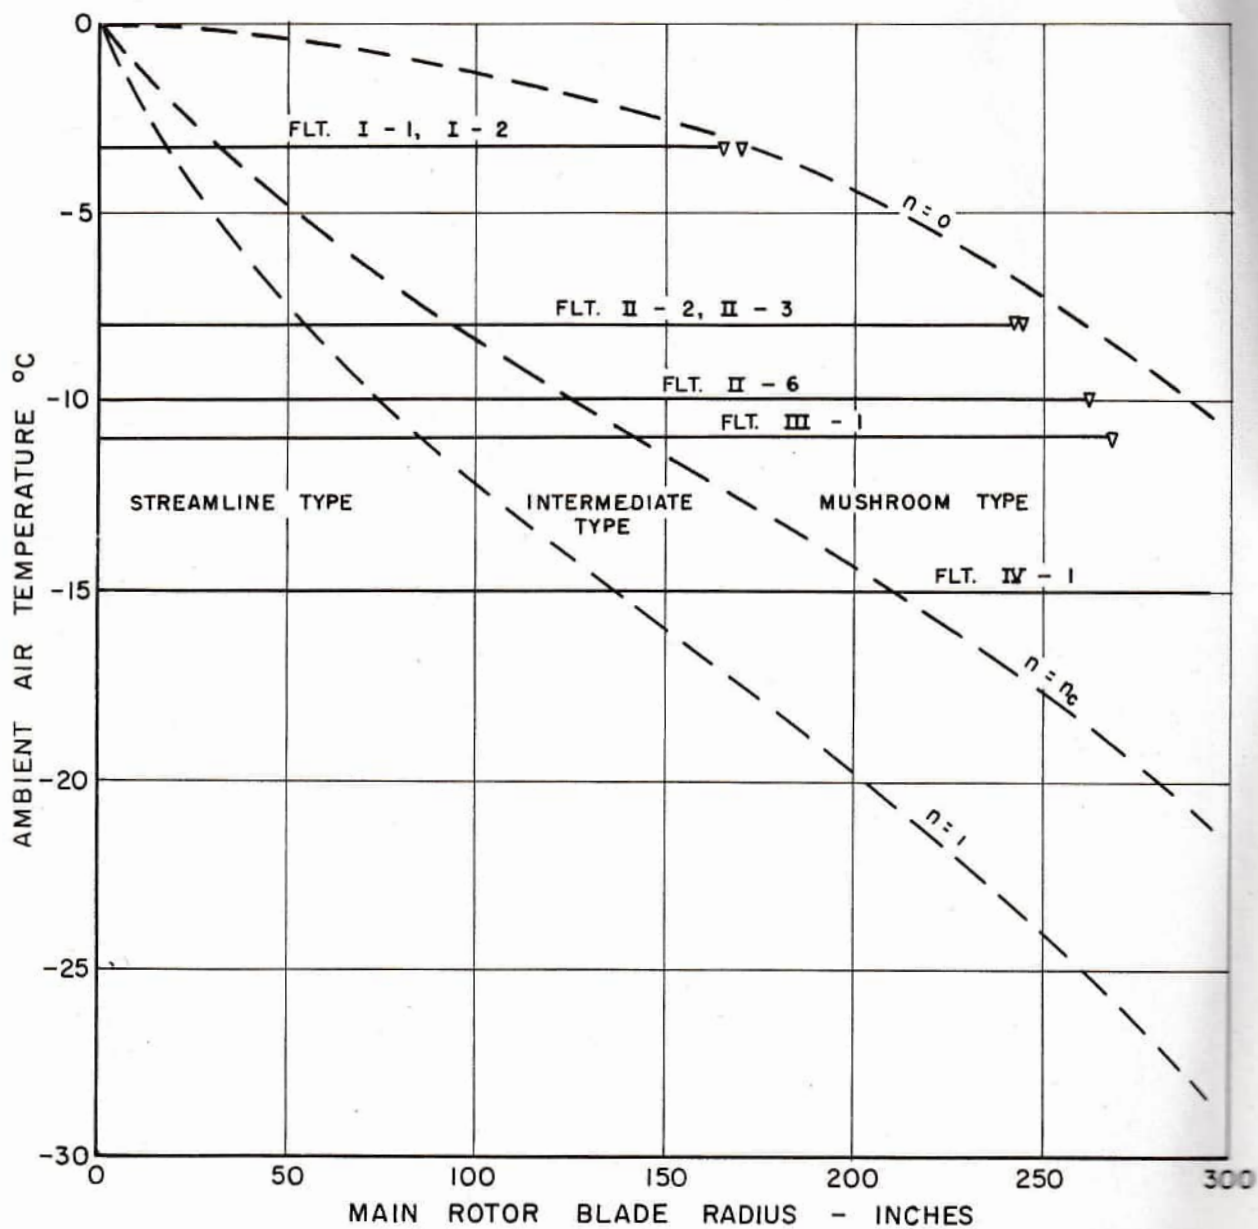
MAXIMUM SPANWISE EXTENT AT STAGNATION LINE
AND CALCULATED ICE ACCRETION CHARACTERISTICS
FOR L.W.C. = 0.3 GM./M.³

Figures 25, 26 and 27 show the maximum spanwise extent noted during the trials compared with the theoretical curves for different liquid water contents. The theoretical changeover points for different types of ice are also shown, but these points were never well defined although the type of ice did vary along the span in accordance with the theoretical calculations. The inboard end of the blade did not produce the streamline ice expected, but rather a large double ridge shaped rime accretion which can be seen in Figure 17.

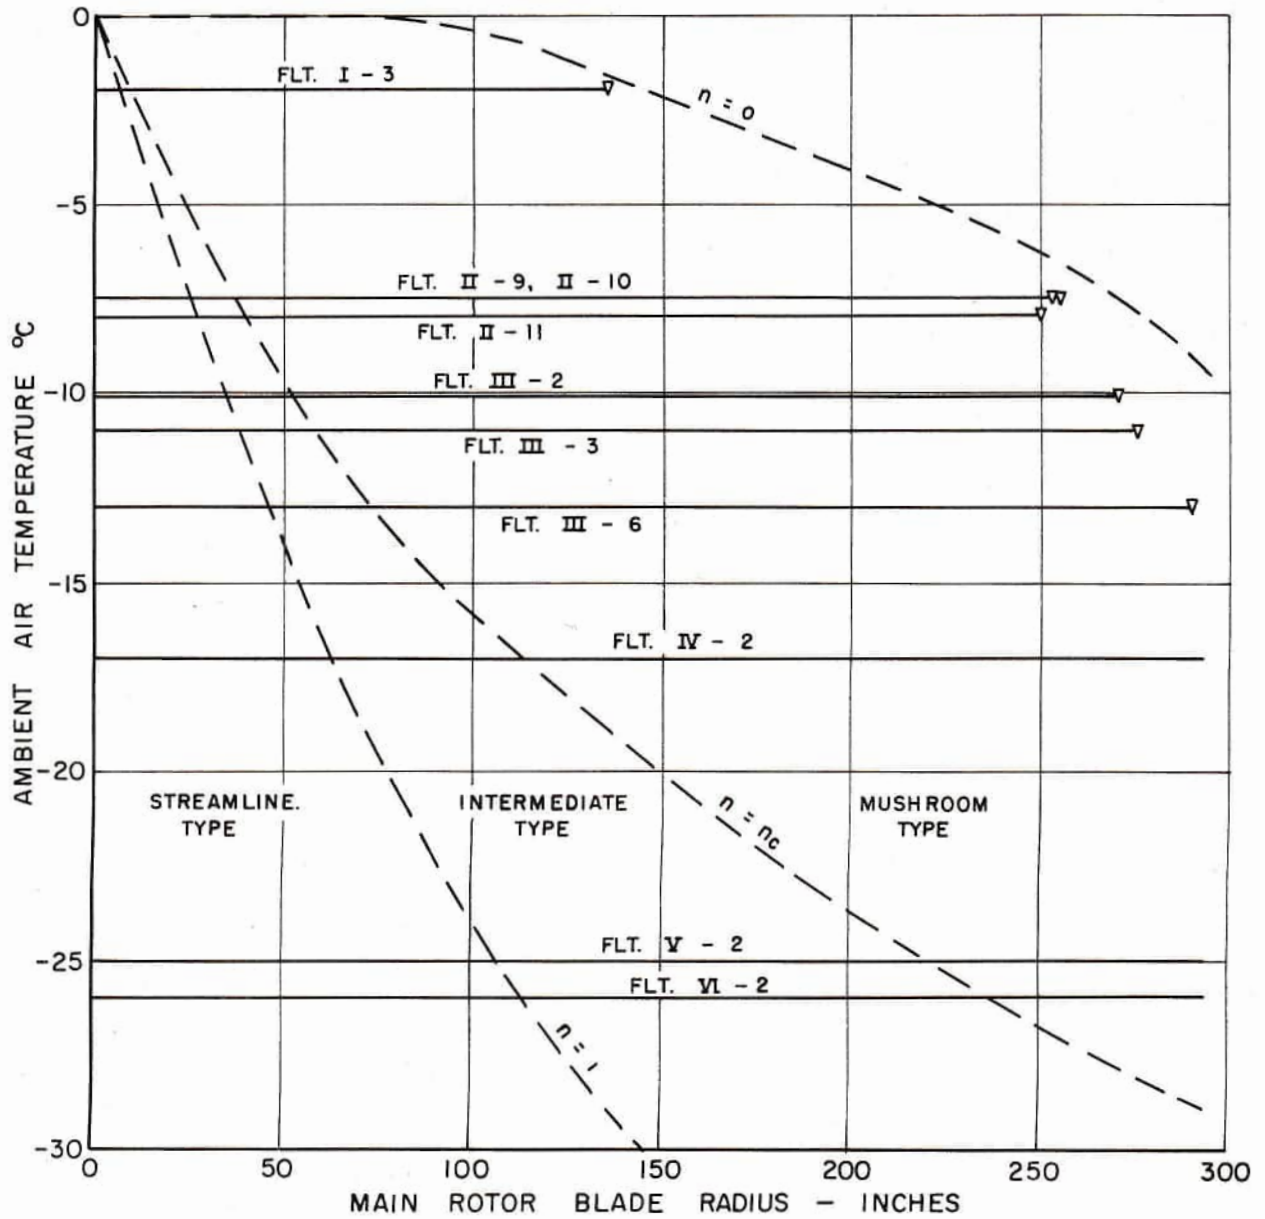
MAXIMUM SPANWISE EXTENT AT STAGNATION LINE
AND CALCULATED ICE ACCRETION CHARACTERISTICS
FOR L.W.C. = 0.7 GM./M.³

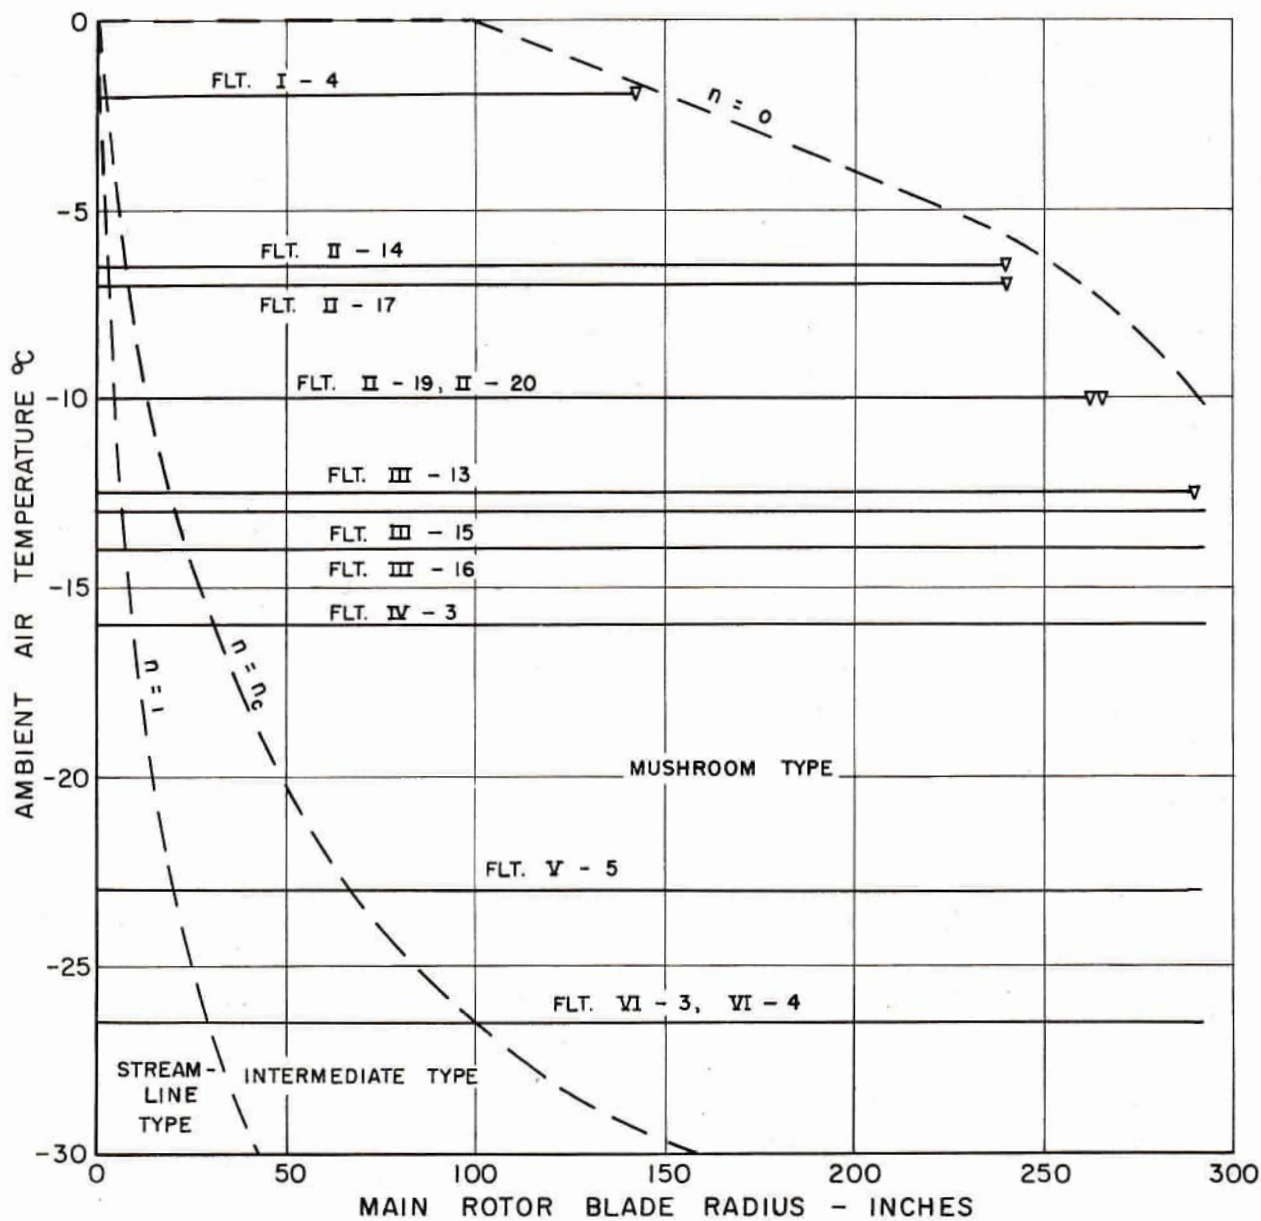
MAXIMUM SPANWISE EXTENT AT STAGNATION LINE
AND CALCULATED ICE ACCRETION CHARACTERISTICS
FOR L.W.C. = 1.5 GM./M.³

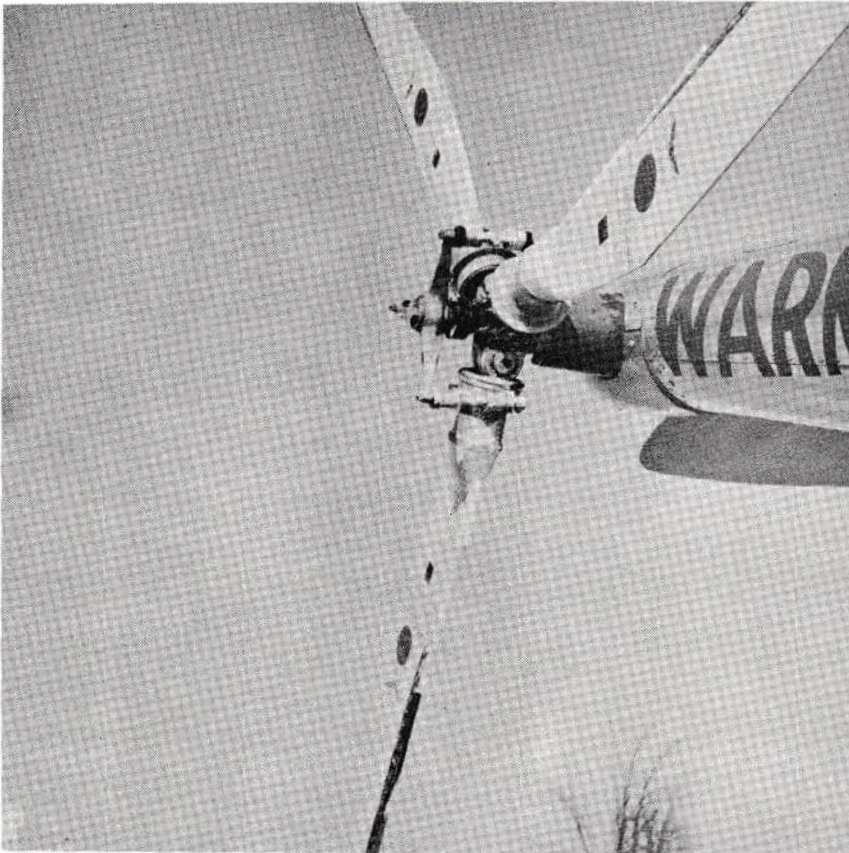
FIG. 28
LR-221

TYPICAL EXAMPLES OF TAIL ROTOR SELF-SHEDDING

Tail rotor icing occurred in a manner similar to that on the main rotor. The fact that it has a higher collection efficiency and centrifugal forces five times greater than the main rotor caused the tail rotor to shed more frequently. This shedding was often asymmetric and could result in severe airframe vibration. The unbalance does not appear to be fed back into the pilot's control. Examples of self-shedding are shown in Figure 28. The observed extent of self-shedding compared with the calculated values is shown in Figure 29.

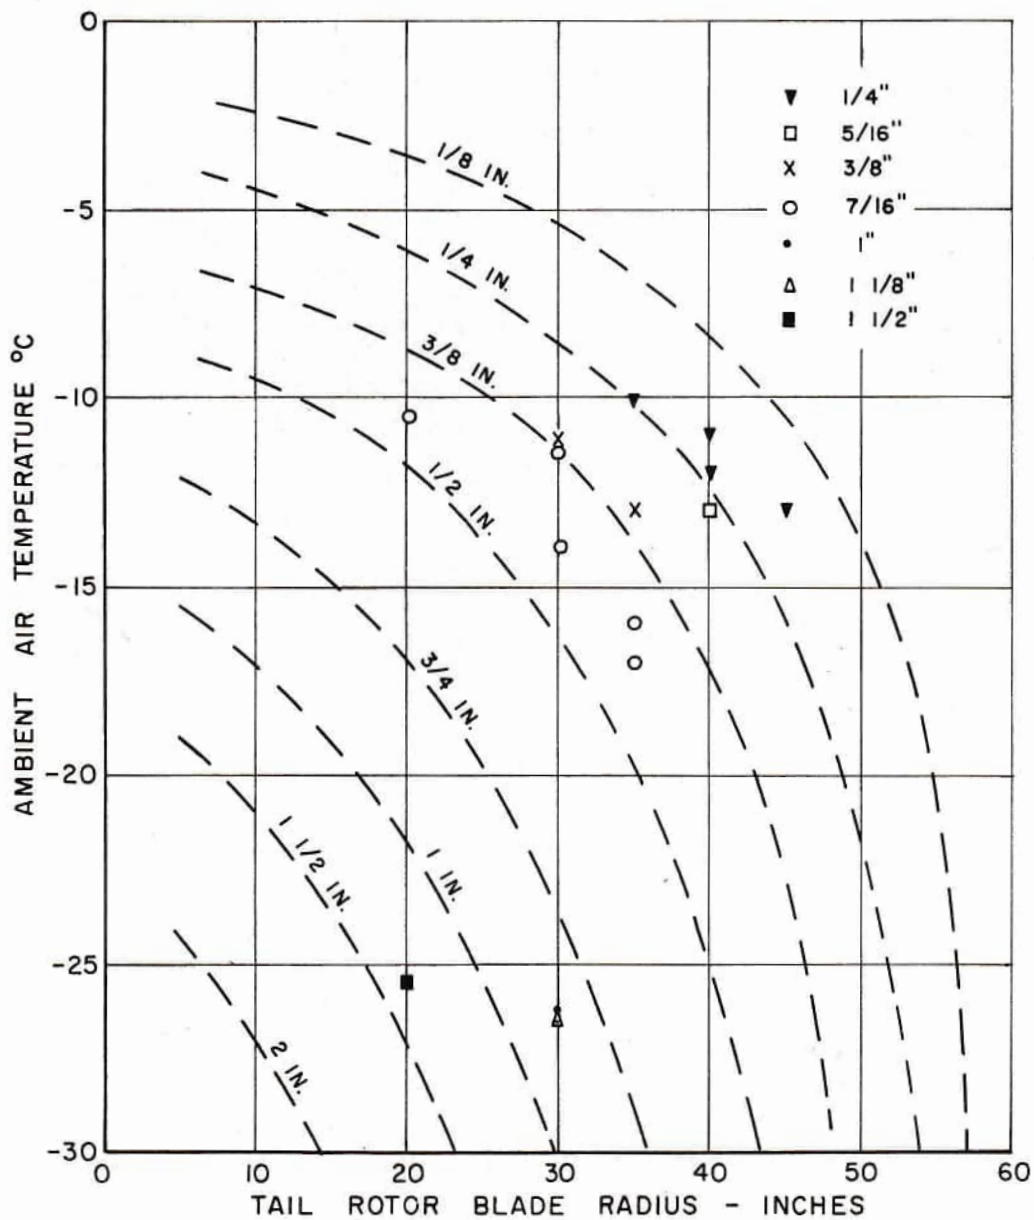
TAIL ROTOR SELF-SHEDDING
CALCULATED AND OBSERVED VALUES

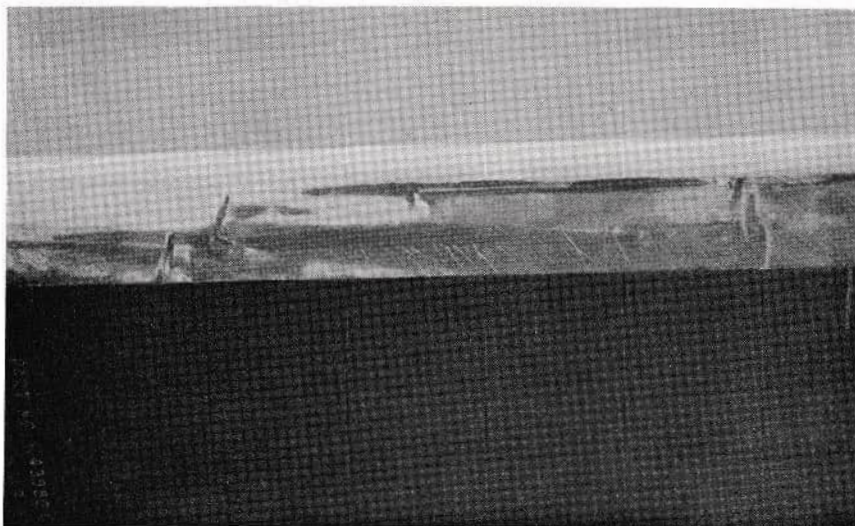
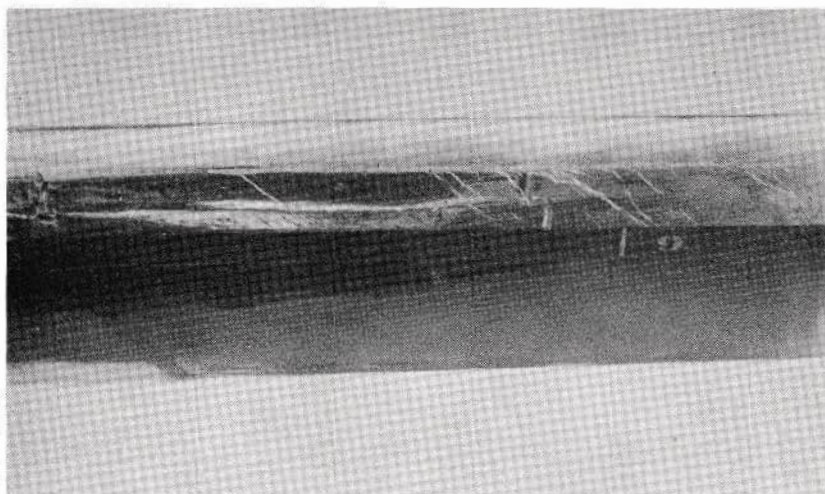
MELTING OF SECONDARY ACCRETION AND RESULTING RUN-BACK
AFTER FLIGHT DI-3. MAIN ACCRETION DID NOT SHED.

RUN-BACK NOTED AFTER FLIGHT DII-2

EXAMPLES OF RUN-BACK ICE

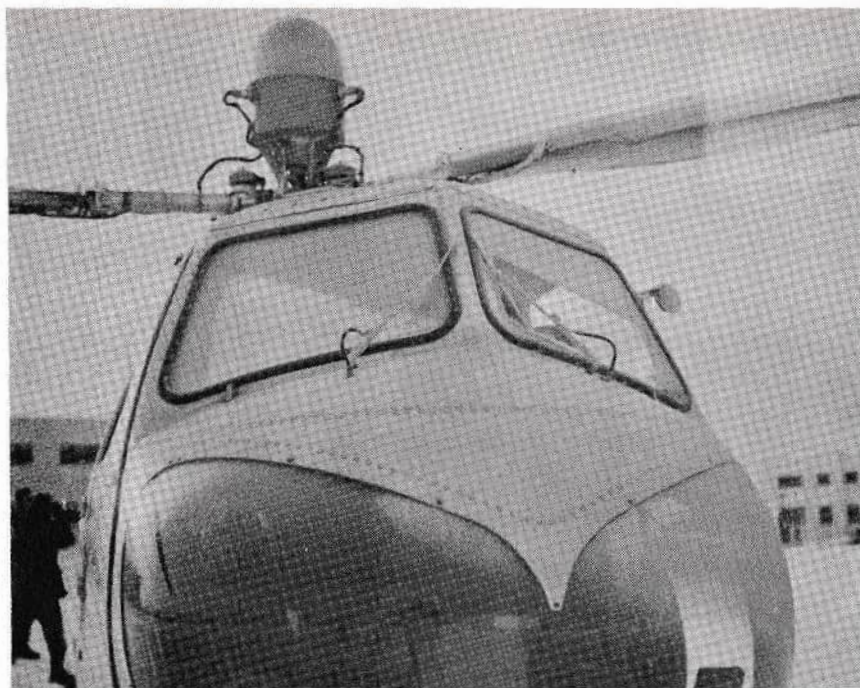
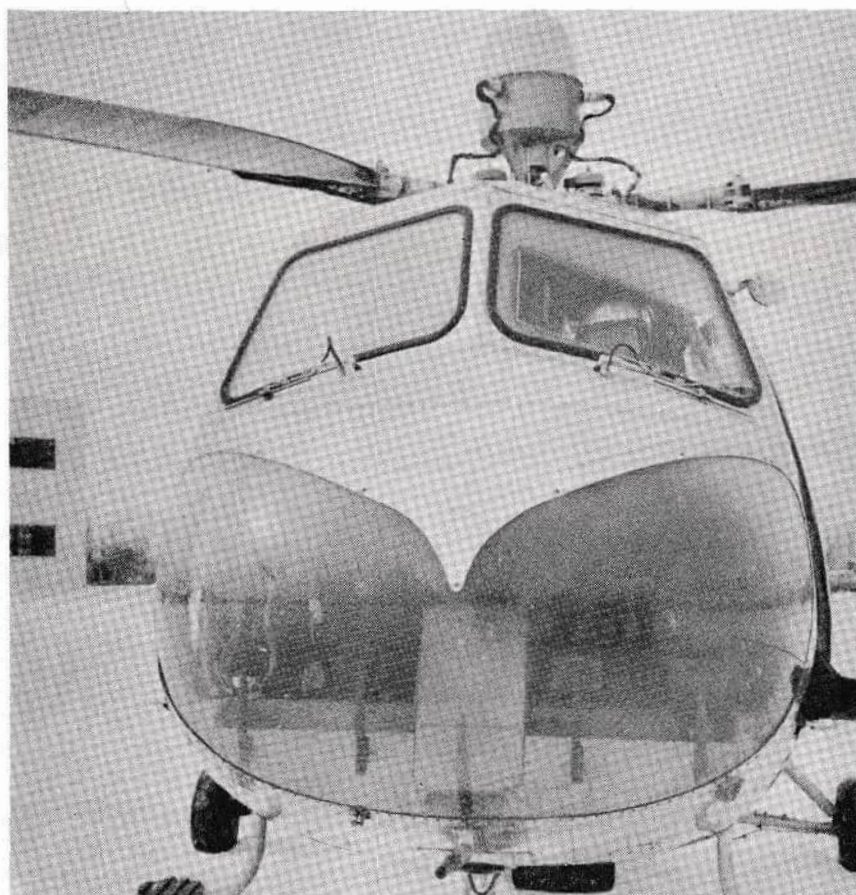
FREEZING RAIN ICE ACCRETION AT 15 M.P.H. T.A.S.
SHOWING HEATED WINDSCREEN AREA
WINDSCREEN THERMAL ANTI-ICING

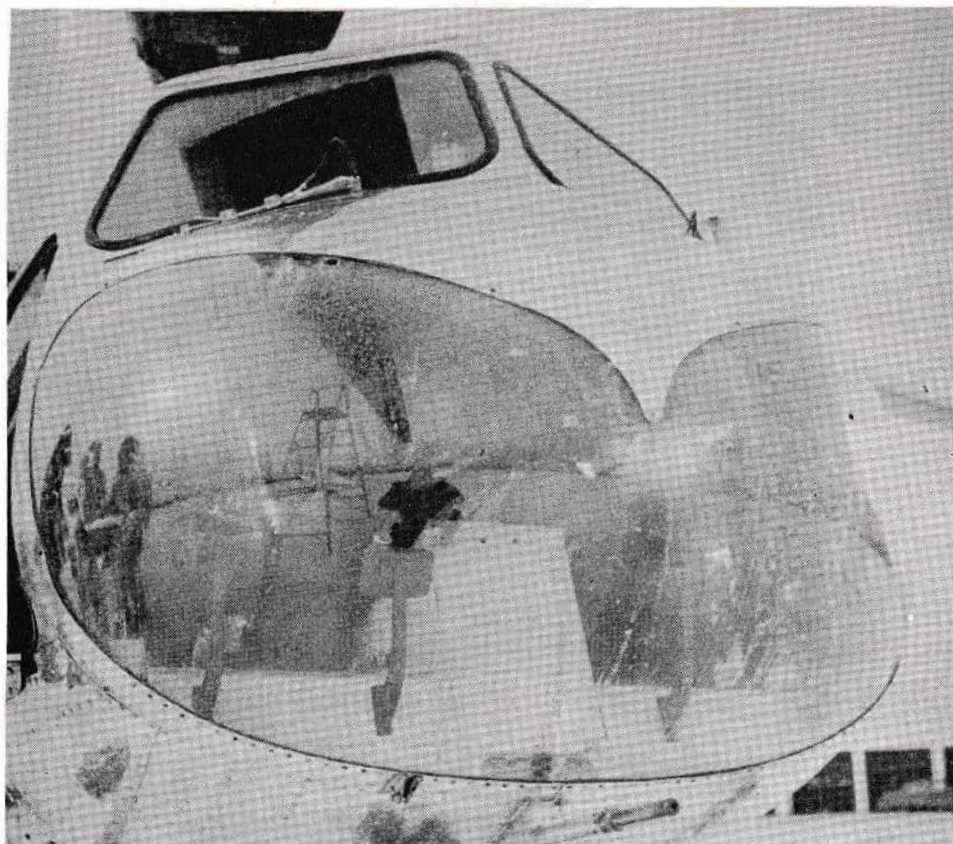
MUSHY ICE ON LOWER VISION PANELS

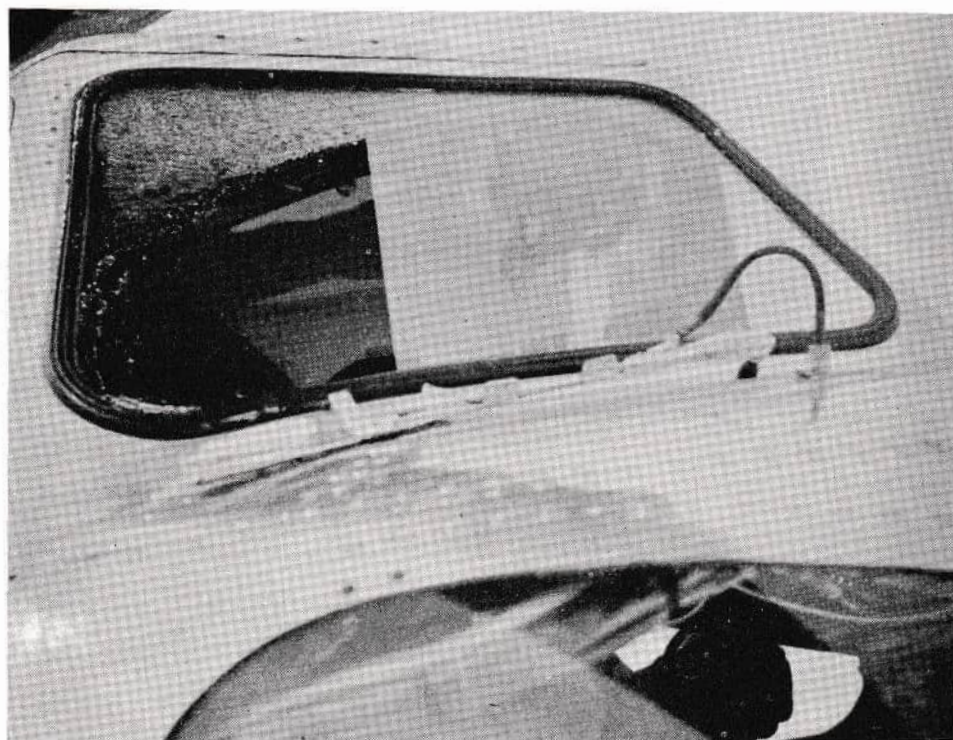
WINDSCREEN ANTI-ICING WITH ALCOHOL AND WIPER ACTION

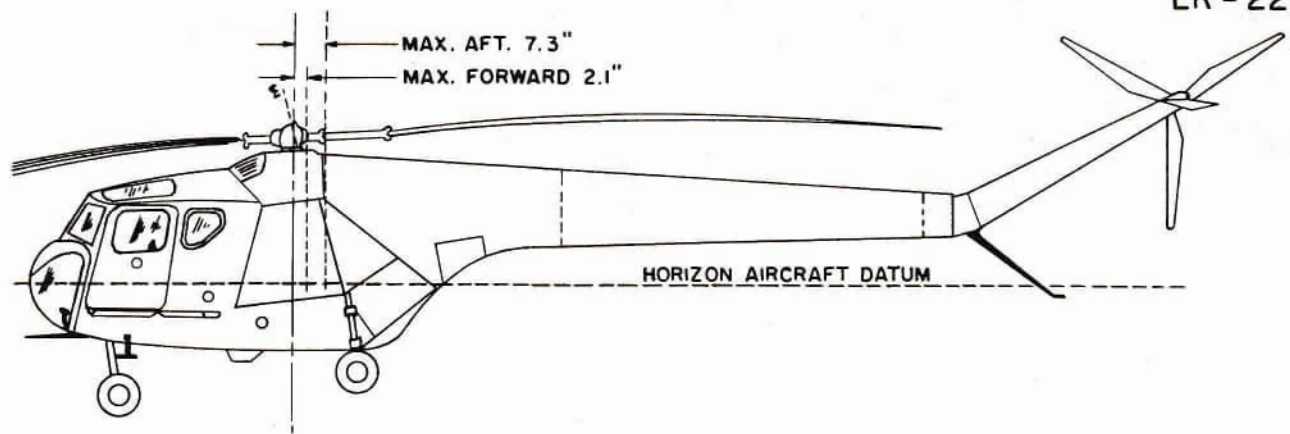
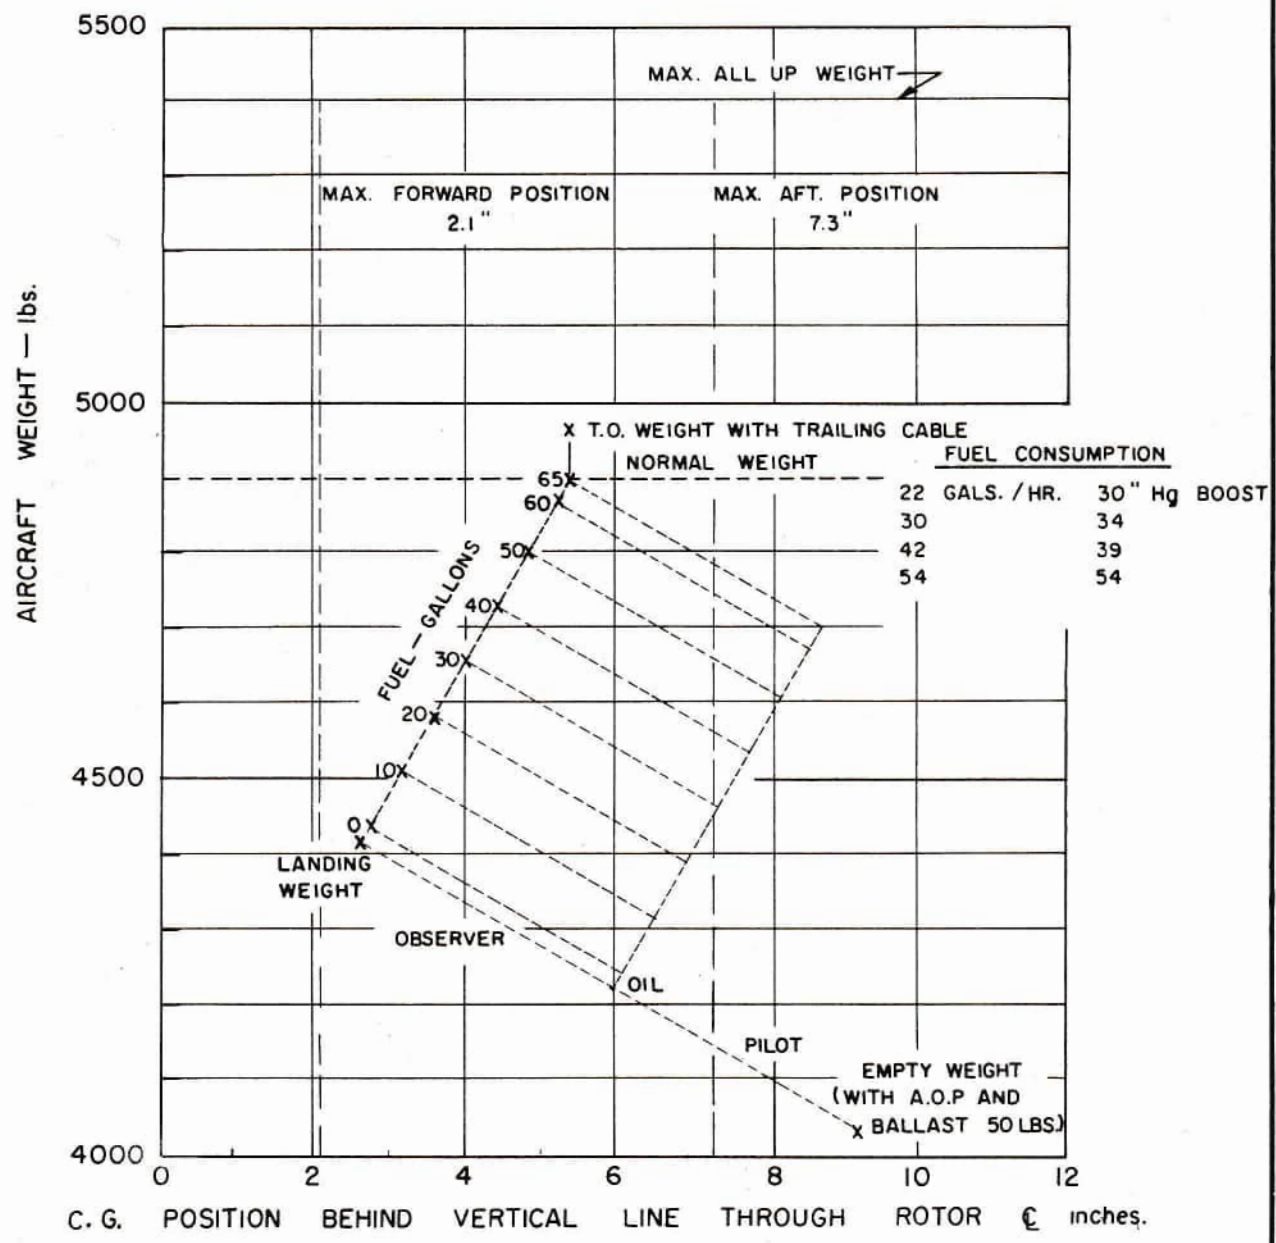
FIG. A1
LR-221

C. G. AND LOADING DIAGRAM
