Helicopter icing and de-icing flight trials on a bristol sycamore type 171, MK.3

LABORATORY REPORT LR-221

HELICOPTER ICING AND DE-ICING FLIGHT TRIALS
ON A BRISTOL SYCAMORE TYPE 171, MK. 3

A Sycamore helicopter fitted with an electro-thermal de-icing system was tested under different simulated conditions of icing severity over a wide range of temperatures. The effect of icing on handling and performance was assessed and power requirement for clean shedding was determined.

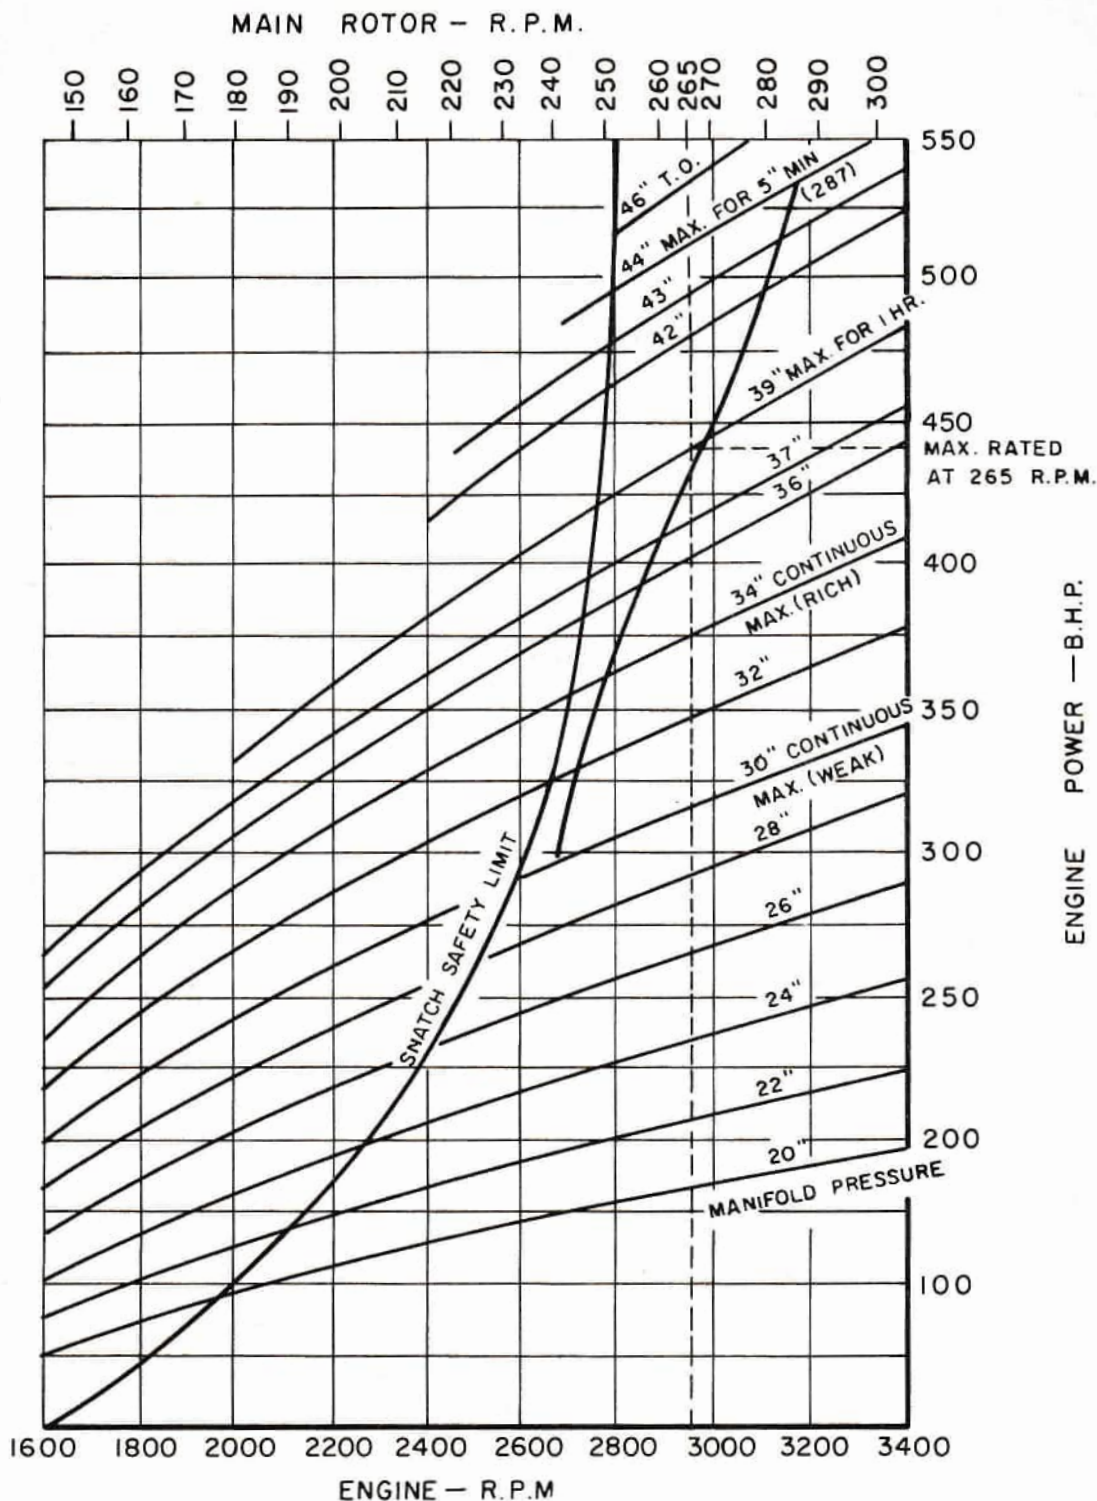
ALVIS LEONIDES 173.02 ENGINE PERFORMANCE
CHART AT SEA LEVEL

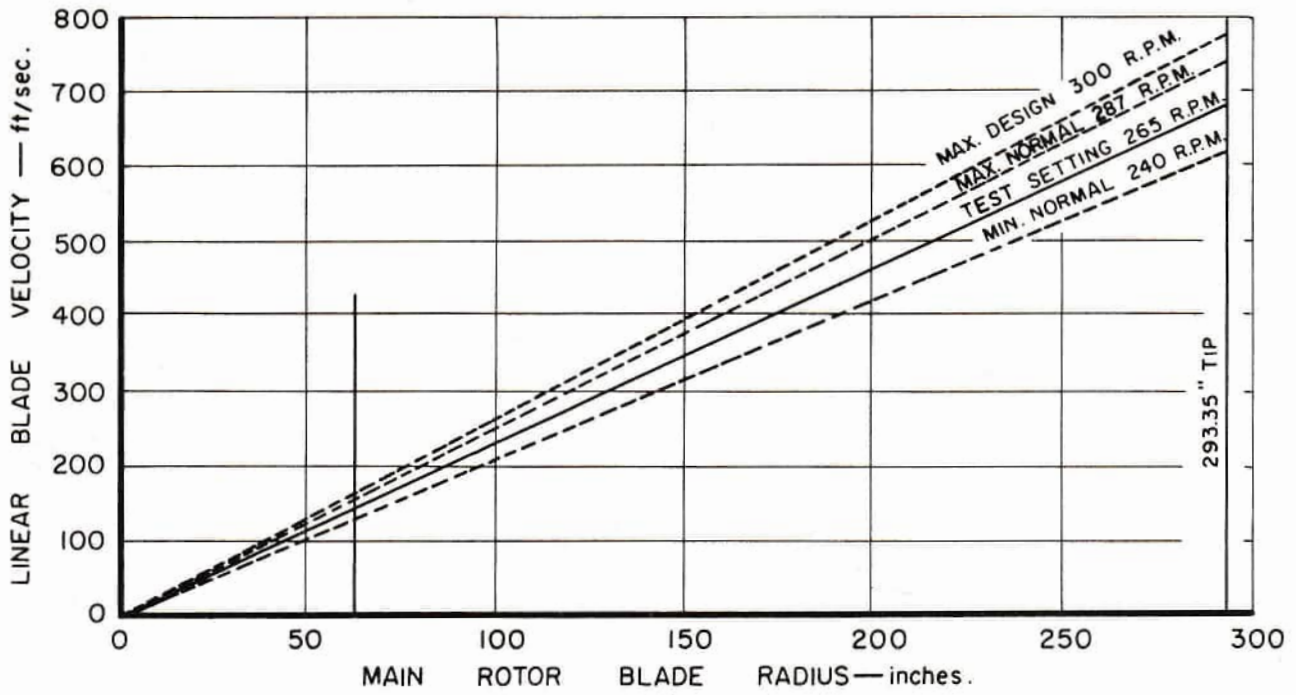
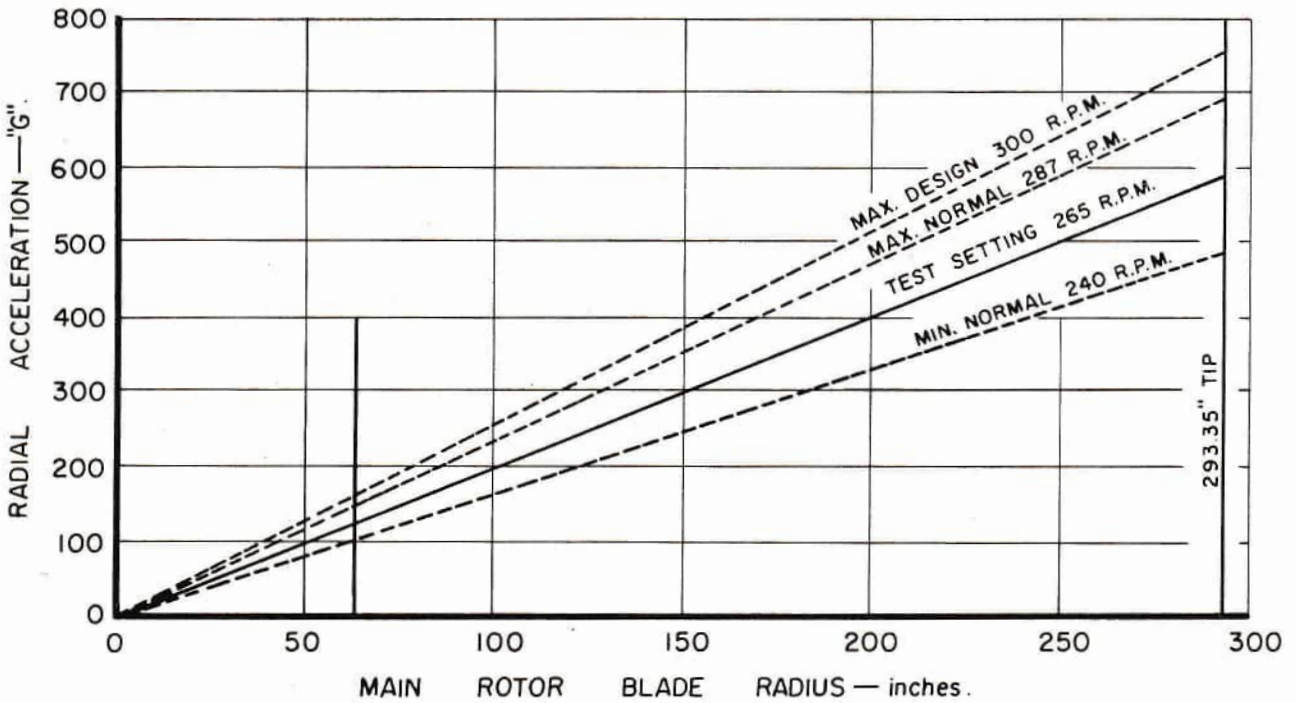
VARIATION OF LINEAR BLADE VELOCITY AND RADIAL ACCELERATION ALONG THE BLADE RADIUS OF THE MAIN ROTOR AT VARIOUS R.P.M.

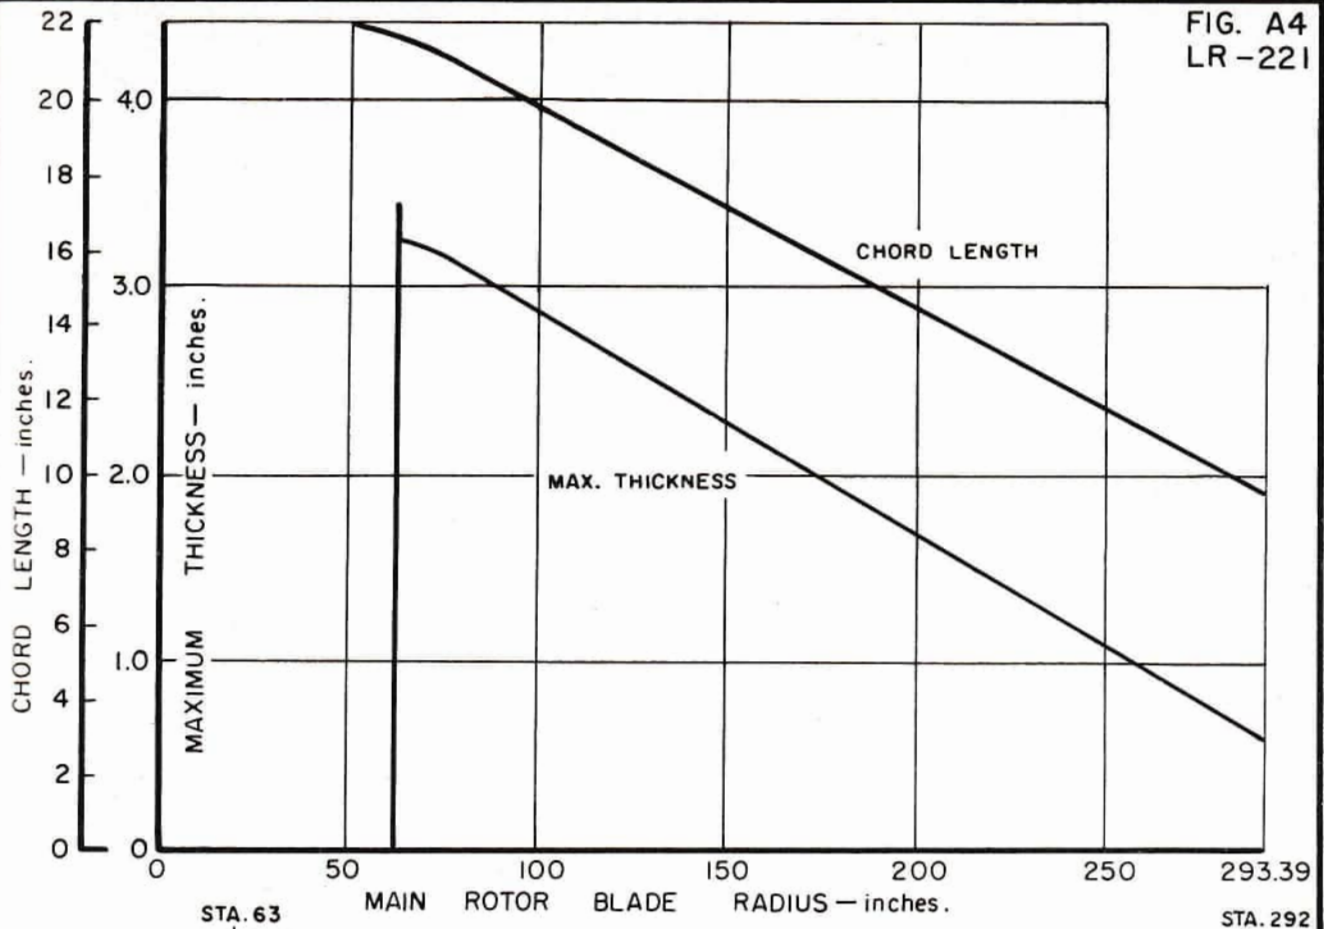
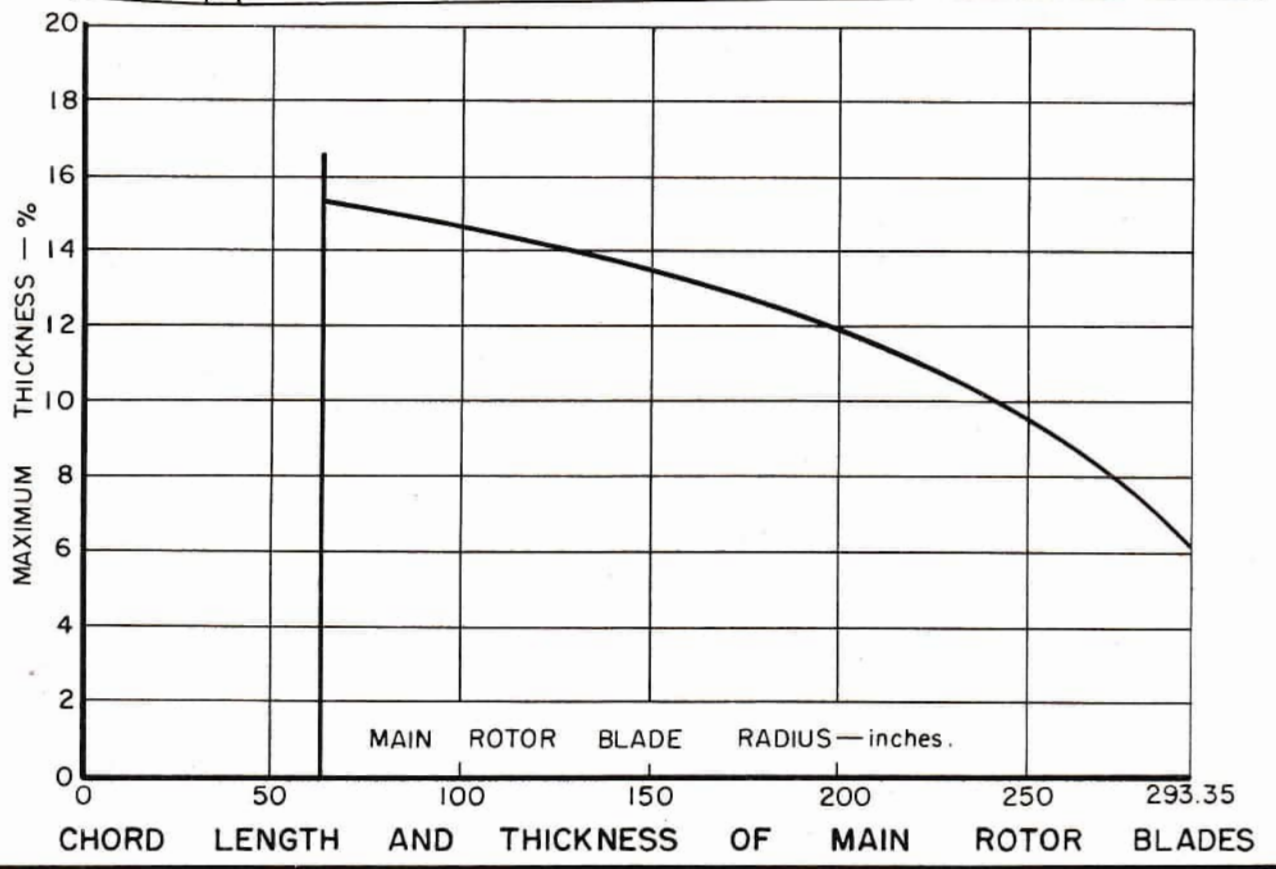
FIG. A4
LR-221

CHORD LENGTH AND THICKNESS OF MAIN ROTOR BLADES

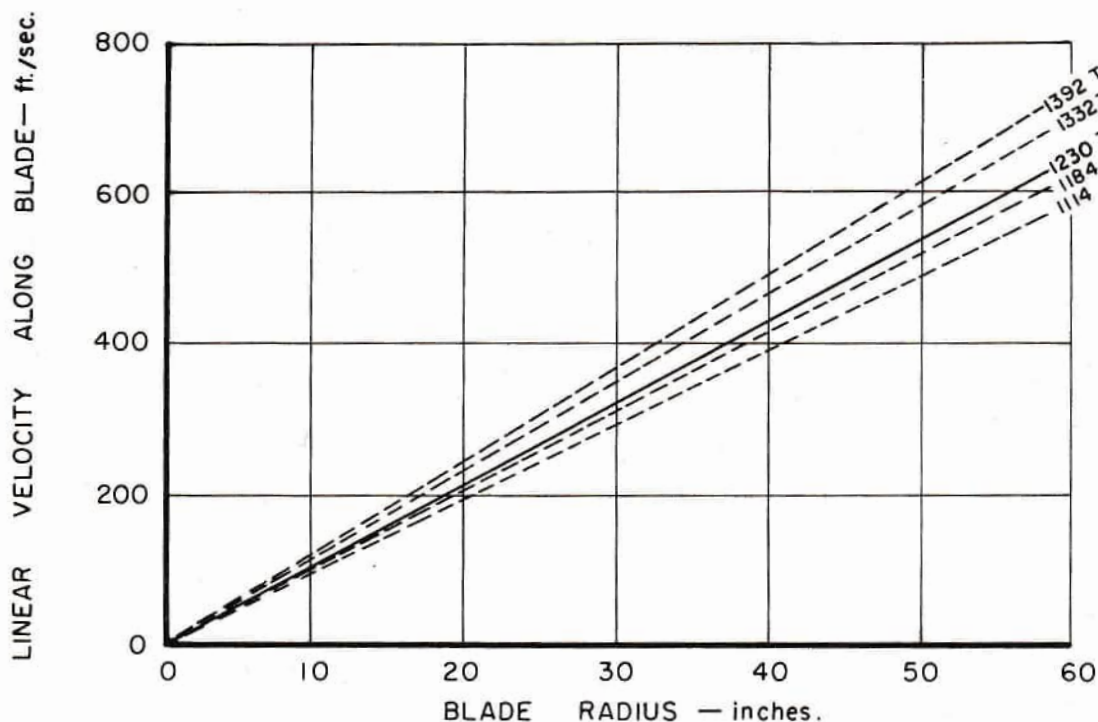
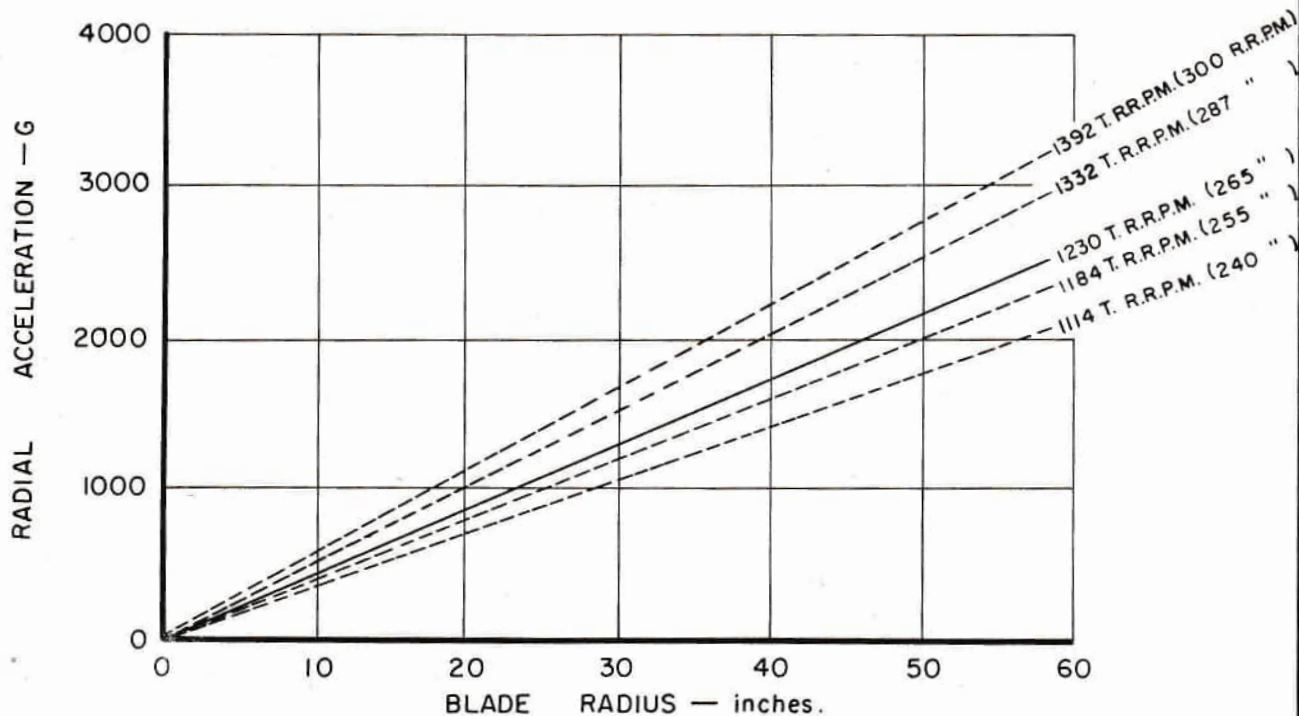
VARIATION OF LINEAR VELOCITY AND RADIAL ACCELERATION ALONG THE TAIL ROTOR BLADE AT VARIOUS R.P.M.

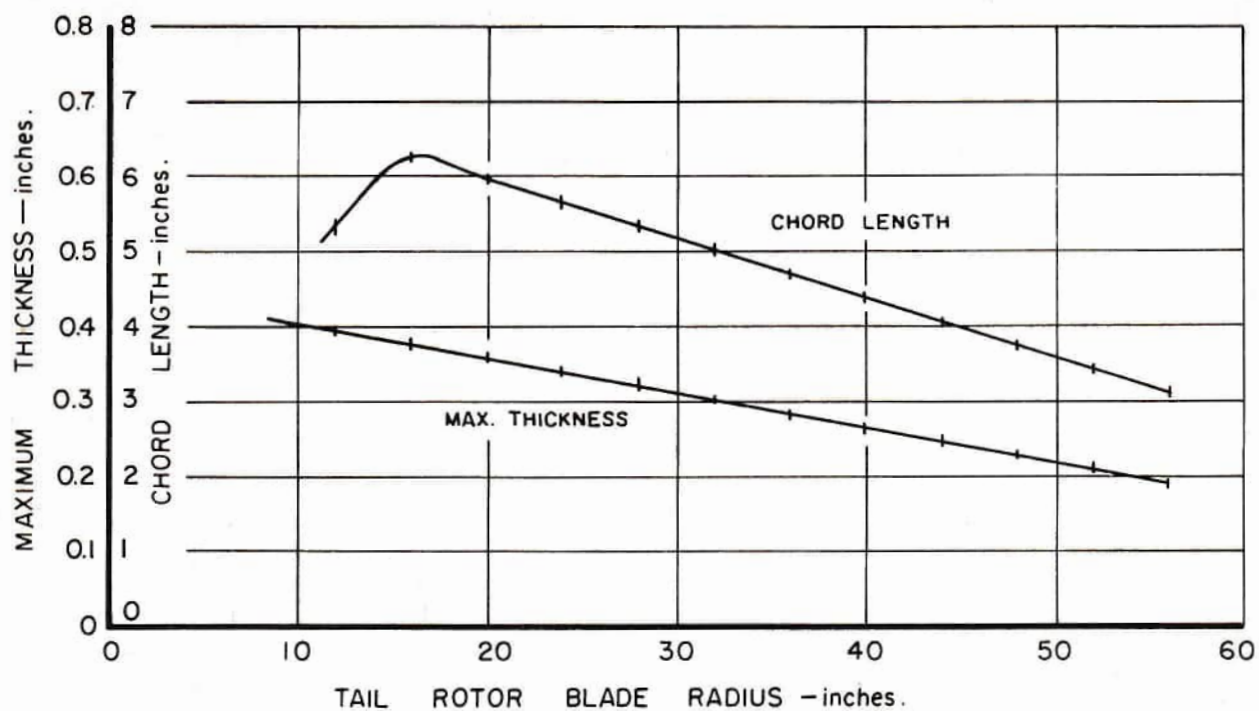
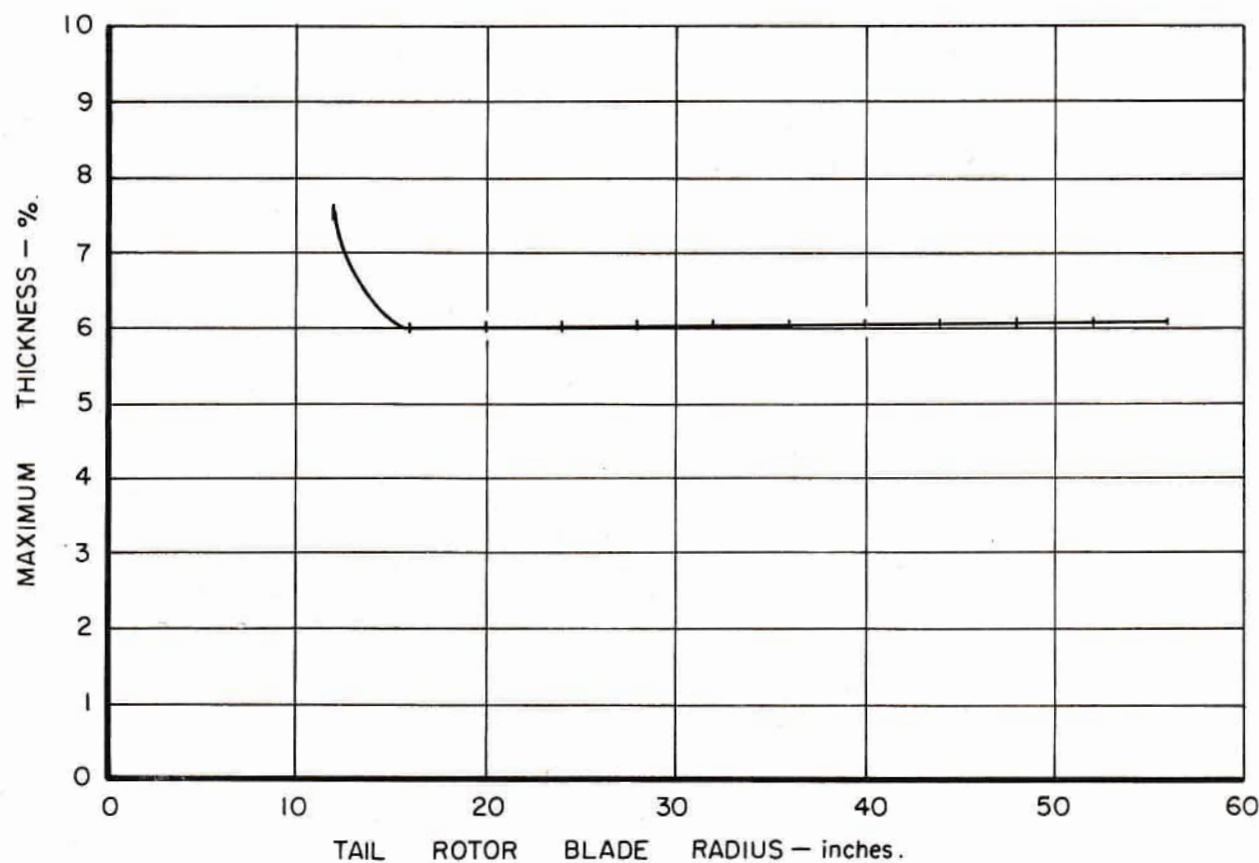
CHORD LENGTH AND THICKNESS OF TAIL ROTOR BLADE

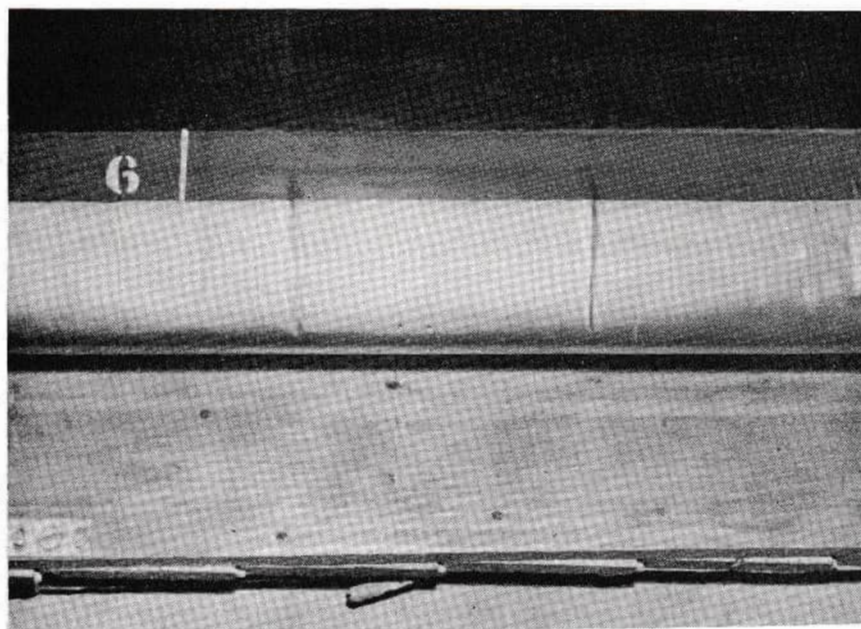
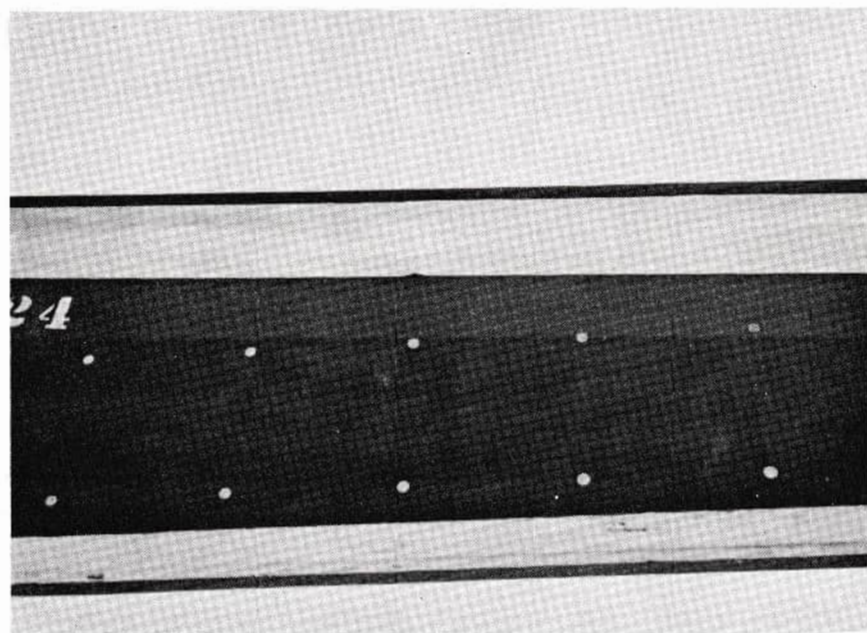
(a) CREASES WHICH DEVELOPED IN STAINLESS STEEL COVER

(b) CRACKING AND LIFTING OF STAINLESS STEEL COVER
DUE TO BLADE FLEXING

DE-ICER PAD DETERIORATION

The de-icer pads had a low fatigue life due to the flexibility of the main rotor blades. Flexing caused creasing of the erosion shield and cracking of the nichrome heater elements.

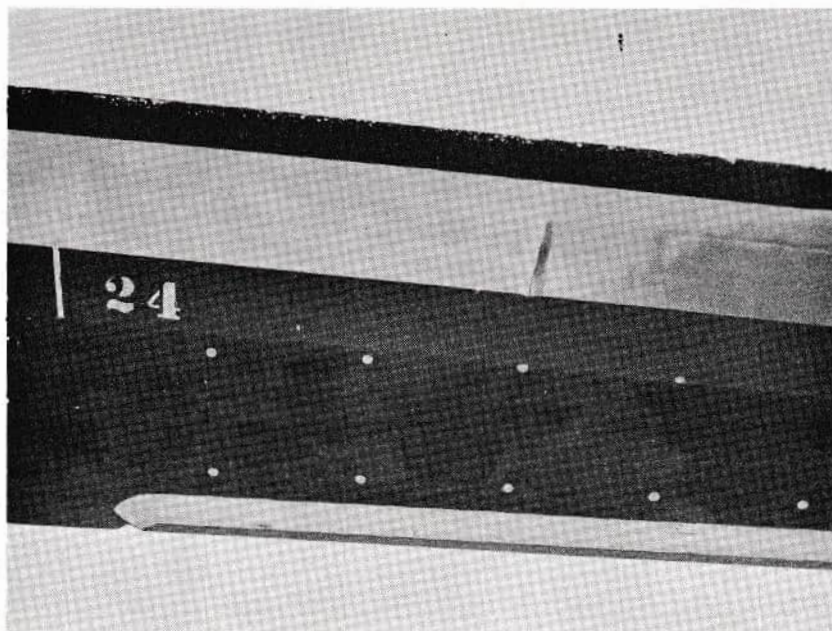
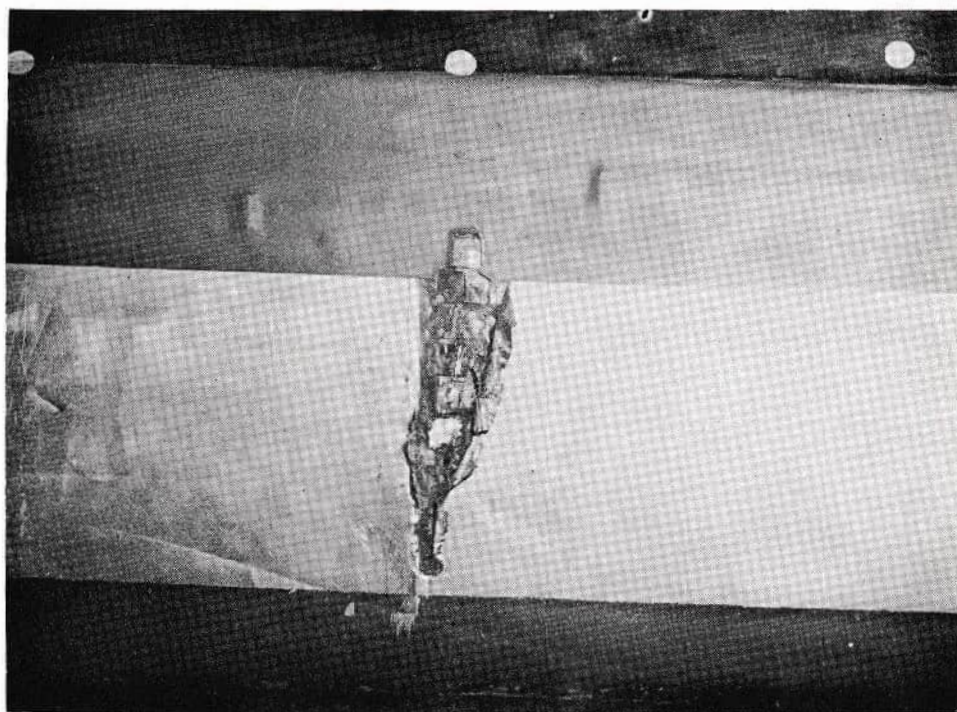
(a) SHOWING HOW CRACKS DEVELOPED ALONG CREASES

(b) CRACKS IN NICHROME HEATER ELEMENT

DE-ICER PAD FAILURE

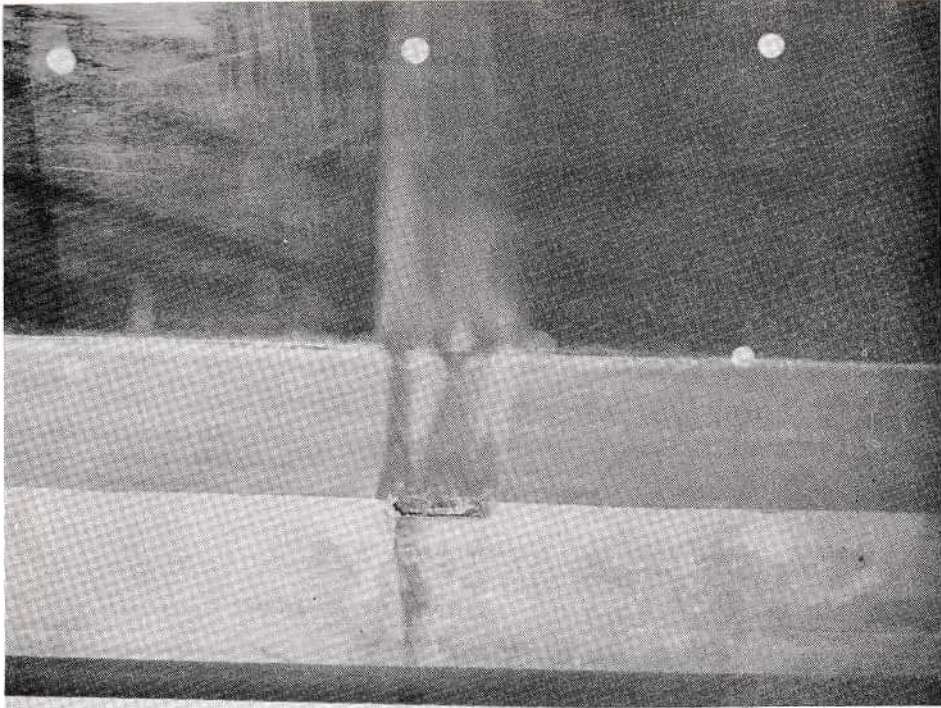
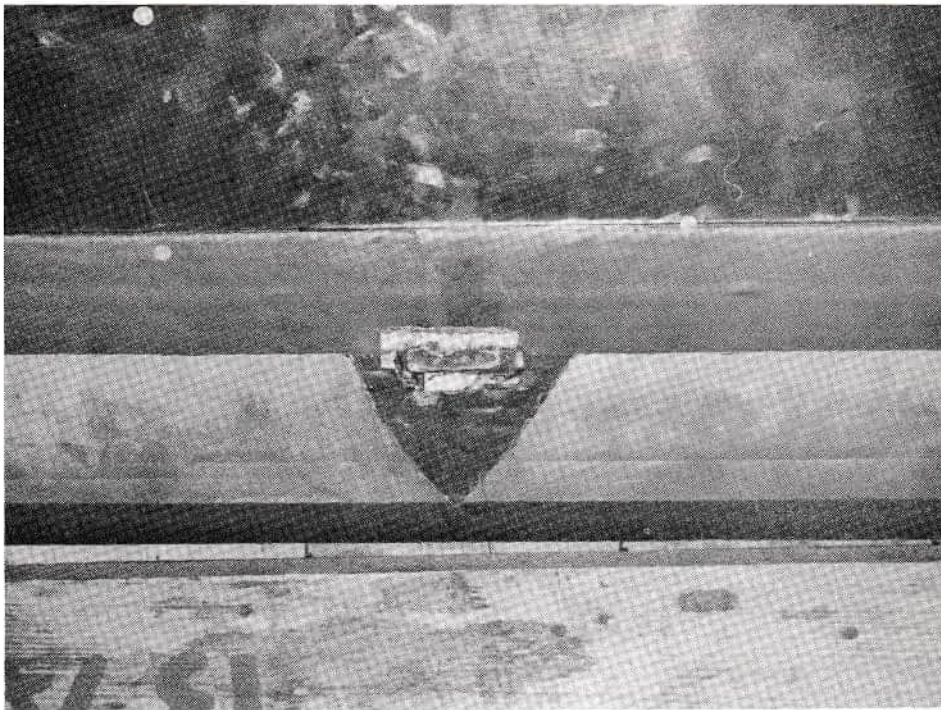
DAMAGE TO WOODEN BLADE DUE TO SHORT CIRCUIT

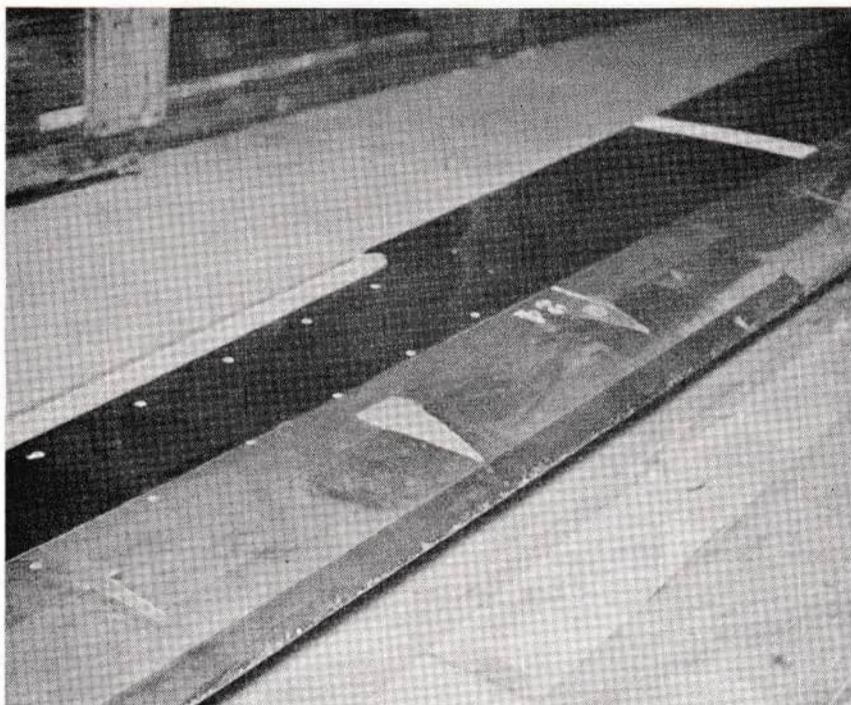
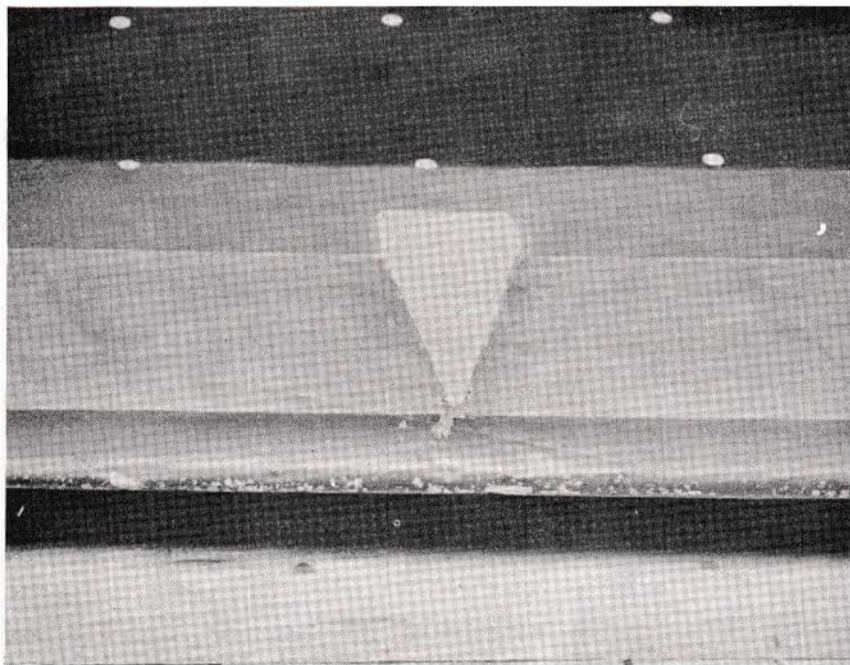
(a) REPAIR SCHEME FOR REMOVAL OF CREASES

(b) REPAIR OF A BROKEN HEATER ELEMENT

(NOTE IMPACT DAMAGE DUE TO ICE THROWN FROM TAIL
ROTOR INTO PATH OF MAIN ROTOR)

REPAIRS TO MAIN ROTOR DE-ICER PAD

Some form of tail rotor protection is essential, not only to limit vibration but also because the accretions which self-shed are thrown into the path of the main rotor, causing damage to the main rotor de-icer pads in the tip region (see Fig. C4(b), Appendix C).

To prevent further cracks from developing in the outer shield a repair scheme was tried in which the metal around a crease was removed and a neoprene patch cemented over the area (Fig. C4(a)). This was not successful as further cracks developed. Removal of the metal erosion shield also caused local delamination between the insulation and the element.

In the case of a broken heater strip the insulation was removed locally and a nichrome strip spot-welded over the gap. A neoprene patch was then cemented over the repair. Figure C4(b) shows such a repair. This repair failed after a further 12 hours flying.
