### **Rolling contact fatigue: a comprehensive review**

Magel, Eric E.

U.S. Department of  
Transportation  
**Federal Railroad  
Administration**

## Rolling Contact Fatigue: A Comprehensive Review

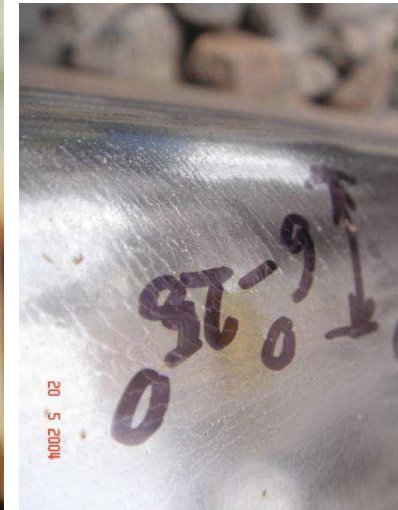
A) Moderate checking at the gauge corner of the rail.

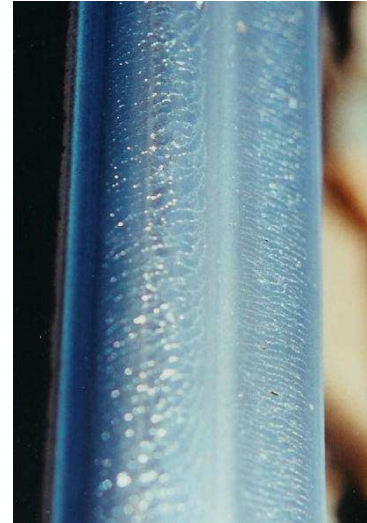
B) Crack orientation changes due to different creep directions of leading and trailing axles.

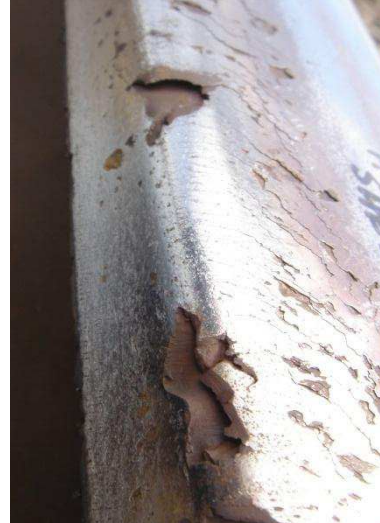
C) High rail shelling.

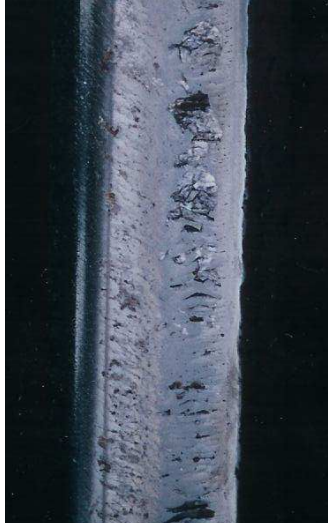
D) Alternating wet/dry conditions→shallow shelling.

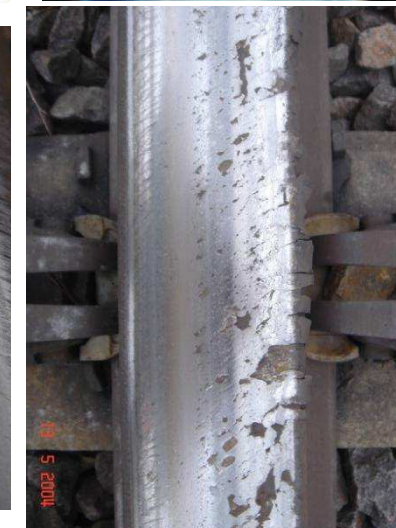
E) Moderate checking across the low rail surface.

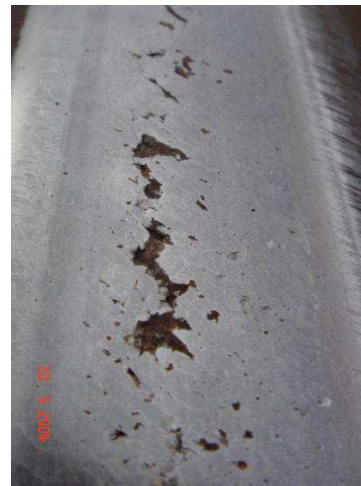
F) Field side cracking eventually deteriorates into plastic flow and shelling.

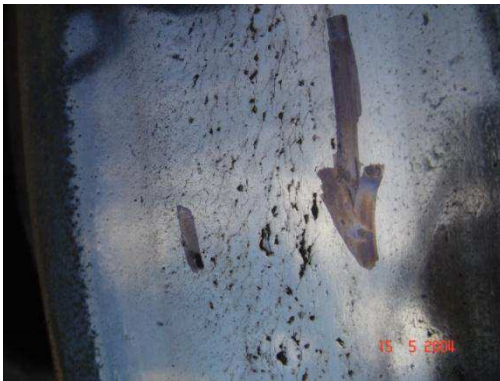
C) Well-defined cracks on the field/rim side of the wheel.

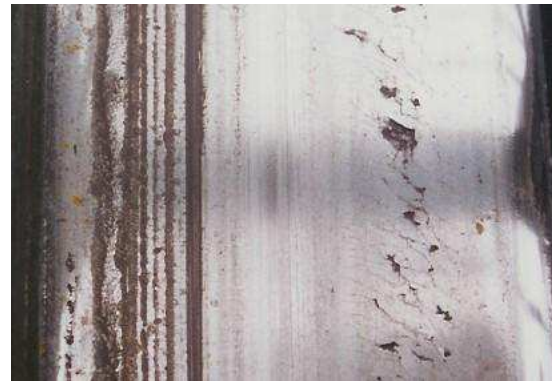
D) Deeper cracks on the field/rim side of the wheel tread with material starting to shell out.

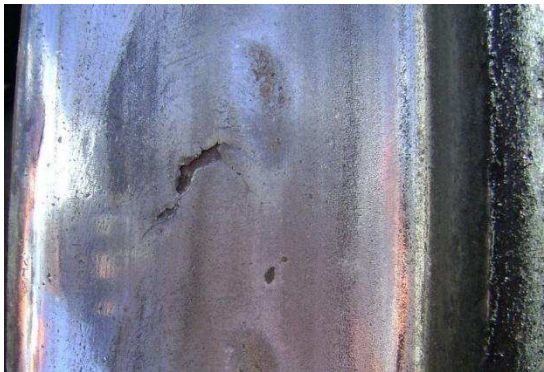
E) Incipient shells initiating at the field/rim side of the wheel.

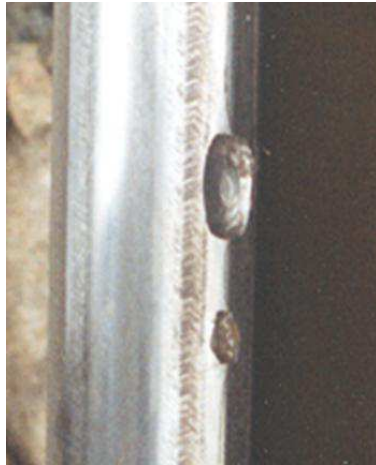
Poorly restrained high rails that rotate outwards under load (Figure 8A), well-lubricated rail with a particularly high-stress gauge corner shape (Figure 8B), and even some dry rails (Figure 8C) see large chunks of metal slough from the gauge corner. The most effective treatment for this is ensuring the implementation and maintenance of proper rail shapes that eliminate the overloading, reducing the stress for each contact and distributing contacts over a wider portion of the railhead. Modeling the system as a quarter space (see Section 2.1.2.1) found that in practice it is necessary to minimize the number of wheels that touch the railhead within three-eighths of 1 inch (9 mm) of the gage face to avoid gauge corner collapse.

A) Loss of rail cant due to rail seat abrasion resulted in overloading of the gauge corner

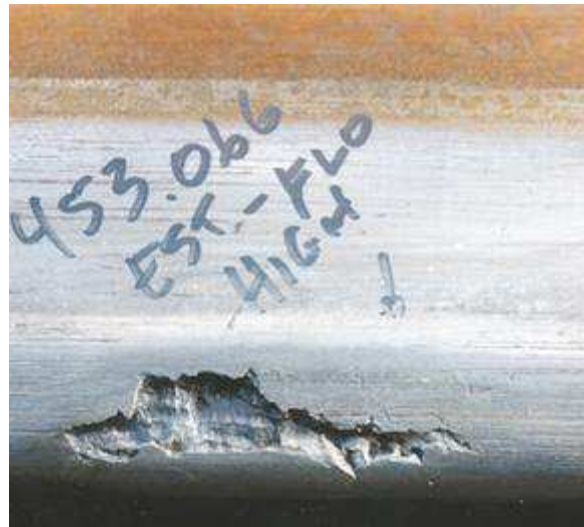
In any case, shells typically develop under the gauge corner of the high rail and most commonly on heavy haul railroads. However, they have also been found on tangent track with local crosslevel errors (see Section 4.5 for examples) and on light axle load transit systems with particularly poor wheel-rail profile matching (Figure 9).

**Figure 9. Gauge Corner Fatigue on a Light Rail System Because of Flattening of Rail (with a reciprocating stone grinder) and Overloading of the Rail Gauge Corner**

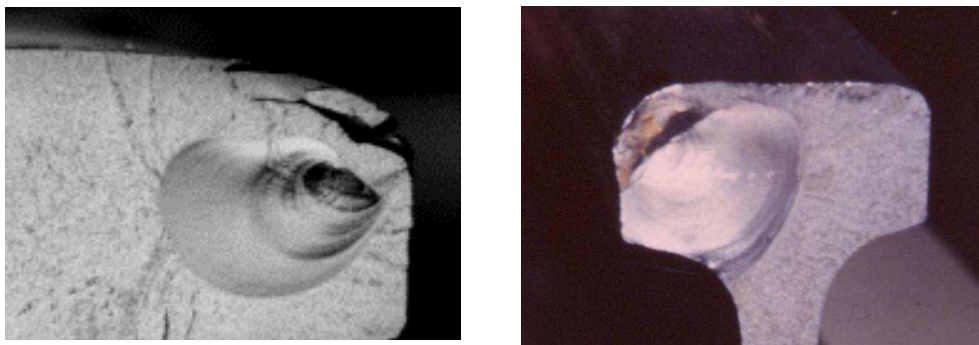
**Figure 10. Transverse Defects Initiated by Deep-Seated Shells, Probably from Gauge Corner Collapse**

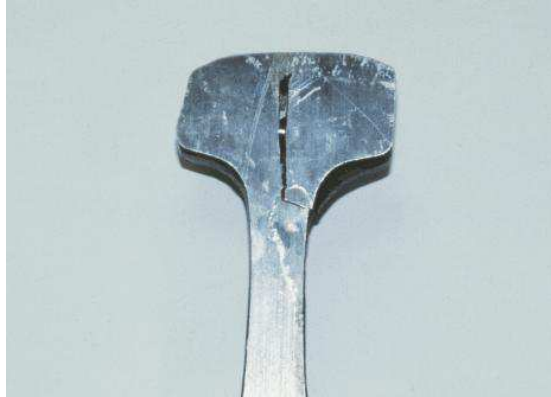
**Figure 11. Vertical Split Head Defect**

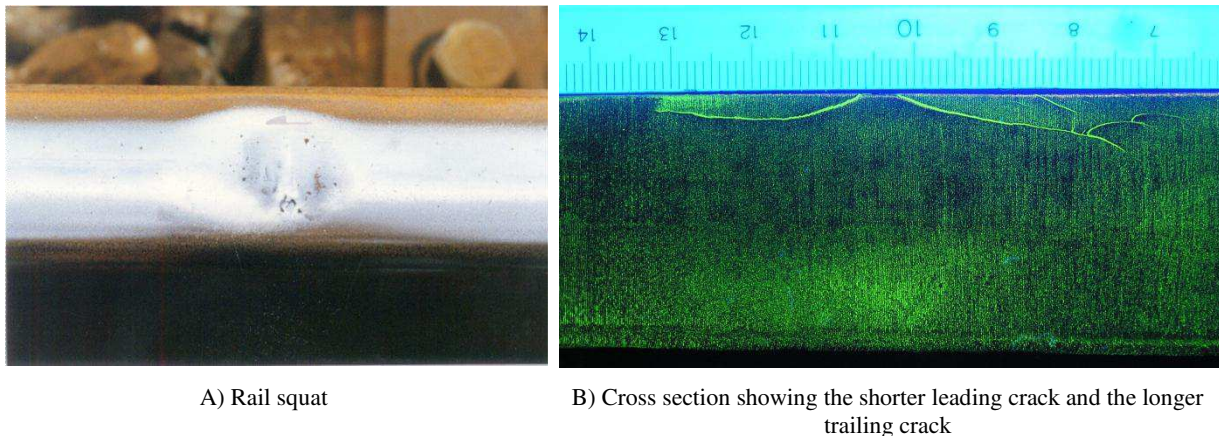
The squat is a surface defect most commonly associated with high-speed rail and areas of high tractive effort. It is characterized as a shallow depression more or less in the center of the rail head on tangent and mildly curved track. This depression is the result of subsurface cracking, reduced strength of the material, and deposits of debris in that depression, giving it the appearance of a dark spot.

**A) Rail squat**

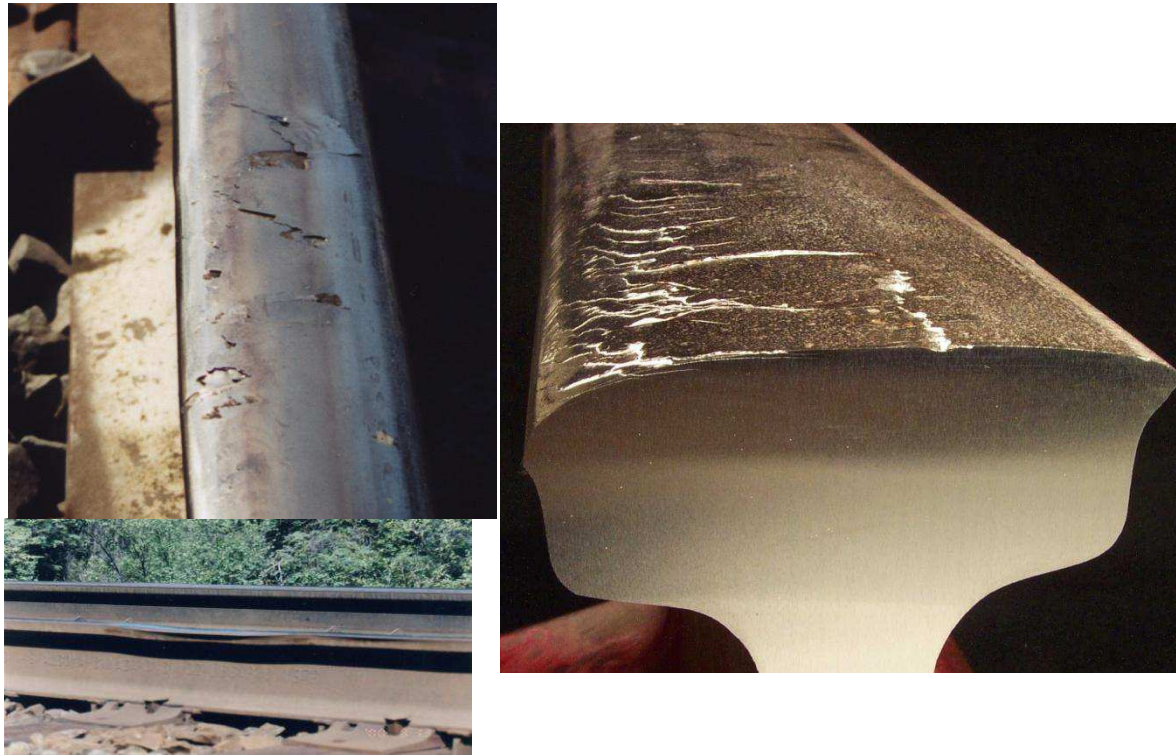
Crushed heads are typically about one-quarter to one-half meter in length. They are characterized by increased frequency and growth of large surface cracks and plastic flow to one or both sides of the running surface. The concentration of cracks is usually caused by a local stress raiser associated with improper rail grinding, lack of rail grinding, track irregularities, dirty steel, or some combination of all of these factors. Grinding can prolong the life of crushed-head-affected rail by either removing damaged material or moving the contact band away from the stress raiser [172]. Crushing is especially problematic on older rail, often having significant vertical wear, where the head may collapse entirely. The crushed head defect and its treatment are discussed in Reference 47.

**Figure 13. The Crushed Head Defect Is Associated with Collapse and Deformation of the Underside of the Rail Head as a Result of Cracks That Initiate at the Mid-Gauge and Propagate to the Center of the Rail**

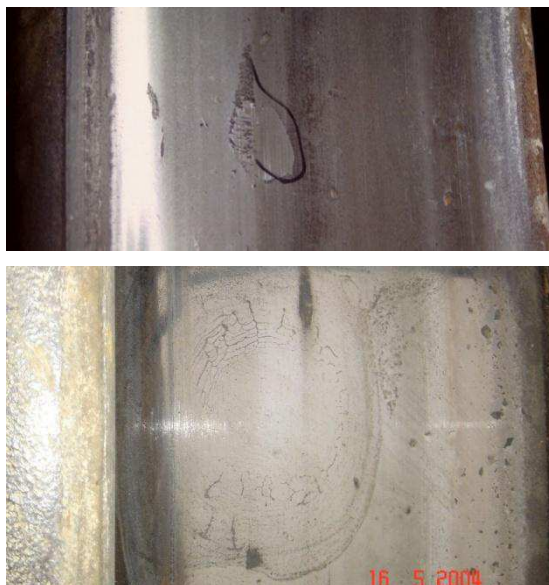
A light martensitic contact patch at a wheel slide location with cracking starting.

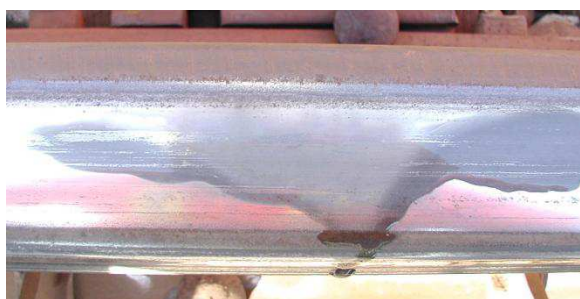
On the rail, a completely analogous effect arises because of the spinning of the wheel on the rail. High tractive effort can leave a more or less continuous thin layer of martensite on the surface of the rail, which has been postulated as the causal mechanism of rail squats (see Section 1.3.5). On a macroscopic scale, a wheel burn is a deep layer of martensite that, upon subsequent wheel passes, develops a whole network of surface cracks, any one of which might be the cause of a broken rail.

A) With a perchlorate etchant

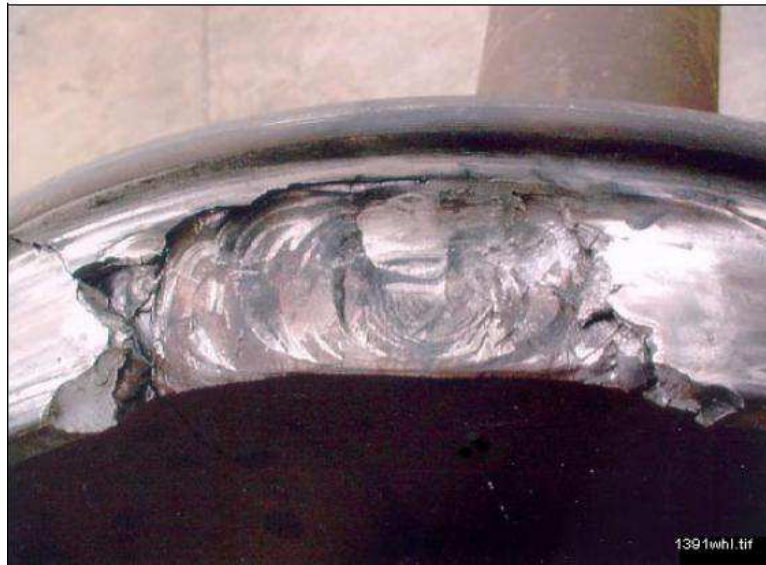
The shattered rim crack usually initiates approximately 12–20 mm below the running surface and then propagates roughly parallel with the wheel tread, eventually exiting out the rim side of the wheel. If a rim crack is discovered, then the wheel can be removed proactively; otherwise, a section of the wheel rim can separate from the wheel [262]. Many shattered rim failures develop early in wheel life—more than half fail within the first 10 percent of available rim thickness and more than 90 percent of the failures occur within the first 50 percent of the available wheel thickness.

**Figure 16. A Shattered Rim Failure [262]**

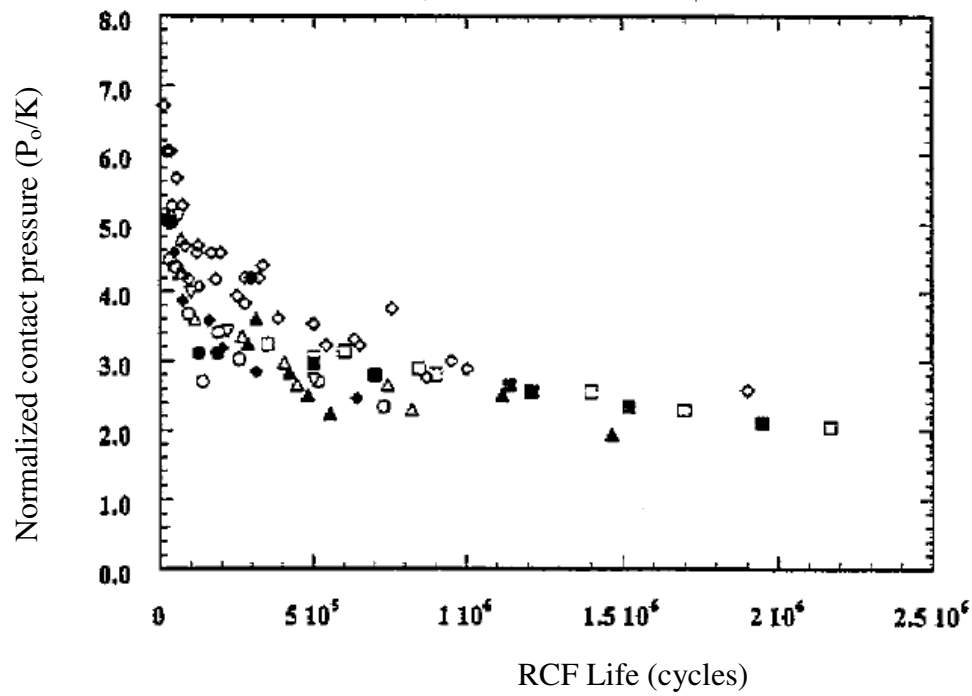
Figure 31. Effect of Contact Pressure on Nine Different Rail Steels [33] for a Creep Ratio of 10 Percent

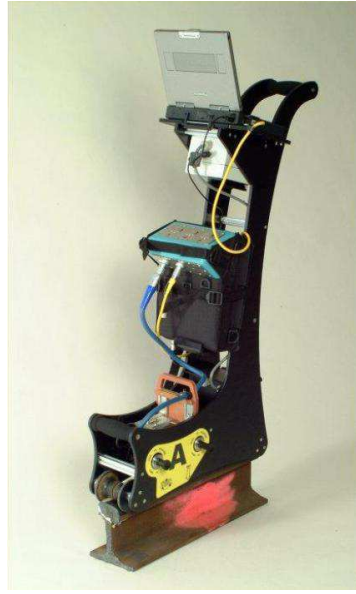
A) The TSC ACFM walking stick

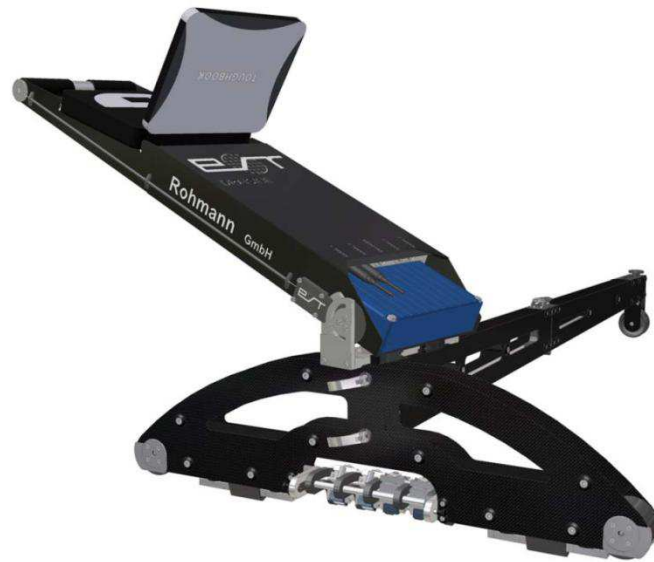
C) Rohmann Drasine trolley

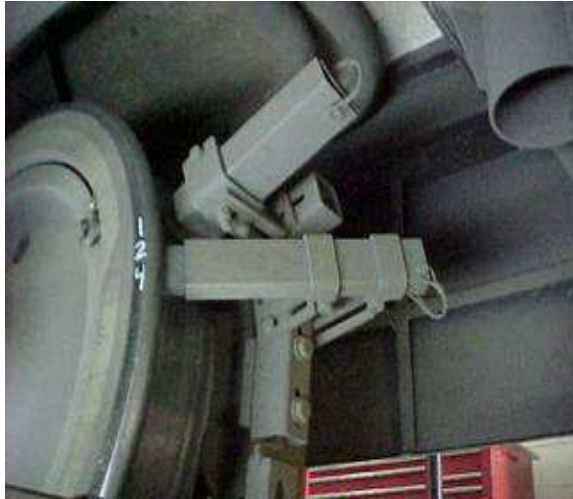
Friction modifier sticks apply products directly to the running surface of the wheel.
