**FIELD STUDY OF ICE CHARACTERISTICS OFF
THE WEST COAST OF NEWFOUNDLAND**

VOLUME 1 PUBLIC DATA

By
K. R. Croasdale & Associates Ltd.

PERD/CHC Report 2-70

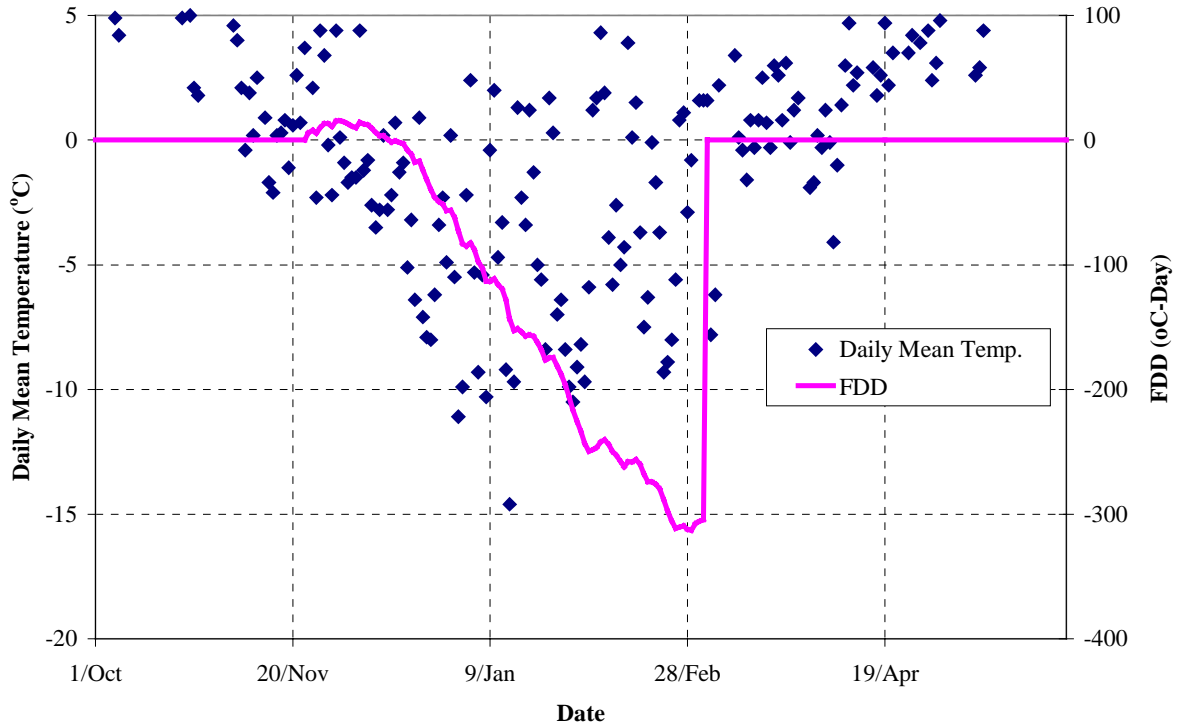
Figure 3-2: Freezing Degree Day Accumulation for Stephenville 1998-1999

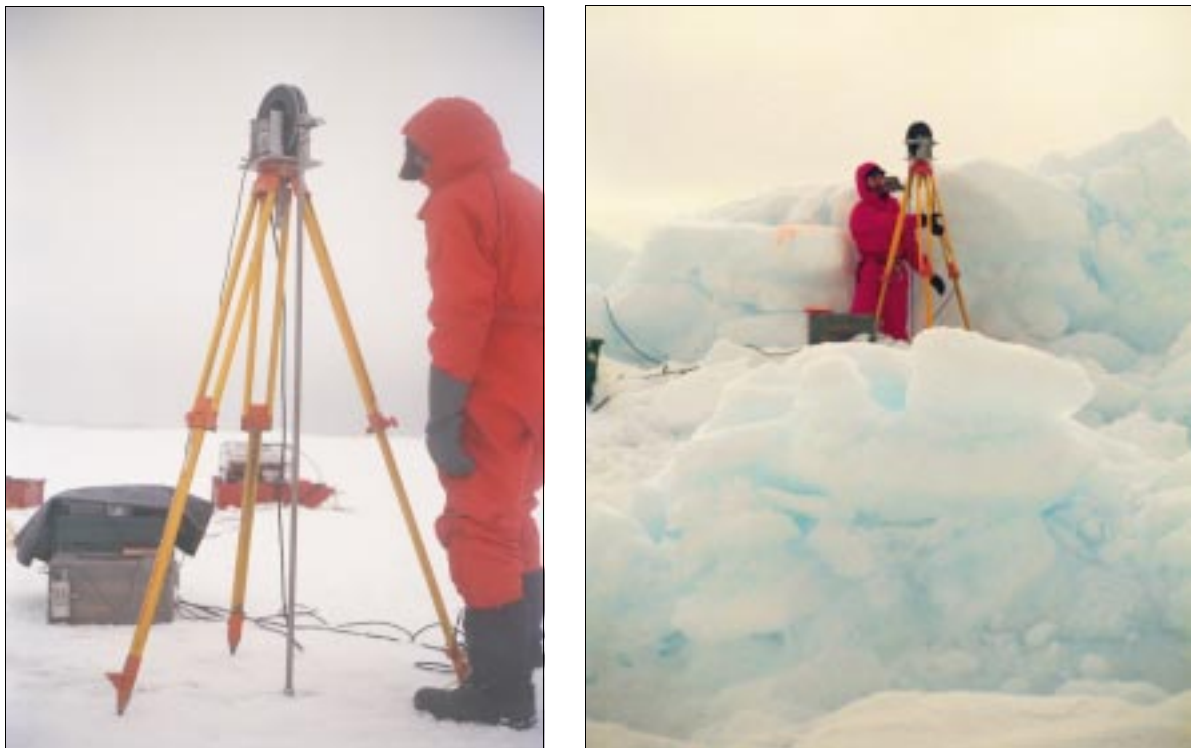
Figure 3-5: AARI Hot Point Drill

A picture of the AARI hot point drill in operation is shown in Figure 3-5 (note the data acquisition system and the generator in the background).

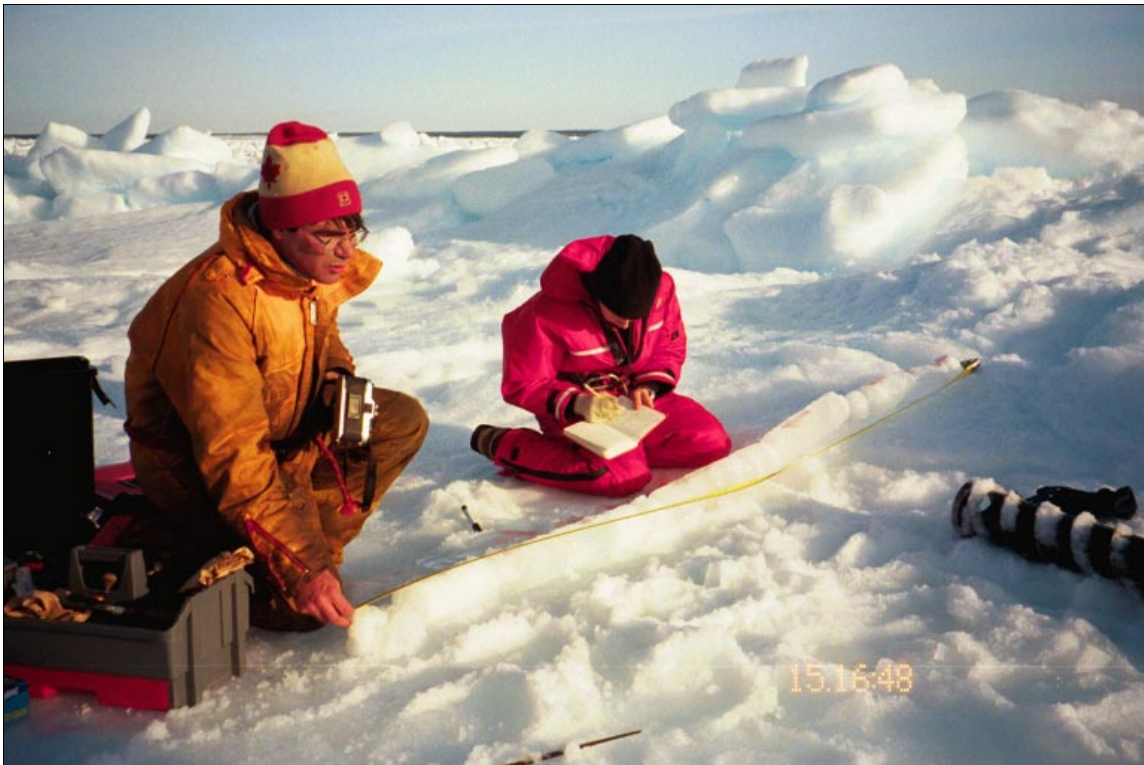
Ice coring was done using a 6 inch (15cm) CRREL core barrel, with a gas power head. With it, a 4 inch (10cm) diameter core can be obtained. Extensions are added when necessary. In general, as soon as a core was retrieved, its temperature was measured by introducing a temperature probe into a small hole freshly drilled into the core. Temperatures were measured every 10 or 20 cm. Sections of the core were cut at regular intervals and placed into sealed bags for salinity measurements. Even though care was taken to do this quickly, inevitably (given the warm temperatures) some brine drainage occurred before the sample was bagged. Figure 3-7 shows some photos of this activity. Usually, a second core was retrieved near the first and these samples were shipped back to Ottawa. Analysis of these cores is reported in Johnston (1999). A third core was retrieved when needed for density measurements.

Figure 3-7: Ice Coring and Associated Measurements

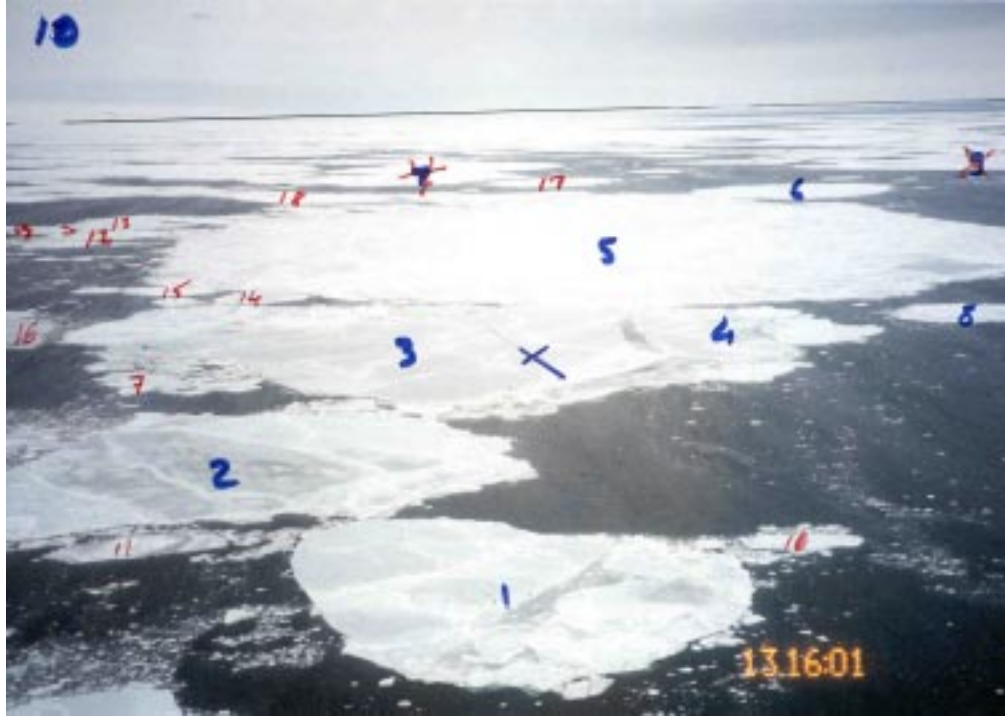
Figure 4-2: Floe Diameters from Oblique Photographs (March 13, Photo 10)

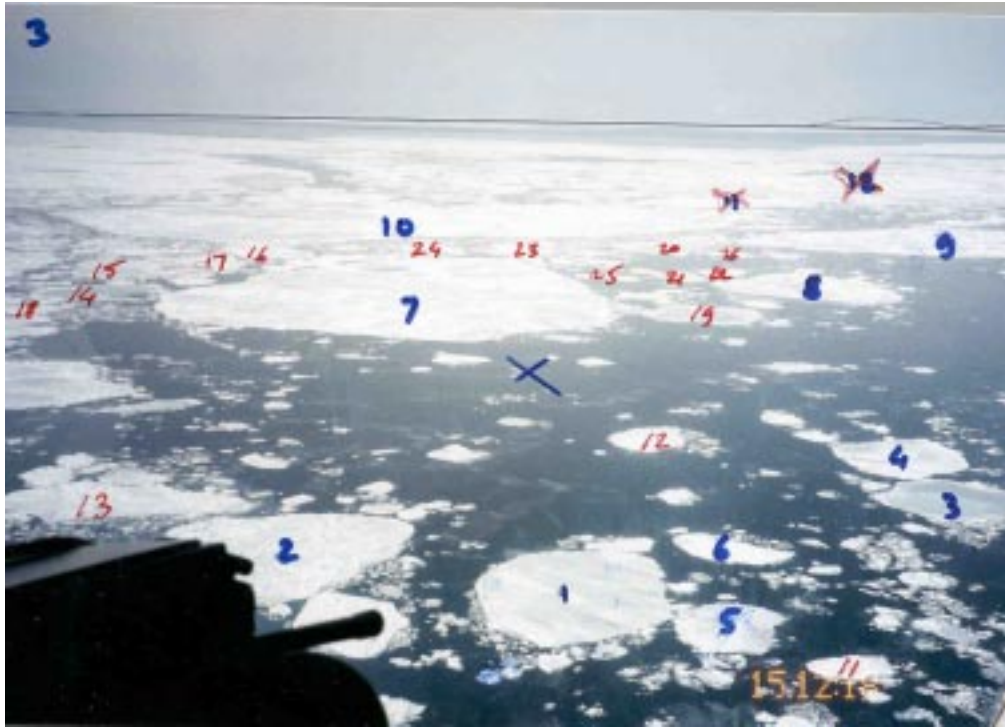
Figure 4-3: Floe Diameters from Oblique Photographs (March 15, Photo 3)

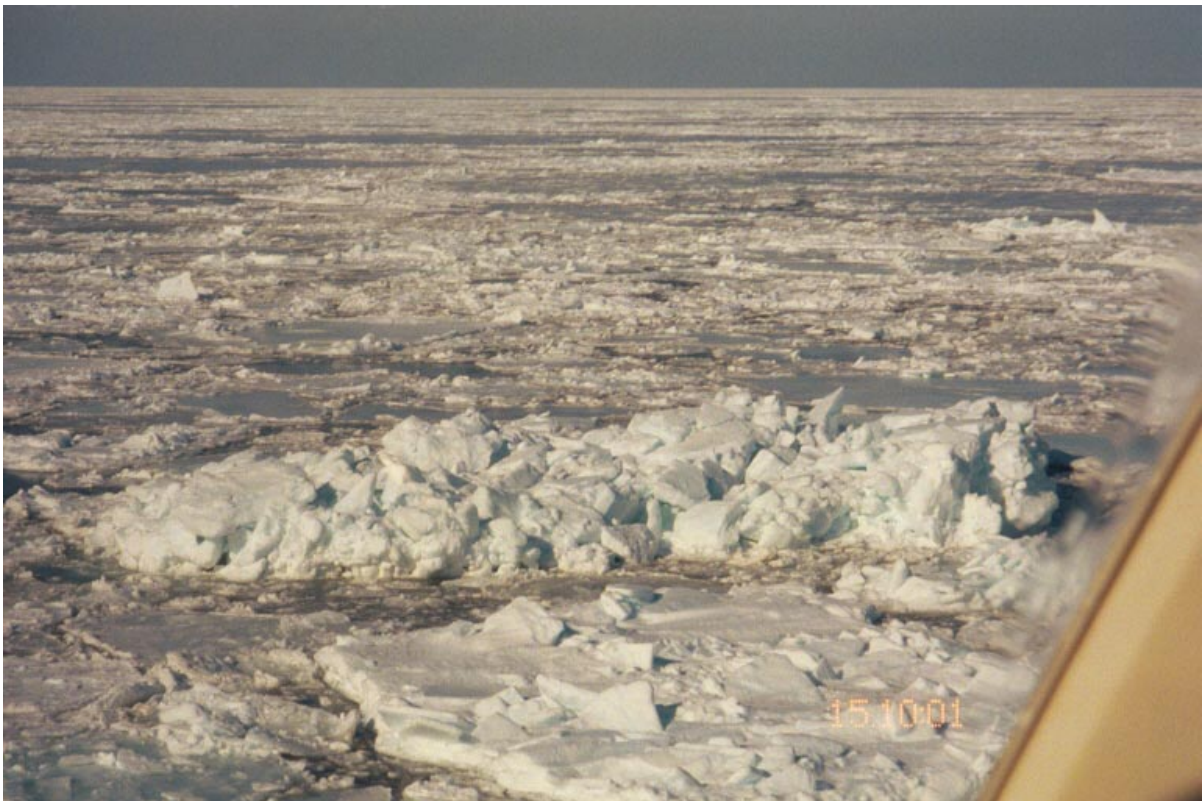
Figure 4-6: Small Rubble Berg, Near Site 7

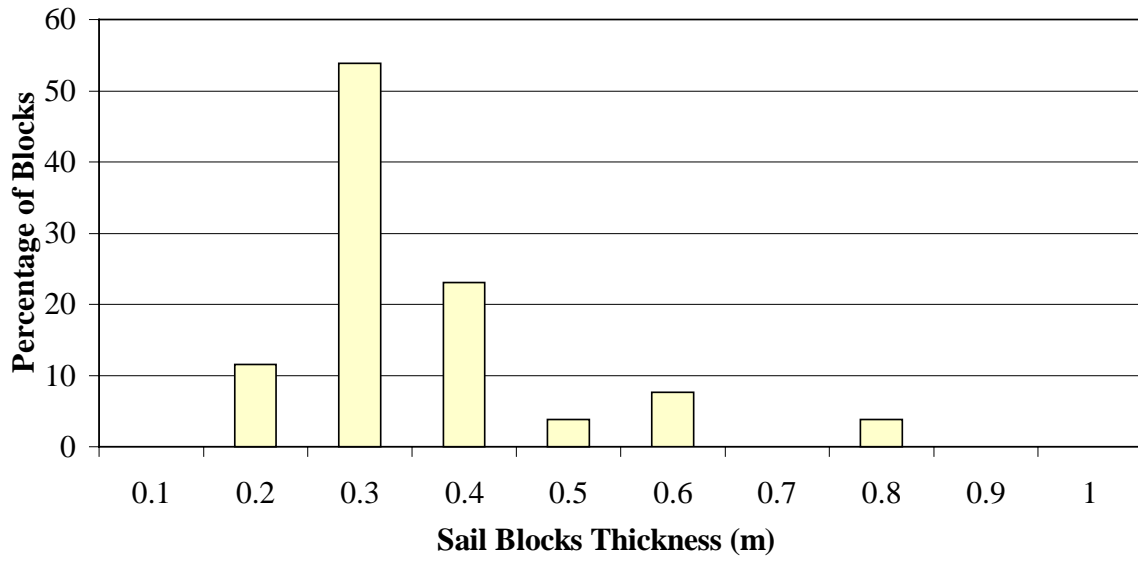
Figure 5-4: Blocks Thickness Distribution, Site 1

A total of 27 ice blocks visible at the surface of the ridge sail were measured. These blocks were, quite uniformly, about 0.30 m thick (as shown in Figure 5-4) with some larger tabular ice blocks noted. The length of the blocks was fairly random between 1 and 2m (see Figure 5-5). Details of the ice blocks measurements are given in Table 5-1. The block length averaged 4.9 times the thickness. While the length to width ratio average was 1.57.

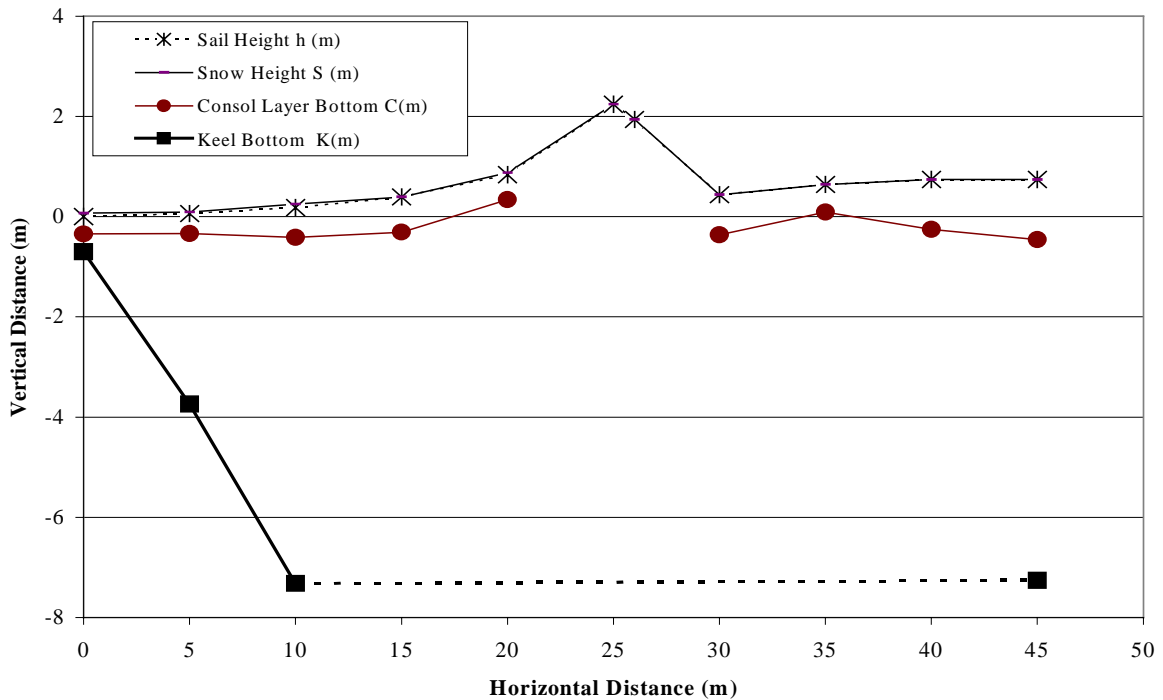
Figure 5-6: Ridge Profile, Site 1

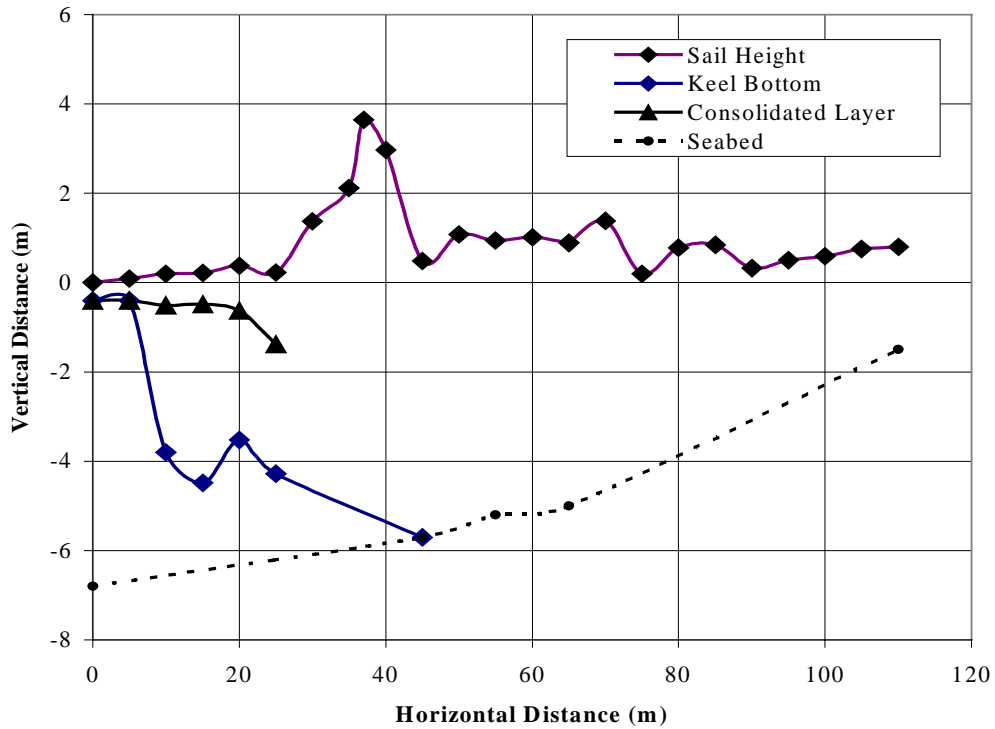
Figure 5-15: Ridge Profile, Site 2, Line 1

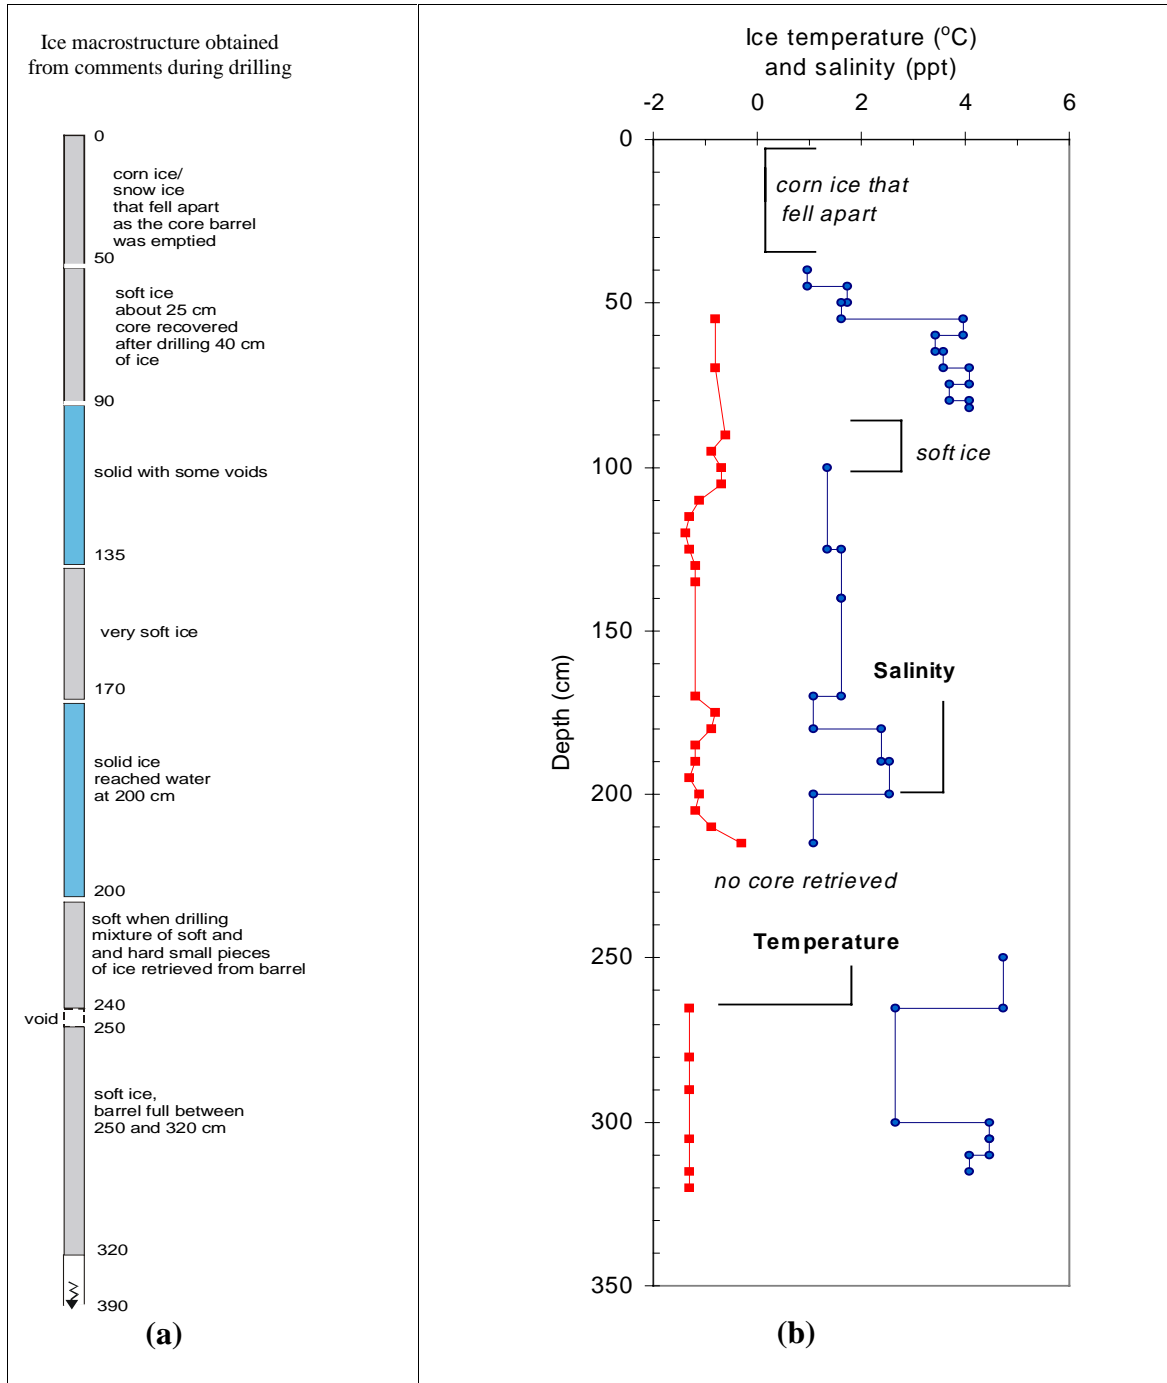
Figure 5-16: Site 2, (a) Ice Macrostructure and (b) Temperature and Salinity Profiles

The core at Site 2 was located near station S2L1-25, near the foot of the ridge sail. Ice macrostructure as well as salinity and temperature profiles are shown in Figure 5-16. The relatively high salinity between 0.50 and 0.80 m depth may be due to intrusion of salt water through the tidal cracks.

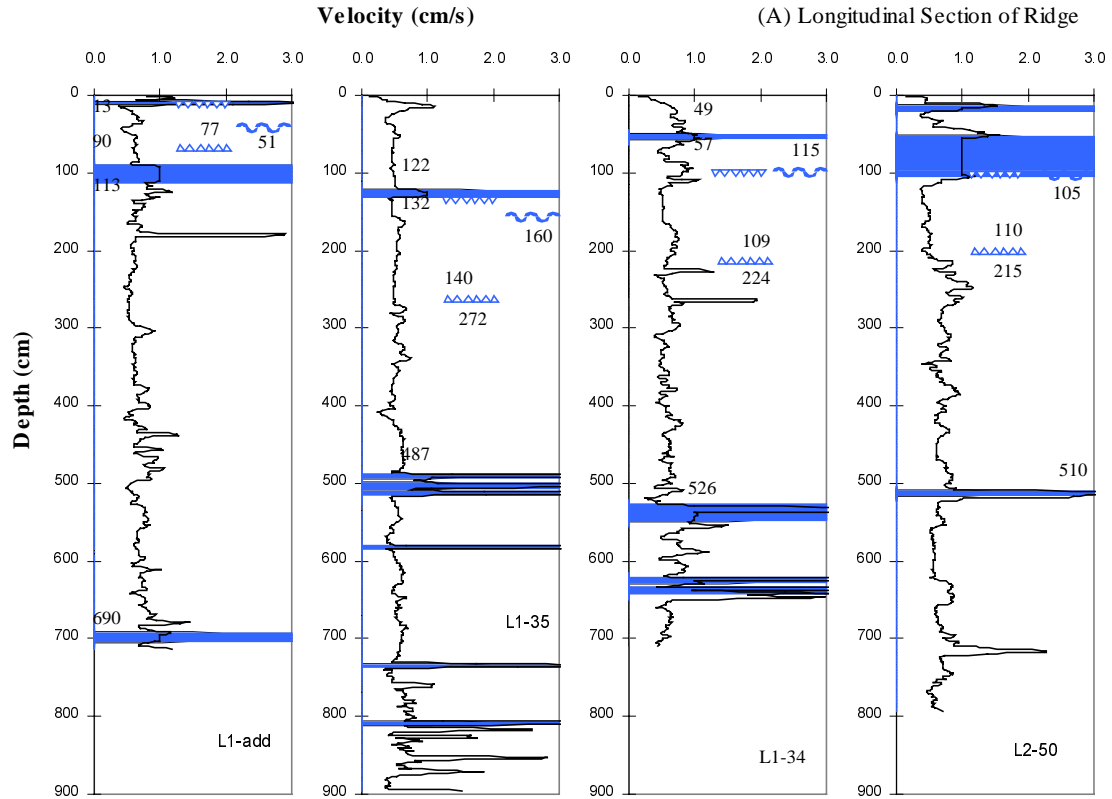
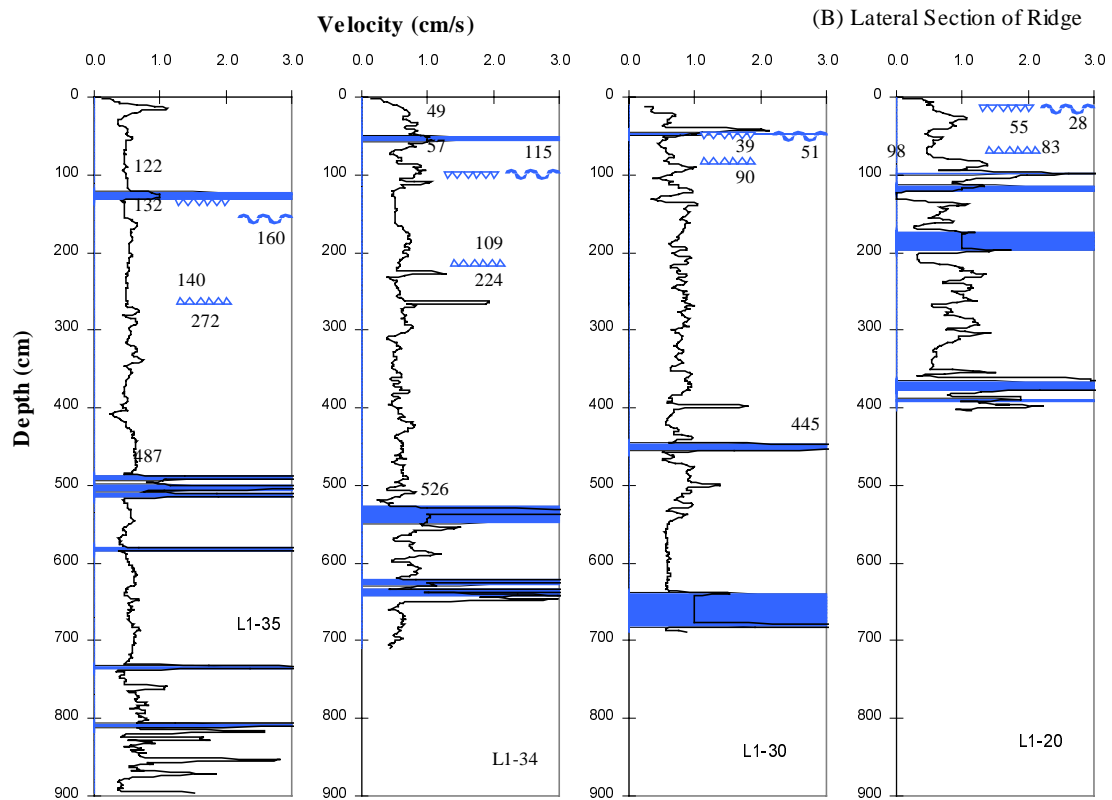
Figure 5-19: Hot Point Drill Profiles, Site 2

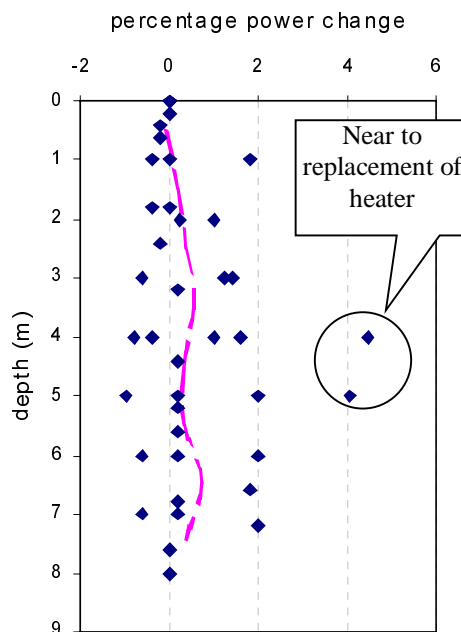
Figure 5-20: Summary Power Change Profile, Site 2

In later hot point drilling, the power measurements were recorded at the start of each profile. These data were written to a field book. Time and date of heater replacements were also recorded.

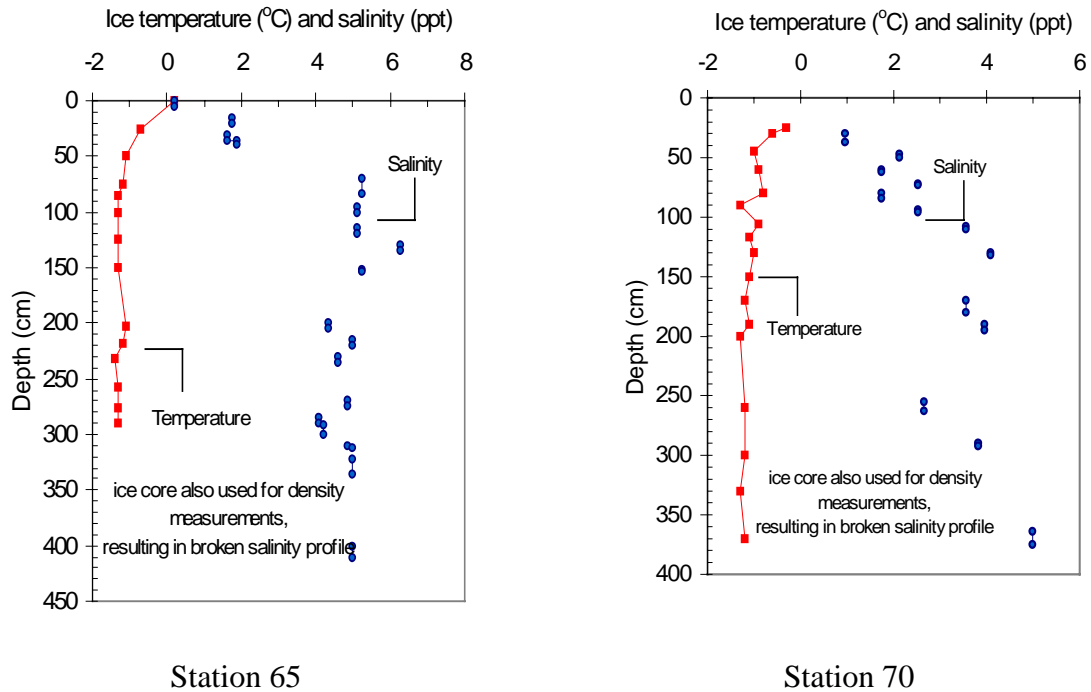
Figure 5-30: Temperature and Salinity Profiles, Site 3, Line 1,

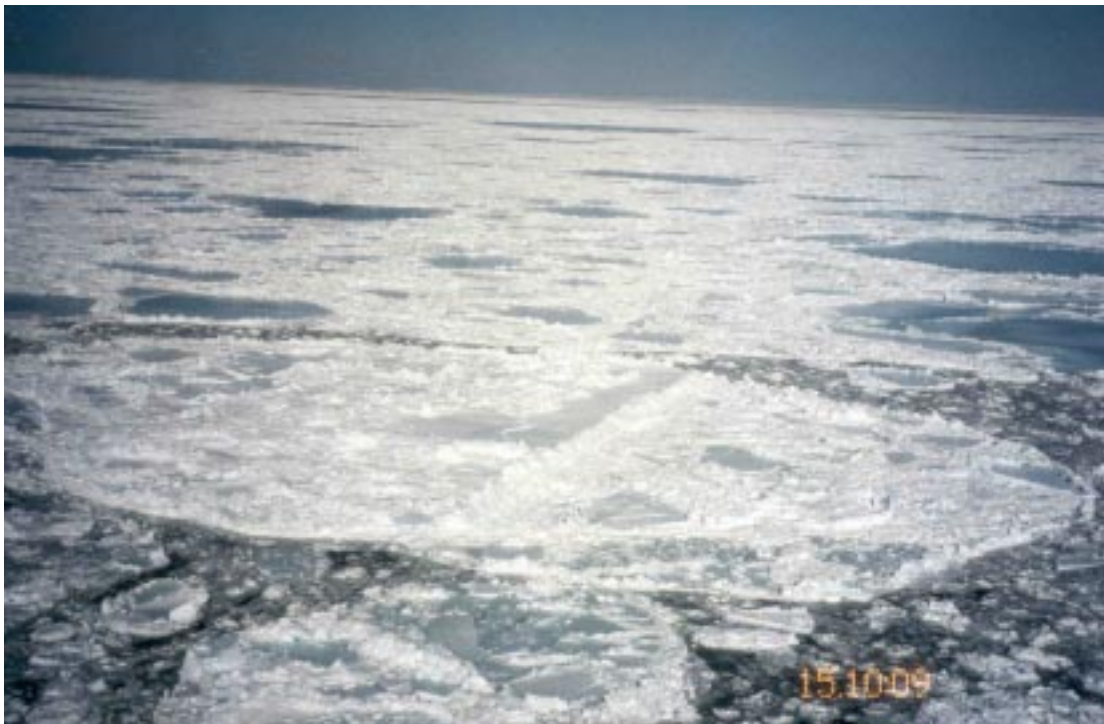
Figure 5-58: Photographs of Shear Ridge at Site 7

Site 7, examined from 10:00 to 12:00 on 15 March, included a noticeable shear ridge (Figure 5-58). Site 7 was used to determine if a shear ridge could have different keel or consolidated layer characteristics than other ridges. The results show no significant difference in the keel depth and consolidated layer thickness of compression ridges and shear ridges. A schematic of Site 7 is illustrated in Figure 5-57, which shows the three lines used to characterize the sail profile (Figure 5-59, Figure 5-60 and Figure 5-61). Maximum sail height was 1.6m. The ice thickness was determined from two auger holes.

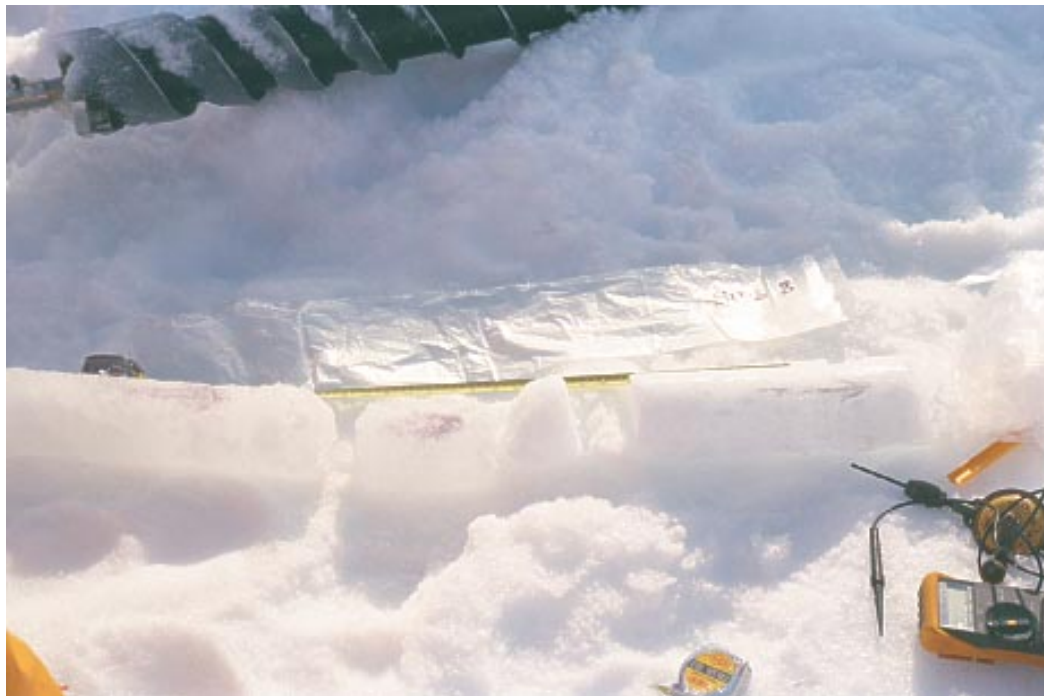
Figure 5-72: Core of Consolidated Layer Retained for Crystallography, Site 8

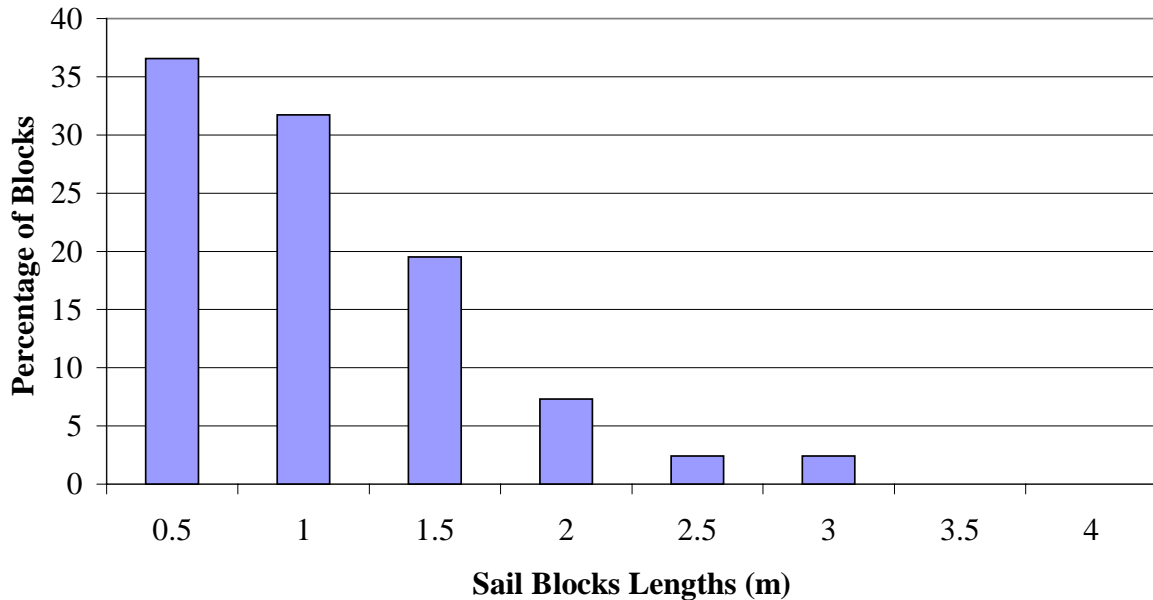
Figure 5-79: Sail Blocks Length Distribution, Site 9

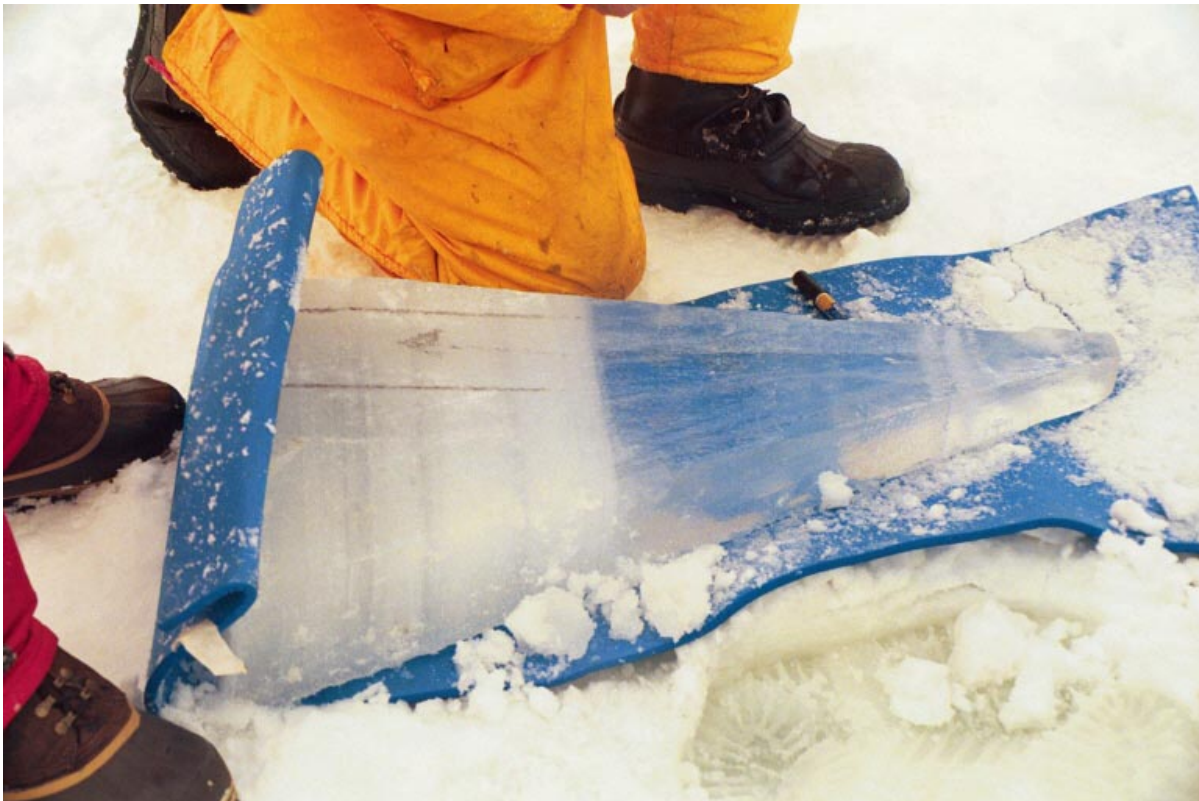
Figure 5-87: Vertical Cross-section of Ice Cover, Site 11

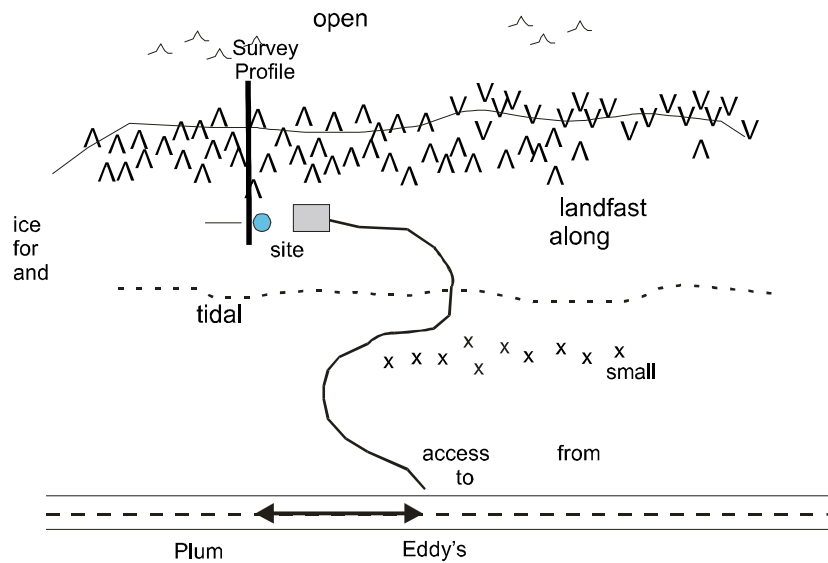
Figure 5-91: Schematic of Site 12
