A comparison between the spanwise and chordwise shedding methods of helicopter rotor blade de-icing

Aeronautical Report (National Research Council Canada. National Aeronautical Establishment); no. LR-270, 1960-01

Subject: A COMPARISON BETWEEN THE SPANWISE AND CHORDWISE
SHEDDING METHODS OF HELICOPTER ROTOR BLADE DE-ICING.

Authors: J. R. Stallabrass
G. A. Gibbard

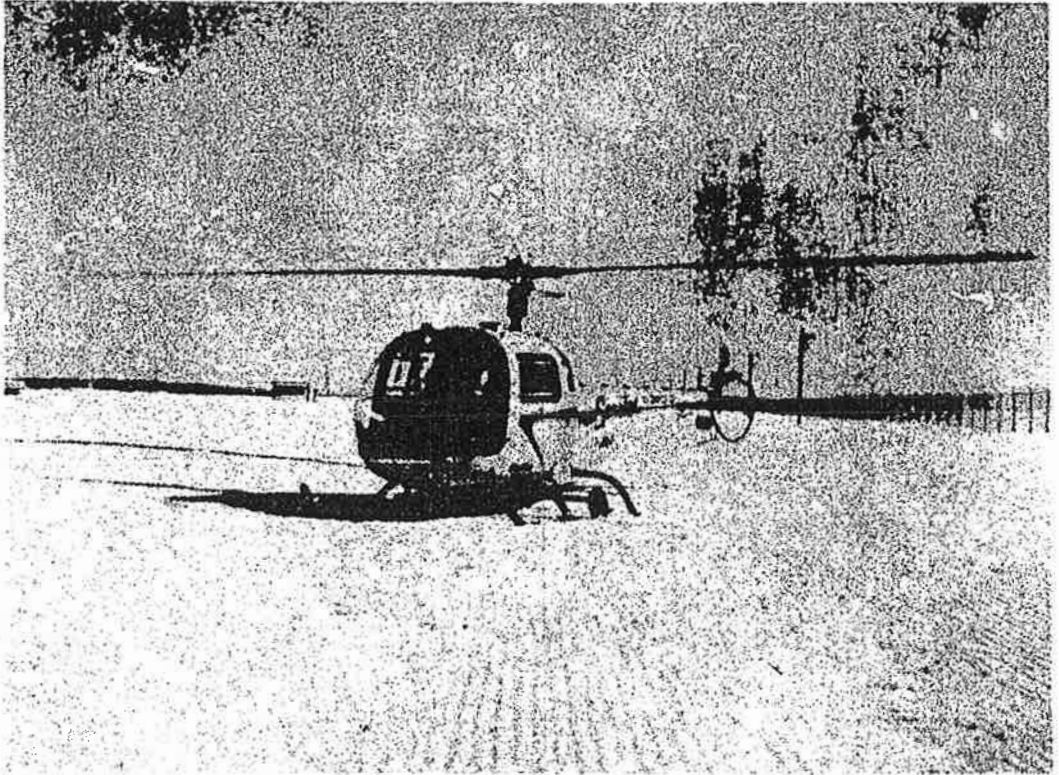
THE TEST HELICOPTER

The aircraft used for all trials was a Bell 47-J helicopter (Fig. 1). The

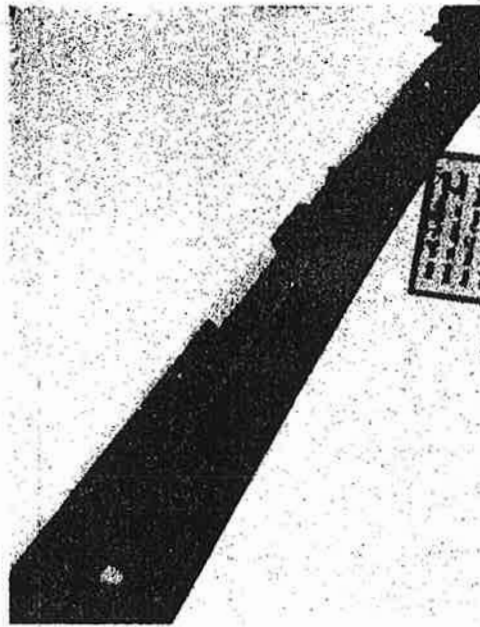
(a) ICE ACCRETION BEFORE DE-ICING

(c) AND (d) DE-ICING RUN

INCOMPLETE SHEDDING

(c) FUNBACK FROM COLD SPOT

(d) RESIDUAL ICE AFTER DE-ICING

CHORDWISE SHEDDING AT LOW TEMPERATURE - FLIGHT C2-1

A very slight reduction in runback was noted for the spanwise shedding method as compared with chordwise shedding. This runback was generally light and confined mainly to the undersurface of the inner half of the blades; its presence was therefore of rather minor importance. Examples of typical runback when de-icing in clear air are shown in Figures 16, 17a and b (for chordwise shedding) and Figure 21 (for spanwise shedding).

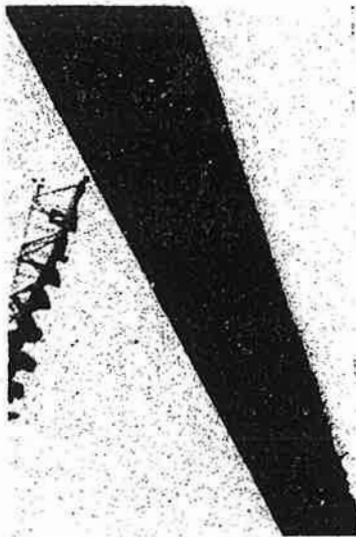
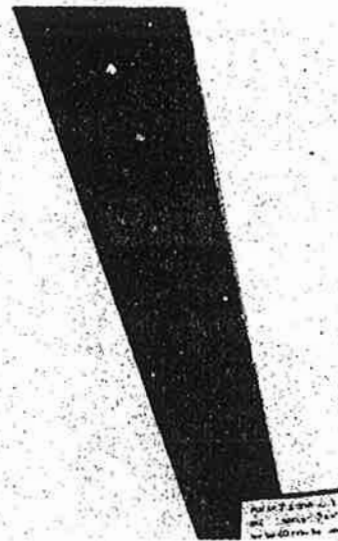
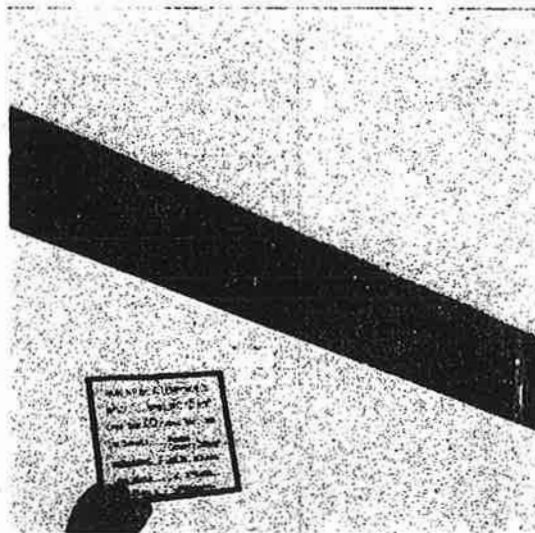
(a) SUCCESSFUL SHEDDING
FLIGHT C4-4

CORRECTED AMBIENT TEMP. -15.8°C
POWER DENSITY 40 WATTS/IN.²
ON-TIME 4.5 SEC.

(b) COLD SPOTS ON BLADE
FLIGHT C7-5

CORRECTED AMBIENT TEMP. -10.4°C
POWER DENSITY 20 WATTS/IN.²
ON-TIME 4 SEC.

(c) ABNORMAL RUNBACK CAUSED BY EXCESSIVE HEAT-ON TIME
FLIGHT C6-5

CORRECTED AMBIENT TEMP. -6.6°C
POWER DENSITY 30 WATTS/IN.²
TIME IN ICING 6 MIN.
2 DE-ICING CYCLES AT 10 SECONDS
ON-TIME

EXAMPLES OF CHORDWISE SHEDDING

On Flights C6-5 and S4-6, the rotor blades were iced and de-iced for a few cycles in the cloud at 30 watts/sq. in. and with excessive heat on-times; i. e. 10-second on-times were used where about $1\frac{1}{2}$ seconds would have been sufficient. The result of these tests was that considerable runback ice was formed on the blades (see Fig. 17c and 18, respectively).

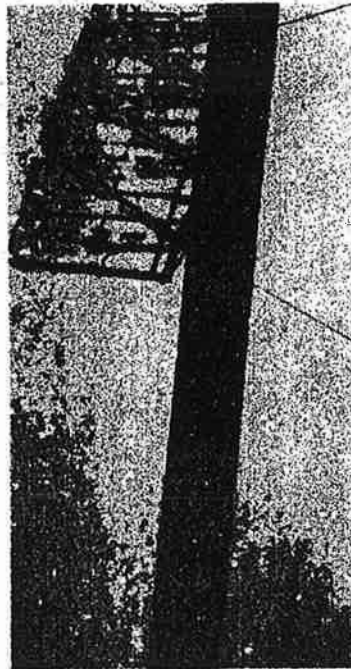
(a) DE-ICING IN THE CLOUD - 4 CYCLES OF SLIGHTLY INADEQUATE ON-TIME

(b) SINGLE DE-ICING CYCLE IN CLOUD

(c) SINGLE DE-ICING CYCLE OUT OF CLOUD

DE-ICING IN AND OUT OF CLOUD - SPANWISE SHEDDING

On Flight S4-7, the rotor was de-iced for several cycles with the helicopter remaining in the cloud but with a marginal heat-on-time to the heater mats. De-icing was not completely successful and again there was runback (Fig. 19a), but to a lesser degree than with excessive on-times. On Flight S4-8, a single cycle of icing and de-icing was performed in the cloud using a marginal on-time. De-icing was complete and there was slight runback on the lower surface of the blade (Fig. 19b).

Flights S4-8 and S4-9 were designed not only to investigate shedding time variations between "in cloud" and clear air shedding, as discussed in Section 6.1, but also to determine whether droplet impingement during de-icing had any marked influence on the degree of runback. The clear air shedding of Flight S4-9 exhibited no runback (Fig. 19c), while de-icing in the cloud (Flight S4-8) produced some in slight degree; this is barely visible in Figure 19b. When a series of 4 icing and de-icing cycles in the cloud was made (Flight S4-7) runback was more extensive (Fig. 19a), yet consisted still of light isolated streaks of runback ice of negligible aerodynamic importance. These streaks are made clearly visible in the photographs by a light frost formation on them caused by a supersaturated condition within the icing cloud resulting from high ambient relative humidity.

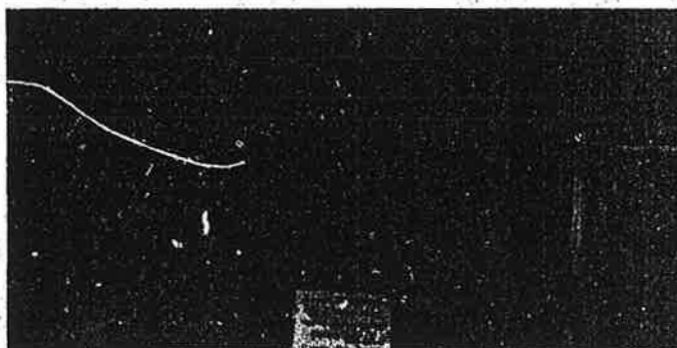
**CORRECTED AMBIENT TEMP. -18.1°C
POWER DENSITY 40 WATTS/SQ. IN.
TIME ON 3 SEC.**

SPANWISE SHEDDING AT LOW TEMPERATURE - FLIGHT S5-3

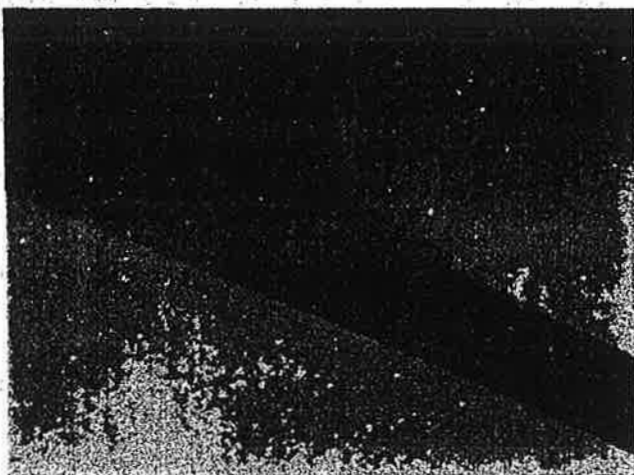
FLIGHT S2-1

CORRECTED AMBIENT TEMP. -16.9°C
POWER DENSITY 30 WATTS/SQ. IN.
POWER-ON-TIME 6 SEC.

FLIGHT S5-8

CORRECTED AMBIENT TEMP. -16.3°C
POWER DENSITY 30 WATTS/SQ. IN.
POWER-ON-TIME 5 SEC.
INADEQUATE ICE THICKNESS
RESULTING IN INCOMPLETE
SHEDDING AND RUNBACK

FLIGHT S5-10

CORRECTED AMBIENT TEMP. -16.0°C
POWER DENSITY 30 WATTS/SQ. IN.
POWER-ON-TIME 4.5 SEC.
