TESTS ON THE BIRD IMPACT RESISTANCE OF POLYURETHANE FOAM†

by H.S. Fowler *, AFCASI

National Research Council of Canada

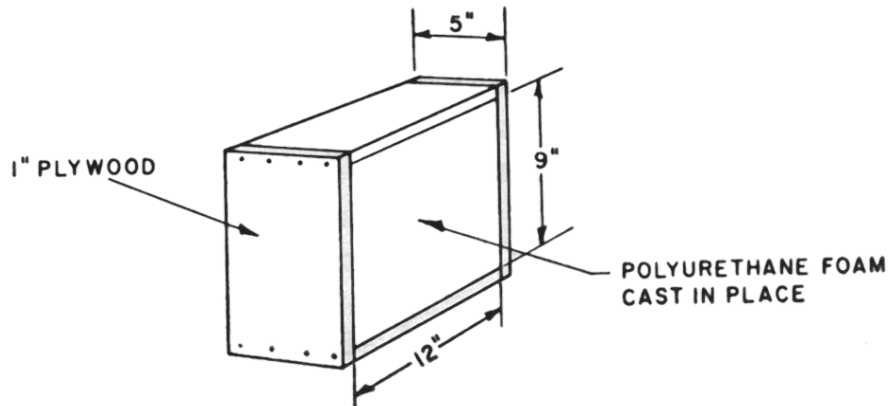
Figure 1. Foam target boxes

The foam tested was a polyurethane foam^a, cast into frames, to a density of 3 lb./ft.³ Since it would be difficult to cast more than a 5" depth of foam, the samples were made up in stout wooden frames 9" x 12", of 5" depth, whose top and bottom were removed after the casting operation was complete. Three of these frames clamped together thus gave a total thickness of 15" of foam, of 9" x 12" cross-section, as shown in Figure 1. This would reasonably represent a unit of foam cast between the upper and lower skins and a pair of ribs, in a tailplane or small aircraft wing, by way of example. No parting agent was used in casting, so the foam adhered firmly to the inner walls of the frames.

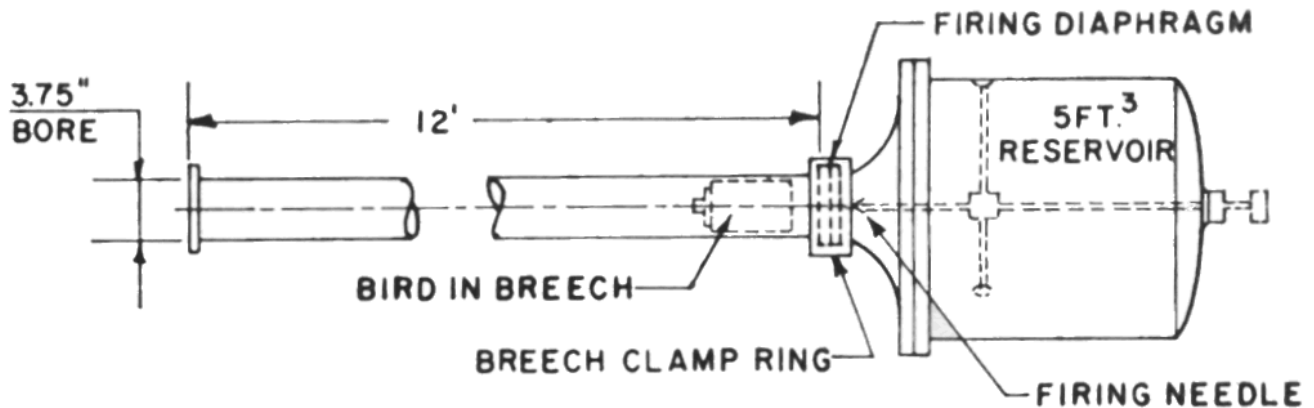
Figure 2. Airgun for firing dummy "birds"

The gun used (Figure 2) was a simple 3.75" bore brass tube, 12 ft. long, in the breech end of which the dummy "bird" was placed. Behind this, and separated from the barrel by a .004" brass diaphragm, was a 5½ft.³ reservoir. This was charged to a suitable pressure, in this case 60 psig, and the gun fired by pricking the diaphragm by a pointed steel rod from within the reservoir. The diaphragm then split and the bird was accelerated up the barrel. Its muzzle velocity was established by photographing the run with a Fastax movie camera, at 4000 frames/sec., and counting the frames needed for the "bird" to pass a marked 12" distance in the 4 ft. gap between muzzle and target. These films also demonstrated that the bird arrived intact at the target. The 350 ft./sec. velocity was used as being the lowest speed consistently obtainable with this gun.

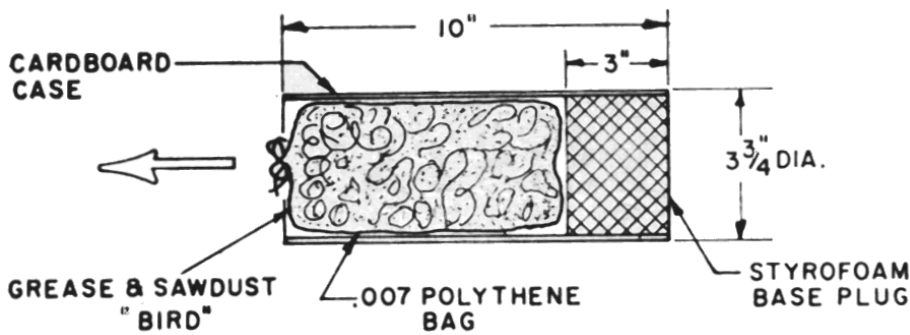
Figure 3 Dummy "bird"

The "birds" used were made of a mixture of X4P Grease M. of a vaseline consistency, and sawdust, of 47 lb./ft.³ density, wrapped in .007" polythene film, and placed in a sabot (Figure 3) for firing. The sabot consisted of a block of very light styrofoam 3" thick, and a one-ply case of thin (.016") cardboard. The weight of the sabot (.10 lb.) is included in the 1.0 lb. weight of the "bird"
