Client Report (National Research Council of Canada. Construction); no. A1-008997-01, 2016-07-19

Les Terrasses de la Chaudière — Preliminary Risk Assessment of Existing Brick-faced Wall Panels

A1-008997-01
19 July, 2016

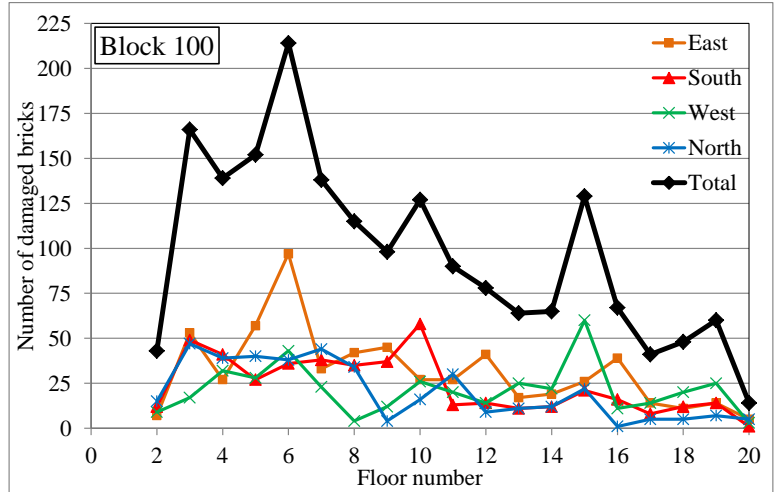
With reference to Block 100, the total number of damaged bricks per floor level appears to be relatively independent of building height from Floor 3 to Floor 19. Despite some local high peaks (e.g. Floor 6 East,

Figure 2 – Number of damaged bricks per floor level – Block 100 (as of 2015)

Floor 15 West), the rate of damage seems to be slightly higher on the East and South elevations than on the West and North elevation, as reported earlier. With a total number of 1860 single panels, Block 100 has an average number of 1.0 damaged brick per panel.

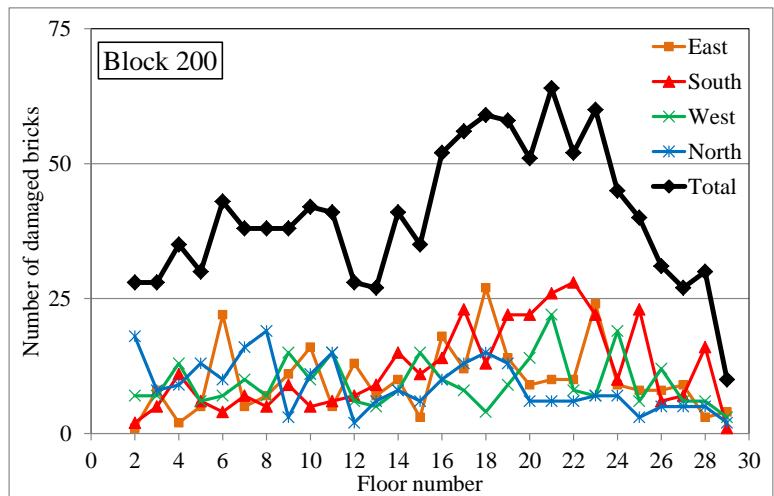
Figure 3 – Number of damaged bricks per floor level – Block 200 (as of 2015)

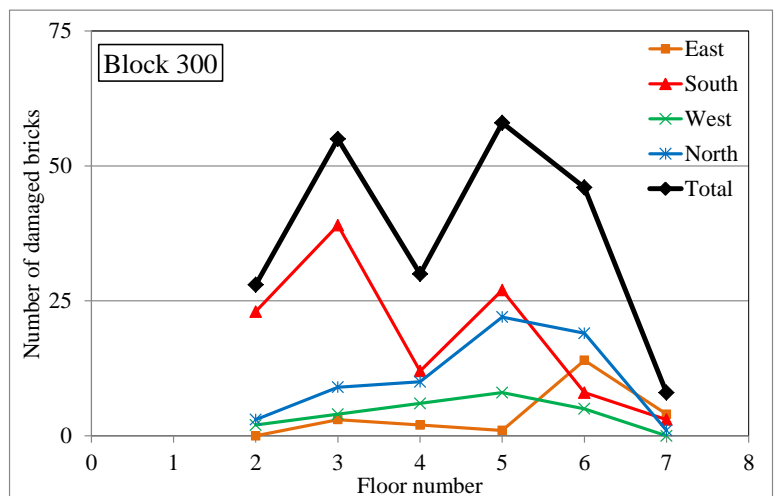
Figure 4 – Number of damaged bricks per floor level – Block 300 (as of 2015)

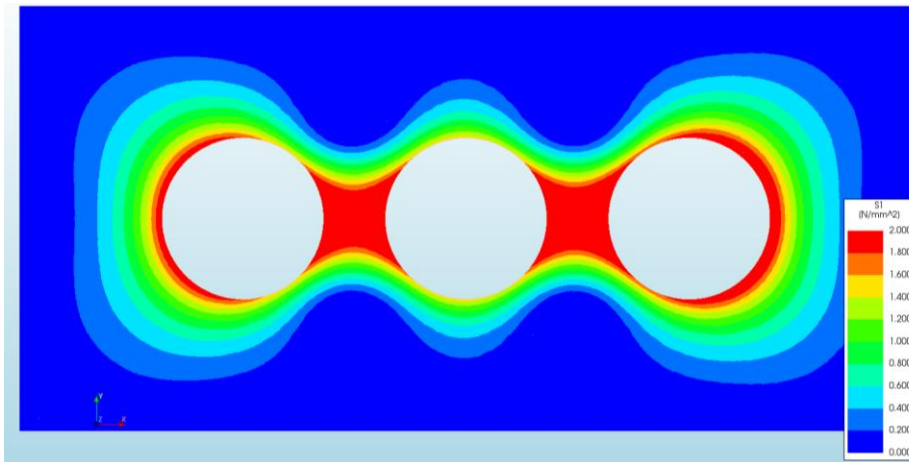
Figure 11 below illustrates the principal tensile stresses in the brick material resulting from a 50°C temperature decrease (relative to the assumed temperature when the mortar was first embedded). Two critical areas of high stress concentrations are observed that exceed the tensile strength of the brick (2 MPa), where finite elements with stresses equal or larger than the tensile strength are illustrated in red. These critical areas are: (i) the portion of the brick between two cores (direct tensile stresses in X direction); and (ii) the portion of the brick around each core (radial tensile stresses), where micro-cracks have likely formed in the brick. One can observe that the high stress area around the 3rd core (in red) is slightly larger than that around the 1st core, which is due to the more important contraction of the steel rebar.

Not only does the mortar have a much higher value for coefficient of linear thermal expansion as compared to the brick (i.e. $8.2 \times 10^{-6} \mu\text{m}/^\circ\text{C}$ vs. $4.1 \times 10^{-6} \mu\text{m}/^\circ\text{C}$), but it also has a greater compressive strength (87 MPa) than the brick in tension (4.7 MPa); as such, it does not yield when it expands against the brick due to thermal thereby causing tensile stresses in the brick and the likely development of micro-cracks.

The presence of a steel rebar within the row-locks units that also differs in coefficient of liner thermal expansion further heightens the stress condition in the brick unit incorporating rebar. It is to be noted that in conventional brick masonry construction reinforcing steel is not typically used in row lock construction.

Figure 11 – Principal tensile stresses from a 50°C decrease in temperature (linear elastic analysis)

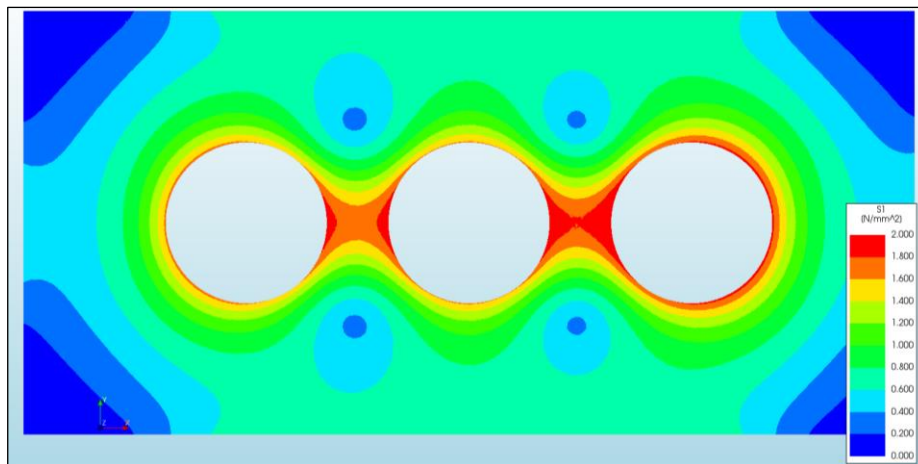
Regarding the 2nd load case, Figure 12 illustrates the principal tensile stresses in the brick material resulting from a 30°C temperature increase (relative to the assumed temperature when the mortar was embedded). Again, one can observe the formation of high tensile stresses in two critical areas as defined above: (i) the portion of the brick between two cores (direct tensile stresses in Y direction), and; (ii) the portion of the brick around each core (circumferential tensile stresses). The presence of the rebar also generates some additional tensile stresses around the 3rd core.

Figure 12 – Principal tensile stresses from a 30°C increase in temperature (linear elastic analysis)

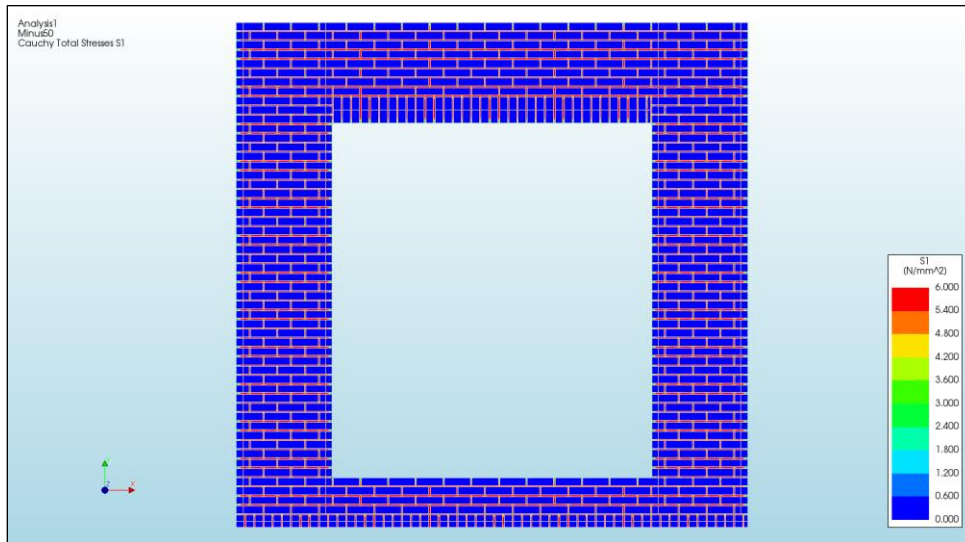
Figure 15 illustrates the principal tensile stresses calculated for a 50°C decrease in temperature. The results show that very high tensile stresses (exceeding the mortar tensile strength of 6 MPa) would localize in all horizontal and vertical mortar joints due to the significant movement restraint from the bricks, which are contracting at a lower rate. De-bonding of the bricks from the mortar joints would be expected in this case, and as observed by JCAL 2000 (Figure 17).

Figure 15 – Principal tensile stresses from a 50°C decrease in temperature (linear elastic analysis)

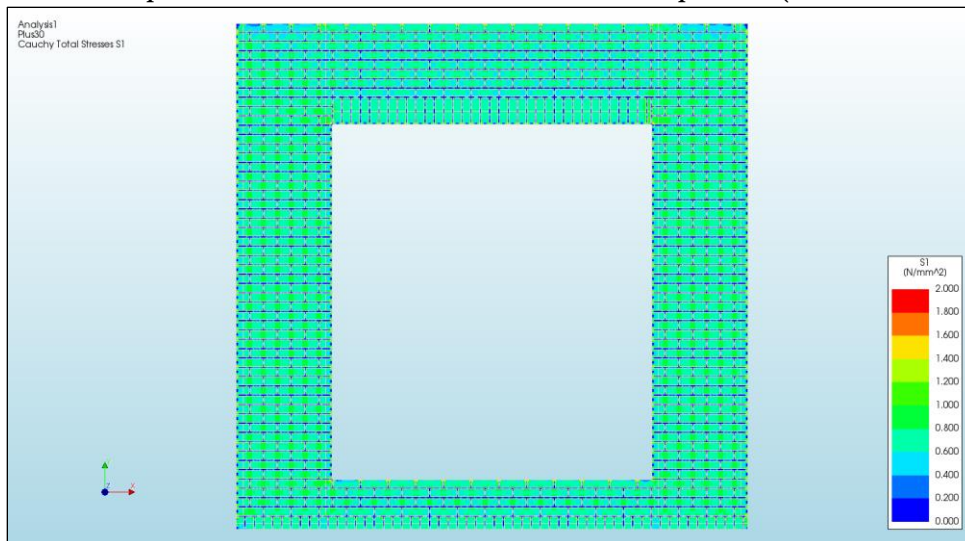
Figure 16 illustrates the principal tensile stresses calculated for a 30°C increase in temperature. The results show that small tensile stresses would be generated in the joints since in this case compressive stresses would dominate. However, moderate tensile stresses of up to 1.2 MPa would be generated in the brick units. From the analysis on a single brick unit it was evident that the mortar within the brick cores would significantly aggravate the problem; it could be inferred that most bricks in the wall panel would, as a result of a 30°C temperature increase, develop relatively high tensile stresses near the tensile strength of the brick (2 MPa).

Figure 16 – Principal tensile stresses from a 30°C increase in temperature (linear elastic analysis)

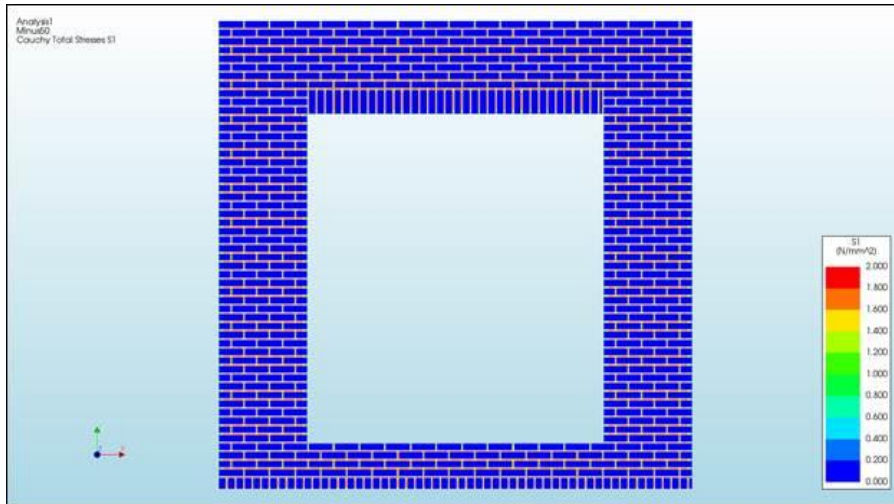
Figure 18 shows the results for a 50°C temperature decrease, with tensile stresses in mortar joints (<1.8 MPa) being lower than the tensile strength of 2 MPa. Figure 19 presents the results for a 30°C temperature increase, with very low tensile stresses in brick or mortar (<0.2 MPa). This suggests that nearby buildings/houses built with conventional brickwork subjected to similar temperature changes may not be at risk of early degradation.

Figure 18 – Principal tensile stresses from a 50°C temperature decrease (linear elastic analysis) (assumed conventional construction)

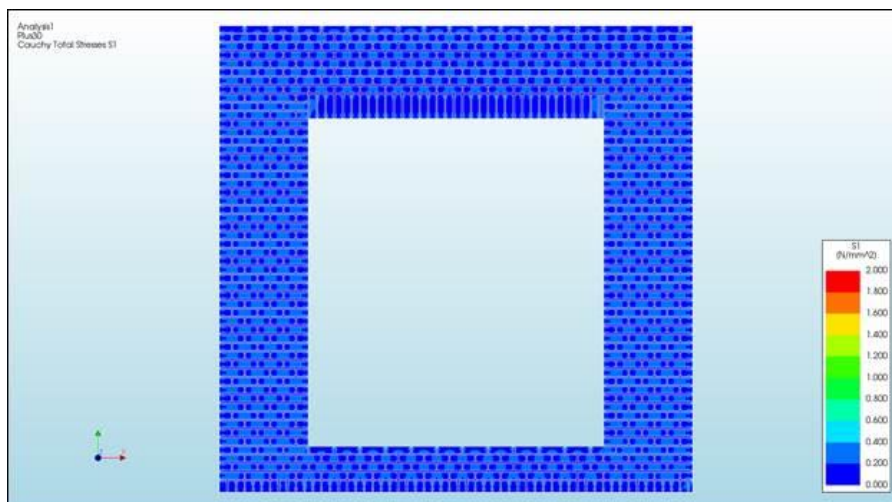
Figure 19 – Principal tensile stresses from a 30°C temperature increase (linear elastic analysis) (assumed conventional construction)

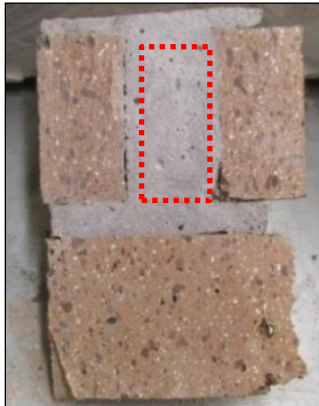
In this instance, Figure 21 shows a typical cross section of the brick that was removed from the wall with the mortar found to be completely filling the voids in the brick units. This is likely due to the construction

Figure 21 – Cross-sectional cut of brick removed from wall panel, displaying fully filled void spaces

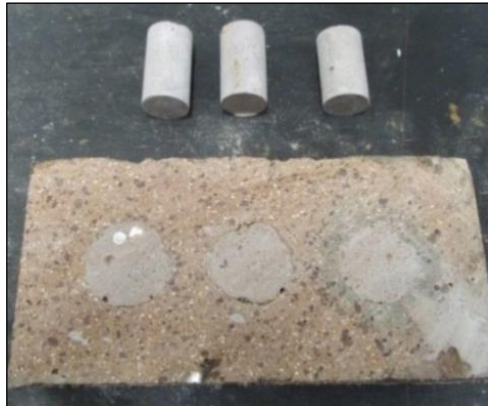
Figure 22 – Sectioned brick from wall specimen showing fully-filled voids and cored mortar samples

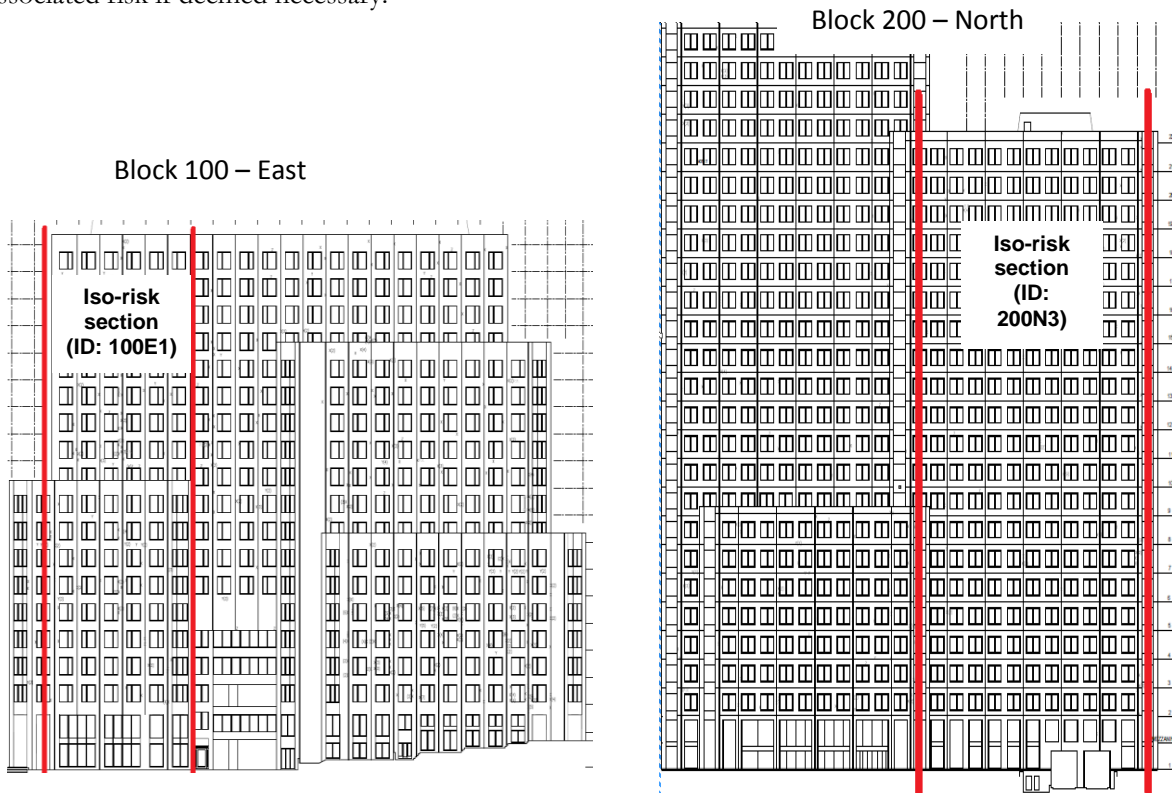
Figure 38 - Block 100 Section above the bus station Figure 39 - Block 200 section above the loading docks

Section 100E1 (Figure 38)			Section 200N3 (Figure 39)		
		Metrics	Calculated value	Rating	Metrics	Calculated value	Rating
Consequence rating based on pedestrian and exposure	Height of the building	72 m	R1=0.056 (see section A below)	4	82 m	R2 = 0.036 (see section B below)	3
	depth of safe area	4 m			0 m		
	depth of exposed areas outside overhead	X ₁ = 4m, X ₂ = 72/3 = 24 m			X ₁ = 0m, X ₂ = 82/3 = 27.3 m		
	Average daily frequency of pedestrians	0.08 (see section A below)					
Adequacy of overhead		NA ²²

- The presence of 10 people present at a bus station for 2 hrs every 24 hrs (i.e., 1 hr in the AM and 1 hr in the PM);
- At this level, WEs are not considered differently;
- 2 people on average passing by all the time during the day time (e.g. over a 12 hr period).
- Height of the building H = 72 m
- Dimension of the exposed area is shown in Figure 40 (23 m x 24 m).

Section 100E1			Section 200N3		
Likelihood factors		Section width	Calculated value	Rating	Section width	Calculated value	Rating
Likelihood rating based on 2015 inspection report	damaged bricks (2015)/section width/month	3x7.6=22.8 m	$137/22.8/57.5^1 = 0.1$	2.5 TBC ²	6x6.069=36.4 m	$95/36.4/57.5 = 0.05$	1.25
	Percentage of damaged bricks with high risk of rebounding		$63/137=46\%$	2.5		$44/95=0.46$	2.5
	Overall section deterioration condition		$72/102 = 70\%$ % panels defected	3.5		$42/120=35\%$	1.75
Total rating				8.5³			5.5

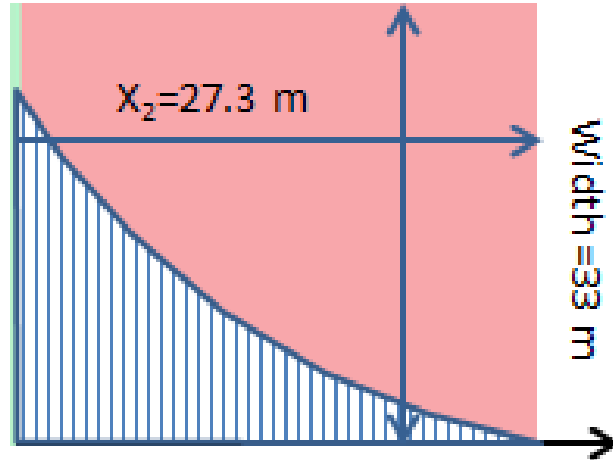
Figure 41 - Example of Size and Location of exposed area (Section 200N3)

- The presence of 5 workers at the loading docks for 3 hours and for 2 days / week
- WEs are not considered as different at this level
- 2 people on average passing by during the day (12 hours).
- Height of the building $H = 82$ m
- Dimension of the exposed area is assumed to be 33 m x 27.3 m as shown in Figure 41.
