# **Water Stream Displacement of Aircraft Windows and Overwing Exits – A Preliminary Study**

**Report No.:** LTR-SMM-2017-0032

**Date:** February 2017

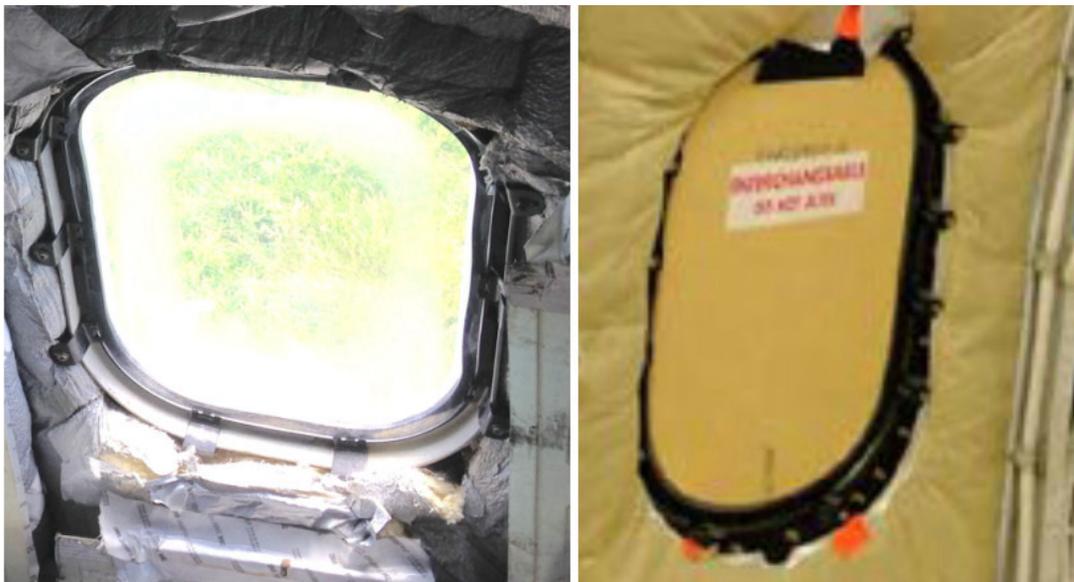
**Figure 4: Interior view of Boeing cabin windows and clips.**

The information provided in this section is from the author's personal experience, photographs and maintenance manuals. Boeing 727, 737, 747, 757, 767 and 777 aircraft have 10 perimeter clips that locate the two acrylic panes of the cabin window system, shown in Figure 4. Both acrylic panes fit into a rubber gasket. B727 through B767 cabin windows have an exposed surface area of 0.92 ft<sup>2</sup> (0.085 m<sup>2</sup>). The B787 has larger cabin windows which require the support of two more clips, one on each side, for a total of 12, shown in Figure 4. Under normal conditions the outer pane in the rubber gasket is forced against the edge of the opening in the forged aluminium frame by cabin pressurization. The second panel in the gasket has a hole in it to allow pressure equalization and aid in relieving condensation. A third transparency (the innermost pane and the one that a passenger can touch) is carried in a fixture on the back side of the cabin liner panel and includes the movable sun shade. The B787 has an electrically dimmable glass inner pane that replaces the mechanical sun shade. The spring-steel clips used by Boeing have changed little over the years as has the method by which they are anchored to the window frame around the perimeter. The contact area on the window assembly and the mechanical restraint imparted by the clips is minimal. The clips serve only to locate the window so that the seal will be in position when cabin pressure is applied. They are easily displaced if force is applied on the window panes from the exterior. This is known to ARFF firefighters as they typically train to displace these windows manually with a maul or axe. This is also known in the de-icing industry as operators have proscriptions against direct spray application on or around fuselage windows or doors as the fluid can be forced past the seals entering the cabin [2]. Fuselage de-icing fluid application is restricted to above the windows and doors and relies on gravity to clear ice and snow from these areas.

a) B737 window with 10 clips.

b) B787 window with 12 clips.

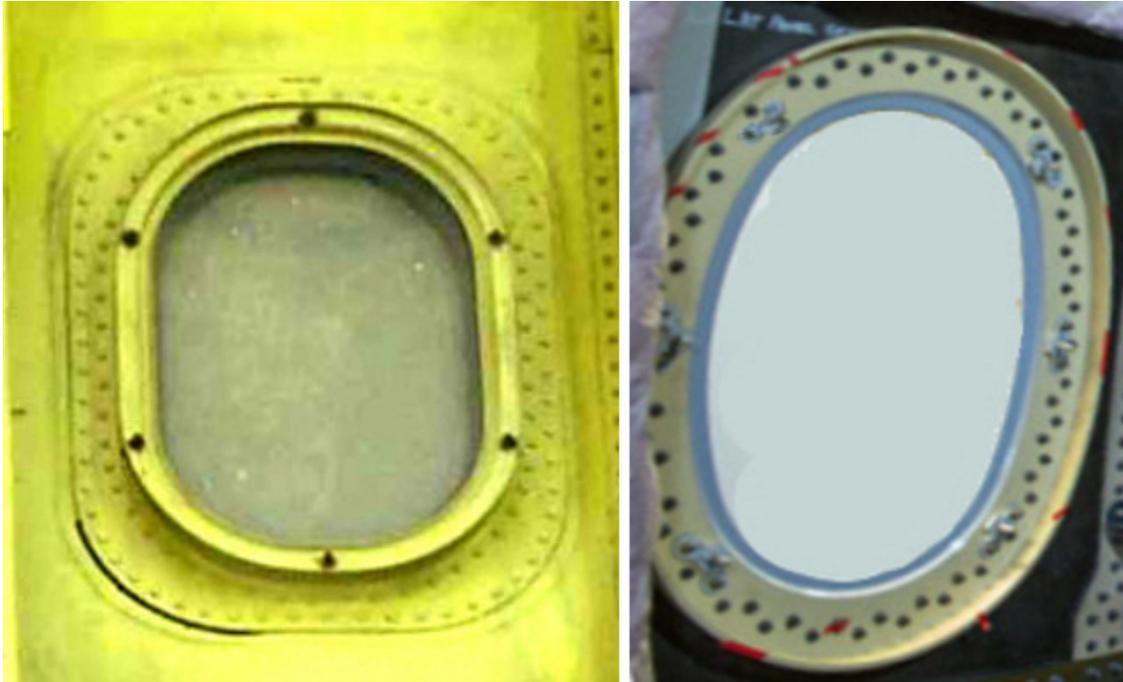
**Figure 7: Airbus cabin window assemblies.**

The Airbus family of aircraft follow a different installation methodology where the outer two panes and their pressure seal are retained by a formed metal ring that is secured by six bolts, shown in Figure 7. A330/340 and A380 cabin windows are larger than those on the A320 series. It has not been proven to date whether a water stream could break the fasteners or otherwise displace the panes. It may be that once the panes are shattered manually from the exterior, the pieces can be readily removed by a water stream. The A350 window installation is different, Figure 7b, but it is not know if it is possible to displace these with a water stream.

a) A300 with six bolt retainer ring

b) A350 cabin window

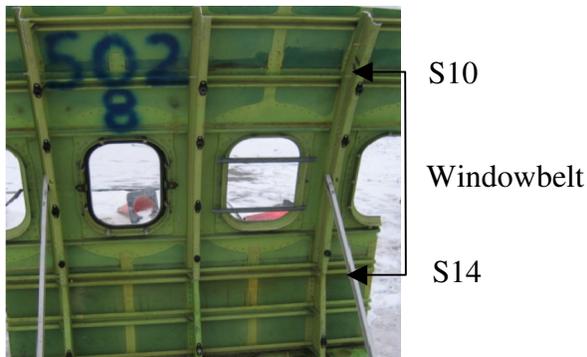
**Figure 9: B737 windowbelt zone between stringers S10 and S14 right and left.**

The windowbelt is the section of the fuselage sidewall that incorporates the cabin windows, shown by arrows in Figure 8, with the inner surface shown in Figure 9. The skin sheet layers are thicker along this belt than in other areas to support all the openings in the fuselage pressure vessel. The multiple sheet layers and window frames make this a more difficult area to breach for firefighting and forced-entry rescue.

Figure 10 shows the interior view of the window pane and cabin liner damage and displacement caused by the water stream striking the window at location B. Figure 9 shows the inner surface of a section of B737 fuselage illustrating the bare structure of the windowbelt area.

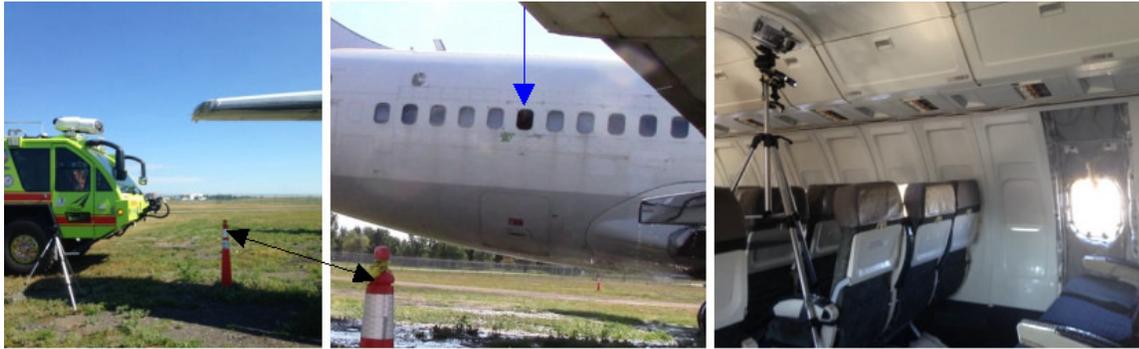
**Figure 11: B737 Cabin side window test setup.**

To better understand what was happening, a test was set up against a single window in the starboard aft area of the B737 cabin and cameras were positioned to record the external and internal views simultaneously, shown in Figure 11.

a) truck & camera      b) target window (arrow)      c) interior camera (post-test)

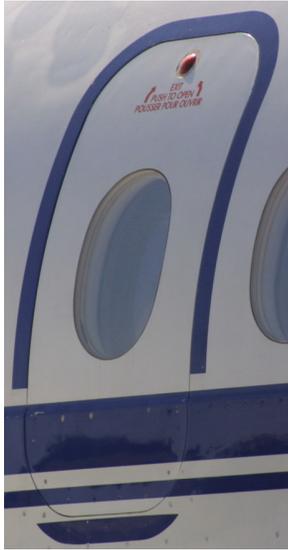
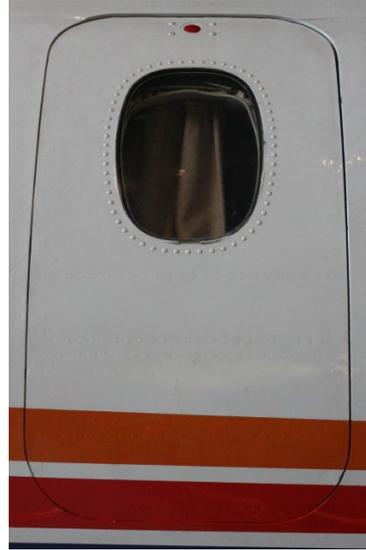
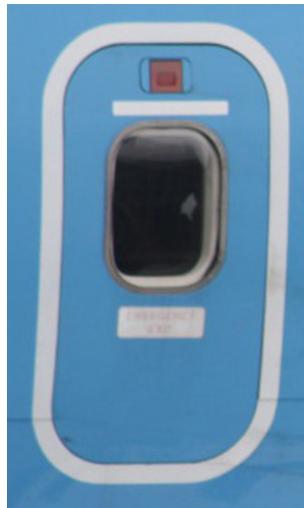
**Fig. A-4 Type IIIA OWEs that may be opened by a water stream.**

The small size of the push-button release may prevent exterior actuation by a water stream if the stream becomes dispersed due to stand-off distance.

The B757 and 767 exterior panel has an integral handle. It is not clear if this changes the operation compared to B737 aircraft OWEs.

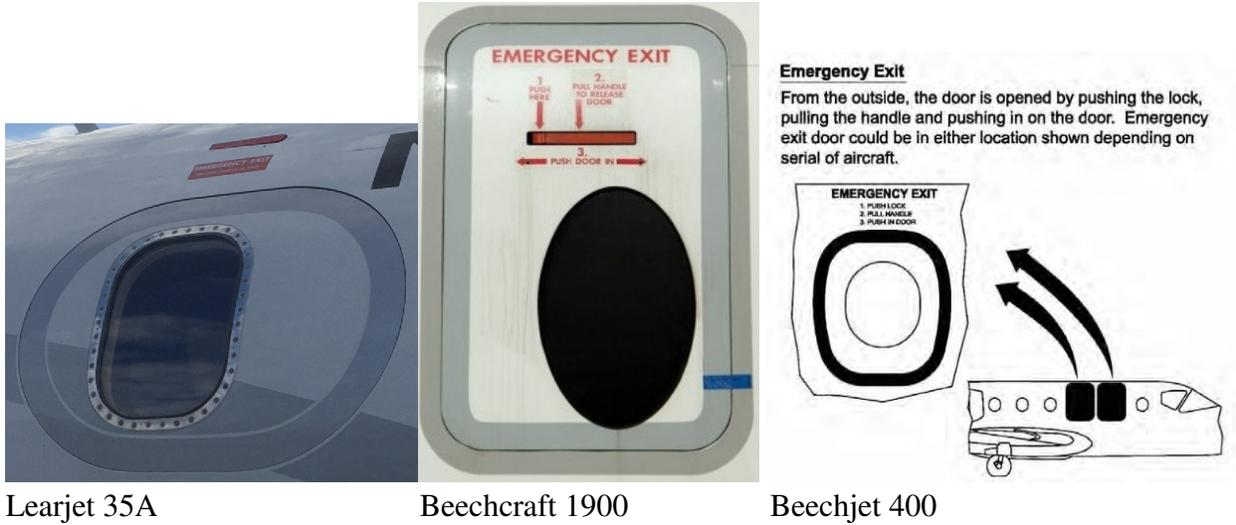
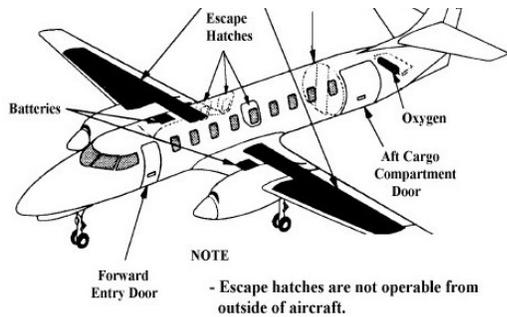
**Fig. A-7 Examples of Type IV OWEs that cannot be opened by a water stream.**

851 Fairchild Metro/Merlin aircraft were built and 225 were in airline service in 2016. The three over-wing escape hatches are NOT operable from outside the aircraft except in rare cases.
