Marine icing events: an analysis of images collected from the Marine Icing Monitoring System (MIMS) Gibling, L.

Student Report (National Research Council of Canada. Institute for Ocean Technology); no. SR-2007-07, 2007

**MARINE ICING EVENTS AN ANALYSIS OF IMAGES
COLLECTED FROM THE MARINE ICING MONITORING
SYSTEM (MIMS)**

SR-2007-07

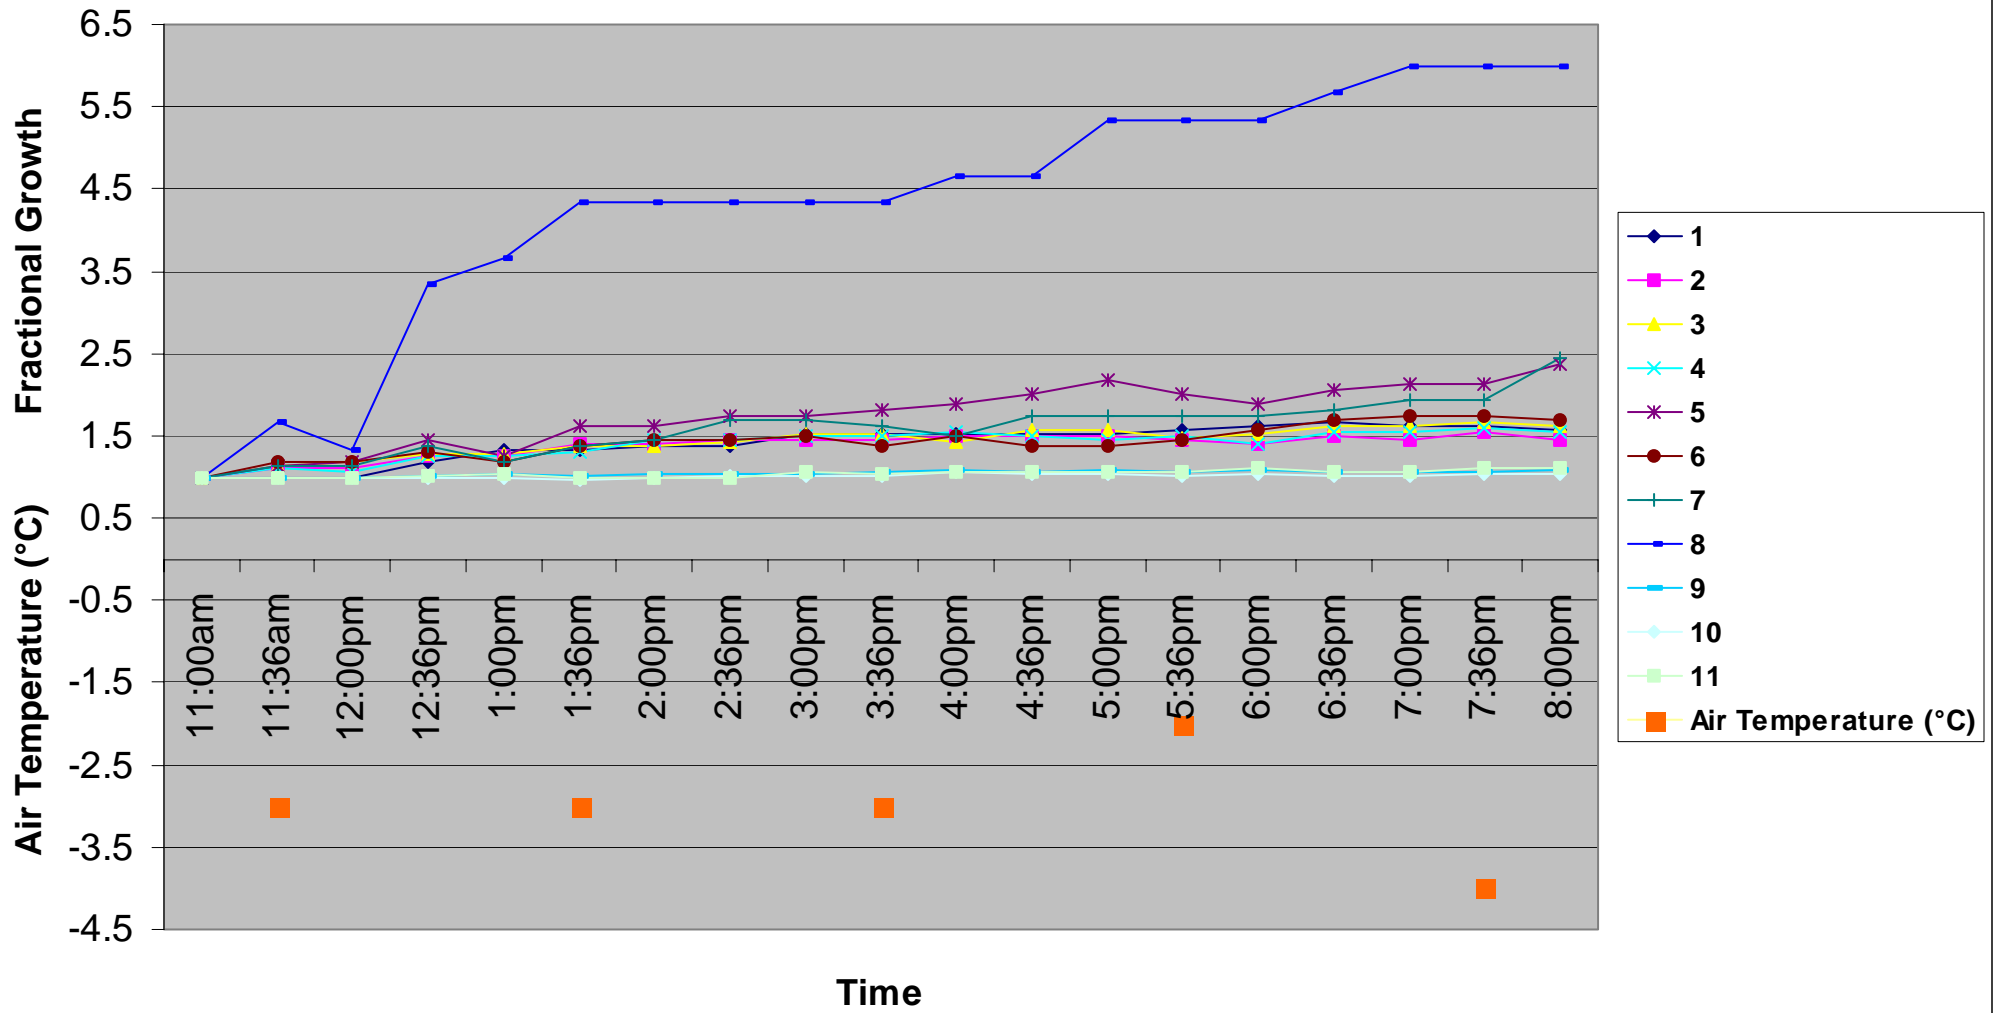
Starboard Camera December 29, 2006

Graphs were made comparing the air temperature to the ice growth rate. It was observed that during periods where the temperature remained constant, the ice growth increased gradually. However when the temperature dropped, the growth rate increased more rapidly. This suggests that there is a correlation between the air temperature and the ice growth rate.
