Degradation of the bird impact resistance of polycarbonate

LTR - ST - 1326

DEGRADATION OF THE BIRD IMPACT RESISTANCE OF POLYCARBONATE

6 JANUARY 1982 OTTAWA, CANADA

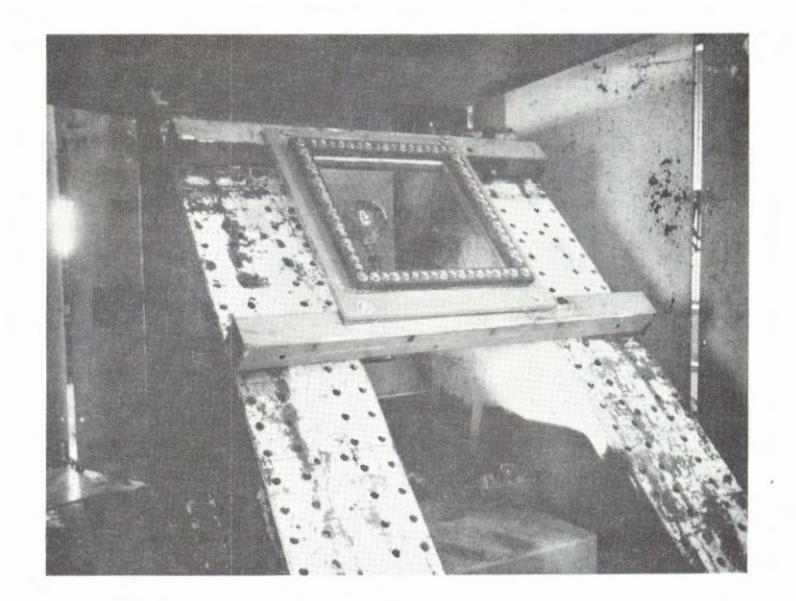
FIG. 2 TEST SPECIMEN SET-UP

The polycarbonate test specimen, 24 inches by 24 inches, was "clamped" to a one inch thick aluminum mounting plate at 45° to the horizontal. The mounting plate had outside dimensions of 28 inches by 30 inches with inside dimensions of 19 inches by 19 inches. The inside edges were radiused to prevent shearing of the specimen during impact. The mounting plate was bolted to two, four inch by four inch box beams, which were then clamped to the support structure. The test specimen set-up is shown in Fig. 2.

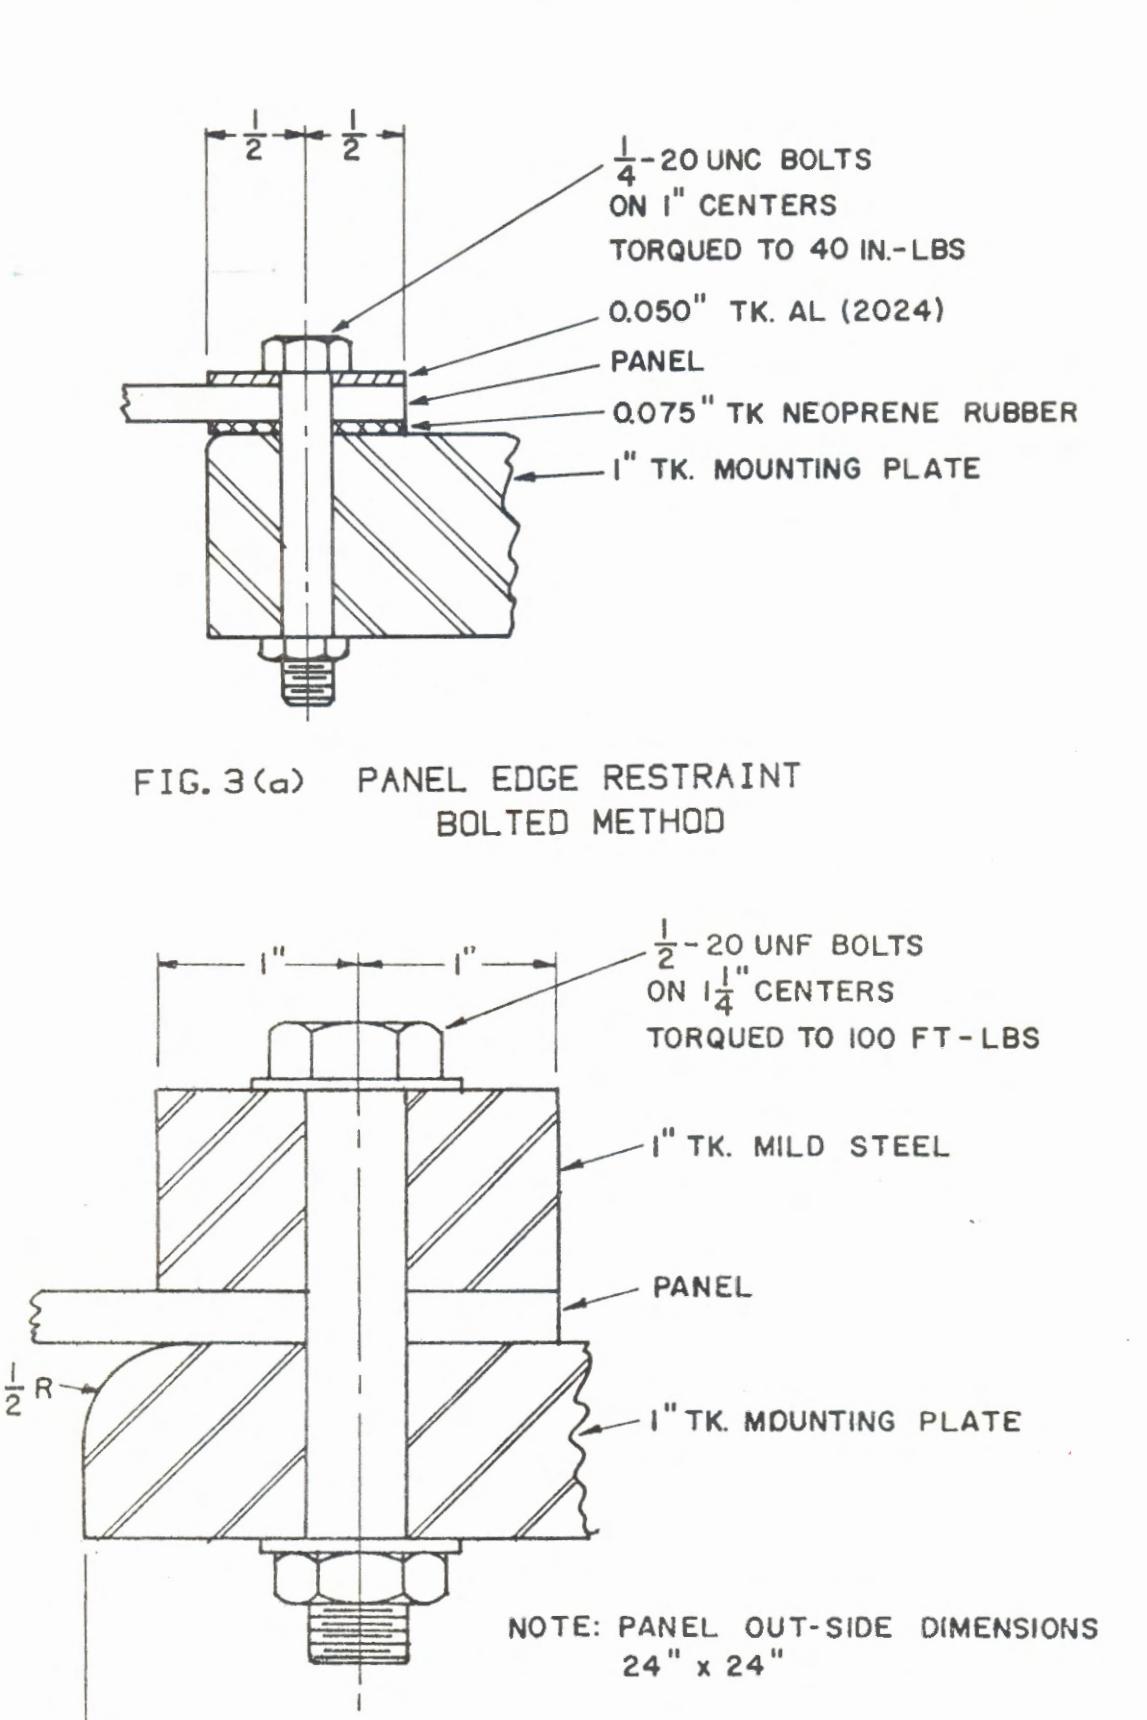
FIG. 3(b) PANEL EDGE RESTRAINT "CLAMPED" METHOD

The method for clamping polycarbonate specimens was developed in earlier work (Ref 2) and under bird impact loading prevented failures from originating at the bolt holes or specimen edges. Fig. 3 details the clamping method.

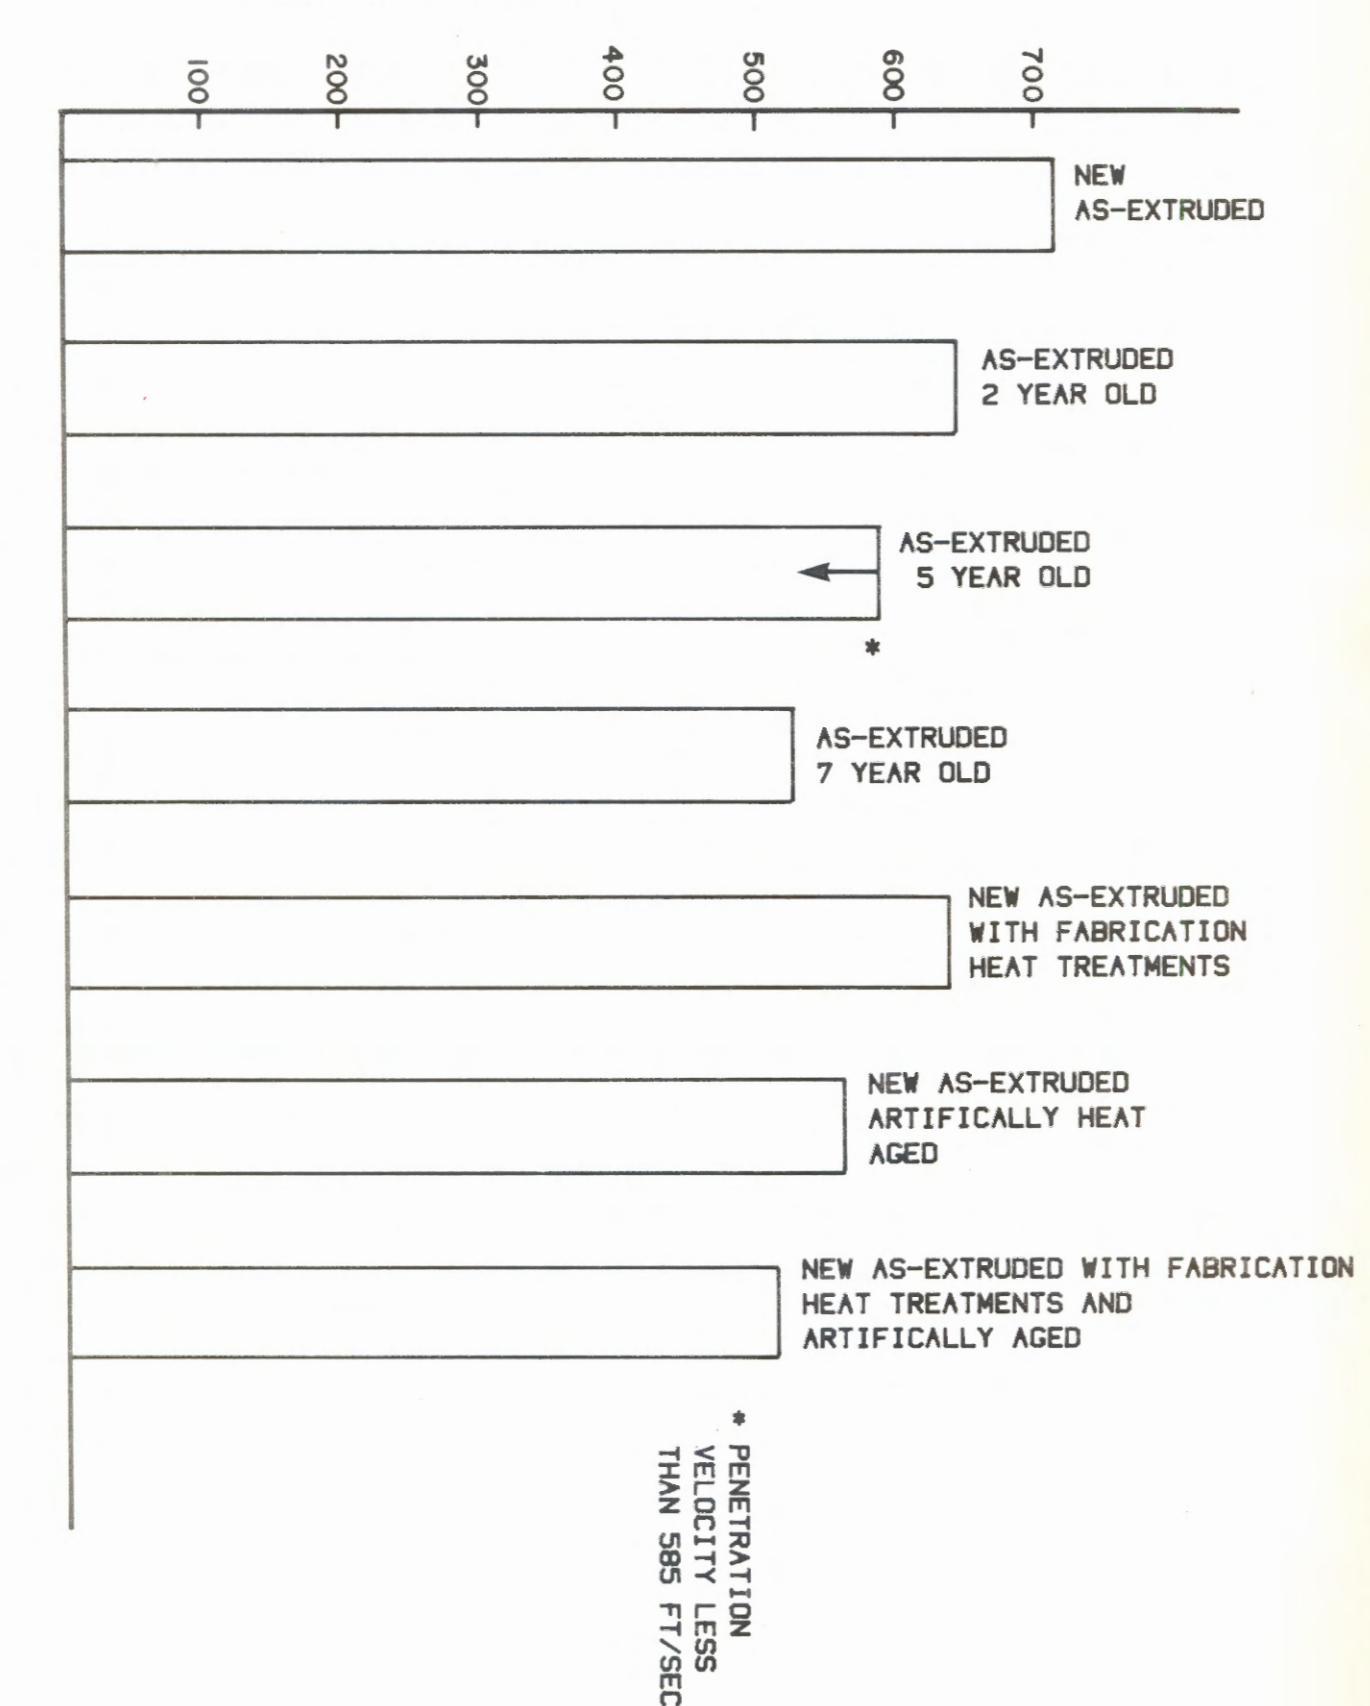
FIG.5 EFFECT OF MATERIAL HISTORY ON PENETRATION VELOCITY OF POLYCARBONATE

The results of the impacts of the 0.250 inch thick panels are summarized in Table 7. The effect of natural aging and various heat cycles are shown in Figs. 5 and 6. Typical impact results are shown in Figs. 7 to 13.
