State-of-practice, research gaps, and plan for safety and serviceability performance evaluation of residential building balconies in a changing climate

Bélec, Gilbert; Almansour, Husham

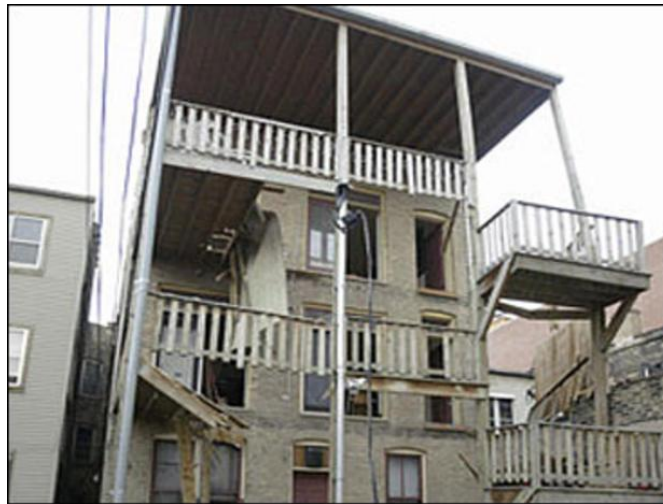
A three-storey housing complex with “double-decker” timber balconies was hosting an evening party. The third-floor deck, pictured below, was filled with as many as 50 guests when it suddenly collapsed, taking the second-floor deck down with it and sending as many as 100 guests total tumbling down into a basement pit. Witnesses reported that the balcony “looked sturdy” yet beams tore away from the wall with little warning. After the collapse, the rest of the structure was brought to the ground as it was deemed a safety hazard. Initially, blame was laid at the feet of the guests as some witnesses reported “jumping” and considered the balconies overcrowded. City inspectors would later reveal that the porch extended too far away from the building, was larger than allowed by city code, did not have proper supports, had insufficient wood flooring, and was secured to the wall with screws lacking adequate capacity.

Figure 9: Chicago balcony collapse (AP)

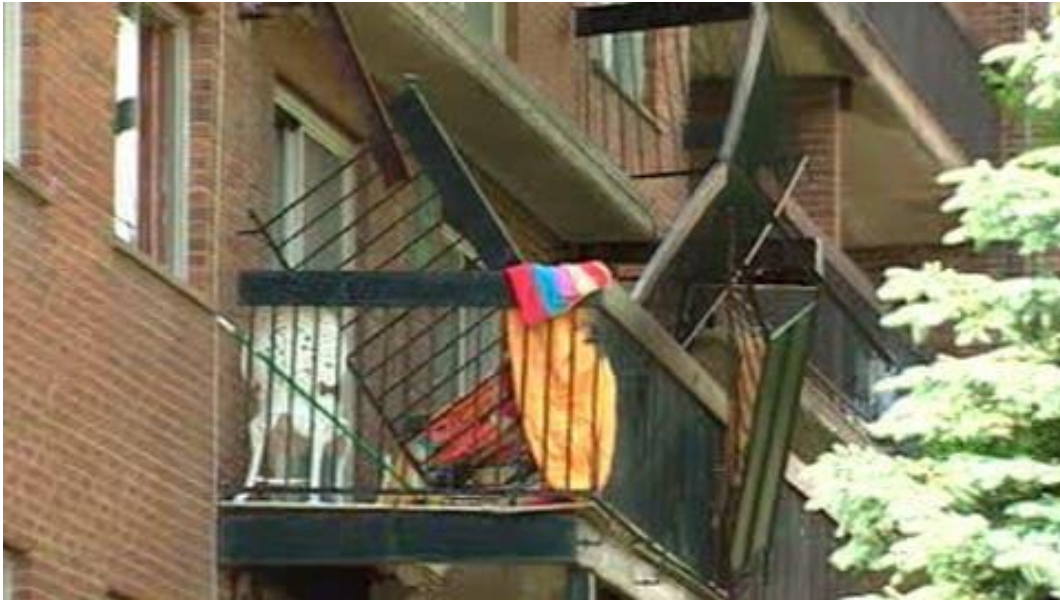
A five-storey building's occupant was sitting on her fourth-floor balcony when it suddenly collapsed, leaving her stranded, one floor below as shown in Figure 10. The balcony was constructed with concrete and structural steel and showed considerable corrosion of steel beams. The victim's neighbour, who shared the same balcony, claims water would seep inside the building at the balcony level during each rainstorm. This was the second such incident at this location, as another balcony had collapsed in the same building seven years prior.

Figure 10: 2010 St-Laurent balcony collapse (Radio-Canada)

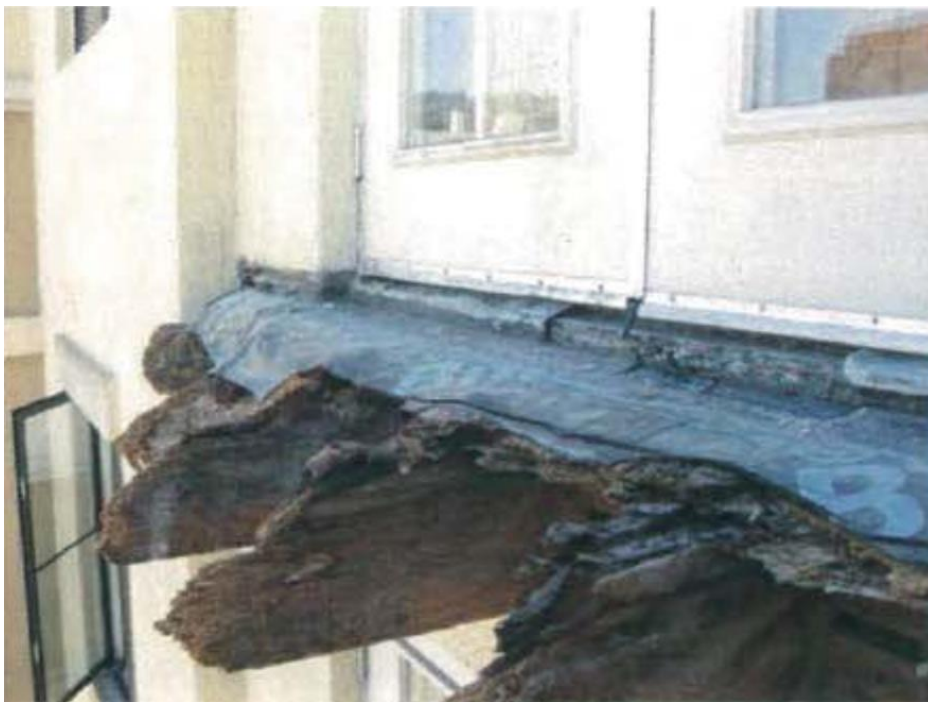
suggested that the load from the 13 occupants was within the design capacity of the balcony. The failure mechanism occurred due to dry rot which began on the top side of the cantilever beams, as seen in Figure 11, which caused the beams to fail beneath the design capacity. Despite the building being less than 10 years old, dry rot was accelerated due to the long-term presence of high moisture saturation in the sheathing layers which were in contact with the support joists. The deck material thickness was not explicitly stated on the drawing (referring to another section) leading to the contractor selecting a section only a third of the required thickness, and a sacrificial membrane was not provided by the contractor, which resulted in water infiltration that ultimately led to the incident (CSLB, 2017; Global News, 2015; McGreevy, 2017; Slowey, 2017; Taggart, 2015). Following the incident, the State of California passed bill SB-465 to legislate balcony inspections.

Figure 11: 2015 Berkley balcony collapse (CSLB)

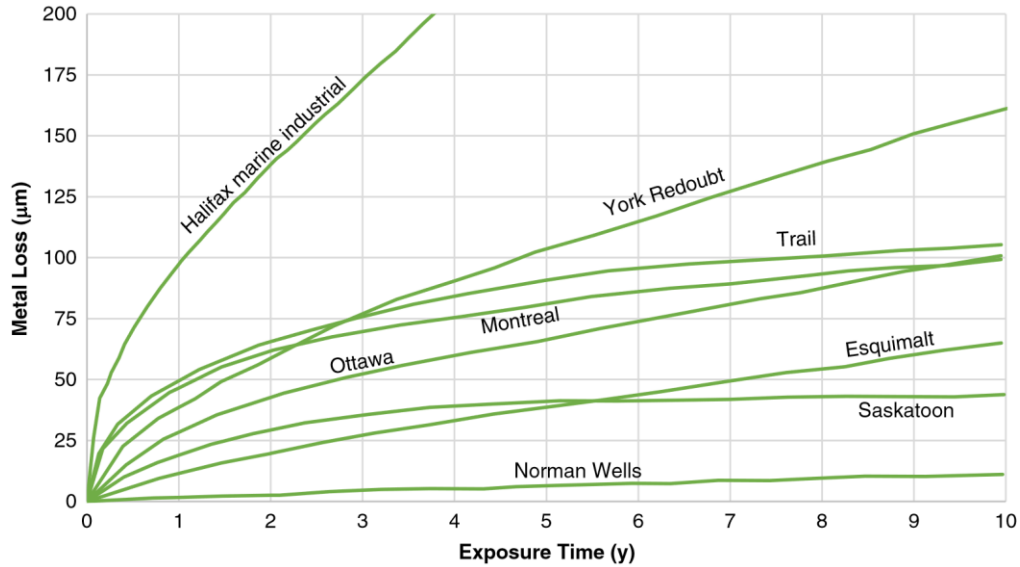
Figure 13: Corrosion mass loss as a function of time for steel in Canada

A similar assessment of steel structures was performed by (Ozkan et al., 2023). The research polled the status of steel samples in 8 cities across Canada to monitor the progression of steel loss based on time exposure to environmental effects. A comparison of loss against time for some Canadian cities can be seen in **Error! Reference source not found.** The developed methodology was also used to predict the corrosion rates up to 2100, based on predictive climate models. Over the next 80 years, it is expected that an increase in corrosion during the first year of exposure will lie between 7-20% for most locations investigated. Preservation of steel can be achieved by ensuring proper drainage so that it does not sit in a pool of water. There will nonetheless be risks of corrosion due to atmospheric humidity which can be mitigated by specialized coatings (as often done on steel bridges), however, this may be expensive for small-scale applications such as fixtures, leading building owners to typically wait until replacement of the steel is required.
