Measurements of spatial and temporal variations in ice impact pressures

Sopper, Regina; Gagnon, Robert; Daley, Claude; Colbourne, Bruce

Proceedings of the 23rd International Conference on Port and Ocean Engineering under Arctic Conditions, June 14-18, 2015, Trondheim, Norway, 2015-06

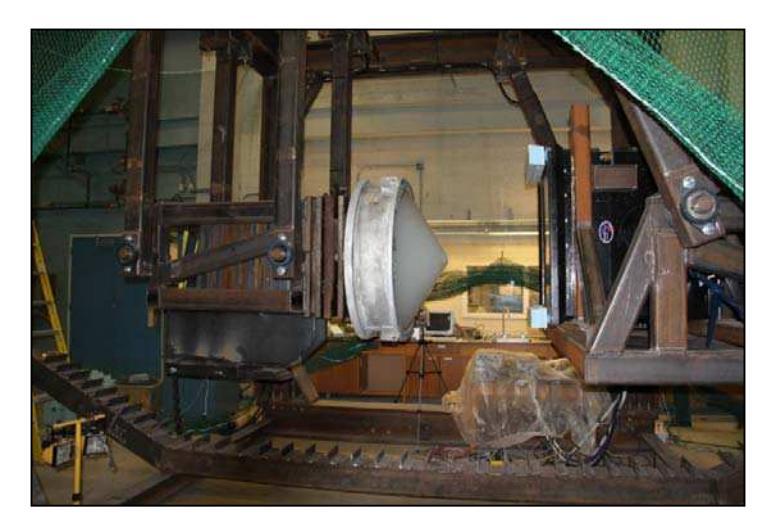
Figure 1: Large pendulum apparatus with ice cone mounted on the left carriage and Impact Module on the right.

The experimental setup involved a large double pendulum apparatus. A detailed description is given in Gagnon et al. (2015). The apparatus consists of a steel frame of approximately 4 m height with two swinging carriages. The mass of both carriages can be varied and the carriages pulled back to different angles. When the carriages are allowed to swing into each other, impacts with different energy levels at the midpoint can be created. The results presented in this paper were obtained for a release angle of 35° from the vertical for the swing arms of the pendulums. One carriage supported a 1 m diameter conical ice sample and the other supported the Impact Module as shown in Figure 1.

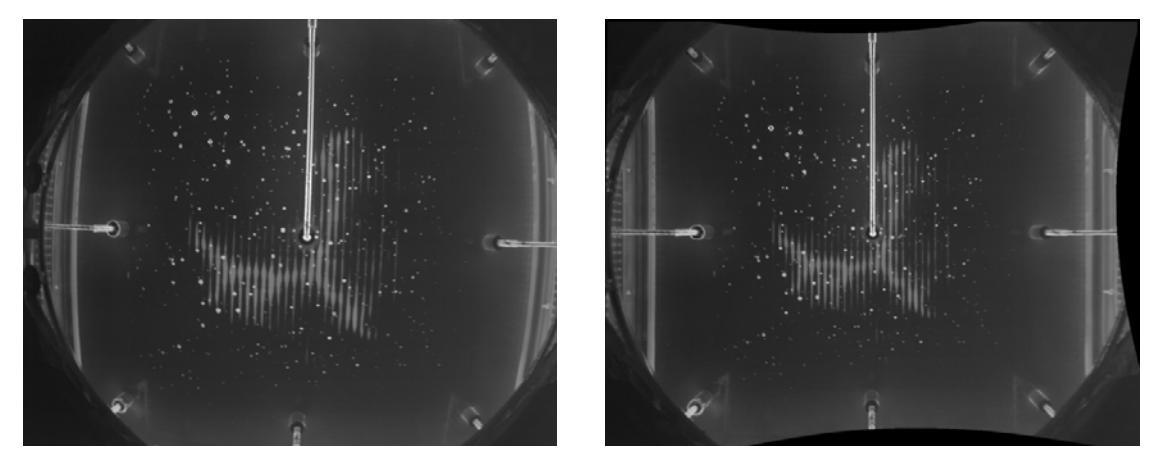
Figure 2: (Left) Raw image 18 from the high speed camera inside the Impact Module showing the contact area associated with the ice impact that appears as flattening of the pressure strips that covered the surface of the Impact Module. (Right) Image 18 corrected for distortions related to the fisheye camera lens and movement of the camera during the test. Note, the images show a cloud of small air bubbles that are remnants of the acrylic block casting process. These bubbles do not influence results from the experiments.

Several steps using different software packages were involved in the analysis of the contact area images. The high speed camera behind the acrylic block was mounted on a small block that rested on four silicone pads to compensate for vibration during the dynamic impact. However, the setup allowed some movement in the horizontal as well as vertical directions with respect to the impacted surface. Furthermore the high speed camera was instrumented with a fisheye lens to capture almost the entire area of the pressure panel. These circumstances resulted in a series of pictures with slightly shifting centres and distortions. This was taken into account by manually processing the images using the software PTLens 8.7.8TM. Each frame was centred, rotated and the lens distortion removed. Figure 2 shows image 18 from the test. In the raw picture on the left the clockwise rotation and the lens distortion are clearly visible. Both these aspects are removed in the corrected image on the right.

The objective of the analysis of the images is to determine the areas where the acrylic strips (white vertical strips in the image) have been compressed and the degree to which they have been compressed. The small white dots that are apparent in both images are air bubbles enclosed in the acrylic block resulting from the casting process.

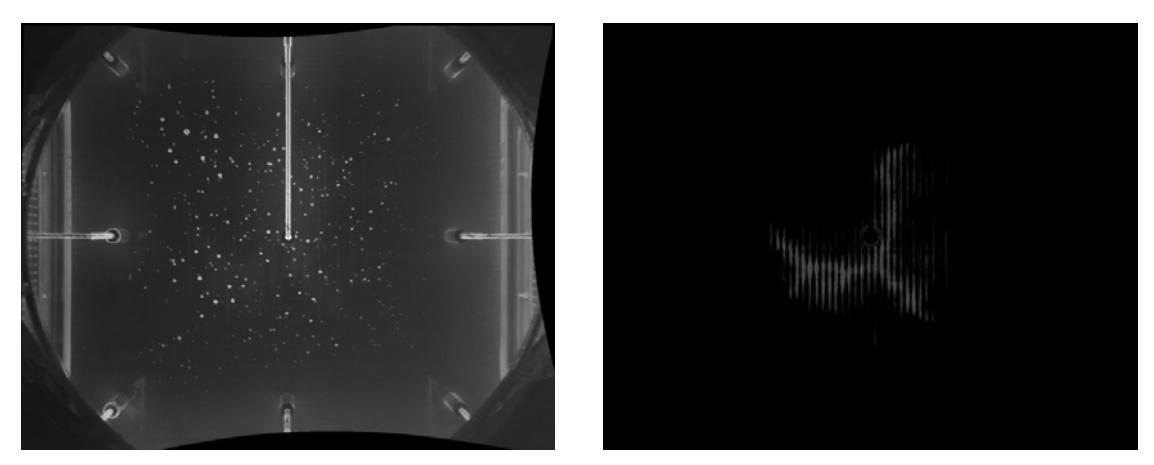
Figure 3: (Left) Null image of image 18. (Right) Image showing the result of subtracting the null image from the corrected image where only the pressure strip information is visible.

In order to analyse the images the pressure information (i.e. the white vertical strips) needs to be separated from the background of the images. Therefore, a null image for each image was created using Paint Shop Pro 6^{TM} . To do this, first light areas representing the signal from the acrylic strips were shaded to the colour of the background in their vicinity so that the image only showed the background as it is displayed on the left in Figure 3. This null image was

then subtracted from the initial (corrected) image. The resulting image displayed only the acrylic strip contact area. There were some small black holes in the strip areas where air bubbles were located. In order to make up for this area lost due to the subtraction process the black holes were manually filled in to obtain an image, as shown on the right in Figure 3, that is ready for the next stage of analysis.

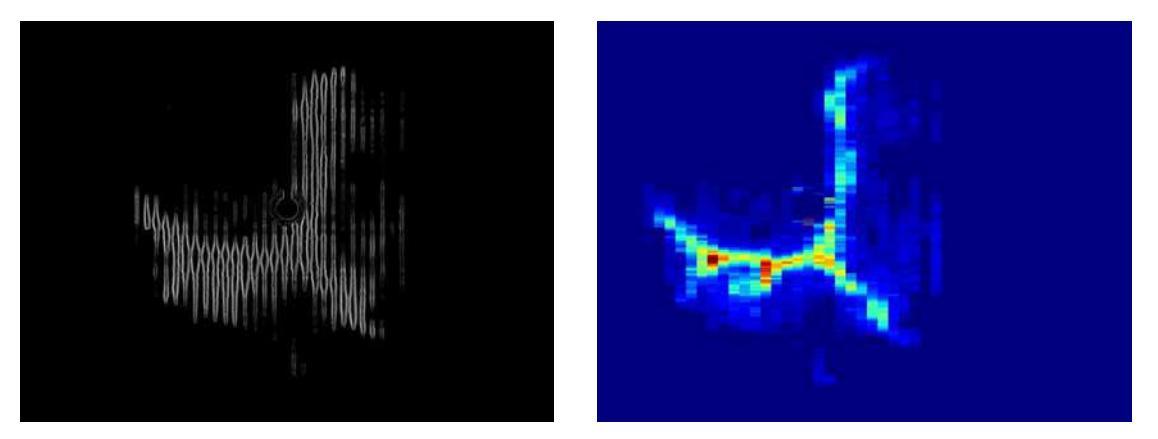
Figure 4: Close ups of image 18. (Left) Image showing edge detection. (Right) The resulting pressure distribution. A scale of suitable size for viewing is included with the full set of analysed images in the appendix. The width of each image corresponds to 0.64 m.

In order to convert the pressure strip information of the image to pressure data it is necessary to measure the contact width along each of the pressure strips. To do this efficiently, the pressure strip image was edge-detected using the software ScanProTM. Then a dedicated computer code, written in the software PythonTM was applied to the edge-detected image to determine the width of each strip at all points along its full length. The program converts the width of the strip at each point along its length to the pressure at that point. The result of the edge detection step is shown on the left and the resulting pressure distribution on the right of Figure 4. In addition the software calculates total load, total area, average pressure and maximum pressure.

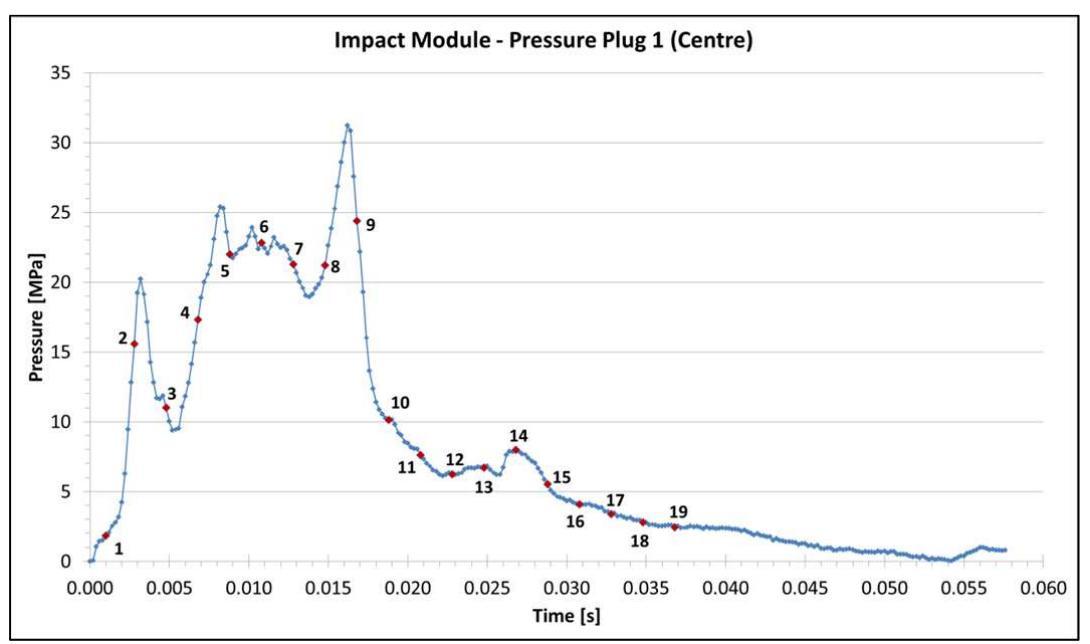
Figure 5: Pressure-time history of the centre pressure plug. The red markers and associated numbers correspond to the points in the record when images were acquired.

In image 2 the shaded area is rather circular implying that the tip of the ice cone hit the Impact Module in the centre where the pressure plug is located. Subsequent images display high pressure zones emerging in the middle of the contact area as it is indicated in red colours. Up to image 8 these evidently form one fairly large connected area. Between images 9 and 10 a significant spalling event occurred in the vicinity of the pressure plug and was therefore quiet evident in the record in Figure 5. This is shown by the sharp drop in pressure that arose when the portion of the ice contact area that encompassed the pressure sensor suddenly broke away.

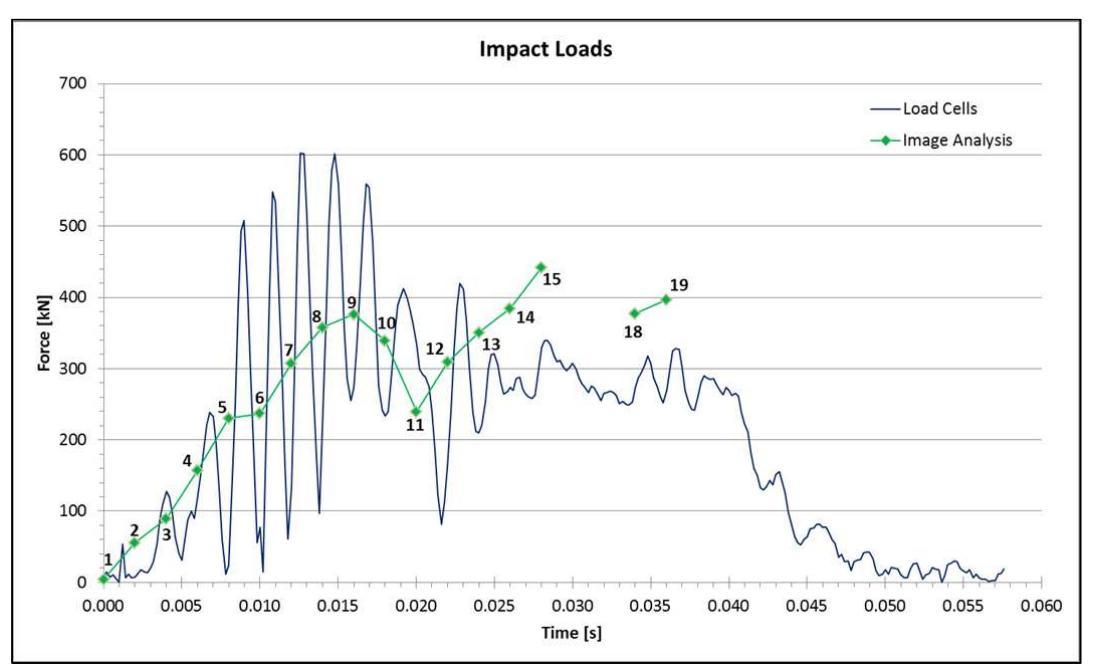
Figure 6: Force-time plot of the output of the load cells and the integrated loads of the image analysis.

we would expect that the integrated values tend to be higher than the actual values of the load cells output. This is due to the temperature at which the pressure strips were calibrated as discussed above. The other factor that comes into play when integrating the pressure is the offset introduced into the data due to the fact that the central pressure plug obscures part of the pressure pattern for centrally located ice contact. We see evidence of both of these effects when we plot the output of the load cells and the load as determined using the image integration in one graph (Figure 6).

In Figure 6 the load cell record shows large oscillations near the beginning which correspond to resonant oscillations of the Impact Module load sensing system. While these oscillations do not reflect the actual loads, the average values of the oscillations are reasonable estimates of the true load. The data plot of the integrated image loads does not display the oscillations that are apparent in the load cell data because the pressure sensing technology has a significantly higher resonant frequency that is not excited during these tests. Furthermore up to image 10 the load data from the images roughly passes through the average of the oscillations in the load cell data.

Starting with the earlier part of the test (images 1 to 10) we may have expected that all of the load data from the images would have been higher than the values from the load cells as is evident in images 13 to 19. However, the other competing factor (i.e. that part of the area is concealed by the pressure plug) seems to compensate for the overestimation. For images 1 to 10 the pressure plug is centrally located in the pressure patterns and therefore reduces the visible contact areas and the integrated loads. The two competing effects seem to roughly balance out for images 1 to 10. On the other hand in images 13 to 19 the pressure plug is not encompassed by the contact area so it does not influence the integrated image loads. Therefore for these images only the offset associated with the calibration temperature is present.

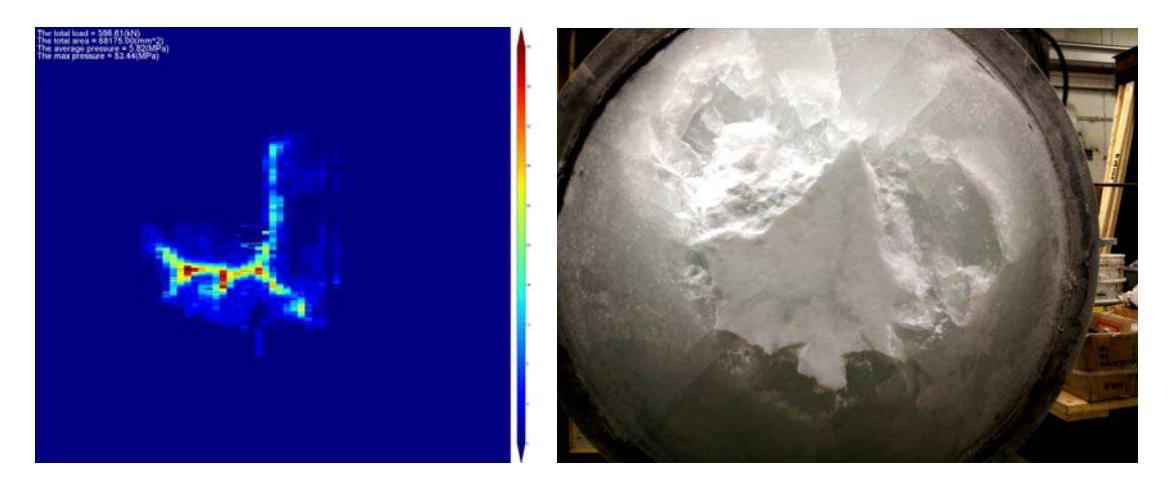
Figure 7: (Left) The pressure distribution from a image captured near the end of the impact, i.e. when ice penetration had stopped. The size and shape of the contact region is distinctly different than earlier in the test as shown in the appendix. (Right) A photograph of the impacted ice sample shortly after the ice holder has been removed from the apparatus. The shape of the high pressure contact region, as depicted on the left image, is clearly visible as the darker area of the contact zone. (Taken from Gagnon et al. (2015))

On the left in Figure 7 the pressure pattern for the last image of the test is shown that occurred when the ice penetration had come to a complete stop. On the right is a photograph of the ice sample after it had been removed from the apparatus. The hard zone area of the impact region is clearly visible as the branching dark area on the contact surface of the ice that corresponds to relatively intact ice. The shape of this hard zone is closely reflected in the pressure distribution on the left of Figure 7.

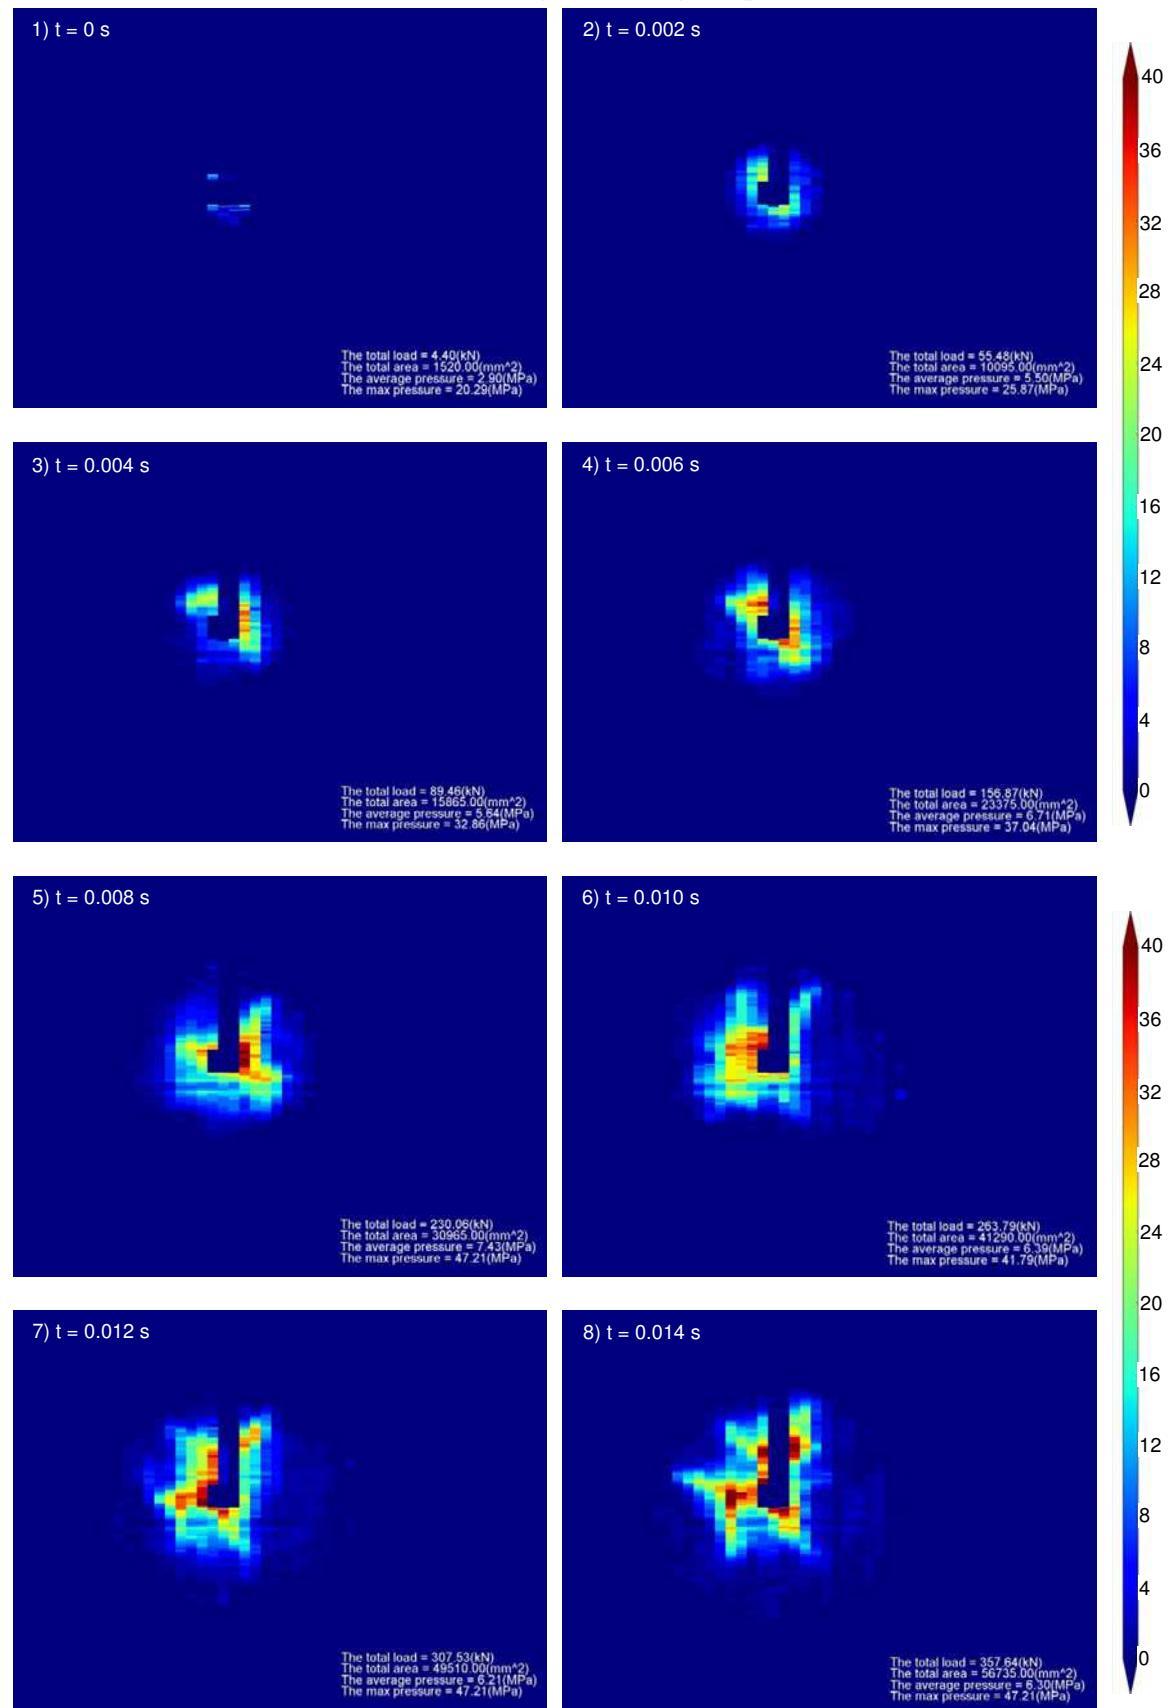
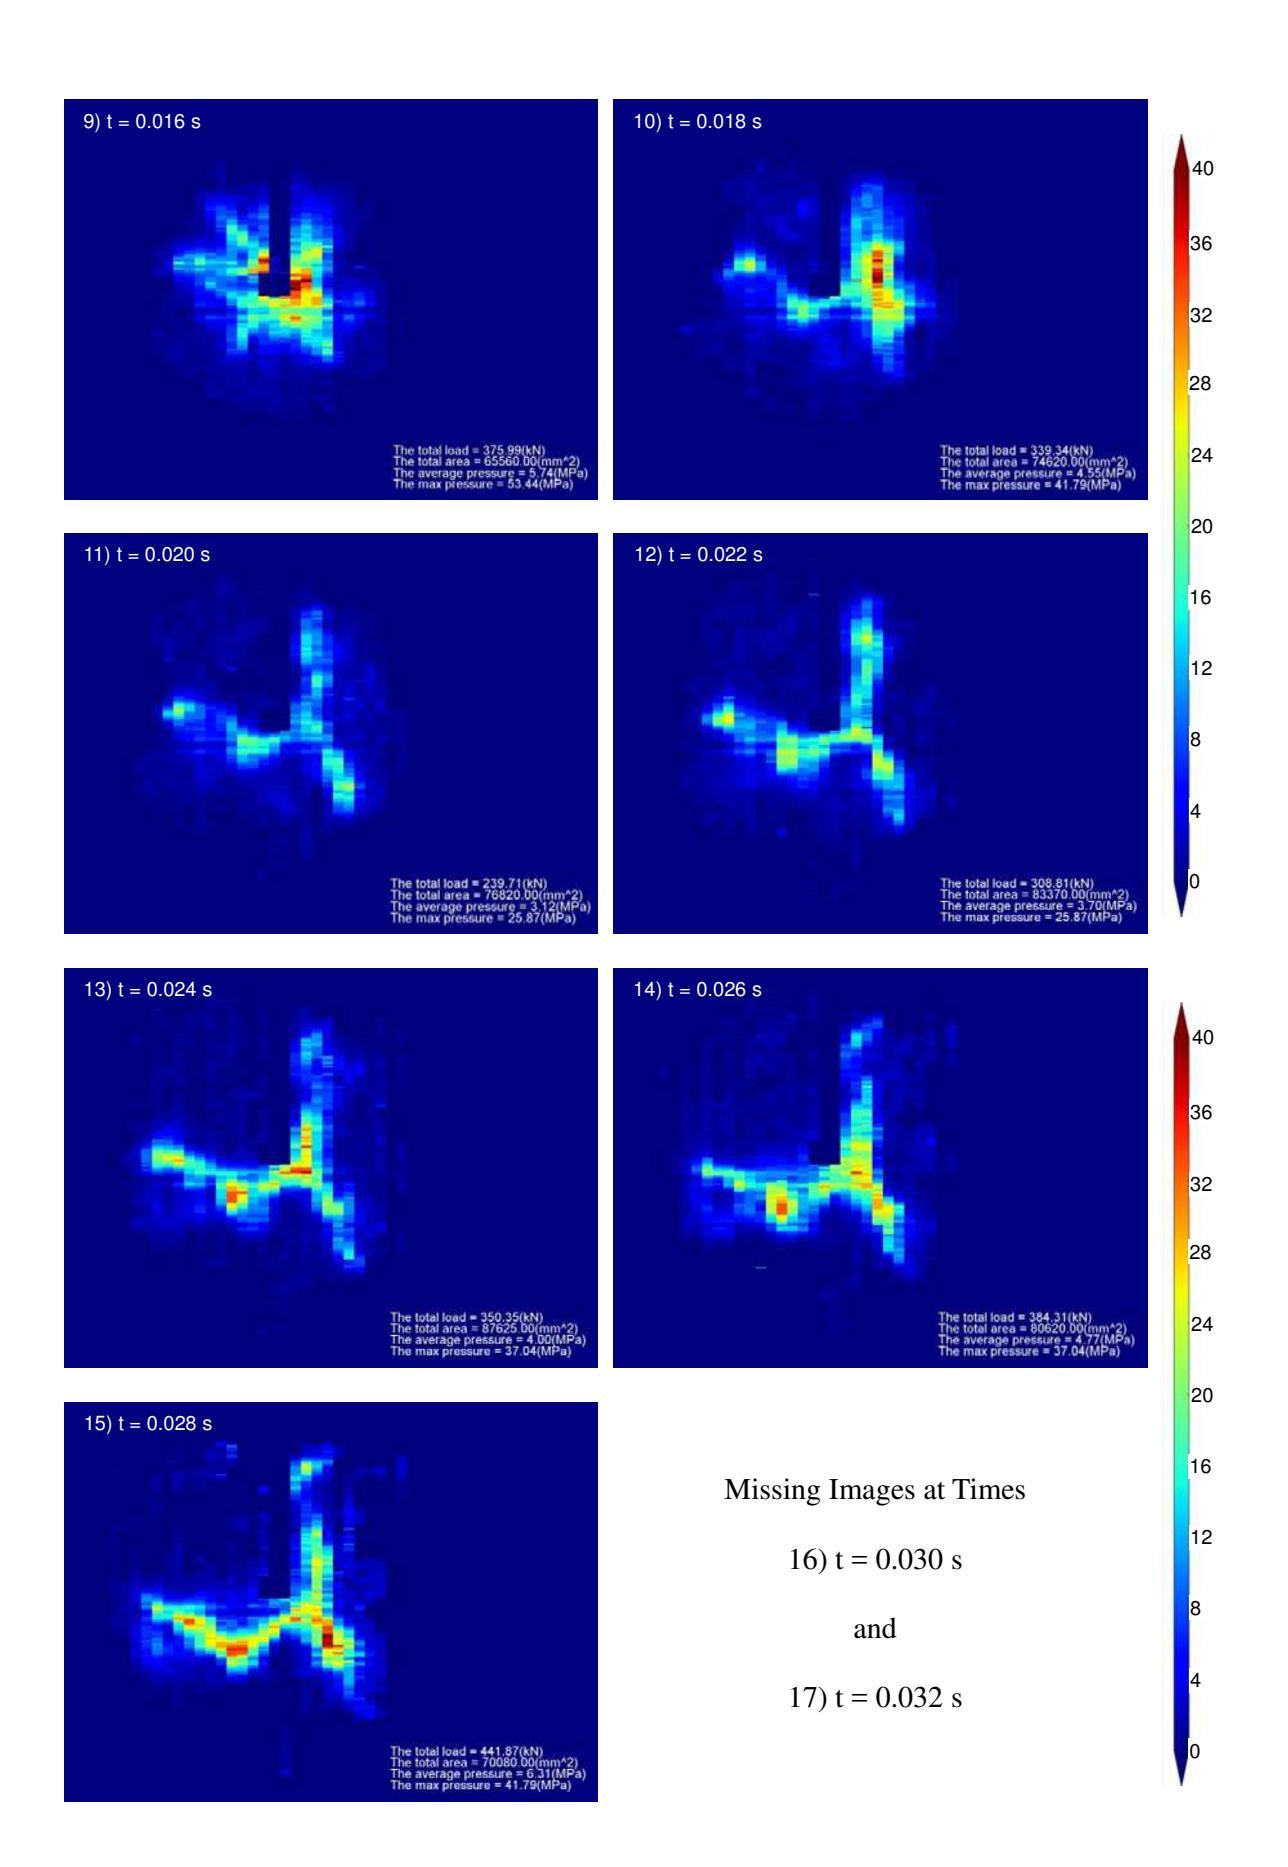
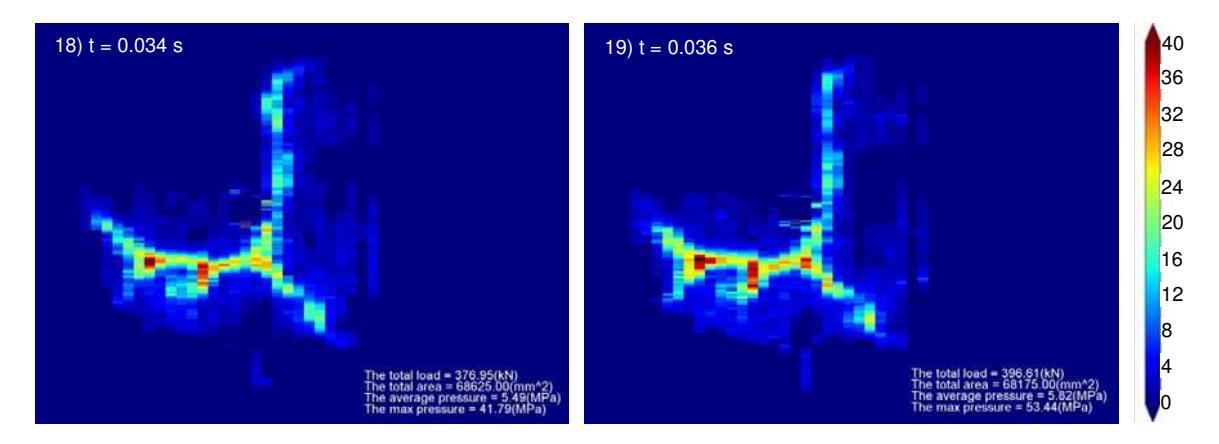
APPENDIX: 17 Analysed images showing the pressure distribution

The width of each image in the appendix above corresponds to 0.64 m. The unit on the colour scale is MPa.

The series of images (appendix) clearly shows a characteristic pressure pattern. Zones of high pressure are surrounded by zones of lower pressures. The former would consist of relatively intact ice whereas the latter would be pulverized spall debris. As the event proceeds, the increasing contact area progressively shows a distinct branching pattern. This was found to be characteristic of all other crushing and impact tests that we conducted using cone shaped ice samples at high rates.

While it is instructive to study the images individually it is also very useful to view the images in a movie sequence. Dynamic behaviour becomes more evident when the sequence is viewed multiple times. For example the flow of crushed ice (low pressure areas) away from high pressure zones is quite visible from images 9 to 19.
