# INVESTIGATION OF GROUND AND MAINTENANCE CREW NOISE EXPOSURE FOR THE ROYAL CANADIAN AIR FORCE CH-147F HELICOPTER

Andrew Price, Sebastian Ghinet, Viresh Wickramasinghe, Yong Chen, Anant Grewal  
NRC Aerospace, Flight Research Laboratory, Ottawa, Canada

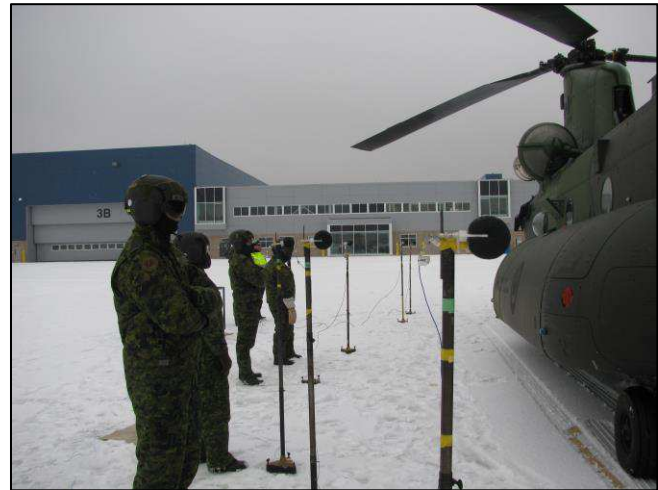
Figure 2: Exterior Noise Measurement

The microphones were mounted at a standing height as per ISO 5129 on fixed hard-mount stands and fitted with windscreens. Each stand and cable combination was managed by a ground crew member whilst in the vicinity of the running aircraft. The approximate locations of the sensors are shown in Figure 1 and Figure 2. The microphone locations are labelled in Figure 1. The eight locations on the starboard side of the helicopter are the exterior ground measurement locations. The remaining locations are interior measurements which will not be discussed in this paper.

The helicopter exterior noise data was collected using an LMS SCADAS front end, eight ICP Piezotronics 378B02 microphones and a Dell precision M6500 laptop workstation. Post processing was completed in LMS Test.Lab.
