*Proceedings of the 8th International Conference on CANDU Maintenance, 2008, 2009-01-01*

# DEVELOPMENT OF NON-DESTRUCTIVE CONDITION MONITORING TECHNIQUES FOR LOW-VOLTAGE CABLES

F. Guérout<sup>1</sup>, L. Cissé<sup>1</sup>, R. Boor<sup>1</sup>, and A. Blouin<sup>2</sup>

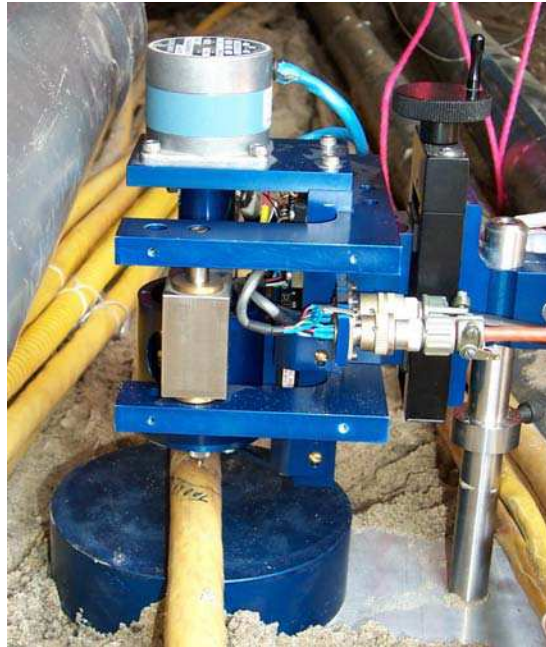
**Figure 1 EDST Test Stand Used to Assess Damaged Cables at CRL**

A sophisticated laboratory indenter called the Elasto-Dynamic Spot Tester (EDST) was first developed at AECL in the early nineties. Initially, the EDST was used to derive the elastomer spot stiffness during indentation and also to study various post-indentation viscoelastic properties, such as the percentage of force relaxed after a given time and the time to recover a given percentage of the initial deformation. A photograph of the EDST used for cable aging assessment at the CRL site is shown in Figure 1 below.

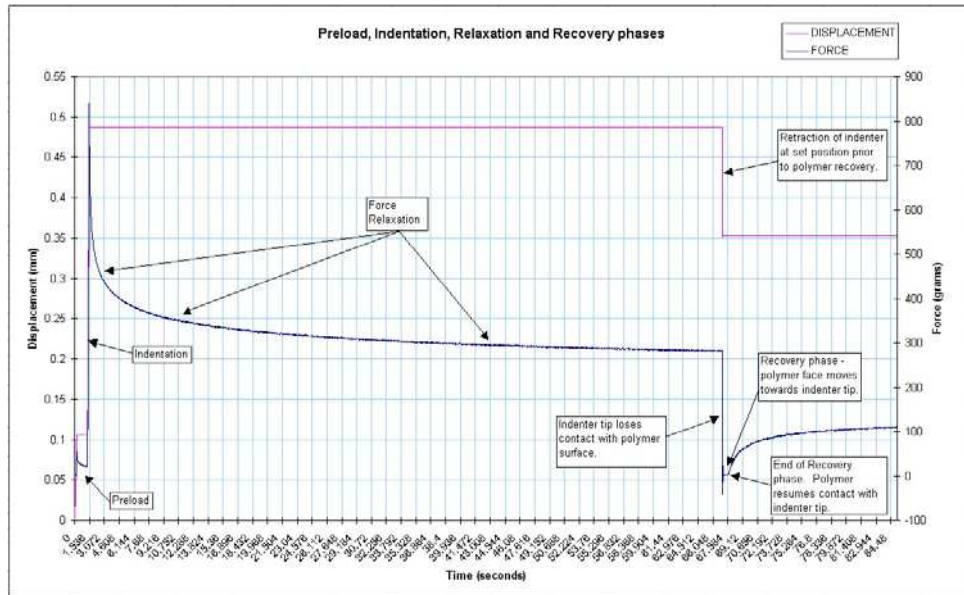
**Figure 3 Typical Test Sequence for the Portable Polymer Tester**

The test sequence and data acquisition are controlled using a computer with Windows XP operating system. The Windows programming environment is LabView®<sup>3</sup> based. The Portable Polymer Tester offers the option of programming the indenter probe profile and controlling the probe position to derive post-indentation parameters. These parameters are similar to those accessed using the EDST. They include the force relaxation (once the material has been indented), and the time to recover a set percentage of initial deformation (once the indenter is quickly retracted following the relaxation phase). A typical PPT sequence is shown in Figure 3.

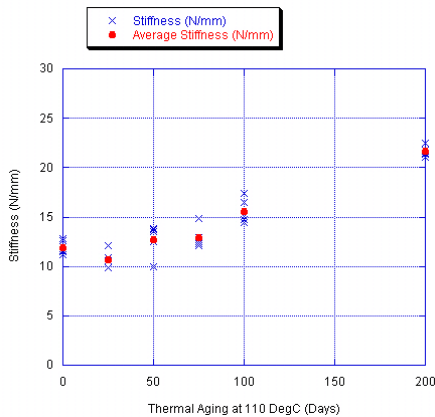
**Figure 4 Stiffness for a Thermally Aged PVC Cable Jacket**

A series of PVC cable jacket samples was thermally aged at 110°C in a ventilated oven for durations of up to 200 days. The stiffness results are shown in Figure 4. There is a gradual change in stiffness as a function of the number of thermal aging days, from 11.9 N/mm for the unaged samples to 21.7 N/mm for samples thermally aged during 200 days at 110°C. The time to recover 35% of the initial deformation is shown in Figure 5 as a function of days of aging at 110°C. It can be seen that the recovery time is very sensitive to the effect of increased thermal aging duration, with a change of about +75% after 50 days, +167% after 75 days, +392% after 100 days, and +788% after 200 days.

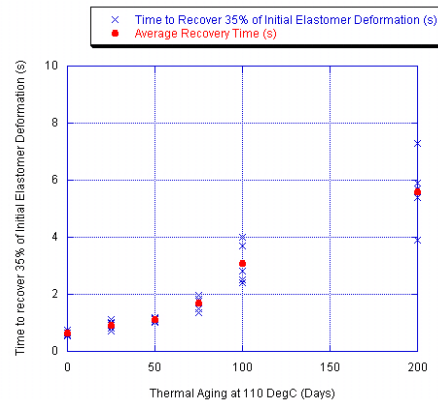
**Figure 5 Recovery Time for a Thermally Aged PVC Cable Jacket**

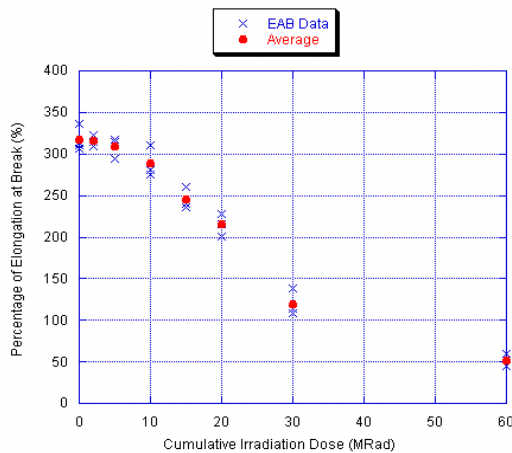
**Figure 6 EAB Results for the Irradiated Cable Jacket Samples**

A series of PVC cable jacket samples were irradiated in a gamma cell at doses ranging from 2 to 60 MRad. The reference elongation-at-break data for these irradiated PVC cable is shown as a function of irradiation dose in Figure 6. The graph shows that at 60 MRad the elongation-at-break is down to 50%, a level of degradation that corresponds to the commonly accepted end-of-life point for a cable [2].

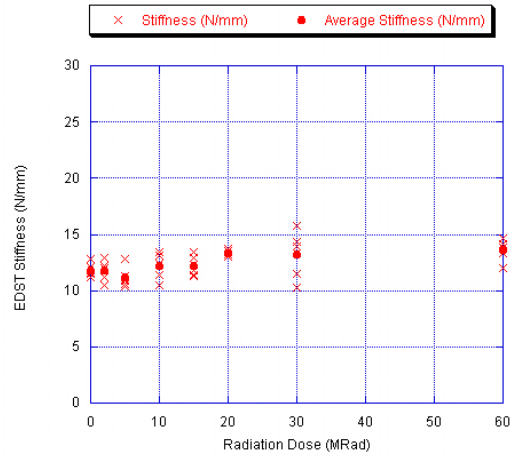
**Figure 7 Stiffness Results for the Irradiated Cable Jacket Samples**

The stiffness results for irradiated PVC cable jacket samples are shown in Figure 7. The stiffness parameter is not sensitive to the degradation resulting from PVC irradiation. This confirms what was found for earlier studies reported in the literature [2].

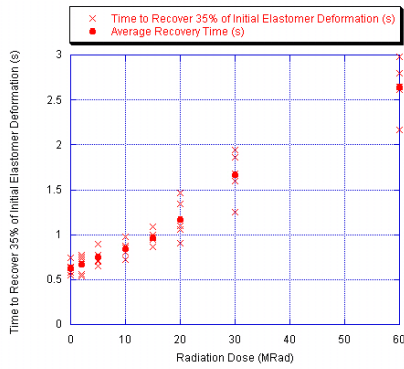
**Figure 8 Recovery of Deformation for Irradiated Cable Jacket Samples**

The recovery of deformation data for the same irradiated samples is shown in Figure 8. The time to recover one third of the initial deformation increases almost linearly as a function of irradiation dose. From the unaged condition, there is an increase of the average recovery time of 33% at 10 MRad, 86% at 20 MRad, 165% at 30 MRad, and 320% at 60 MRad. Therefore, this new approach using the recovery time provides a means of assessing, for the first time, the degradation of irradiated PVC while using an indentation method. Moreover, the deformation recovery time correlates very well with the EAB values measured for the various irradiation levels, with both parameters being extremely sensitive to the material degradation. The good correlation between the elongation-at-break and the time to recover one third of the initial deformation is shown in Figure 9.

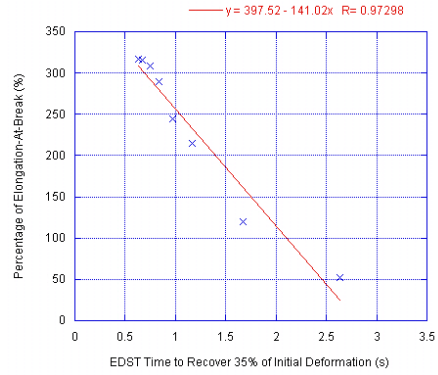
**Figure 9 Correlation of EAB and EDST Recovery Results**

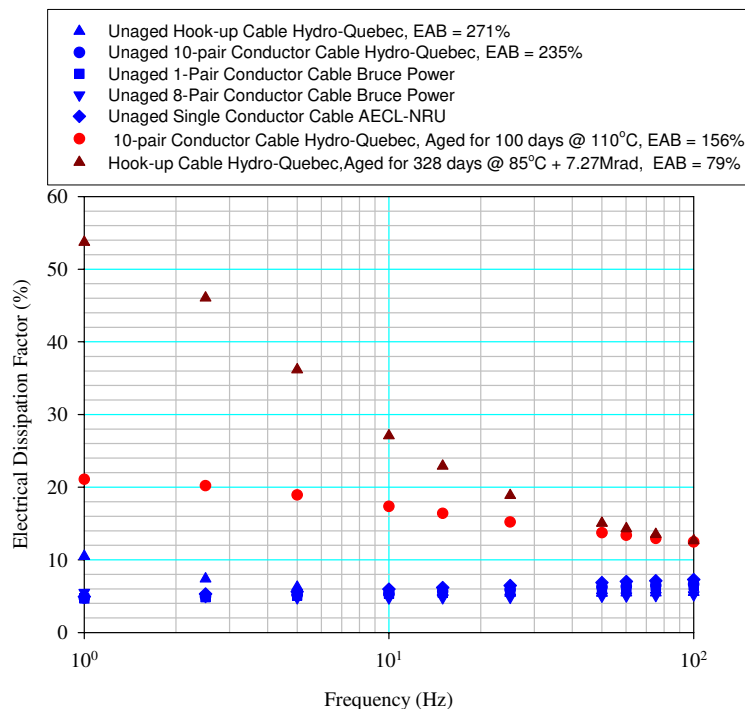
**Figure 12 Comparison of Electrical Dissipation Factor Results Obtained for a Variety of PVC Cables Using the Semi-Conductive Tape Technique**

The electrical dissipation factor results obtained for these five unaged cables at frequencies ranging from 1 to 100 Hz are shown in blue in Figure 12. The reference EAB measured for two of the unaged cables was 271 and 235%, respectively. The electrical dissipation factor values are very repeatable from one type of PVC insulation to the other. For example, at 10 Hz, the data obtained for the five cable samples was always between 4.5 and 6 %.

One of the 10-pair conductor cable provided by Hydro-Quebec was thermally aged at 110°C (EAB of 156%). The broadband electrical dissipation factor measurements on this sample are shown in red in Figure 12. The results show that the technique is very sensitive to cable degradation especially at low frequencies. For this thermally aged cable, the electrical dissipation factor measured at 5 Hz, increased by a factor of three from the unaged reference data.

One of the hook-up single conductor cable was thermally aged for 328 days at 85°C and irradiated to a dose of up to 7.27 Mrad (EAB down to 79%). The broadband electrical dissipation factor measurements on this sample are shown in brown in Figure 12. For this thermally aged and irradiated cable, the electrical dissipation factor measured at 5 Hz, increased by a factor of six from the unaged reference data.

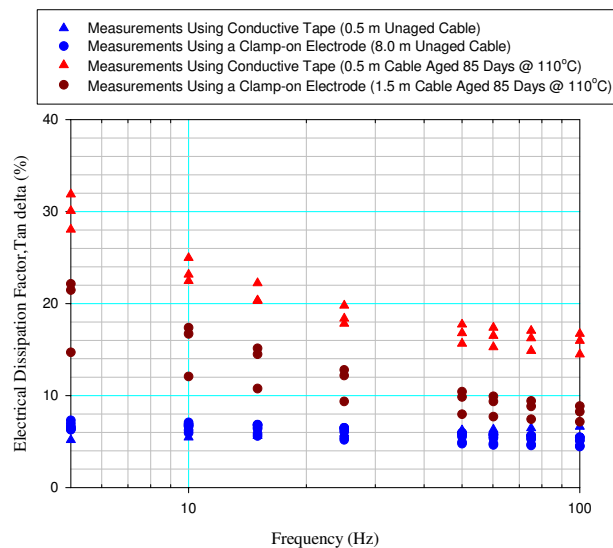
**Figure 13 Comparison of Electrical Dissipation Factors Measured Using the Semi-Conductive Tape and the Clamp Electrode Techniques**

Although the clamp electrode measurement technique is more rudimentary than the reference semi-conductive tape technique, the results obtained for an unaged cable were in good agreement and were consistent when taken over the entire length of the cable. For thermally aged cables the sensitivity to cable degradation decreased slightly when using the clamp electrode from what could be detected when using the semi-conductive tape. However, the degradation was still revealed. For example, as shown in Figure 13, when applied to a PVC cable thermally aged for 85 days at 110°C, the average semi-conductive tape tan delta measured at 5 Hz was 30%. The corresponding clamp electrode average value was 20%. The electrical dissipation factors measured on the unaged sample using both techniques were 5 and 6.5%, respectively.

The electrical dissipation factors measured using this technique are similar to what was previously obtained when using the semi-conductive tape laboratory technique. For a PVC cable thermally aged during 85 days at 110°C, the semi-conductive tape tan delta measured at 10 Hz ranged from 22 to 25% (see Figure 13). The electrical dissipation factor measured from cable end ranged from 18 to 22%, as shown in Figure 14. The electrical dissipation factors measured on the unaged sample using both techniques were around 5% (see Figures 13 and 14).

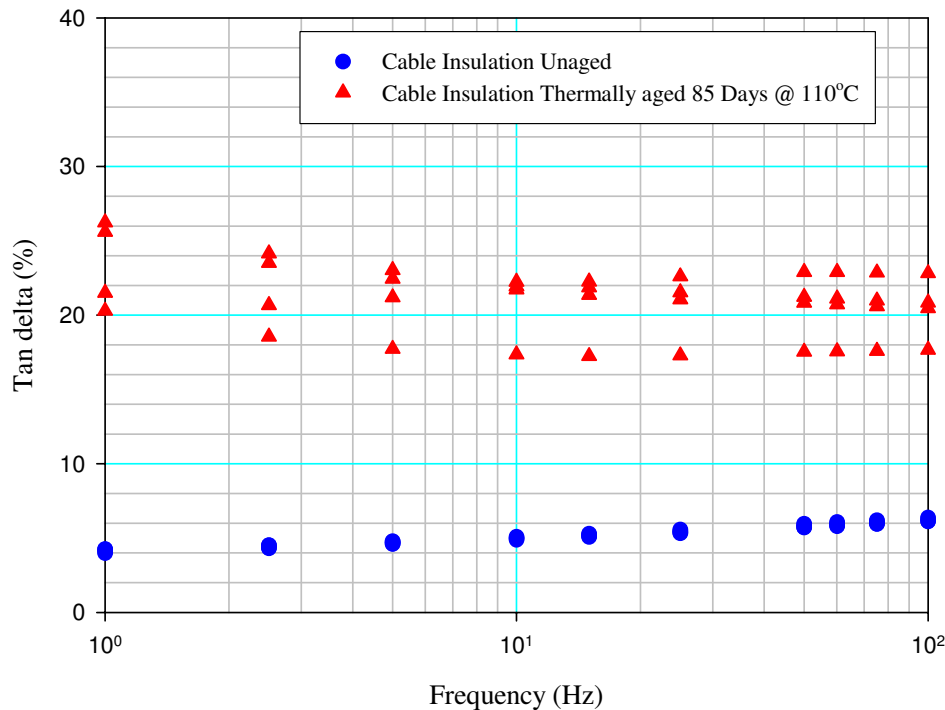
**Figure 14 Electrical Dissipation Factors Measured from the Cable Ends of a Multi-Pair Conductor Cable**

This technique was developed for jacketed multi-pair conductor instrumentation and control cables. For these cables, the conductors within one pair are intertwined and, as a result, the insulation of both conductors is in contact at multiple points along the length of the cable. The input voltage electrode is directly connected to one of the conductors. The measuring electrode is connected to the second conductor within that pair. A third electrode is connected to a ground wire within the cable. The ground wire is used as a guard electrode. The electrical dissipation factor is measured using the insulation contact points within one given pair of conductors. Therefore, it provides a global assessment of the insulation degradation over the entire length of the cable (via the contact points), and there is no cable length limitation to the application of this technique.

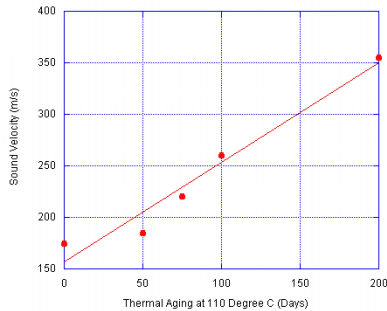
**Figure 16 Sound Velocity for Cable Samples Thermally Aged at 110°C**

Measurements were then taken for a variety of thermally aged cables (aged 50, 75, 100, and 200 days at 110°C). The results are shown in Figure 16. The sound velocity increased linearly with aging from 175 m/s for the unaged cable to 355 m/s for the cable aged 200 days at 110°C. The sound velocity measured for the low frequency is therefore highly sensitive to cable degradation. Moreover, as shown in Figure 17, there is a strong correlation between the reference EAB results and the sound velocity results.

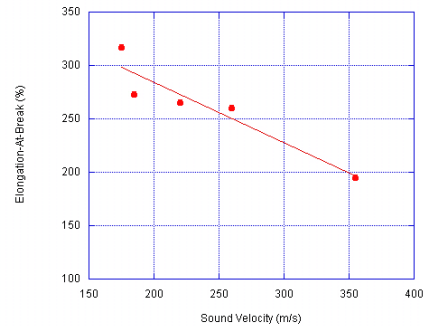
**Figure 17 Correlation of Elongation-At-Break and Sound Velocity for Cable Samples Thermally Aged at 110°C**
