Marine Icing System Modifications to System 1 Farr, J.

Laboratory Memorandum, 2006

LM-2005-07

Marine Icing System Modifications to System 1

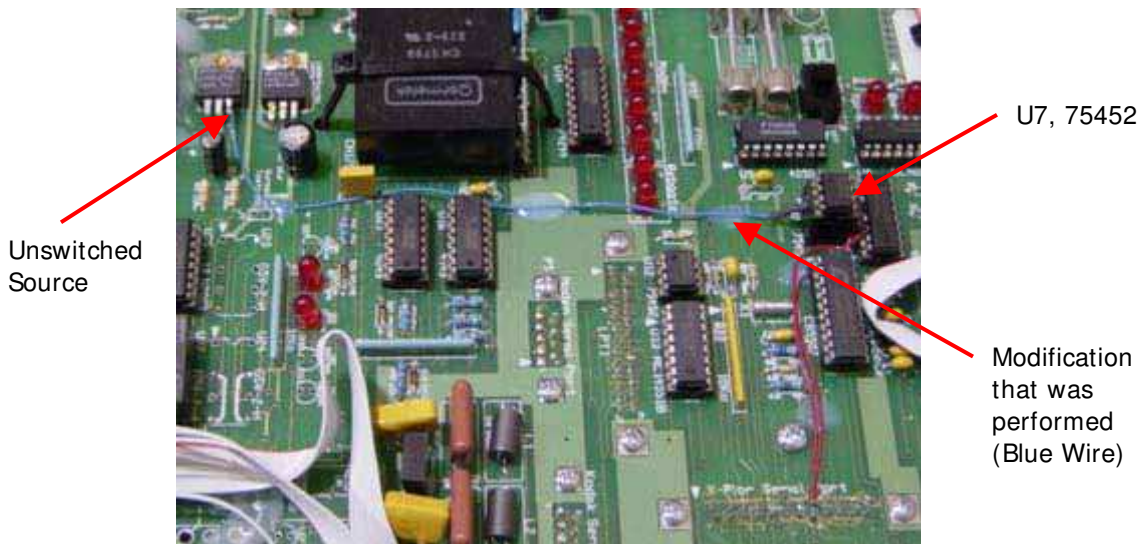
The system as it was delivered had a small bug that may have caused complications in the field. This bug caused the wiper blades and pump for each camera enclosure to momentarily engage and do one complete wipe and spray. This may have caused problems in the field if the power was cycled for some reason and ice or snow had accumulated on the glass of the camera enclosure. Erdman video systems supplied us with a solution for this problem. Technically, the problem was with a switched power source being used instead of an unswitched source. The chip that was affected was U7, 75452. To remedy this problem, two pins on the 8-pin, U7 IC had to be removed from the current circuitry and then tied to an unswitched source. The following picture shows the modification that was performed.

Figure 1. Board modifications

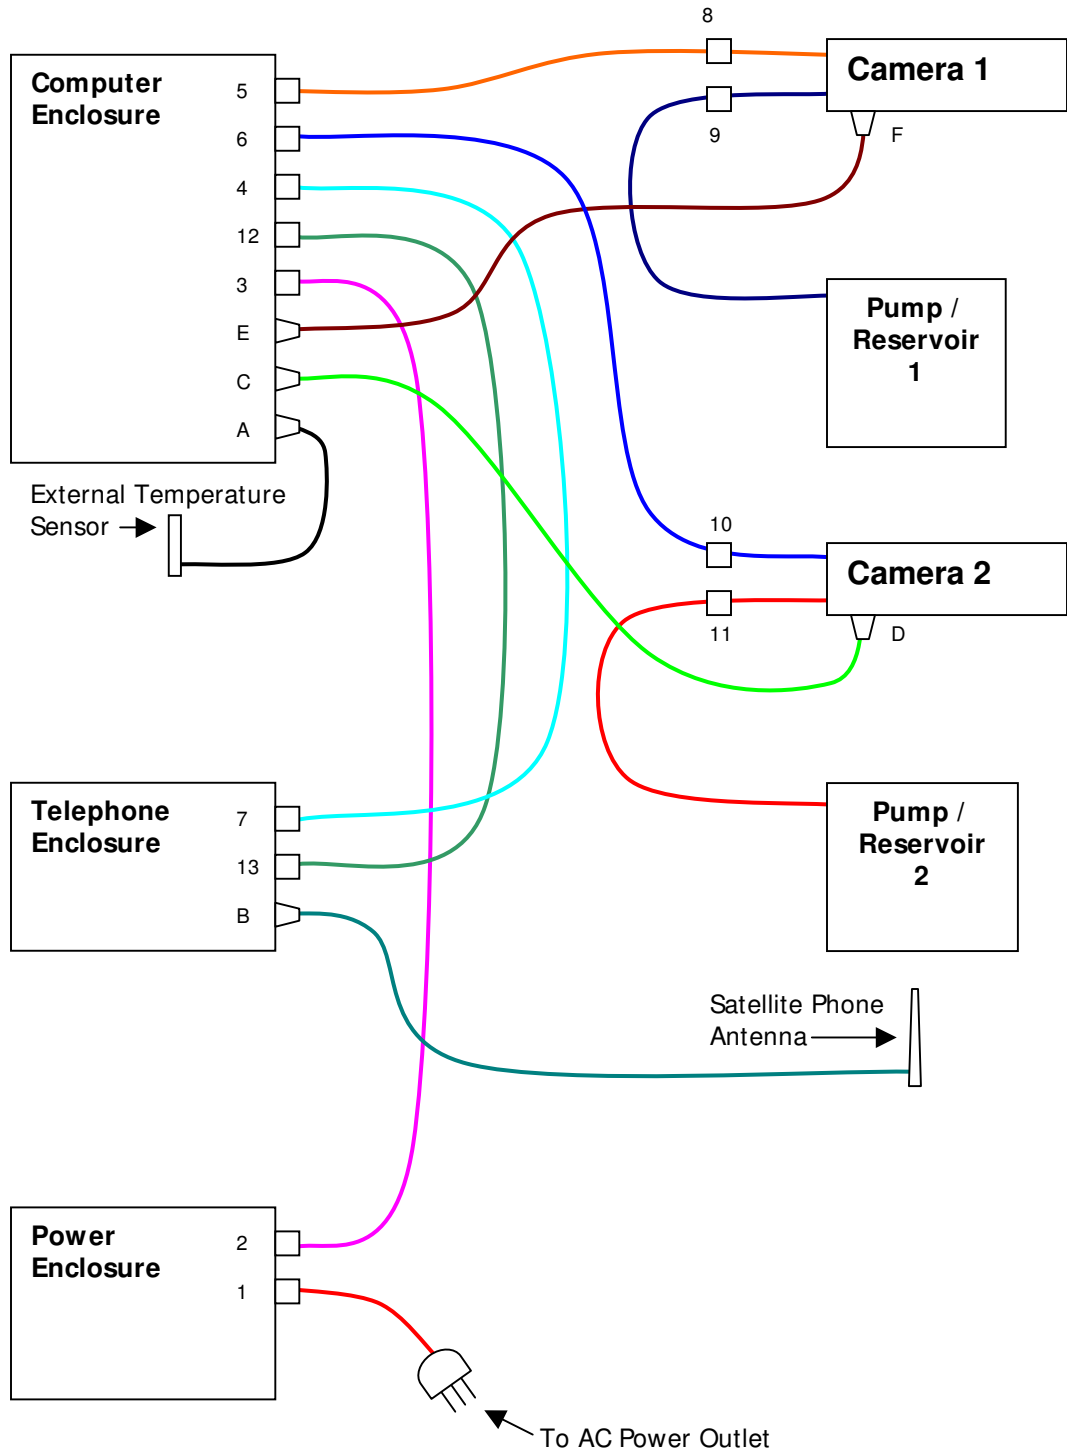
Figure 2. Connection Diagram

Check all connections to insure that they are done correctly. It would be advisable to take a photocopy of Figure 2 to use as a checklist for connections. Check the position of the main power switch on the computer enclosure and make sure it is in the off position.

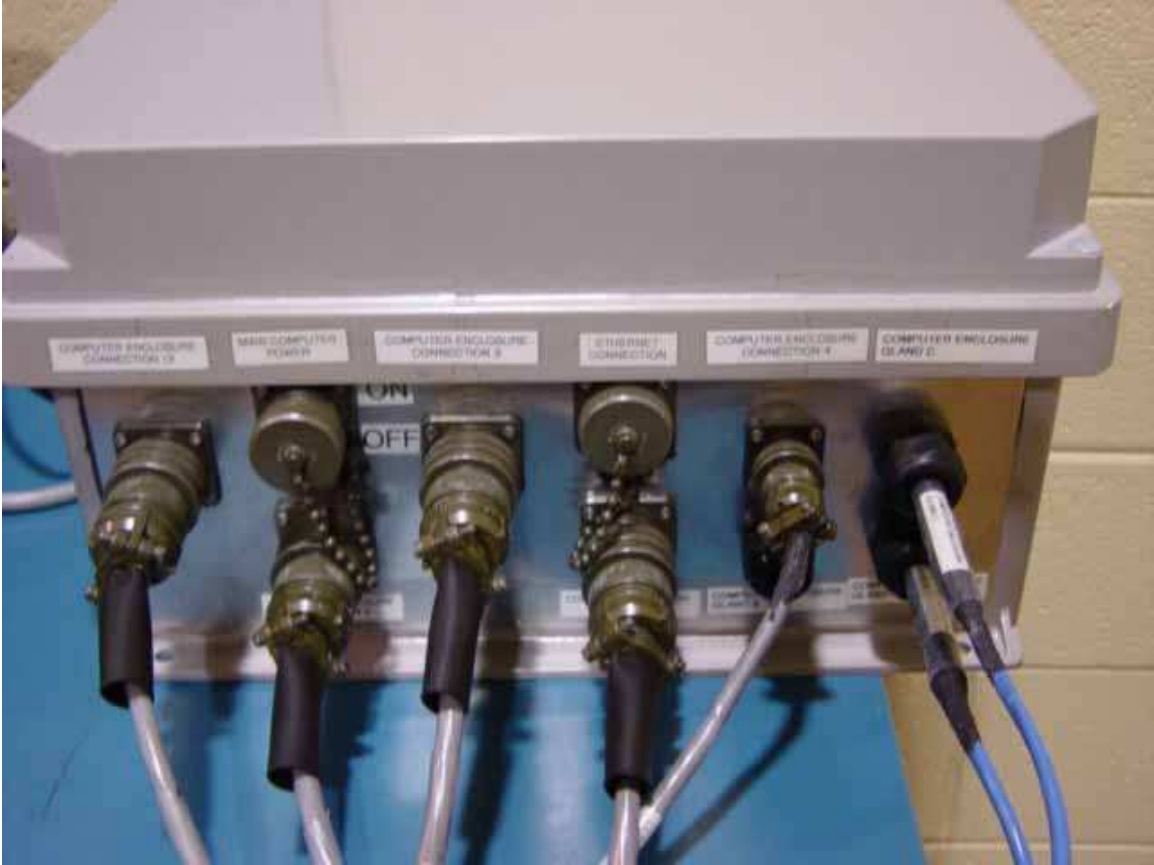
Figure 3. Computer Enclosure Exterior

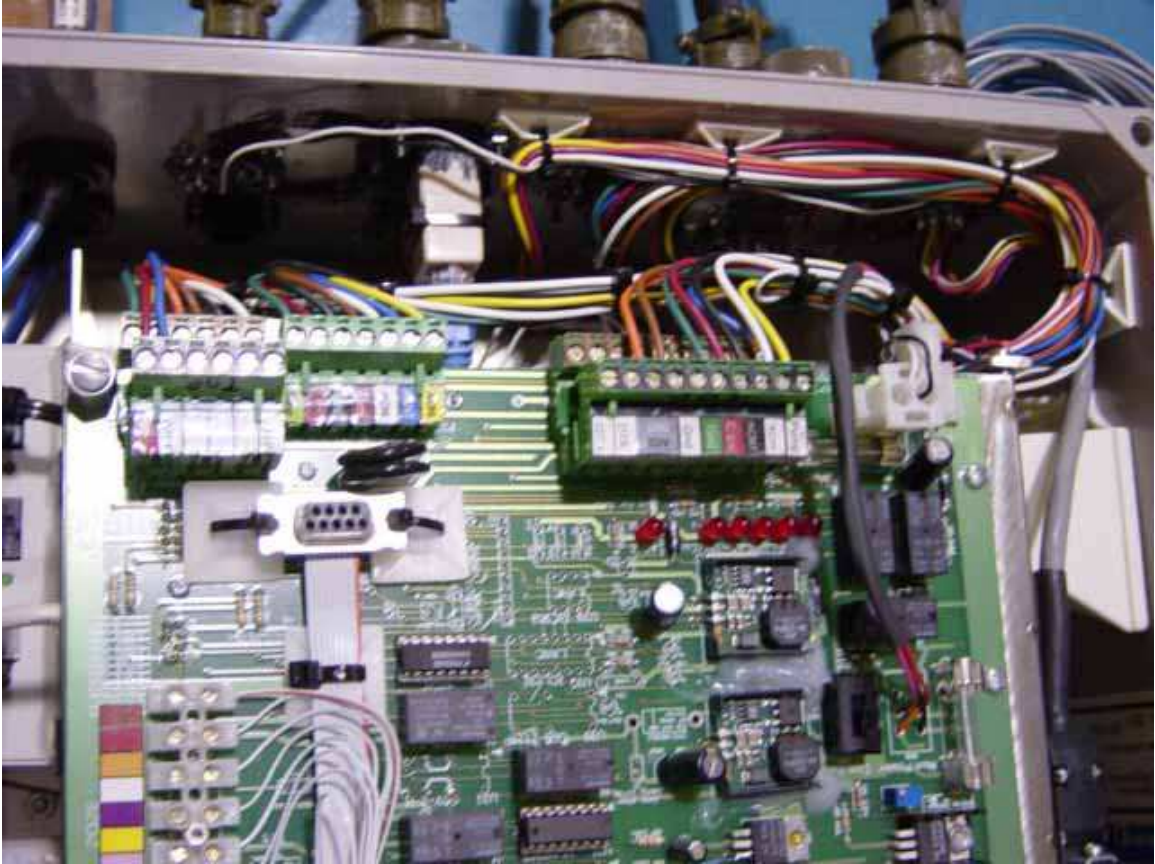
Figure 4. Computer Enclosure Interior

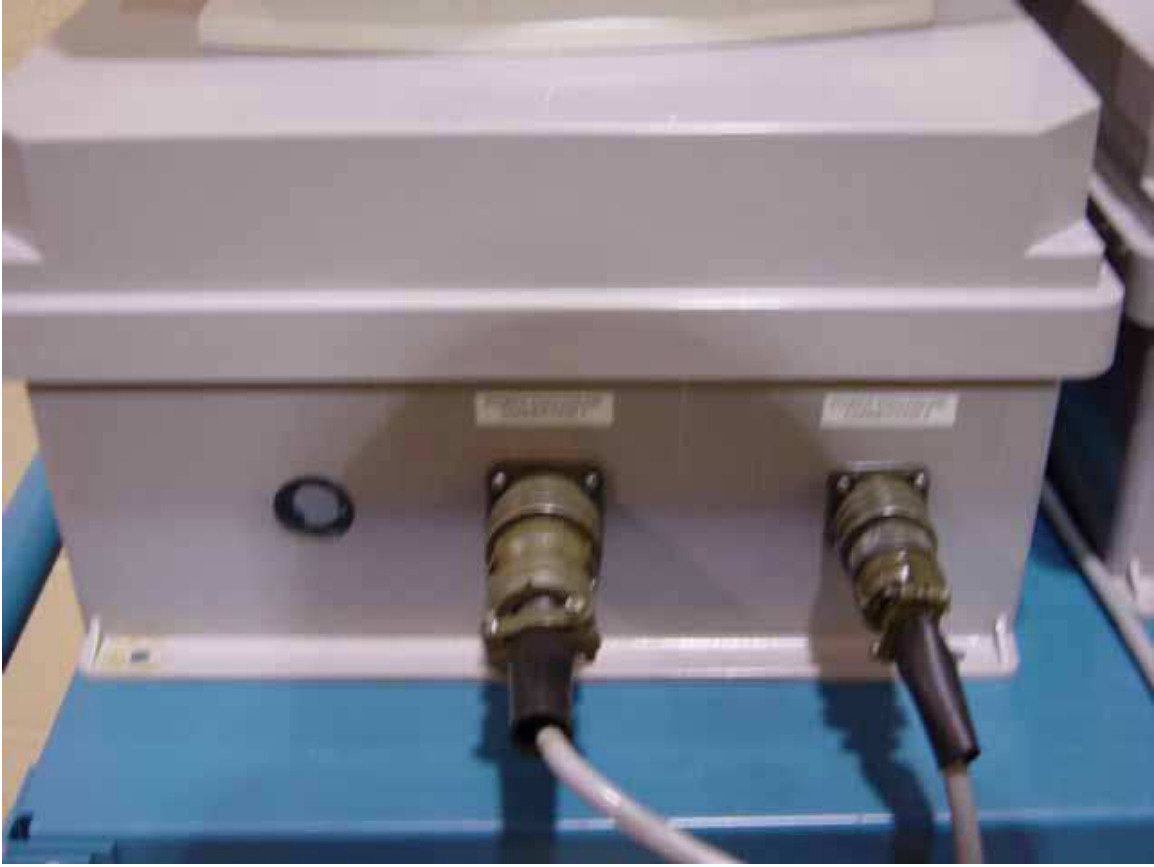
Figure 5. Power Enclosure Exterior

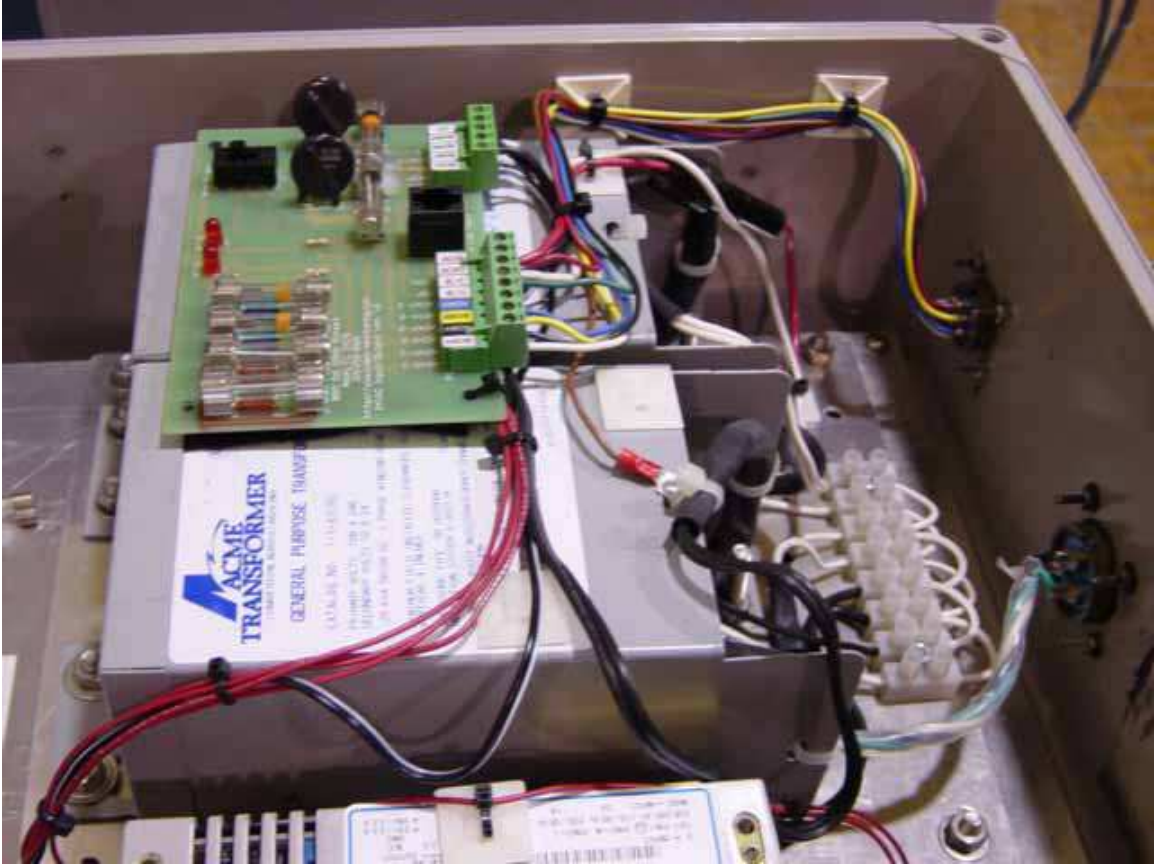
Figure 6. Power Enclosure Interior

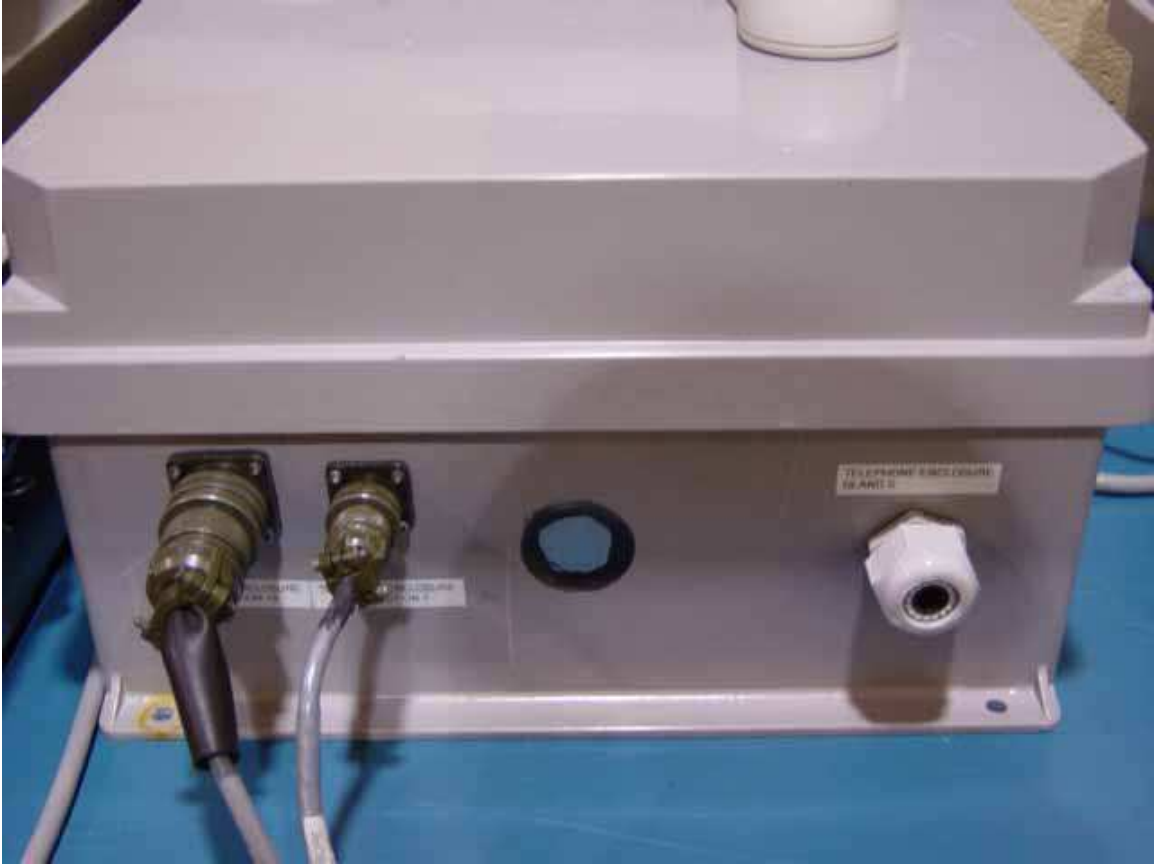
Figure 7. Telephone Enclosure Exterior

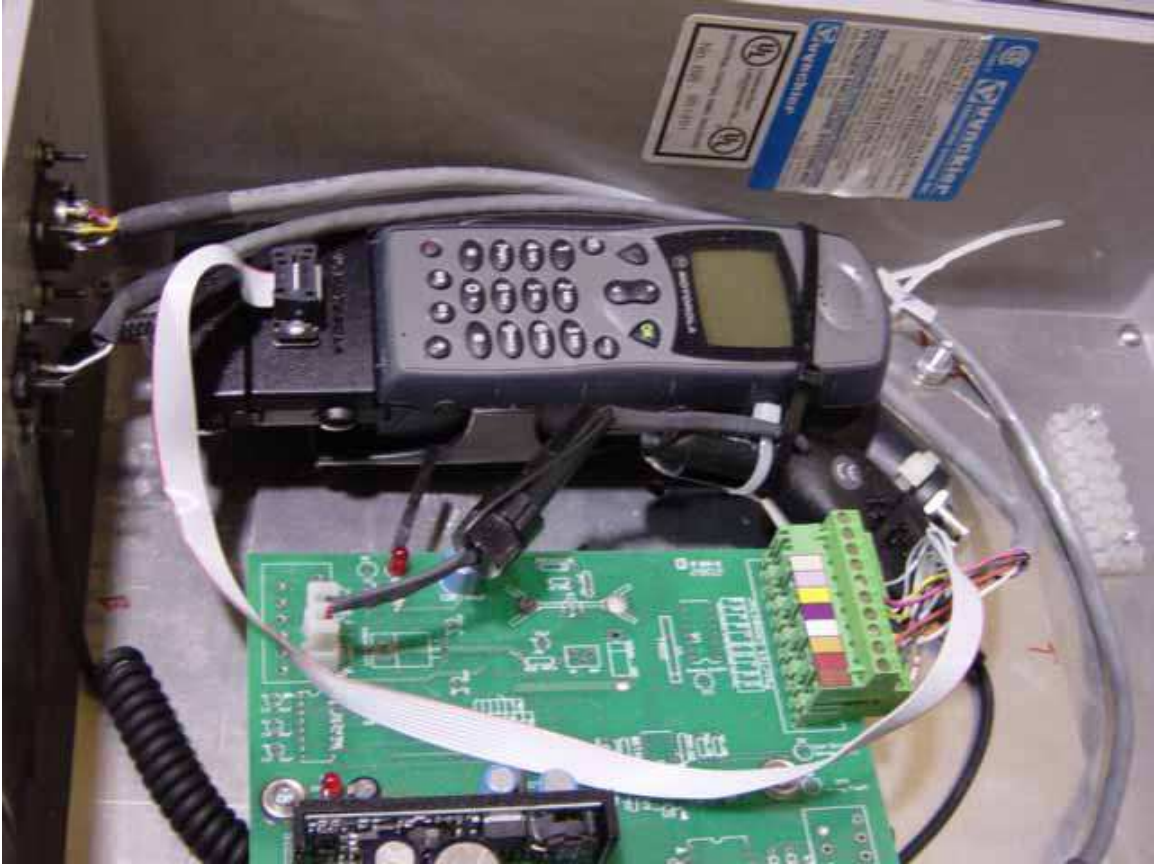
Figure 8. Telephone Enclosure Interior

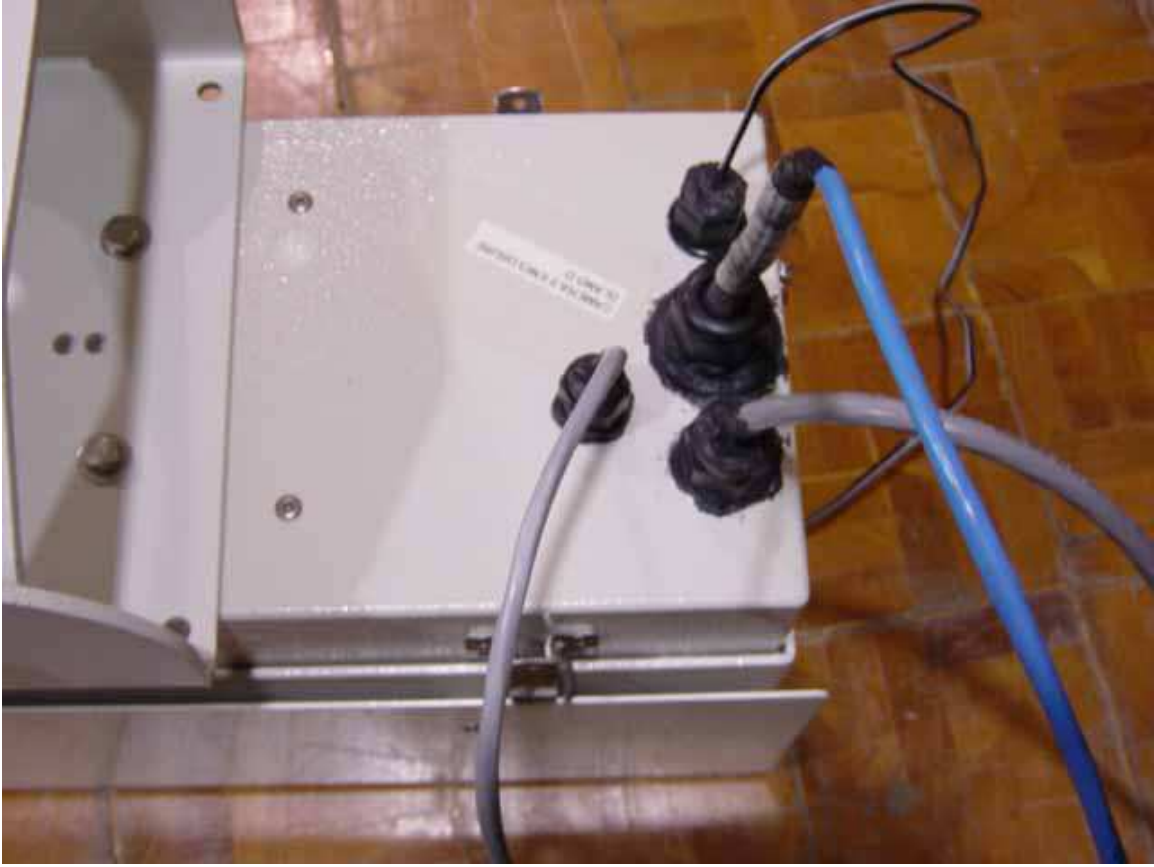
Figure 9. Camera Enclosure Exterior

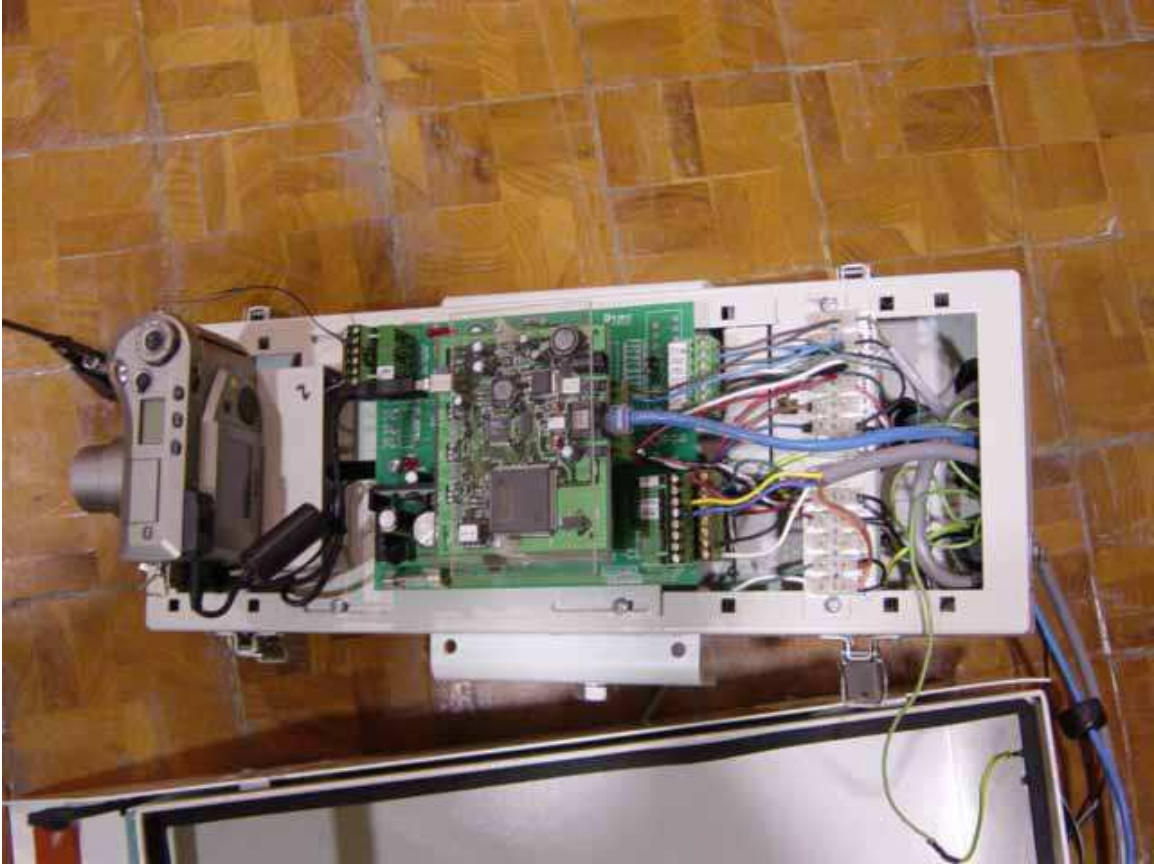
Figure. 10 Camera Enclosure Interior
