### **Ship Collisions with Iceberg Database. Report to PERD: Trends and analysis**

## **SHIP COLLISIONS WITH ICEBERG DATABASE. Report to PERD: Trends and analysis**

TR-2005-17

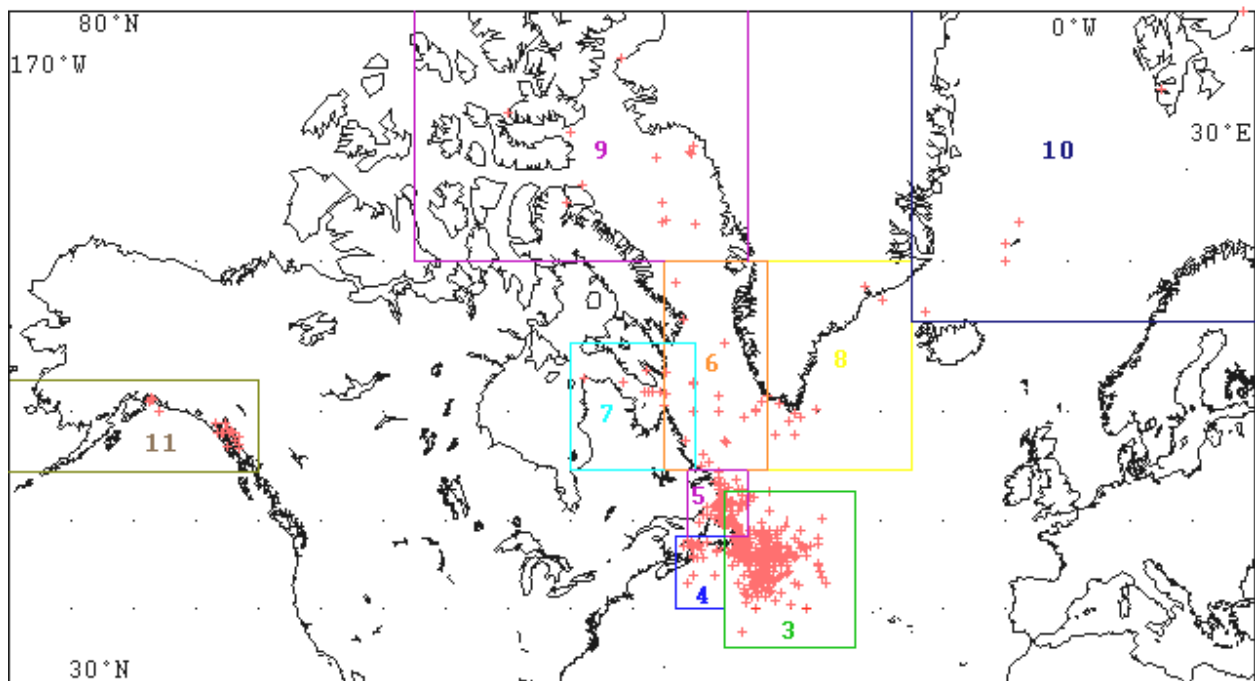
**Figure 1 Map Showing Geographical Locations**

The geographical areas are shown in Figure 1 and defined as:

Figure 1 also shows the geographical distribution of the collisions with icebergs. Most of these locations are known with accuracy but several have been estimated based on knowledge of vessel's route and circumstances. Not surprisingly the bulk of the events occurred on the Grand Banks and Strait of Belle Isle areas in the paths of trans-Atlantic shipping and coastal traffic. The geographical representation is shown in Figure 2. There is some overlap with the Strait of Belle Isle and Grand Bank areas but it is clear that this combined area is significantly worse for iceberg collisions than anywhere else. Figure 3 shows the trend in collisions by decade since the early 1800s and compares the trans-Atlantic shipping routes of the Grand Banks and the Strait of Belle Isle with the remaining areas of the North Atlantic. No particular trend is evident for the remaining areas because the number of collisions in these areas is not very high, and the fluctuations could be due to a number of reasons including variable ice conditions, ship traffic

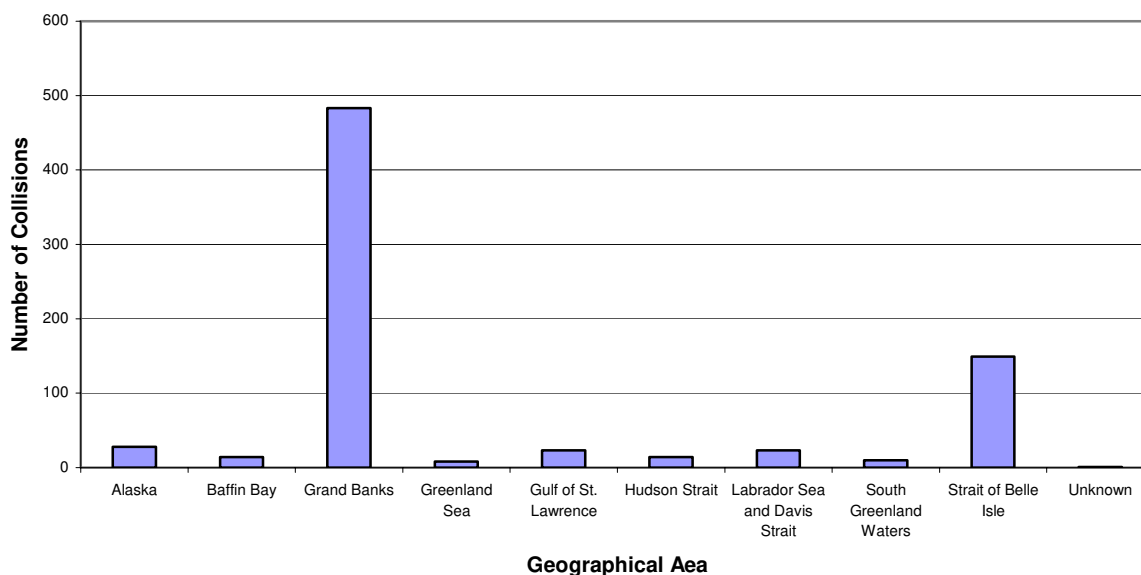
Figure 2 Distribution of Iceberg Collision by Area

and how well the accidents have been reported. However the variation of collisions on the Grand Banks and Strait of Belle Isle areas shows large fluctuations peaking in the late 19<sup>th</sup> century and waning in the late mid 20<sup>th</sup> century.

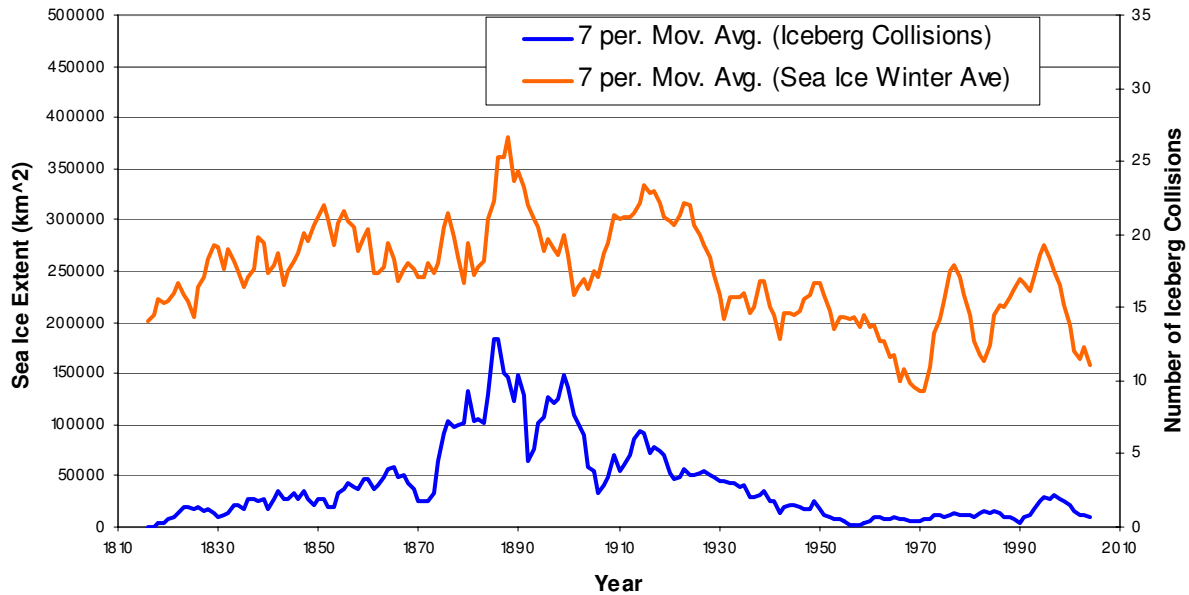
**Figure 4 Interannual Variation of Iceberg Collisions and sea Ice Extent with a 7 year period moving average.**

Figure 4 shows this in more detail and compares the interannual variation with that of the known sea ice extent to the east of Newfoundland south of 52°N and extending towards and over The Grand Banks. The ice extent numbers are from Hill<sup>2</sup> and updated with current data from the Canadian Ice Service. At present there is no accurate iceberg count for any of the years during the 19<sup>th</sup> century but there is a general relationship between the amount of sea ice and the number of icebergs<sup>3</sup> with the presence of sea ice preserving the life of the iceberg by protecting it from wave erosion so the ice extent in the figure is a proxy for iceberg severity. A 7 year moving average is used to highlight the overall trends and it is apparent that the late 19<sup>th</sup> century was a time of unusual ice severity and this period is marked also in the trend of ship collisions as one of high casualties. The overall trends of each are very similar although the number of collisions becomes less with time as a reflection of better iceberg detection and monitoring techniques being developed and employed, particularly with the inauguration of the International Ice Patrol (IIP) after the sinking of the *Titanic* in 1912, and also with the later introduction of ship borne radar systems after World War II. It is interesting to note that after a long period of severe ice conditions there was a general improvement from the mid-1920s which was followed by two spells of bad conditions, one in the late 1970s and the other in the early 1990s. The return to severe ice conditions in the latter period is also marked by an increase in the number of iceberg collisions.

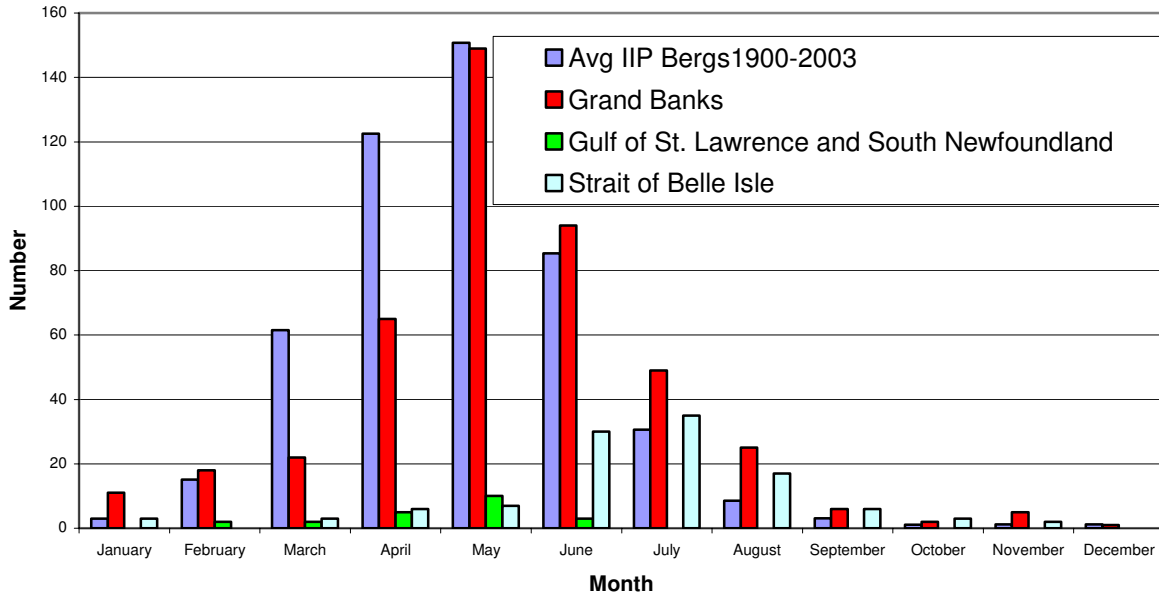
Figure 5 Monthly Distribution of Icebergs and Iceberg Collisions on and near the Grand Banks

Figure 5 shows the monthly distribution of collisions on the Grand Banks and its adjacent areas of the Strait of Belle Isle and the Gulf of St. Lawrence / South Newfoundland compared with the average monthly numbers from the IIP data set of icebergs crossing south of 48°N for the years 1900 to 2003. As one might expect for the Grand Banks area there is an obvious correlation

between the number of icebergs and the number of collisions with them, the numbers rising and falling together during the months with the only exception being in November. The total number of collisions in this month for the Grand Banks area is only 5 and all these occurred in the 19<sup>th</sup> century. We do not yet have iceberg numbers for that century and it is possible, as seen in Figure 4, with the severe ice conditions that occurred in the latter half of the century there were more icebergs in November than more recently. In fact, study of the IIP data shows 106 iceberg observations in the first half of the 20<sup>th</sup> century compared with 15 in the latter half so it is quite likely that the month of November in the late 1800s was more hazardous than of late, as evidenced by the SS *Arizona*, Figure 6, on 7 November 1879 which became one of the most famous ships to have survived an impact with an iceberg at speed (13½ knots).

lagging behind those of the Grand Banks and the Gulf of St. Lawrence areas as in Figure 5. Shipping increases as the navigation season resumes, and so does the number of iceberg collisions until the iceberg threat retreats later in the summer. Similar trends for Baffin Bay and Hudson Strait areas are shown in Figure 7. Typically shipping does not open in these areas until high summer and the season is relatively short, traffic consisting mainly nowadays of resupply vessels to the Arctic communities and ore mines, and bulk carriers to the grain terminal at Churchill in Hudson Bay, while in days gone by it consisted largely of whaling vessels and others engaged in Arctic exploration. The collisions in the Labrador Sea area are also largely confined to the summer months. Here, the season is open in the east all the year round while the ice season blocks access to Hudson Strait and Baffin Bay to the north.

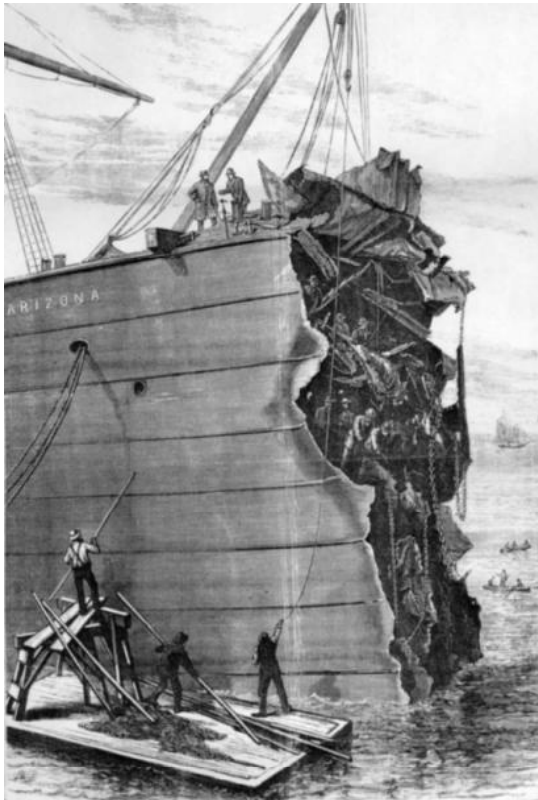
Figure 6 SS Arizona at St. John's after Collision

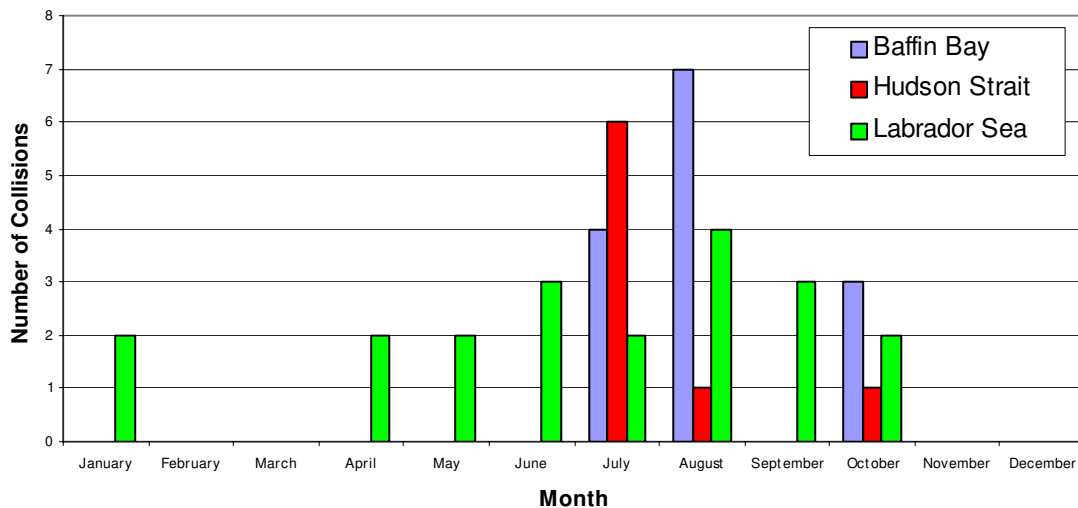
**Figure 7 Monthly Distribution of Collisions in Baffin Bay Areas**

Collisions in the Strait of Belle Isle show a slightly different trend. The northern route through the straits is often used by ship traffic between northern European ports and the St. Lawrence River ports such as Montreal. Traditionally, the Strait of Belle Isle is closed during the ice season which may stretch from late fall to late spring resulting in the trend of iceberg collisions

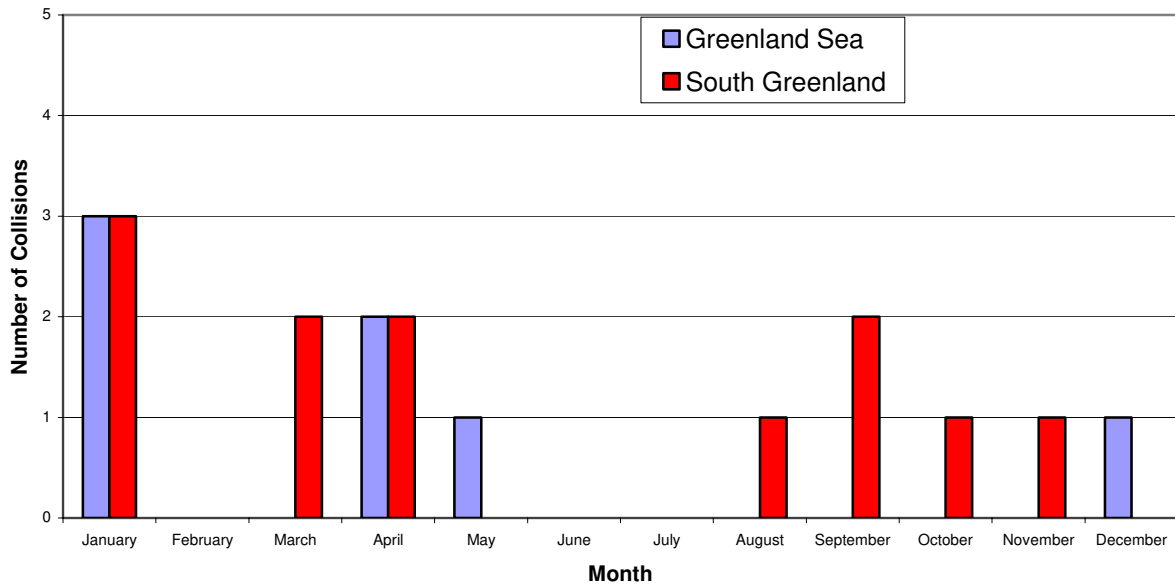
**Figure 8 Monthly Distribution of Collisions in the South and East Greenland Areas**

Ship collision with icebergs in the seas to the south and east of Greenland are shown in Figure 8 and are presented more as a matter of interest as the numbers should be regarded as a sample only and not as a comprehensive representation. Source material used in compiling the collision database was largely North American and British whereas this geographical area comprising the waters around East Greenland, Iceland, Jan Mayen and Svalbard were largely Scandinavian. Consequently, it is likely only the more noteworthy of the collisions such as the sinking of the *Hans Hedtoft* in January 1959 and incurred a large loss of life that reached wider reporting in source documents. Although there were a few events involving whaling vessels in Spitzbergen in the 17<sup>th</sup> century most of the other incidents have been recorded since 1940, including the wartime loss of the tanker *Svend Foyn*, again with a large loss of life.

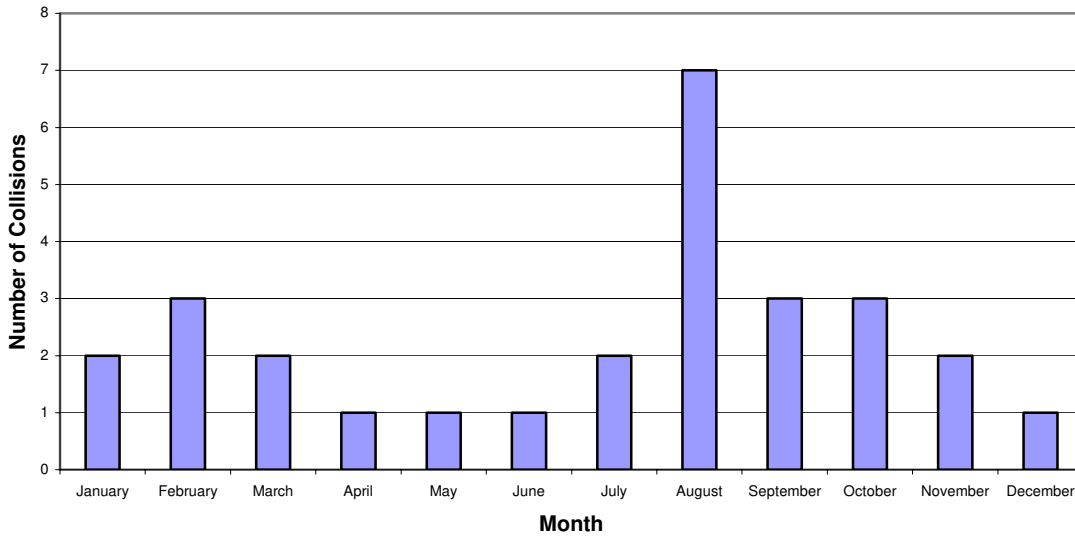
**Figure 9 Monthly Distribution of Collisions in Alaskan Waters**

Iceberg collisions in Alaska are shown in Figure 9. The monthly figures mostly fluctuate at low levels between one and three, the exception being the month of August in which a number of summer tourist+ sight-seeing vessels have come to grief.

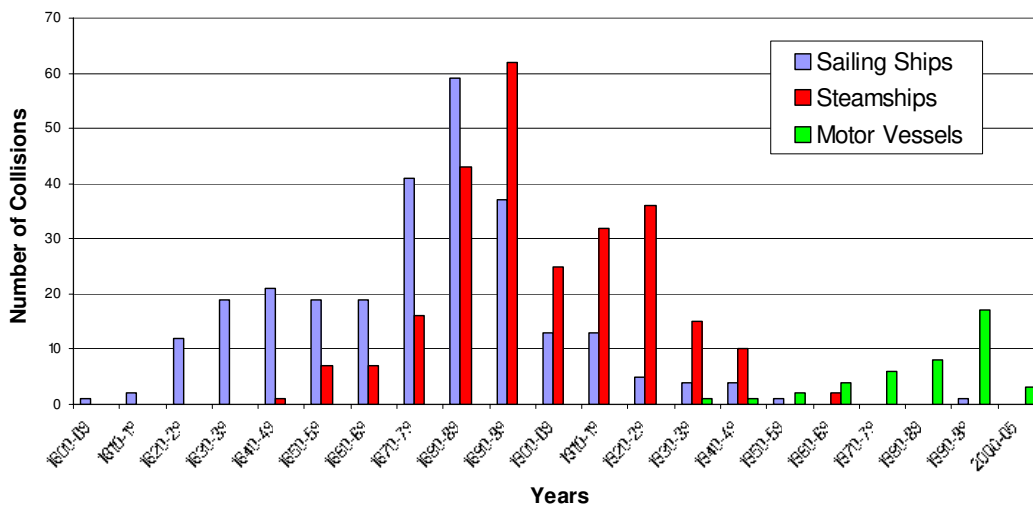
### Trend of Differently Powered Ships in Collision with Icebergs in the Grand Banks, Strait of Belle Isle and Gulf of St. Lawrence Areas

**Figure 10 Decadal Trend of Variesly Powered Ships in the Grand Banks Areas**

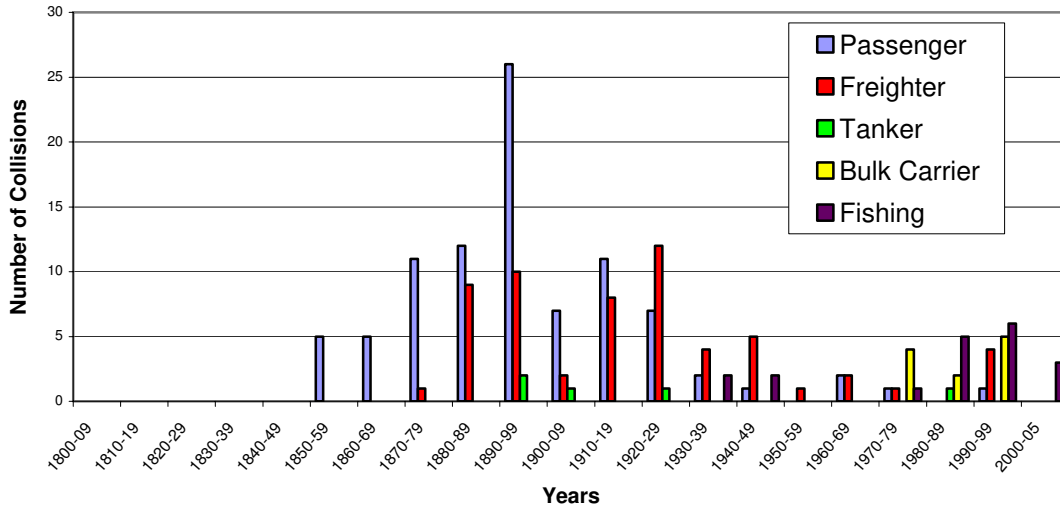
**Figure 11 Trends of Collisions with Different Types of Vessels in the Grand Banks Areas.**

Figure 11 shows the trend in iceberg accidents with vessels of different types which were categorized into 5 types; passenger liners, freighters, tankers, bulk carriers and fishing vessels. Sailing ships were ignored and only steamships and motor vessels were so identified. It is evident that passenger ships took the highest toll around the turn of the century at a time when emigration to North America was also at its highest. It was an unfortunate coincidence that passenger traffic peaked when the ice in the North Atlantic was at its severest and when ships were traveling faster than ever before without the benefit of later iceberg detection and monitoring. The decrease in passenger liner collisions after the 1890s was no doubt partly due to ameliorating ice conditions and later, a decrease in emigration. From the 1920s onward cargo ships, including the later bulk carriers, surpassed the liners in casualties. The last decades of the twentieth century show a slight

worsening of ice conditions (Fig.3) and this corresponds to an increase in the number collisions primarily with bulk carriers and fishing vessels. Bulk carriers can carry a wide range of cargoes but when acting as tankers for oil or chemicals, the pollution risk in the event of a collision is high. *Omikronventure L* carrying 600,000 barrels of crude was a case in point, striking a growler on the edge of the Grand Banks in April 1993 and cracking her hull open, but fortunately not the cargo tanks.

Fishing schooners were ignored as they were regarded as sailing vessels. It is seen from the figure that modern day fishing vessels are more prone to iceberg collisions than any other type of vessel. Recent examples are the sinking of the *BCM Atlantic* in March 2000 off the coast of Labrador near the Strait of Belle Isle, and the collision of the *Solborg* near St. John’s in June 2004. Both were shrimp trawlers, the former actively fishing at the time of the collision, and the latter on way to her port with her cargo. It is the nature of this kind of industry that necessitates these vessels operating in ice conditions.

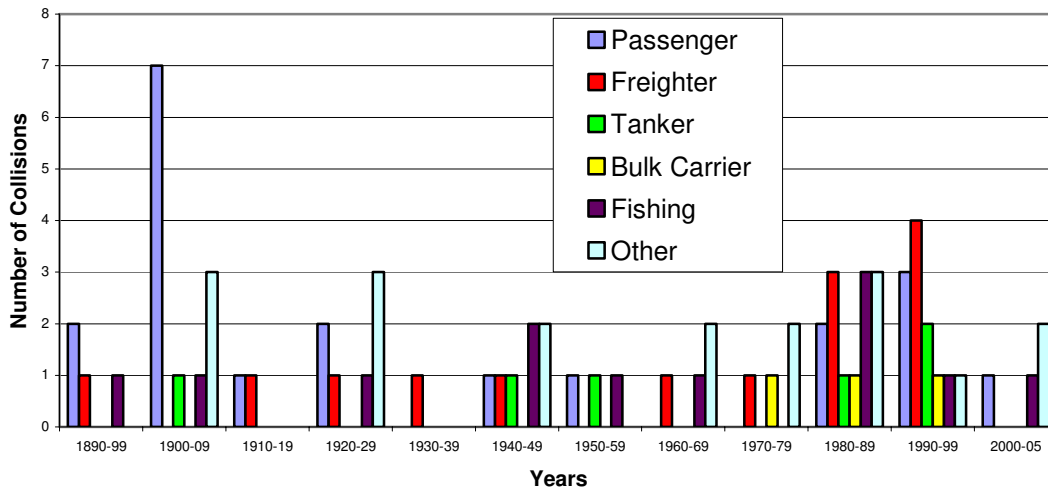
**Figure 12 Trends of Collisions with Different Types of Vessels in Other Areas.**

Almost 80% of the iceberg collisions from the period 1898 to 1929 in these areas (Fig.12) occurred in Alaska, a reflection of the volume of traffic spurred on by the Yukon gold rush of 1897 that had to navigate glacial fiords to reach the ports of Juneau and Skagway. The remainder of the vessel casualties in this period was a mix of vessel types that came to grief largely in the Labrador Sea – Davis Strait area. The rise in collisions towards the end of the time frame shown in the plot could be partly due to the better reporting of accidents and the relative ease of finding source material in the recent period, but probably also indicates increasing traffic to the remoter areas. Four of the six passenger ships to collide with icebergs within the last 20 years were small

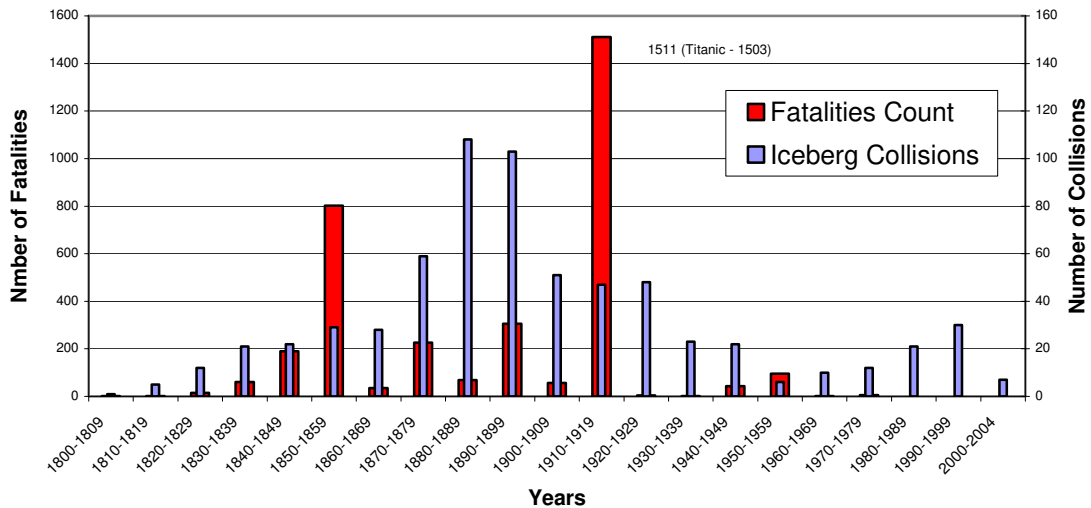
Figure 13 Collisions with Icebergs and Known Fatalities.

Figure 13 shows the distribution of known fatalities since 1800, some 3,422 in all, more than twice the toll of the *Titanic*. This number is probably conservative as scores of others must have perished amongst the icebergs from vessels for which there is no record. By the same token, the numbers include those from ships whose true fates are unknown but are traditionally attributed to loss by icebergs and involved large numbers of fatalities. Such examples are the *City of Glasgow* with the loss of 480 in 1854, the *Pacific* with the loss of approximately 200 persons in 1856, the

The trend shown in the figure generally follows the trends in collisions and ice severity as seen in the previous figures at least up until 1910-19; the more severe the ice conditions leading to more collisions and more fatalities. The magnitude of the *Titanic* disaster is quite apparent and is exceptionally large compared with anything before or after. There were eight other known fatalities that decade, six died on fishing schooners and two were crushed in the bow of an ocean liner. Since the *Titanic* the next collision with a large number of fatalities was the *Svend Foyn* in 1943 with the loss of 43 souls. The collision was due in part to war conditions when the convoy in which she was part was routed north close to Greenland to avoid detection by the U-boat packs which concurrently devastated two convoys further to the south. The next fatality was the *Hans Hedtoft*, a passenger /cargo ship operating between Denmark and Greenland, and was on the return portion of her maiden voyage when she struck an iceberg in a blinding snow storm off Cape Farewell in January 1959 and went down with all hands for the loss of 95 lives. Just as the sinking of the *Titanic* was the final motivation for the much needed International Ice Patrol for the Grand Banks, so to was the *Hans Hedtoft* in the formation of the Greenland Ice Patrol. The *Hans Hedtoft* had seven watertight compartments and a double hull. The *Islander*, which sank in Alaska in 1901 with the loss of 42 lives, and the *Titanic* both with watertight compartments were ships that were proclaimed as being unsinkable. The *Hans Hedtoft* was the last passenger ship to sink with fatalities after an iceberg collision. The last known ship of any sort to suffer fatalities was the refitted Canadian cargo ship *Aigle d'Ocean* that sank off Port Burwell, Quebec in 1975 with the loss of 4 crew and 2 helicopter airman trying to effect a rescue. Ice was not seen as a contributing factor in the Canadian Coast Guard report but bergy bits had been seen earlier and in popular opinion remains the cause of the sinking. Curiously, while the *Titanic* and *Hans Hedtoft* were on portions of their maiden voyages, the *Aigle d'Ocean* was on its last scheduled trip before being scrapped. The plot illustrates the large drop in fatalities since the loss of the *Titanic*. Better

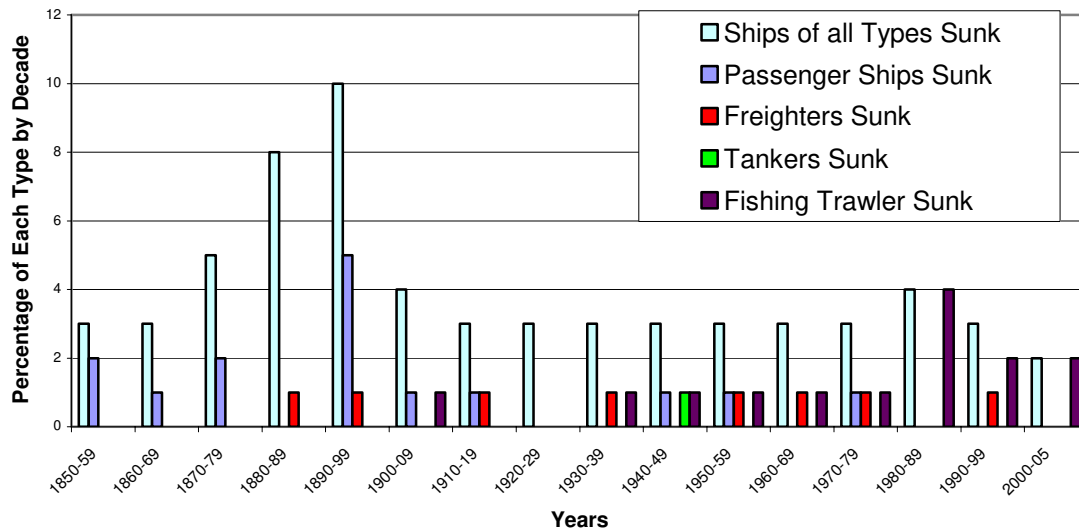
### Trend of Vessel Types Sunk by Icebergs

**Figure 14 Trends of Different Types of Steamships and Motor Vessels sunk by Icebergs**

Over 60 steam and motor vessels, approximately 20% of all vessels since 1850, are known to have sunk. For each decade the total number of the vessels sunk in all areas as well as for the types, Passenger, Freighter, Tanker and Fishing are shown in Figure 14. The totals shown may exceed the sum of the types as the totals include other or unknown types. The total number of ships sunk per decade is remarkably constant through most of the time frame the main exception being in the decades leading up to the end of the 19<sup>th</sup> century which, as discussed, was a period of high traffic and severe ice conditions.

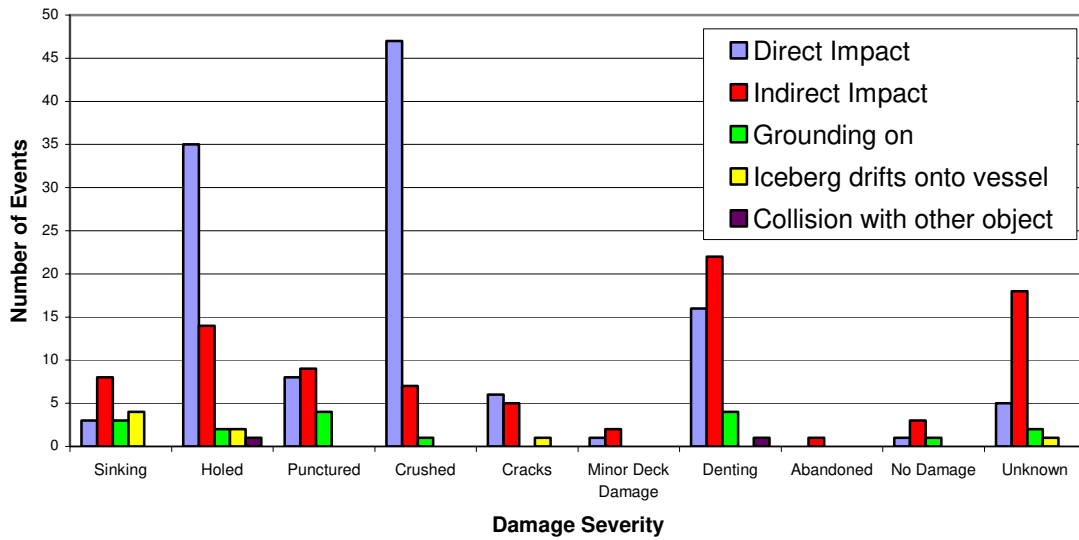
Figure 15 Severity of Damage sustained in Various Accident Scenarios

The data in Table 2 was simplified and condensed for display in Figure 15 by grouping three similar scenarios together (Striking Projection, Glancing Blow, Concealed in Waves/Pack Ice) and calling it Indirect Impact. The various hole and puncture types were combined into two groups, Holed and Punctured. Crushing of bows or bow appendages such as bowsprit and figureheads were the most common result of any direct collision. The next most frequent damage was some kind of serious holing. Denting from Direct and Indirect Impacts were the next most common result, followed by holing by Indirect Impact and then by puncturing. It is emphasized that “pigeon holing” damage scenarios and severities, often from scanty reports, is subjective but gives some indication of the severity of the damage and the figure illustrates the damage sustained in a number of different scenarios.

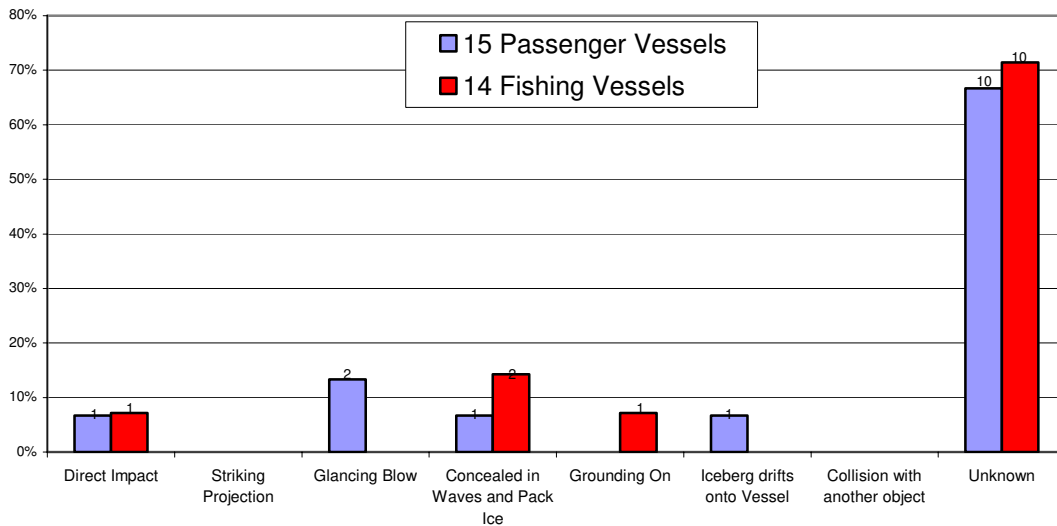
Figure 16 Damage Scenarios for Passenger and Fishing Vessels sunk by Icebergs

Figure 16 shows the relative percentages of passenger vessels and fishing vessels sunk in the various scenarios. The sample size turns out to be disappointingly small with only nine scenarios in the 29 events being known. One vessel of each type was sunk by direct impact; the passenger

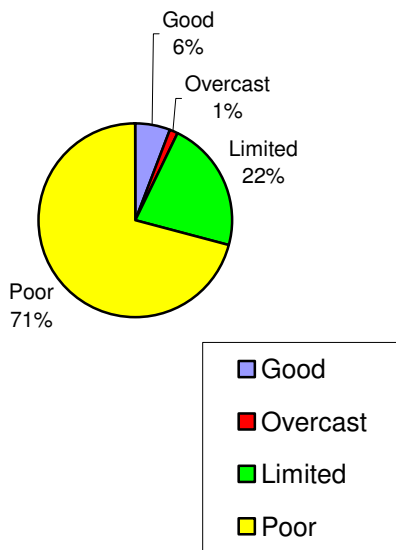
**Distribution of Collisions in known Visibility Conditions**

**Figure 17 Distribution of Collisions in Known Visibility**

Visibility is obviously an important factor in any collision. If an iceberg was spotted under clear conditions then, of course, it would be avoided. In the Grand Banks area of the North Atlantic where the cold waters of the Labrador Current meet warmer waters and warm moist air, fog is a persistent problem. In many accounts icebergs have not been so much hidden in the fog as to have actually been mistaken, in the misty conditions at the time, for a fog bank or thickening mist, until too late. Of the approximate 370 steam and motor vessel collisions descriptions of visibility is known in only 42% of them, and in terms of actual distance only 5%. Figure 17 shows the relative percentages of the various degrees of visibility. The events that occurred in conditions of good visibility were largely impacts with growlers or bergy bits concealed in fields

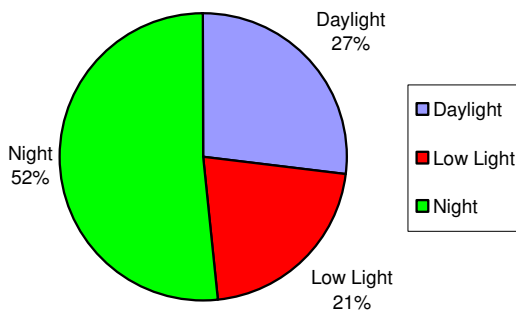
**Figure 18 Distribution of Collisions in Known Light Conditions**

Only 89 of the 370 vessel collisions, less than 25%, have information regarding time of day as to day or night or twilight. The proportions of these are displayed in Figure 18, showing that the majority of the collisions occurred during the night time hours, a logical circumstance. Mist or fog was present in 87% of the time when visibility was known to be impaired, snow 10% of the time and rain 3%. Almost all the collisions that occurred in daylight happened in foggy or snowy conditions except for one instance of striking a concealed bergy bit, and another one unknown. Night in itself is an obstacle to clear vision and almost half of the known night time accidents were unknown as regards further obstructions, but for the majority mist and fog were present. The exceptions include the well known case of the *Titanic* which struck on a clear starlit but moonless night; the *Hurworth* in 1880 which

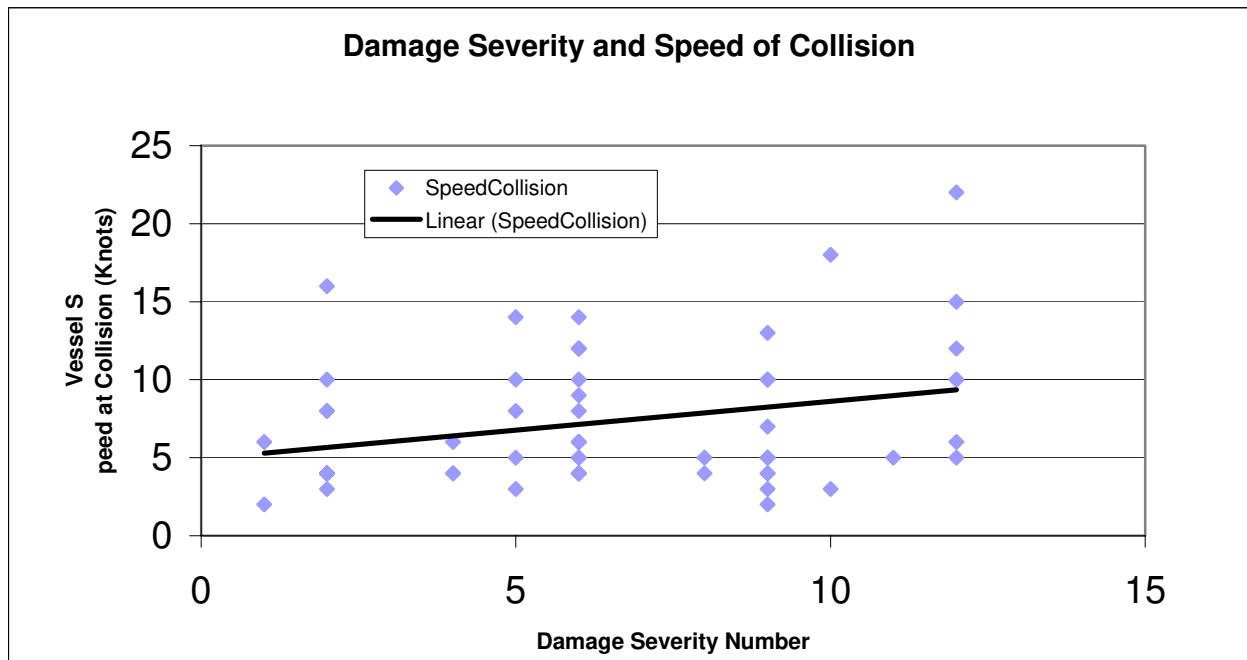
Figure 19 Damage Severity and Speed of Collision

Of the 370 steam and motor vessels collisions there are only about 70 of them in which the speed at the time of collision was known. Neglecting small vessels such as fishing vessels and stationary vessels and limiting the selection to those cases in which the damage severity was known this number was thereby reduced to 58. Vessel speed is plotted against the Damage Numeral as assigned in Table 1 in Figure 19. The trend is, not surprisingly, one of increasing damage with increasing speed though there is a large amount of scatter and it can be seen that even at relatively low speeds sufficient damage can be sustained to sink the ship. The *William Carson* went down in 1977 while travelling at about 5 knots in a heavy ice field and presumably hit a heavy ice piece such as a multiyear ice floe or a bergy bit. In 1932, the *Bright Fan* sank in Hudson Strait after grounding on an underwater ledge of an iceberg at a speed of only 6½ knots. However, the *Kronprinz Wilhelm* struck a small iceberg a glancing blow at 16 knots scattering 20 tons of ice across the decks and knocking both passengers and berg over, suffering little more than a badly

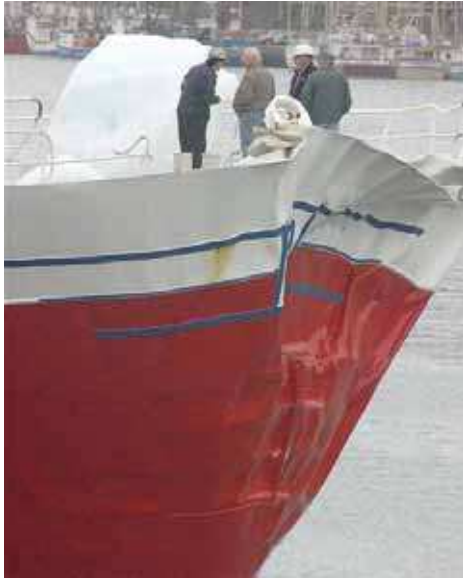
**Figure 20 F/V Solborg with a piece of iceberg on deck**

Ice dislodged from high on the iceberg at impact and falling on to the ship appears to be fairly common, the recent case of the *Solborg* (Figure 18) being an example, and according to the anecdotes, passengers onboard the *Titanic* added ice that had fallen to the deck to their drinking glasses before the seriousness of their situation became known. These appear to be relatively minor ice falls but there at least 17 other known cases and some of these caused fatalities and with a hundred of tons or so of falling ice were enough to threaten the ship. Two men on the deck of the *Montrose* were killed by falling ice after it struck an iceberg in fog in 1928. About 150 tons of ice fell on the decks and into the holds of the *SS City of Berlin* after collision in 1885 where some of it still remained at the time of docking. When the bark *Condor* struck a berg in 1880 two men on the main mast were thrown to the deck and one of them had his legs crushed when ice from the berg came falling down on top of him. So much ice fell on the bow of the *SS Hurworth*, also in 1880, that the stern was lifted high and dry and the ship was in danger of pitching under. The *SS Beacon Light* got it from all sides after collision with an iceberg on her maiden voyage in 1890. Trying to turn the berg she struck a projecting ledge a glancing blow tearing away parts of her forecastle and the force of this together with the impact of a 50 ton piece of ice falling on the foredeck almost turned the vessel on to her beam ends. This was immediately followed by a large piece of ice breaking off from below and coming up and smashing into the hull. In a locally famous case, in July 1890 in Notre Dame Bay, Newfoundland, the 1200 ton *Portia* sailed too near to a large iceberg when it suddenly broke up and a huge piece of ice came up under the vessel lifting it high and dry twelve feet out of the water, its fate literally on the balance until it settled back into the water with little more than a few damaged plates and a slight leak. The bark *Moën* was not so lucky. It struck a large iceberg and jammed solid in it losing one man. The remainder of the crew had just taken to the boats when the berg toppled splitting the vessel in two.

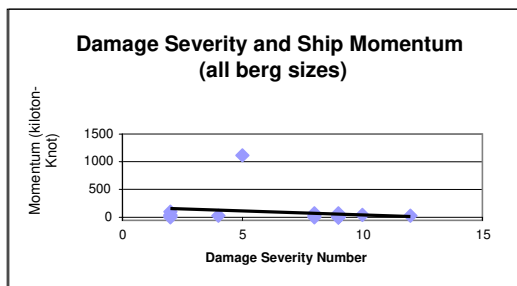
**Figure 21 Damage Severity all Iceberg Sizes**

Figure 21 was an attempt to see if ship momentum could be correlated with damage severity. Only data from direct impact collisions were used. Vessels whose displacement was known at the time of collision were very few so the gross registered tonnage was used though provided not quite so accurate a measure of the actual mass. Even using these data there were only 24 events and these were plotted against the damage severity numeral. The figure shows a trend of increasing damage with decreasing momentum which maybe is not quite what one might expect.

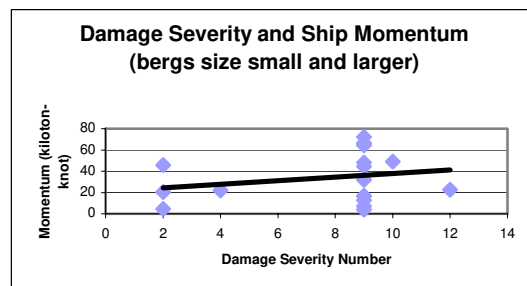
**Figure 22 Damage Severity for Small and Larger Bergs**

The data was filtered to exclude bergy bits and growlers, which because of their comparatively small size may interact differently from the larger icebergs. This resulted in a reduced sample size of 18 events and these were plotted in Figure 22 which does show a trend of increasing damage severity with increasing momentum. Data for the bergy bits and growlers were then plotted in Figure 23 and the trend showed decreasing damage with increasing momentum, though the sample size of 5 was very small. Ship collisions with bergy bits and growlers for all damage

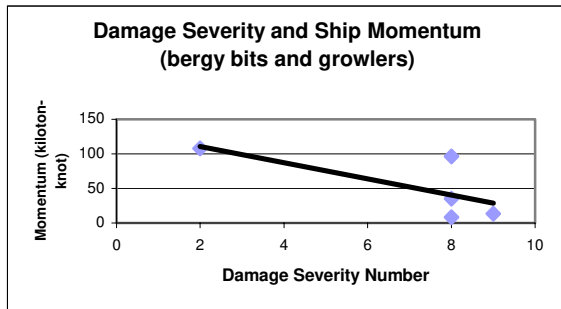
**Figure 23 Ship Momentum with Bergy Bits and Growlers**

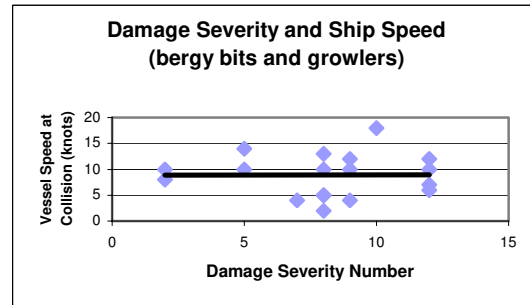
**Figure 24 Ship Speed with Bergy Bits and Growlers.**

scenarios, not just direct impacts, were plotted in Figure 24 and the trend showed no change in damage severity in relation to speed at impact. These plots highlight that despite the large number of collisions in the database there are considerable gaps in some of the data that could be really useful. Also, there is great subjectivity in ascribing a severity value to the known degree of damage and this in itself could lead to a large amount of scatter.

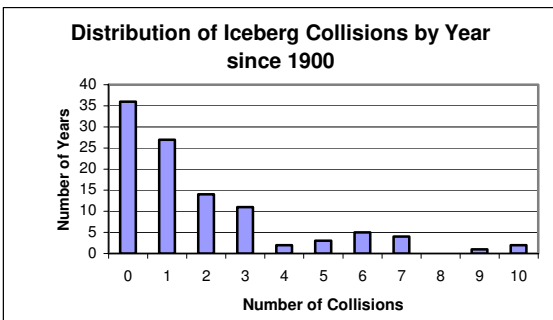
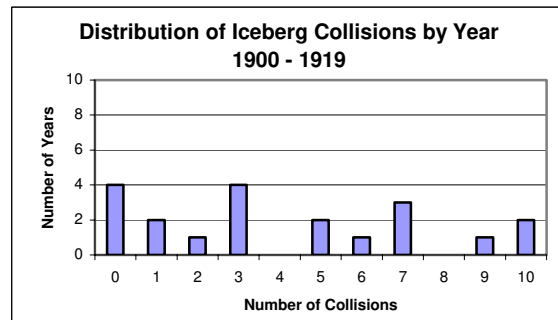
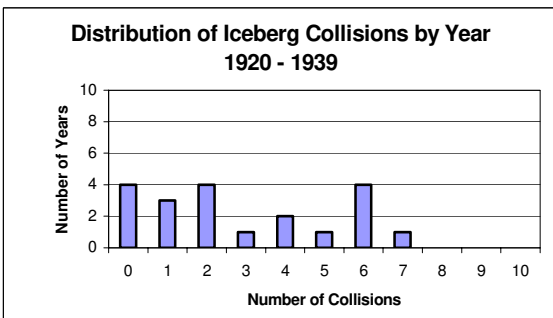
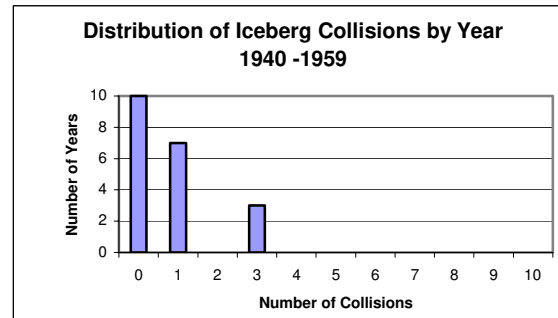
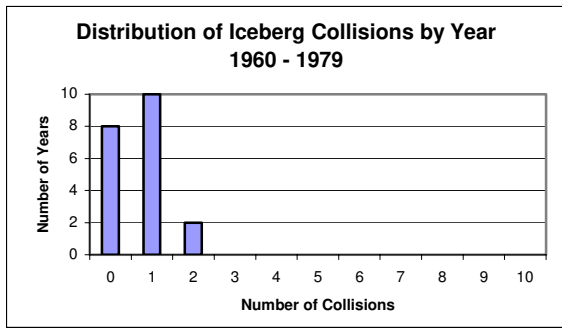
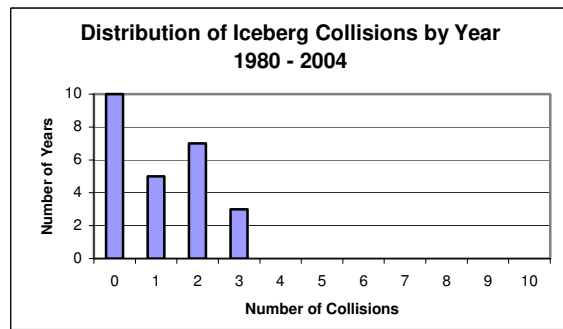
Figure 25 Fig 25a - Distribution of Icebergs by Year since 1900 and by decade (Fig23b-f)

The distribution of iceberg collisions for the Grand Banks – Strait of Belle Isle area south of 52°N is shown in Figures 25a - f. Figure 25a show the distribution for a number of collisions by number of years for the period 1900 to 2004. Figures 25b – f show the distribution for each successive 20 year period (except for the last which is 24 years) starting with 1900. It is interesting to note how the distribution has changed with time from the early 1900s when 9 or 10 collisions in a year were just as likely to happen as 1 or 2. The chart for the 1920s-30s shows a reduction or total absence of years with a large number of collisions, i.e. > 6. The subsequent plots starting in the 1940s show a significant change in the distribution and number of collisions which coincides with the technical advances in iceberg detection and observation techniques being made at the time with the introduction of aerial observation and radar detection.

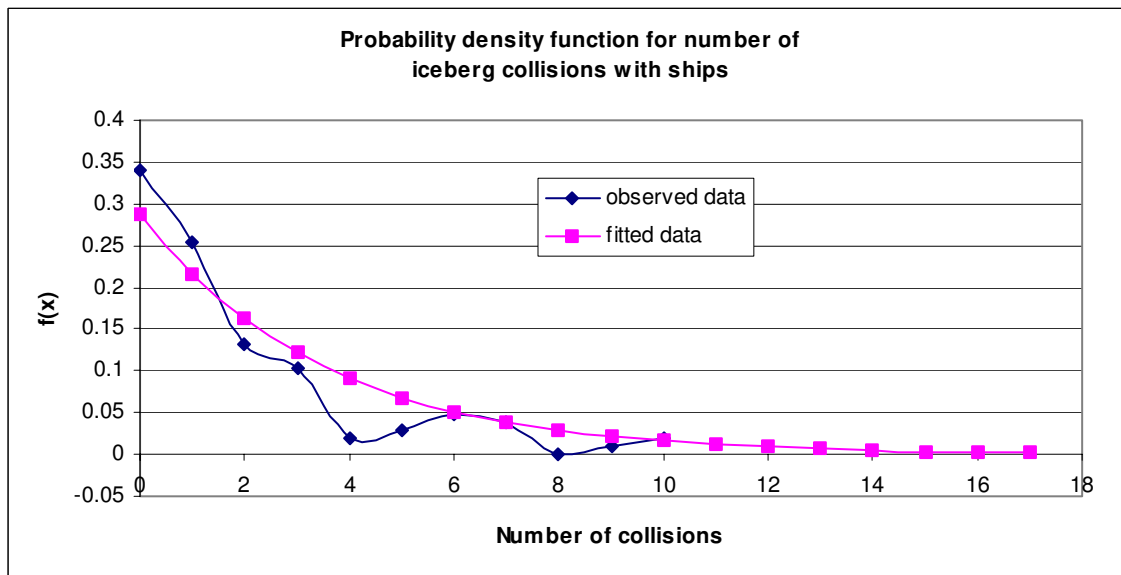
Figure 26 Probability Density Function

$$f(x; \sigma) = \frac{1}{\sigma} e^{-\frac{x}{\sigma}} \text{ with } \sigma=3.4462 \text{ for the observed data can be fitted (Fig. 26). The cumulative}$$

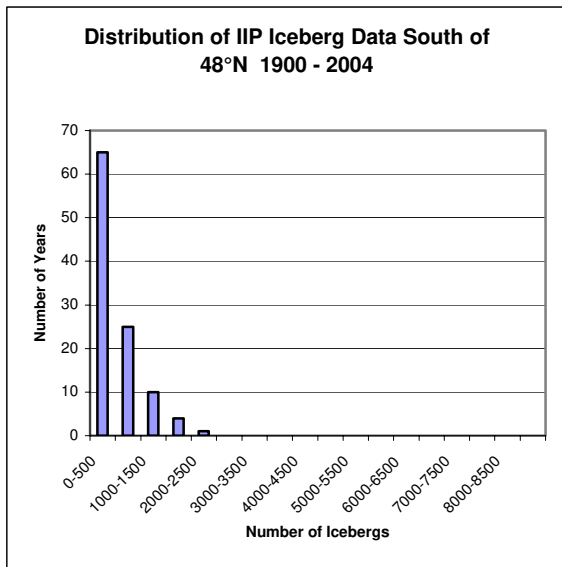
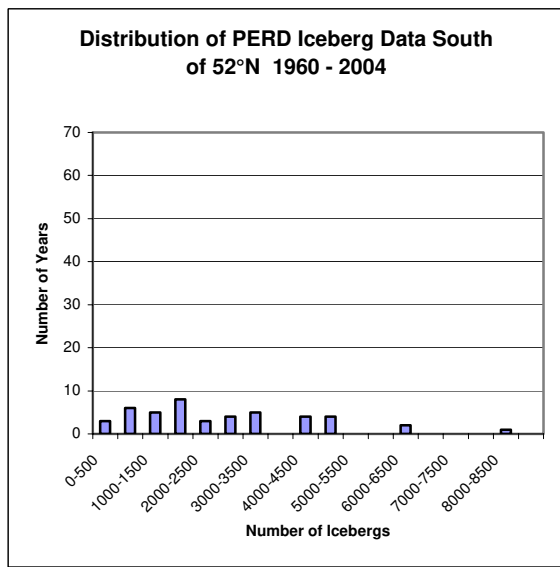
The iceberg numbers in Table 3 are shown for to give a general idea of their magnitude and variability. The distribution by number of icebergs from 1900 for the IIP data and from 1960 for the PERD data is shown in Figures 27 (a) and (b) respectively.

Figure 27a Distribution of IIP Data South of 48°

Figure 27b Distribution of PERD Data south of 52°
