EuroNoise Proceedings 2015, pp. 1121-1126, 2015-06-02

Direct Sound Transmission Loss of Heavy Gauge Steel Stud Walls

Christoph Höller, Berndt Zeitler, Jeffrey Mahn

National Research Council Canada, 1200 Montreal Road, Ottawa, Ontario, K1A 0R6, Canada

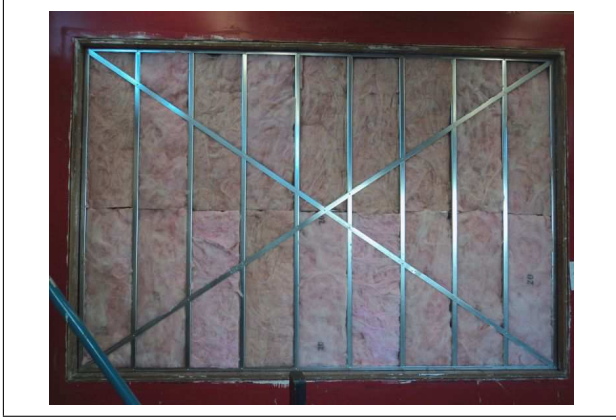
Figure 1. Reference wall assembly in test frame, with sheathing removed. The flat strap cross and bridging channel in the center of the wall brace against lateral and shear loads.

The walls investigated in this study were double-leaf walls with heavy gauge steel studs as framing members. The reference assembly was defined as the following: G16_SS152(406)_GFB152_RC13(406)_G16. Here, G16 indicates one layer of 15.9 mm thick gypsum board (mass per area: 11.0 kg/m²), SS152(406) indicates 152 mm deep steel studs spaced 406 mm on centers (steel thickness: 1.37 mm), GFB152 indicates 152 mm thick glass fiber insulation, and RC13(406) indicates 13 mm deep resilient metal channels spaced 406 mm on centers. The gypsum board was attached with screws spaced 305 mm apart at the perimeter and in the field. In addition to the above named elements, the walls also included bridging channels and steel straps for bracing against lateral and shear loads. Figure 1 shows a picture of the assembly without sheathing.

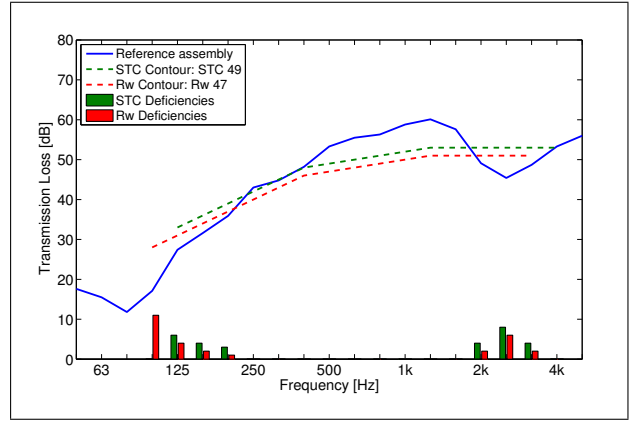
Figure 2. Sound Transmission Loss of reference assembly: G16_SS152(406)_GFB152_RC13(406)_G16

The Sound Transmission Loss of the reference assembly is shown in Figure 2. Single number quantities STC and R_w were calculated from the Sound Transmission Loss curves according to ASTM E413 [2] and ISO 717-1 [3]. The assembly achieves an STC rating of 49 and R_w of 47. The deficiencies occur at low frequencies and in the region of the coincidence frequency. The R_w value in particular is dominated by the deficiencies in the 100 Hz band (11 dB).

The Sound Transmission Loss curve follows the characteristic pattern of double-panel walls. The mass-spring-mass resonance frequency lies in the 80 Hz band (calculated: 56 Hz , assuming air spring). The coincidence dip of the gypsum board occurs in the 2500 Hz band (calculated: approx. 2200 Hz). The coincidence frequency of the gypsum board was also measured using structural drawaway measurements (see Section 4), and was determined to be around 2600 Hz . The reference wall assembly falls just short of the minimum requirement for partition walls between units in the 2010 National Building Code of Canada, STC 50.

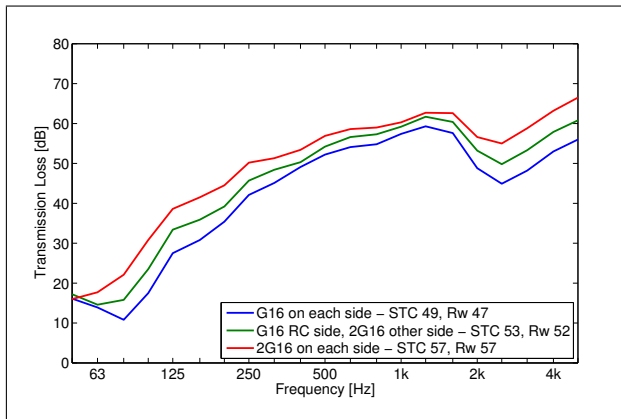
Figure 3. Influence of sheathing. For additional layers of gypsum board, the mass-spring-mass resonance shifts from the 80 Hz band into the 63 Hz band and further into the 50 Hz band.

Figure 3 shows the effect of adding gypsum board to the reference assembly. The mass-spring-mass resonance frequency shifts from the 80 Hz band into the 63 Hz band and further into the 50 Hz band. Each additional layer of gypsum board increases the STC value by 4 points, and the R_w value by 5 points. For assemblies without cavity insulation, the improvement in STC is slightly higher, with 5 points per additional layer (not shown). For assemblies without resilient channels, the improvement in STC is only 3 points per additional layer (not shown). For walls with 92 mm studs, the improvement is 6 points per additional layer (not shown).

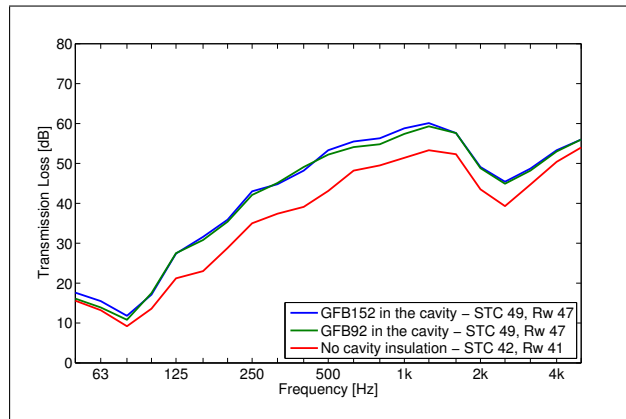
Figure 4. Influence of cavity insulation. Removing the cavity insulation from the reference assembly has a significant effect on the Sound Transmission Loss curve. The thickness of the insulation material tested here is of minor importance.

Removing the insulation material from the reference assembly significantly decreases the Sound Transmission Loss values, as shown in Figure 4. The STC value drops from 49 to 42, the R_w value from 47 to 41. However, Figure 4 shows that reducing the thickness of the glass fiber insulation from 152 mm to 92 mm only has limited effect on the Sound Transmission Loss. The STC remains at 49, the R_w at 47 points. This is in contrast to an earlier report on gypsum board walls [4].

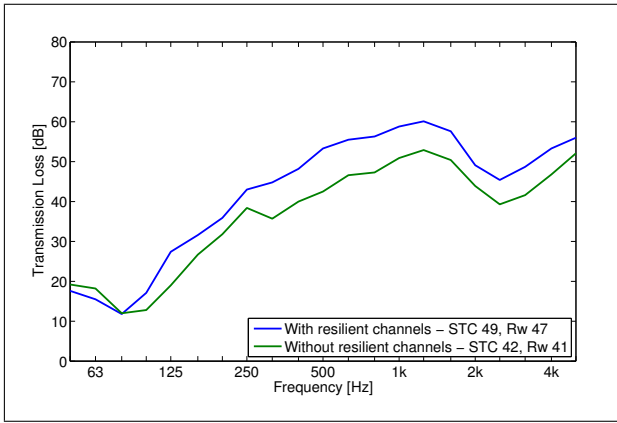
Figure 5. Influence of resilient channels. Resilient channels are among the most effective devices to improve sound insulation performance. The improvement is even higher for walls with more than one layer of gypsum board on each side.

Figure 5 shows the influence of resilient channels. The mass-spring-mass resonance frequency shifts upwards in frequency when removing the resilient channels, decreasing the sound insulation performance above 80 Hz. Also visible in the TL curve for the wall without resilient channels is a pronounced dip in the 315 Hz band. This is likely due to the coincidence frequency of the steel stud, see Section 4. If the studs are not decoupled from the sheathing layers, the stud can “force” its motion onto the sheathing layers. This is particularly important at its coincidence frequency, at which the stud radiates very efficiently.

The STC value in this case drops by 7 points, the R_w value by 6 points. For assemblies with two layers of gypsum board on each side, the degradation is even larger (10 points in STC and R_w , not shown). Given these significant changes, the use of resilient channels is recommended.

The vertical line at 270 Hz indicates the measured coincidence frequency of the steel studs, at which the bending wavelength of the stud equals the wavelength in air. The coincidence frequency of the stud also results in a dip in the Sound Transmission Loss curve. This can be observed in Figure 5, for the wall without resilient channels. For walls with resilient channels, the effect of the stud coincidence dip is mitigated.

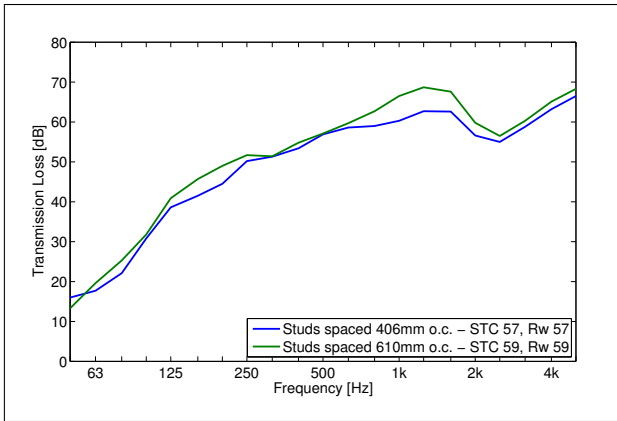
Figure 6. Influence of stud spacing. Increasing the stud spacing improves the sound insulation performance due to less structural connections between the two sides and due to decreased stiffness of the wall.

Two different stud spacings were investigated in this study: 406 mm on centers and 610 mm on centers. The results are shown in Figure 6, for walls with two layers of gypsum board on each side. The change in stud spacing has a notable effect on the Sound Transmission Loss curves. It increases over the entire frequency of interest. The STC and R_w values increase by 2 points each.

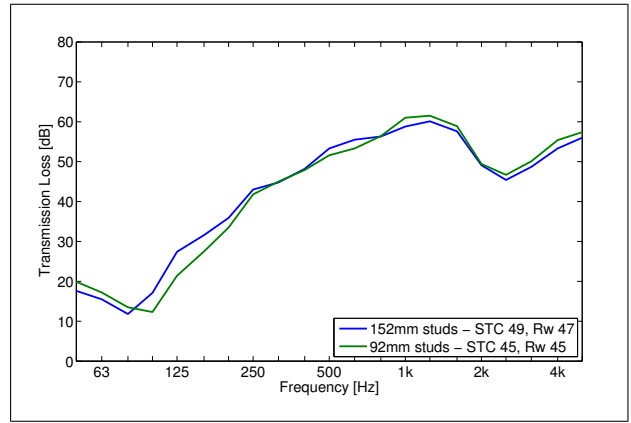
Figure 7. Influence of stud depth. Decreasing the stud depth without changing other parameters degrades the sound insulation performance, because the smaller air gap between the two sides leads to an upward shift of the mass-spring-mass resonance frequency.

Figure 7 shows the influence of the stud depth. Two stud depths were investigated: 152 mm and 92 mm. For both types of stud, the steel thickness and the stud spacing was the same (406 mm on centers and

1.37 mm, respectively). As would be expected, decreasing the stud depth decreases the sound insulation performance. The smaller air gap between the two sides leads to an upward shift of the mass-spring-mass resonance frequency. The STC value drops from 49 for 152 mm studs to 45 for 92 mm studs, the R_w value drops from 47 to 45. If more layers of gypsum board are used, the change between walls with different stud depth gets smaller (not shown). The influence of the stud depth was not investigated for wall assemblies without resilient channels. It is expected that without resilient channels, the increased stiffness of deeper studs could increase the radiation efficiency at low frequencies, leading to a decrease in sound insulation performance.

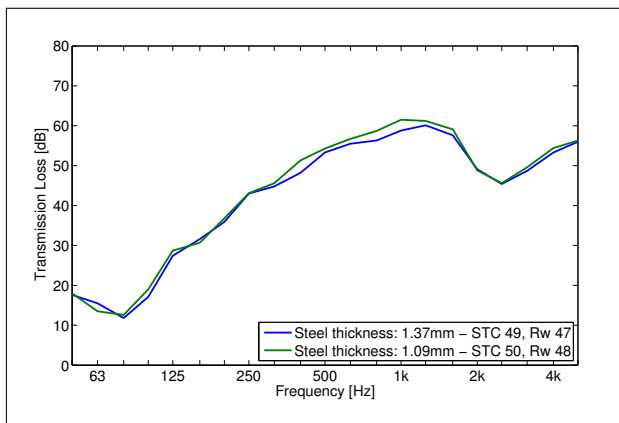
Figure 8. Influence of steel thickness. The steel thickness was found to be of minor importance in this study. However, light gauge walls will show different behaviour in terms of sound insulation.

Figure 8 shows the Sound Transmission Loss of the reference assembly, and of the same wall with studs with smaller steel thickness. There are some differences between the curves, but they are not very significant. The STC and R_w values improve by 1 point for the wall with thinner steel thickness. While the observed effects between walls with different stud steel thickness are not very significant for the cases studied, it is expected that using light gauge studs (0.455 mm, 25 gauge) would show more pronounced effects. Also, the differences between walls with studs of different steel thickness might be larger for walls without resilient channels.

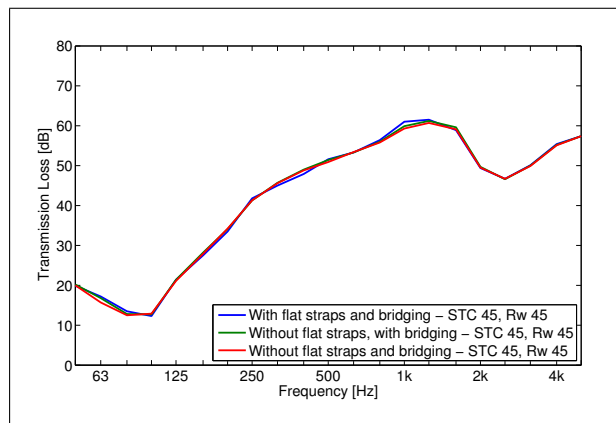
Figure 9. Influence of flat straps and bridging channel. The flat straps and bridging channels do not have a measurable influence on the direct sound insulation of the walls. They may however contribute to flanking sound transmission.

As shown in Figure 9, there is little difference between the three measurements. It is assumed that using the reference assembly (with 152 mm deep studs) would show similar results. The flat straps and the bridging channel do not have a significant effect on the direct sound insulation performance of heavy-gauge steel stud walls. However, they may contribute to the flanking sound transmission in buildings. The bridging channel in particular offers a path for vibrations to travel through the wall assembly horizontally and parallel to the wall surface.

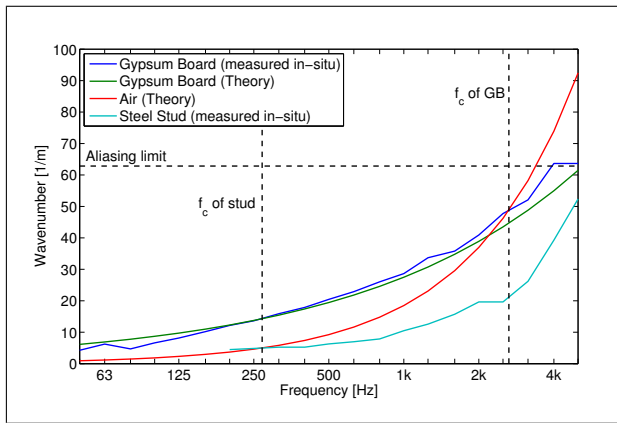
Figure 10. Wavenumbers measured on reference assembly. The cross-over points between the gypsum board/steel stud wavenumbers and the theoretical wavenumbers in air indicate the coincidence frequency of the gypsum board/steel stud, at and above which the gypsum board/steel stud radiates very efficiently.

Figure 10 shows the wavenumbers measured on the gypsum board, and measured directly on the steel stud. Unfortunately, it was not possible to determine the stud wavenumbers below 200 Hz. The first bending modes of the stud are below this frequency, and standing waves made the evaluation of phase differences between the response signals difficult. The horizontal line in Figure 10 indicates the aliasing limit of the calculation, as determined by the spacing between the response positions. Also shown in Figure 10 are the theoretical wavenumbers of the gypsum board and in air. The agreement between the theoretical curve for gypsum board and the measured values is quite good.

The vertical line at 2640 Hz indicates the measured coincidence frequency of the gypsum panels, at which the bending wavelength of the panels equals the wavelength in air. The gypsum board radiates very efficiently at and above this frequency, resulting in the coincidence dip that can be observed in all the Sound Transmission Loss curves presented in this paper.
